1. VESSEL INSPECTION DETAILS (COMBINED REPORT)

| Vessel ID: | hull3 |
| Report Number: | NautiCAI-2026-04-28-001 |
| Inspection Type: | Automated Underwater Hull Assessment (Multi-Image) |

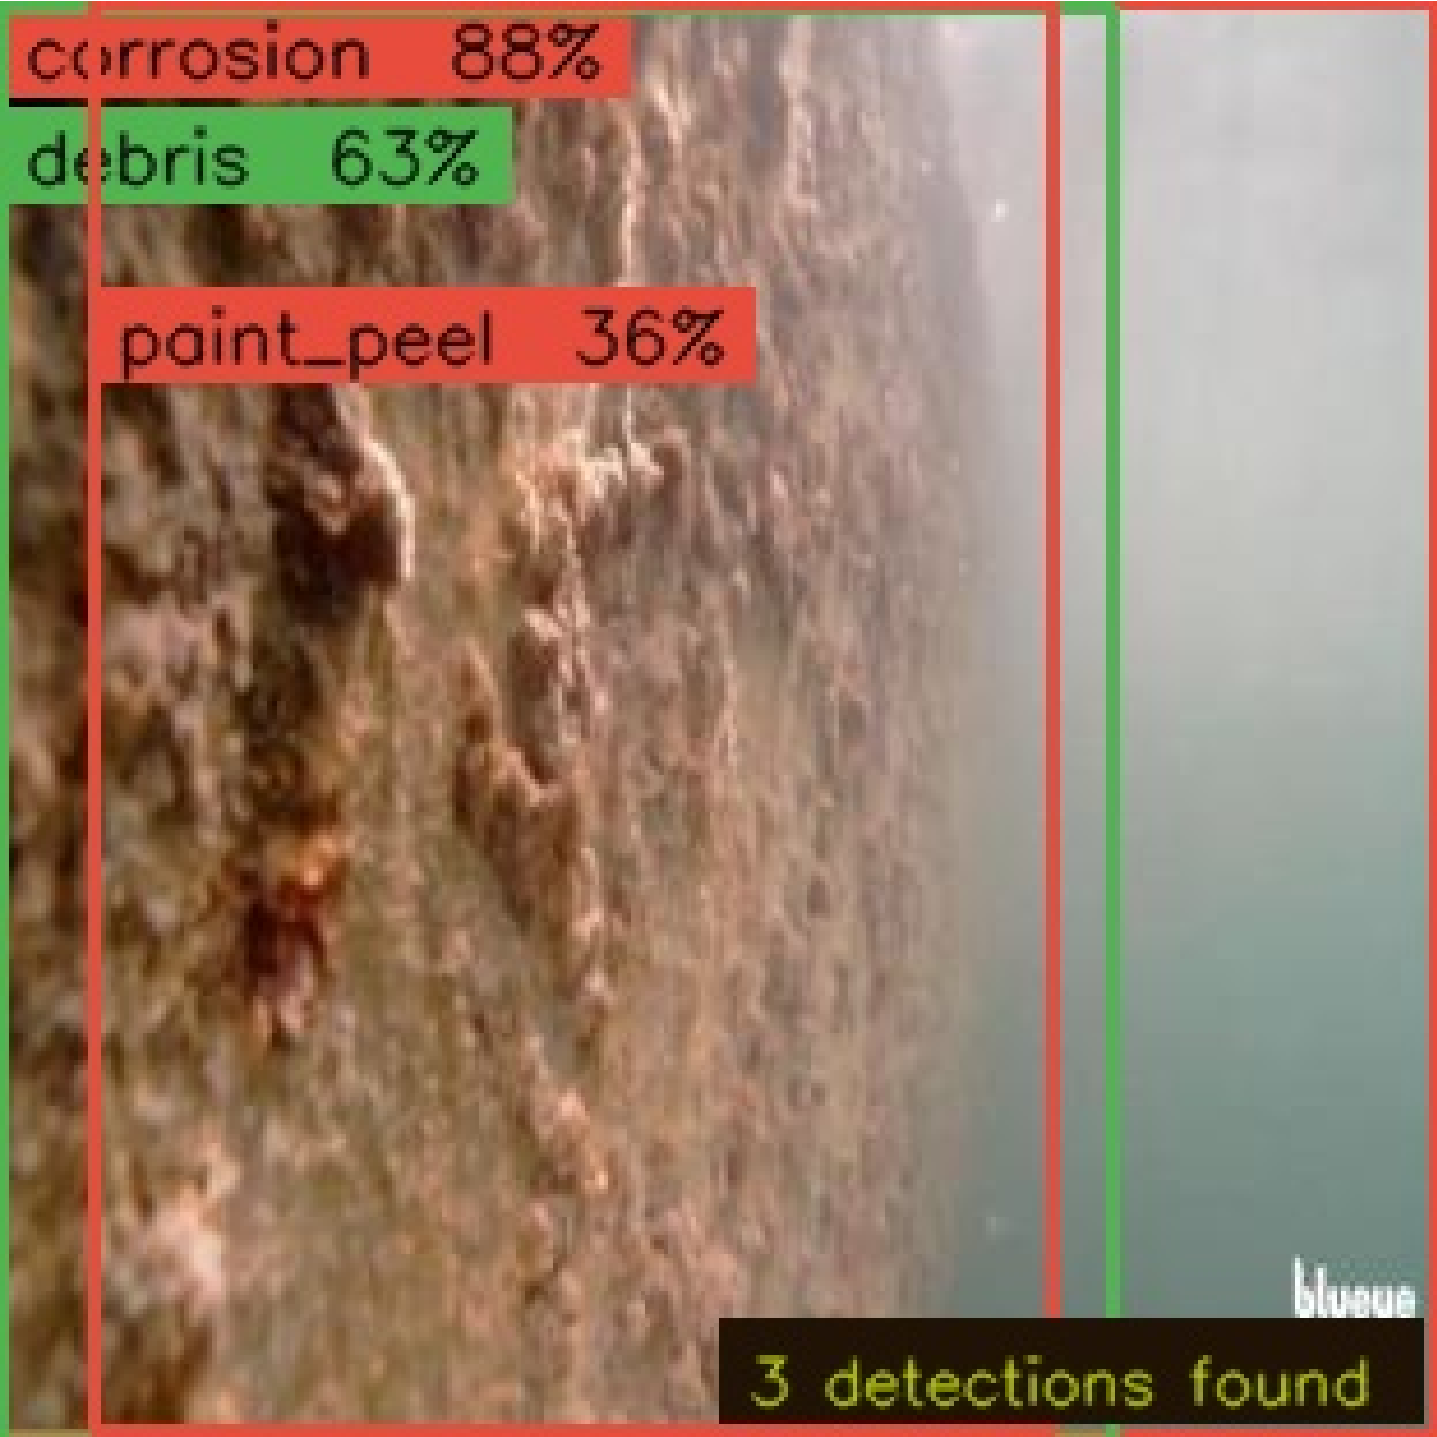
Inspection frame - Image 1 of 3 (annotated)

| Overall Condition: | High |
| Fouling Areas Identified: | 3 |

FR-4 (Heavy Macrofouling - Critical!)

!! IMMEDIATE CLEANING REQUIRED !!

Required Action: URGENT: Immediate dry-dock cleaning required!

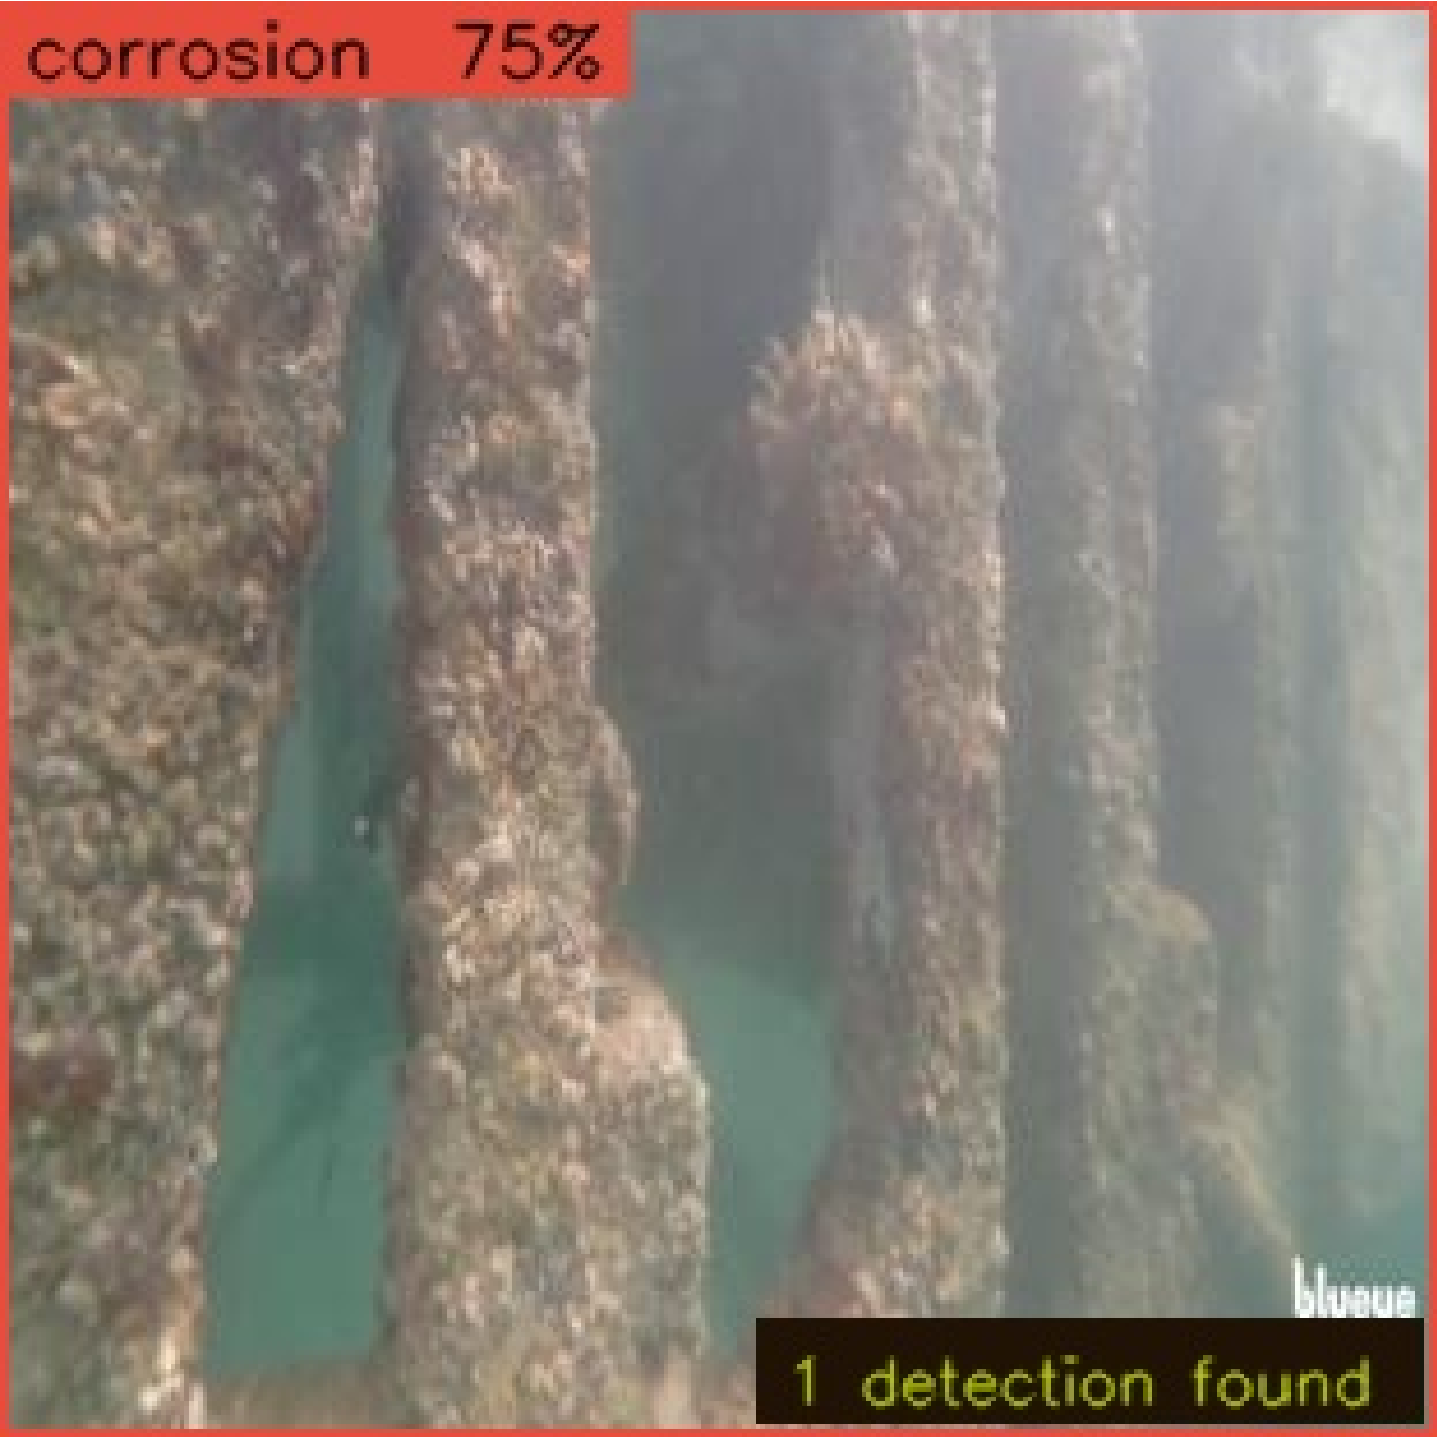
Inspection frame - Image 2 of 3 (annotated)

Overall Condition: High

Fouling Areas Identified: 1

FR-4 (Heavy Macrofouling - Critical!)

!! IMMEDIATE CLEANING REQUIRED !!

Required Action: URGENT: Immediate dry-dock cleaning required!

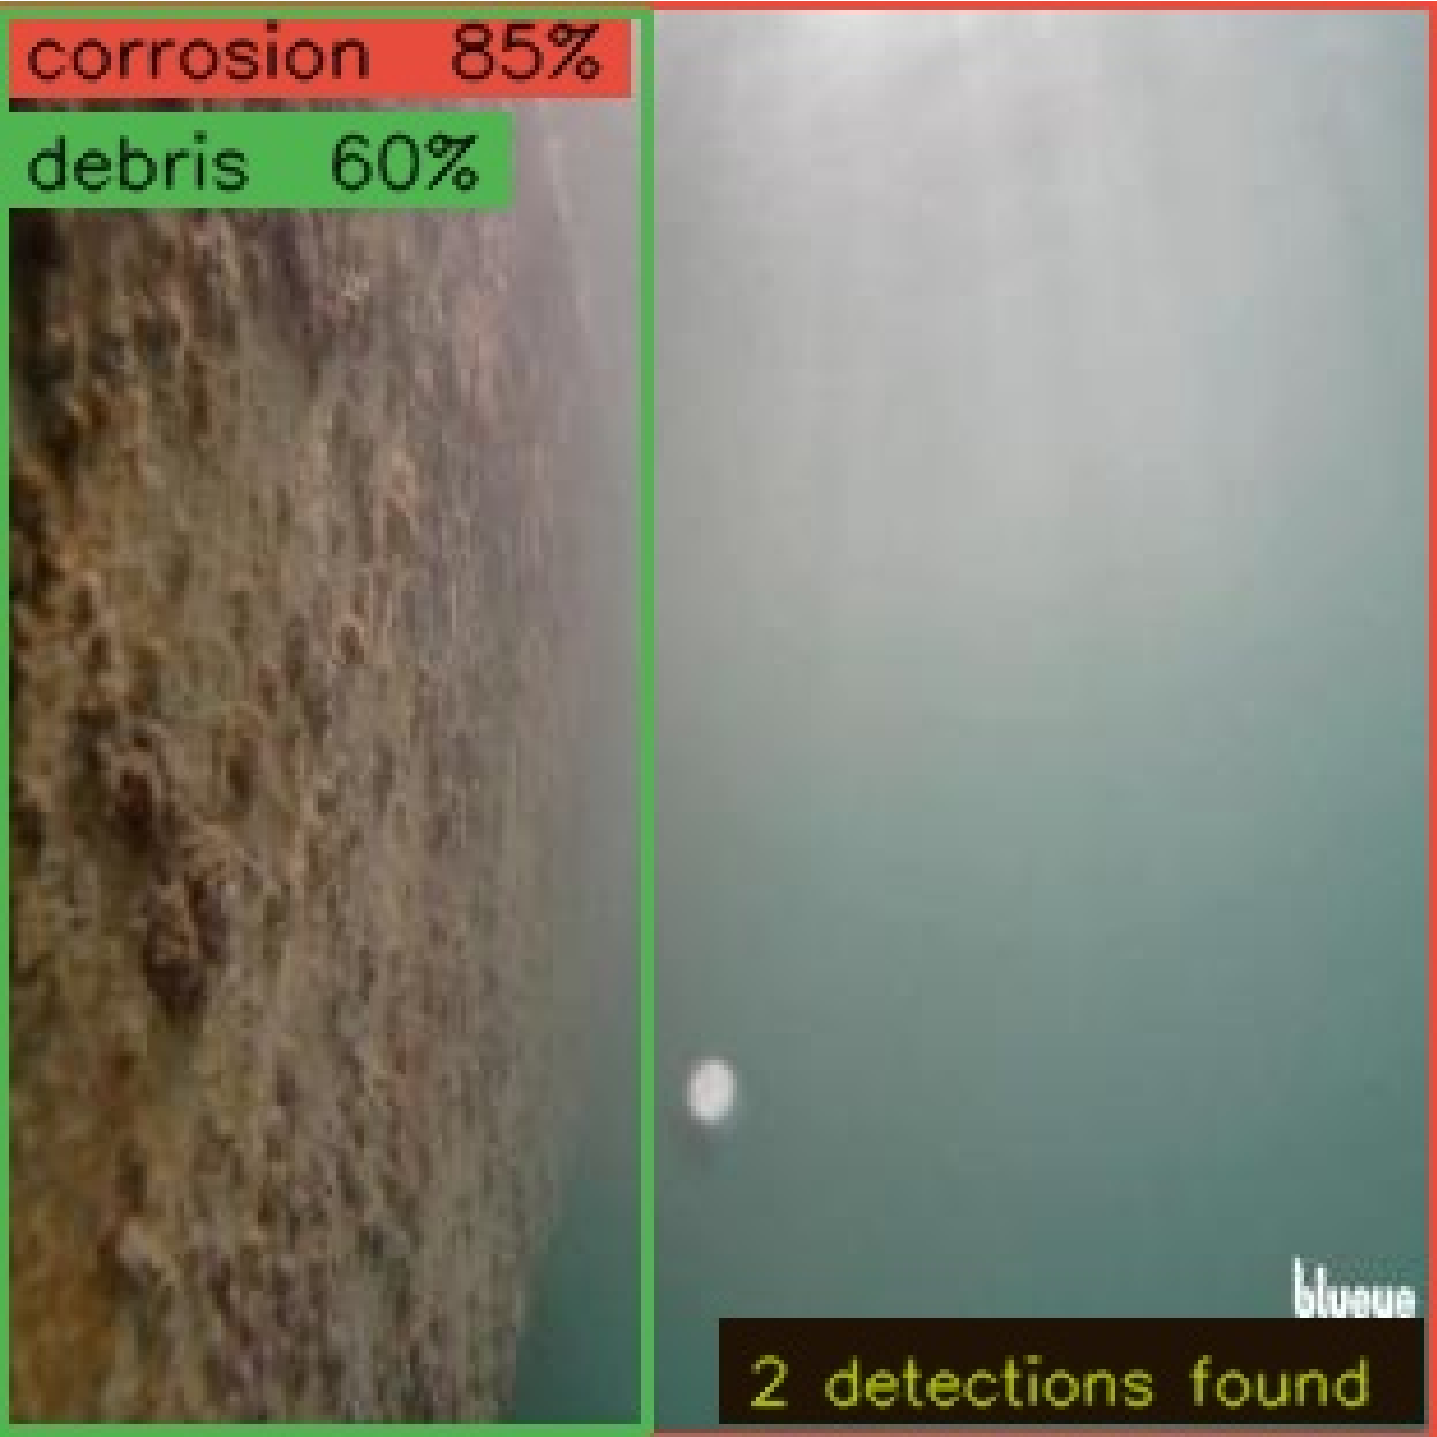
Inspection frame - Image 3 of 3 (annotated)

Overall Condition: High

Fouling Areas Identified: 2

FR-4 (Heavy Macrofouling - Critical!)

!! IMMEDIATE CLEANING REQUIRED !!

Required Action: URGENT: Immediate dry-dock cleaning required!
