**CONSTRUCTION OF A ROAD IN COSTA RICA ALONG THE SAN JUAN
RIVER**

(NICARAGUA v. COSTA RICA)

MEMORIAL

(ANNEXES FROM 1 TO 40)

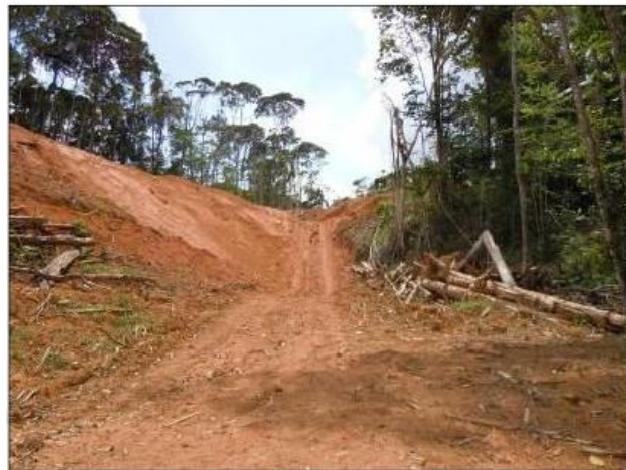
The fill material used to shape the road platform does not seem to have undergone any adequate compaction process. Said material appears loose in most sectors. Figure 28 shows a fill area with loose material eroded by storm water drainage.

Figure 28. Fill area, road section 6.
Source: LannameUCR, May 2012

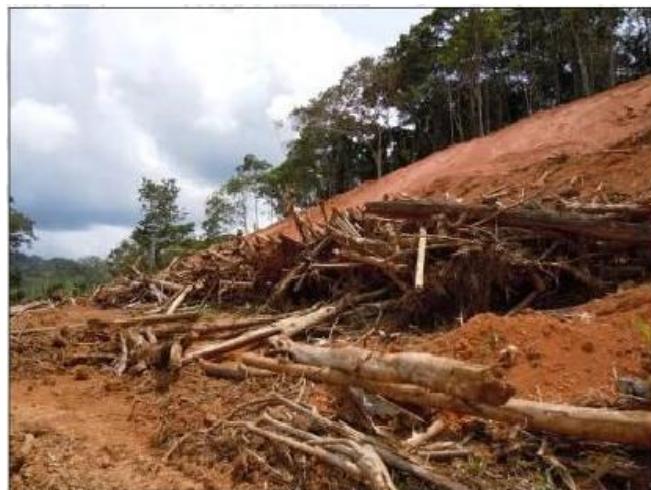
and without entirely covering the fill area. Figure 9 shows tree trunks and brush laid at a fill embankment foot.

Figure 29. Brush and tree trunks laid at embankment foot, road section 6.
Source: LannameUCR, May 2012

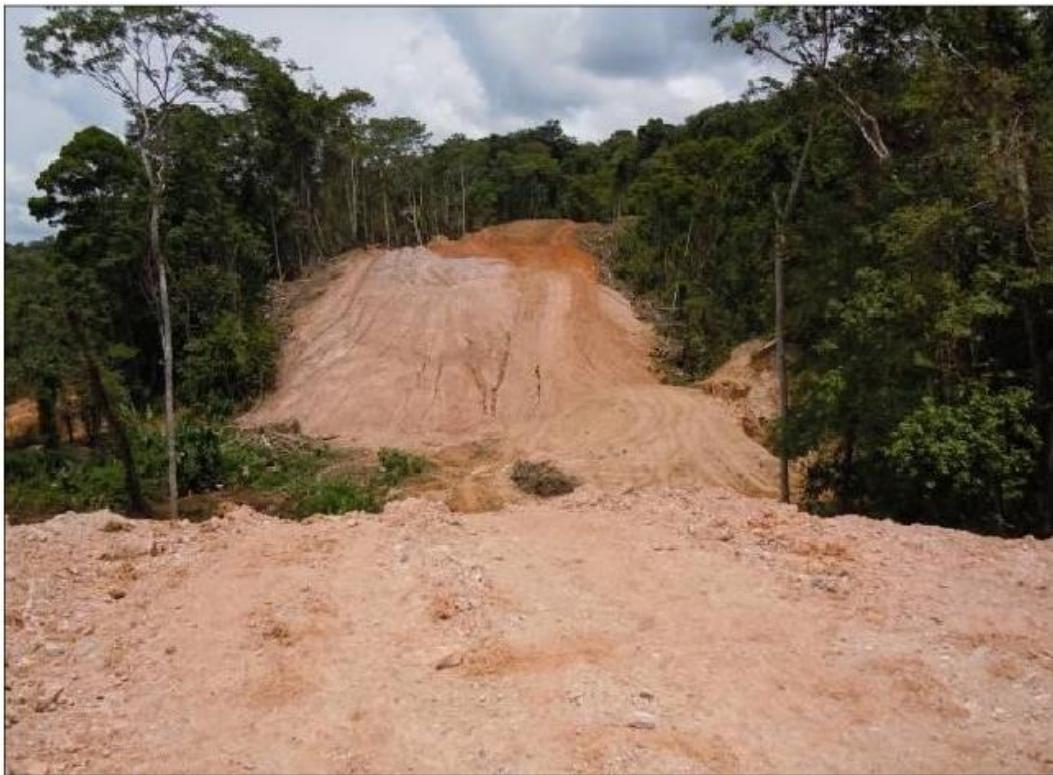
Figure 31. Cut and fill area in mountainous zone, road section 6.

A water course was found at the bottom of the mountain, where a stream crossing should be built, in accordance with existing flow characteristics, to decrease sediment load and changes in the natural channel as much as possible.

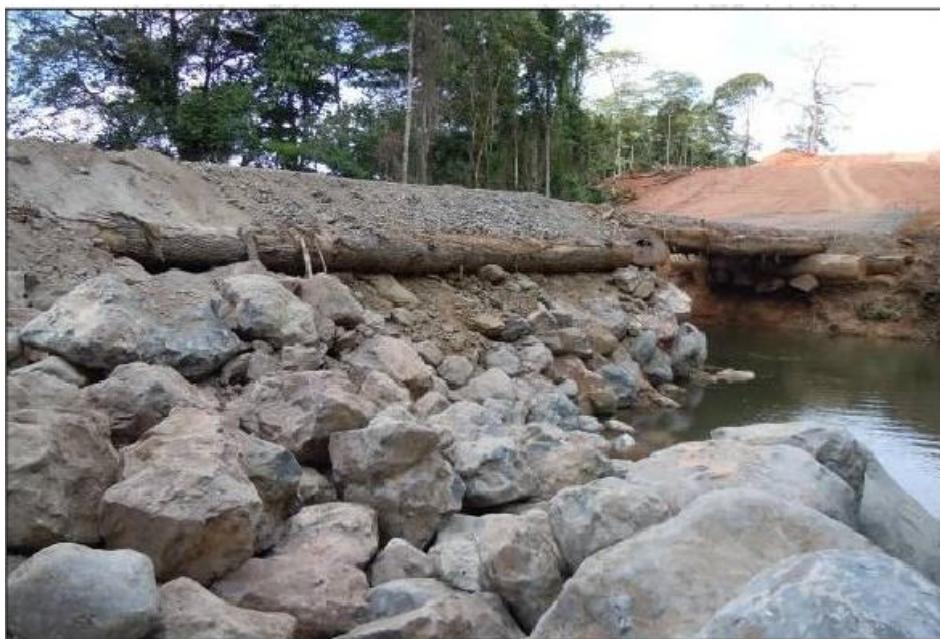
Figure 32. Log bridge over Infiernito River. Reduced hydraulic cross-sectional area.

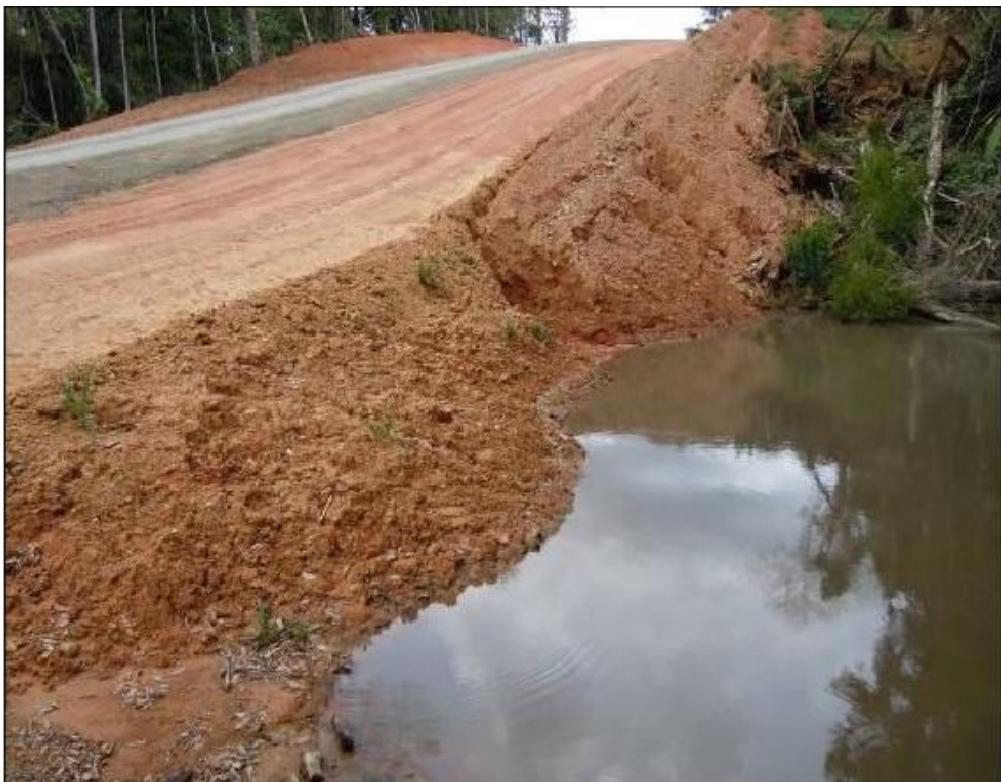
Figure 33. Blocked bodies of water.

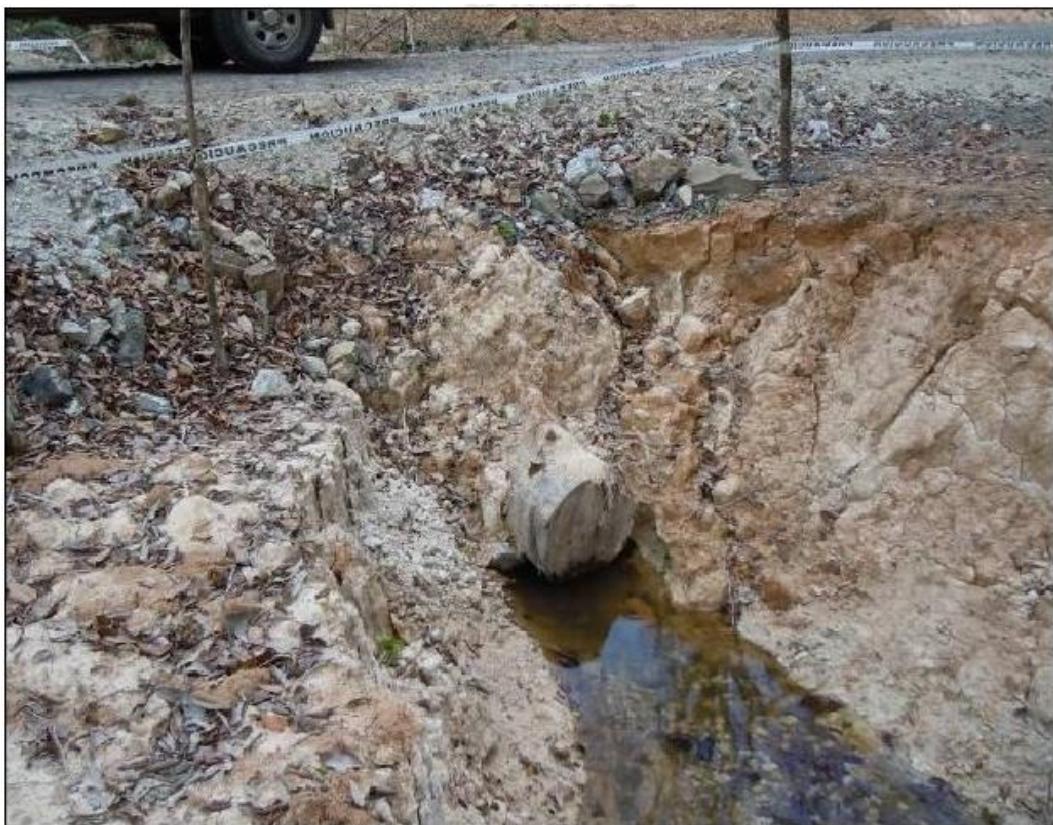
Figure 34. Logs used for stream crossing in road section 7.

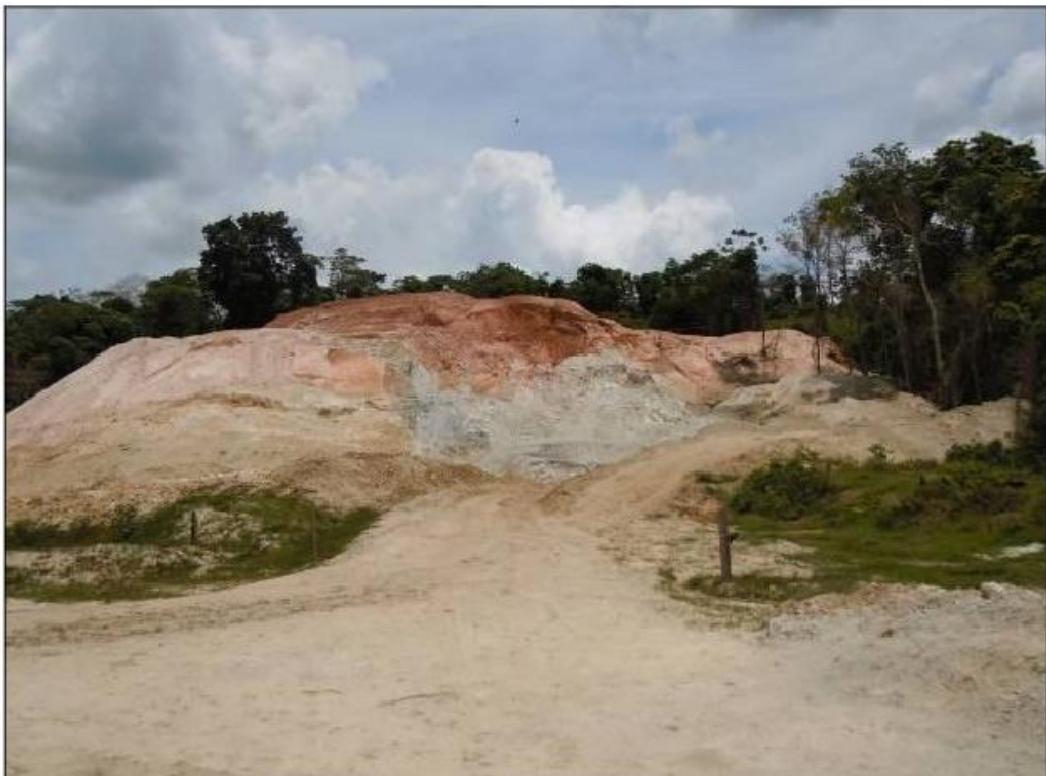
Road surface materials come from different sources. At some points these materials were seen to be taken from some channel excavation; however, materials extracted from some sort of quarry were also identified. In this road section, for instance, there is an operating quarry that apparently has not followed a staged extraction process (typical and mandatory for these sites), thus facilitating nearby waterbody erosion and sedimentation processes (see Figure 35).

Figure 35. Road surface material extraction site.

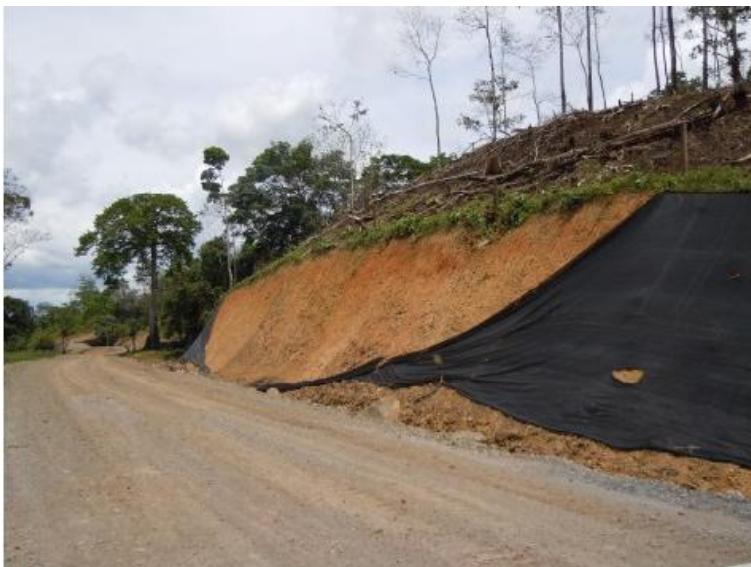
Some points along this road section exhibit a woven material (“saran” type) laid over slopes. This material may reduce rain and wind erosion but will not decrease the amount of sedimentation because it is not a nonwoven geotextile capable of retaining these sediments. In addition, since the material has been placed in a scattered manner it is not significantly effective (see Figure 36).

Figure 36. Scattered placing of woven material on slopes.

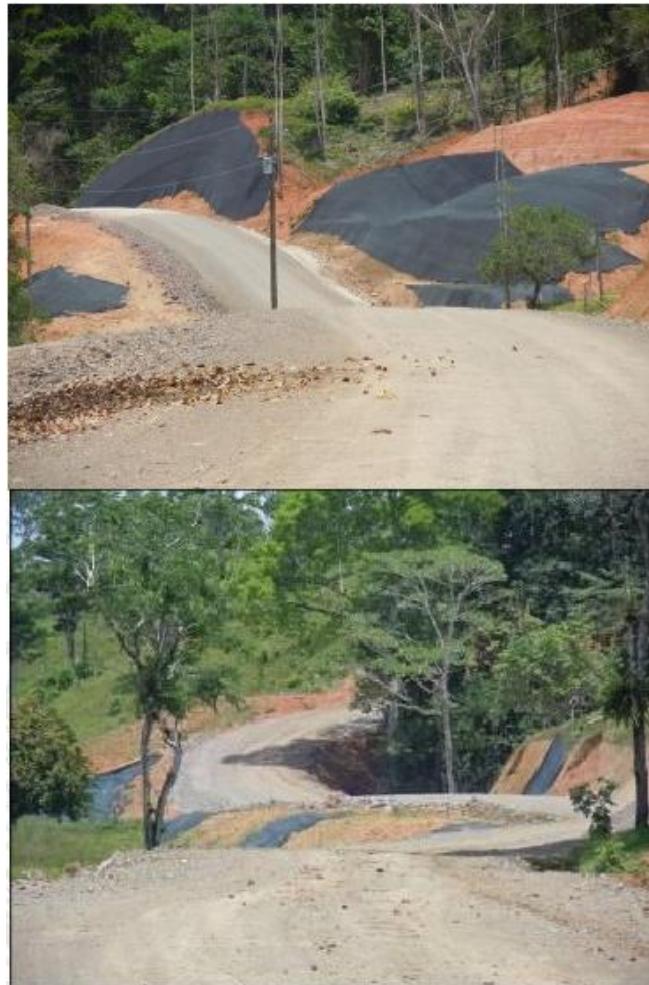
Figure 38. Saran fabric placed on cut and fill slopes, road section 8.

In sectors where saran fabric was placed seemingly to protect slopes, as shown in Figure 38, designing and placing geotextiles would have been most advisable, as recommended by best engineering practices.

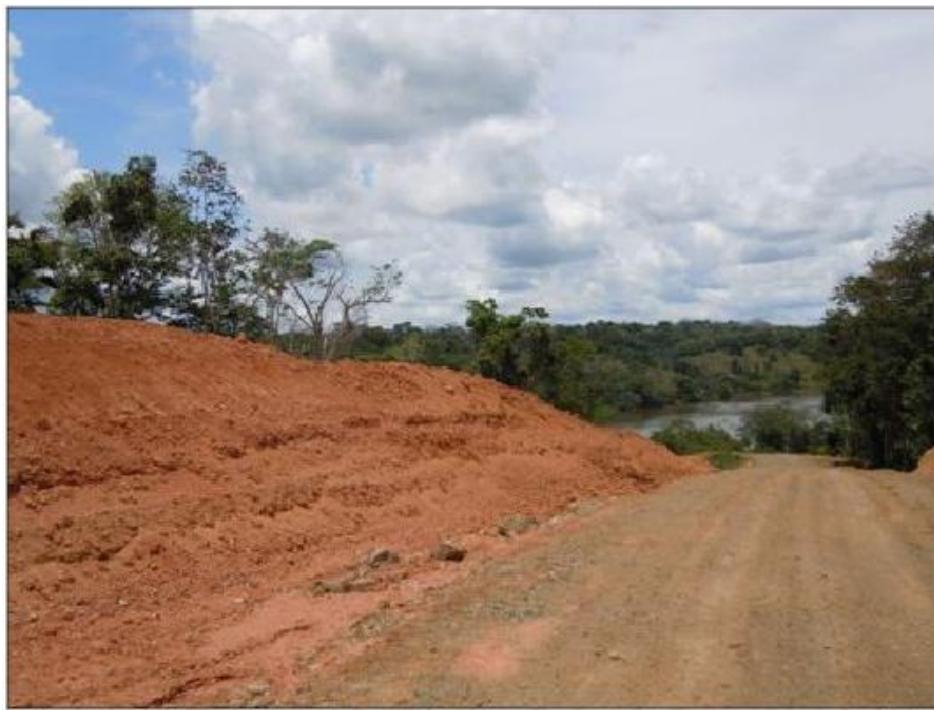
While traveling along Route 1856, most of the soil resulting from cuts was seen side-cast in fill areas, a desirable practice since it eliminates the need for building debris disposal sites. In road section 8, however, an excavated material disposal mound was seen on a mountain slope, which could create stability problems and contribute sediments to nearby bodies of water during the rainy season, as shown in Figure 39.

Figure 39. Excavated material mound, road section 8.

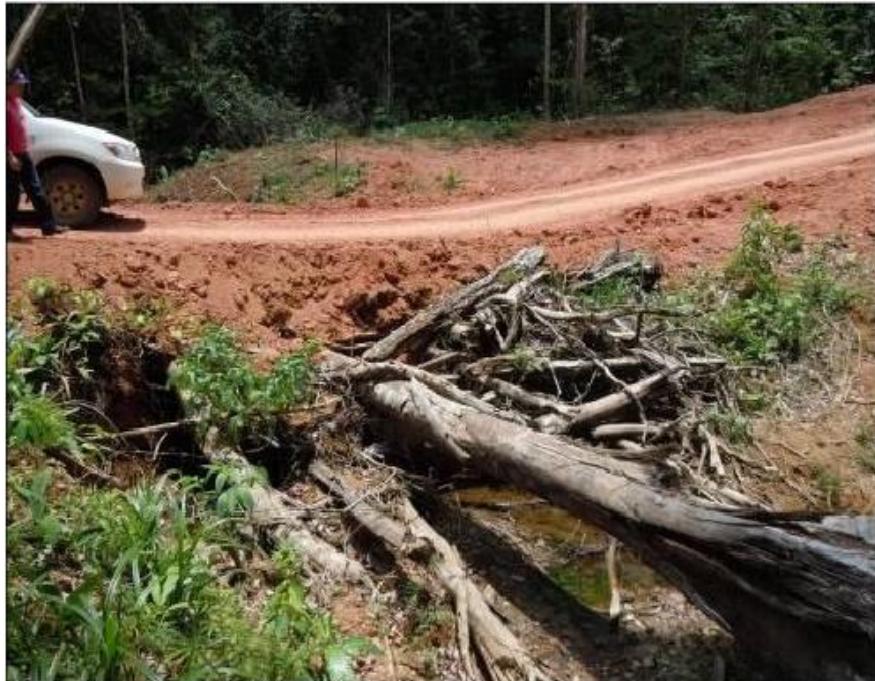
One particular issue along Route 1856 road section 8 is the presence of numerous streams in mountain and forest zones. Small rivers or brooks are found approximately every 200 meters, and provisional drainage measures have been implemented only in some cases, given there are sites where fills have entirely blocked watercourses. Figure 40 shows tree trunks placed as a provisional measure to enable vehicle road traffic at a stream crossing. Natural water flow can be seen becoming plugged and water starting to accumulate at the upstream side of the crossing. This type of provisional measures should be replaced as soon as possible with culverts properly designed according the each stream flow rate to prevent eventual road embankment damage during the rainy season.

Figure 40. Provisional log stream crossing, road section 8.

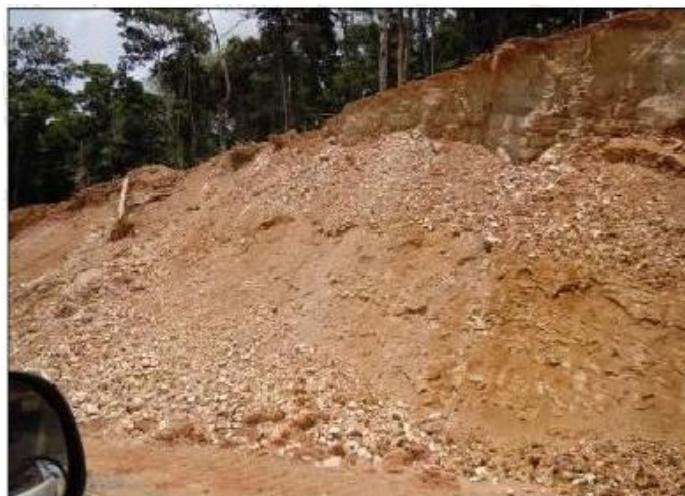
Figure 42. Slope landslides in cut areas, road section 8.

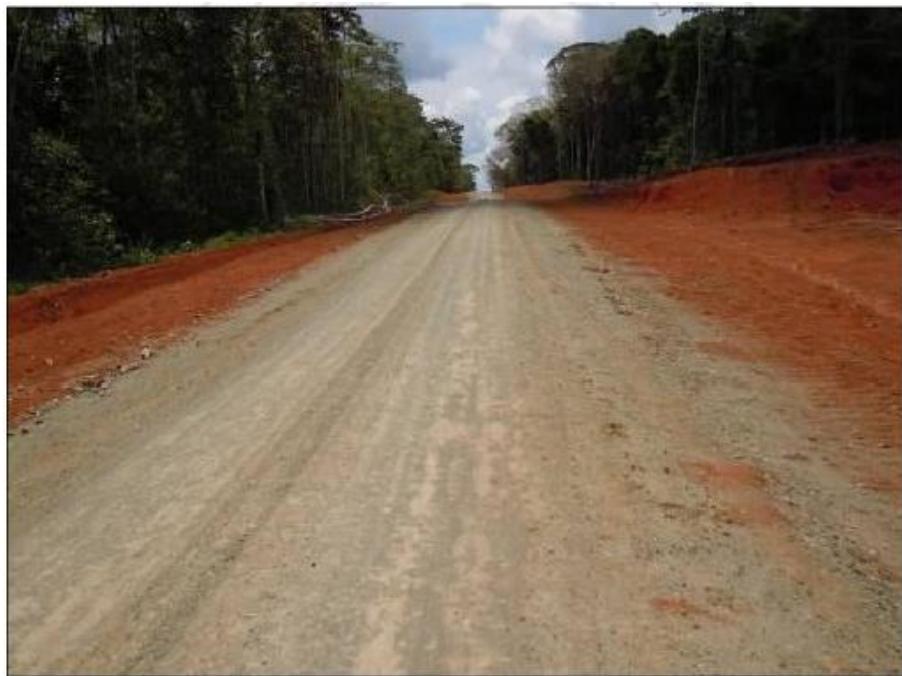
Figure 44. Inadequate road surface granular material on section 9.

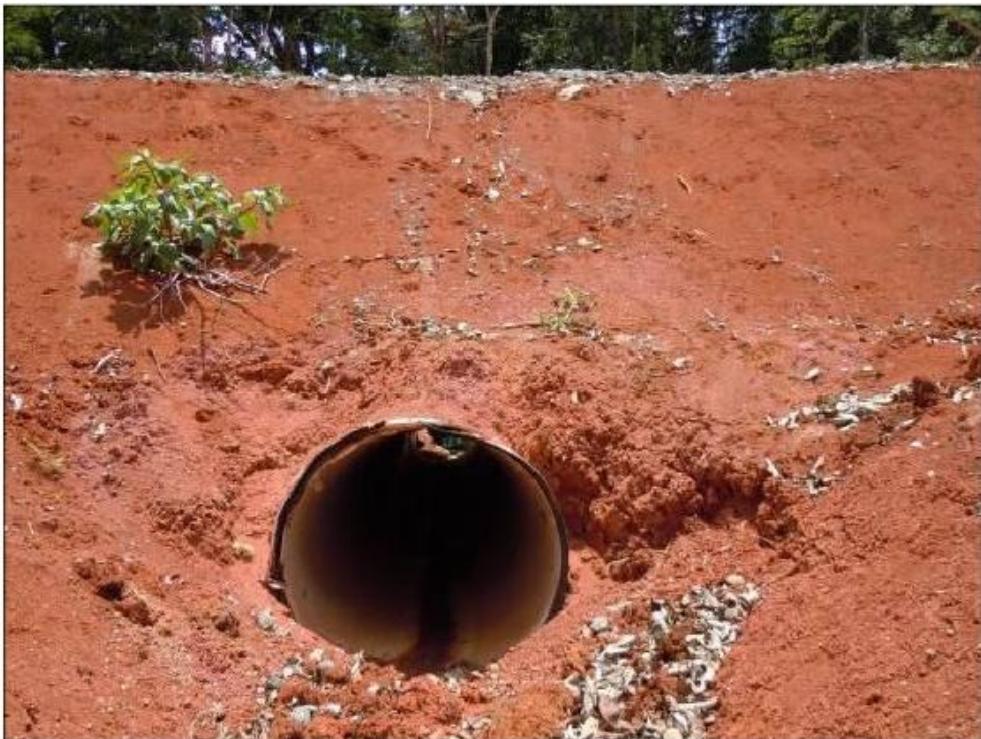
Figure 45. Poorly installed Rib-Loc pipes.

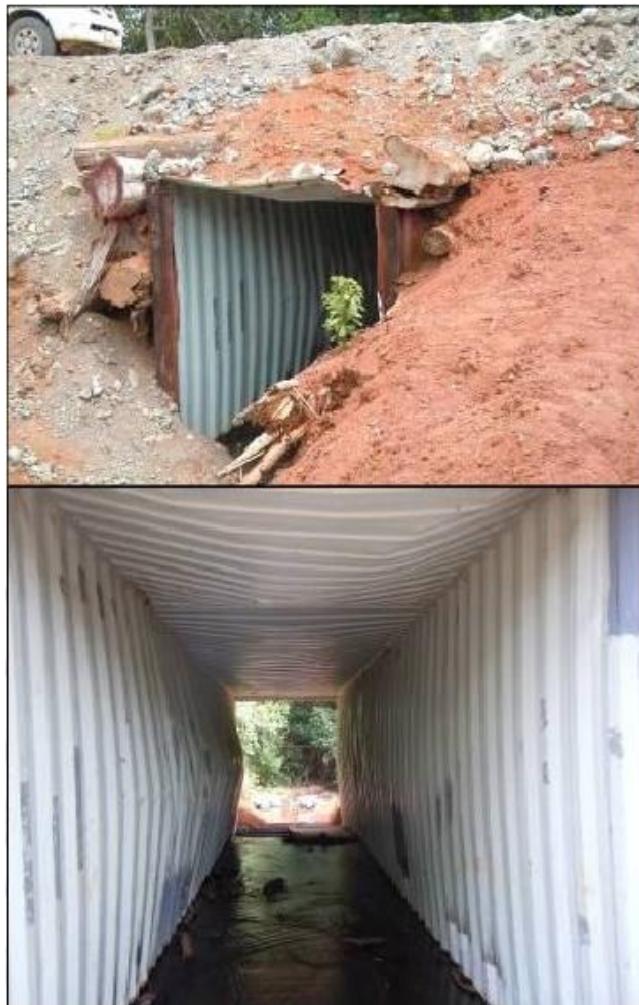
The use of cargo containers as square culverts was noticed at some points along this road section. Obviously, a nonexistent foundation and loads from fills have caused major deformations in these structures since they were not designed for this purpose. This is not deemed to be an adequate solution for stream crossings since there is no assurance these elements will be able to withstand a significant flow rate without resulting in fill loss (see Figure 46).

Figure 46. Containers used as square culvert pipes.

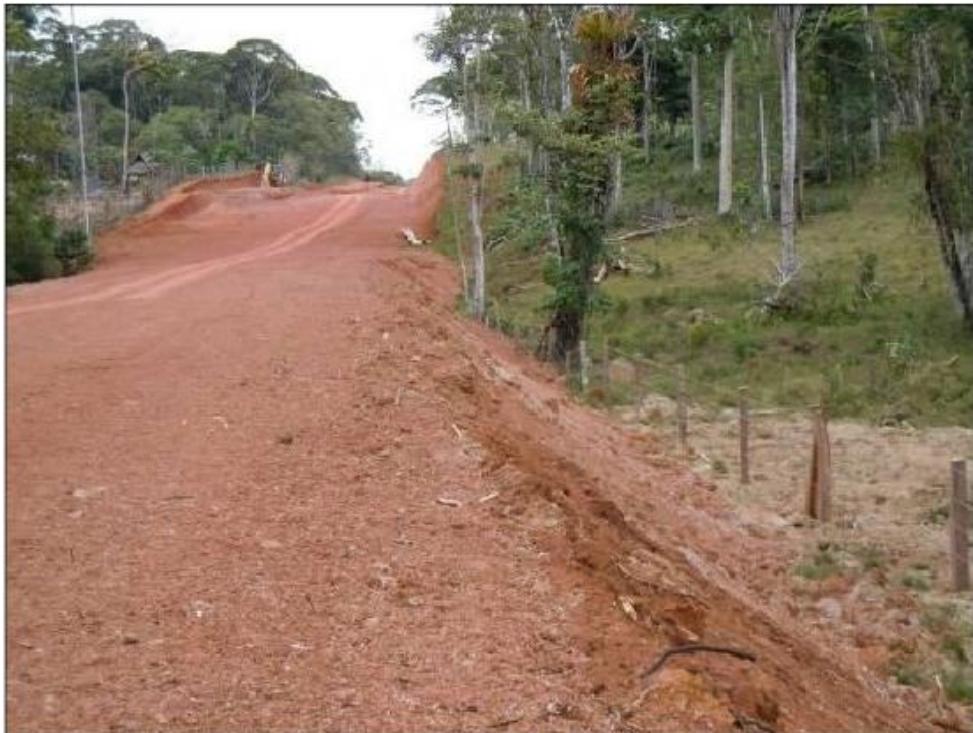
Fills up to 3- meters high with edges breaking down onto adjacent terrain were found in several sectors of this road section indicating they were not built according to suitable compaction processes. Additionally, an absence of drainage structures in several sectors may lead to losses in platform cross-section from run-off water action (see Figure 47).

Figure 47. Fill areas without drainage structures.

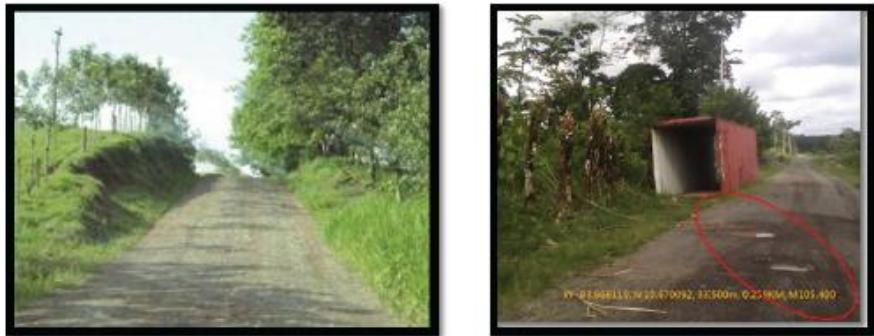
F1. The roads have no drainage ditches, cleared areas in this stretch have no bluff.

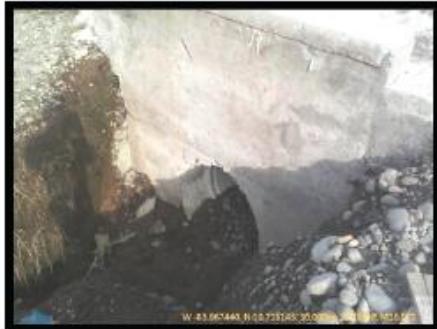
F3. A PVC drainage is obstructed by movement of *finos* of the base layer.

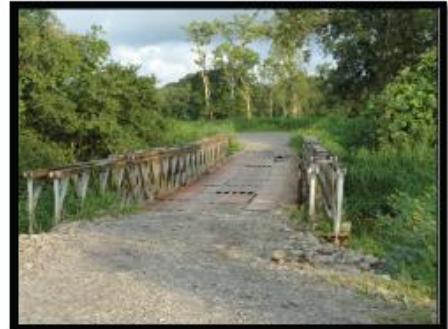
F4. The Bailey bridge is in a state of advanced deterioration, with loose planks.

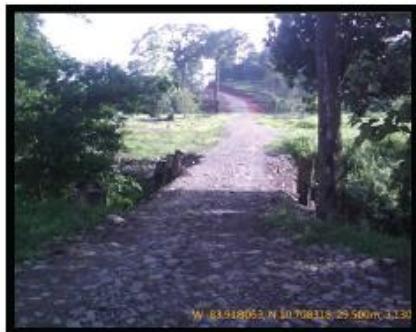
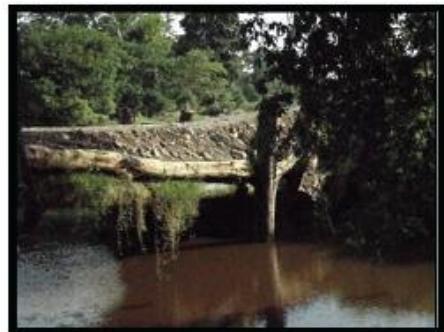
F5. Bridge with a base built from wooden logs.

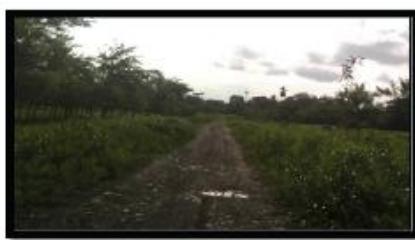
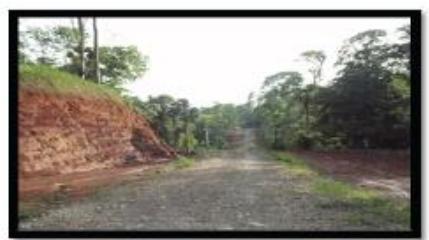
F6. The route has no drainage, there are cracks and holes, and areas where there are oversized boulders not apt for roads.

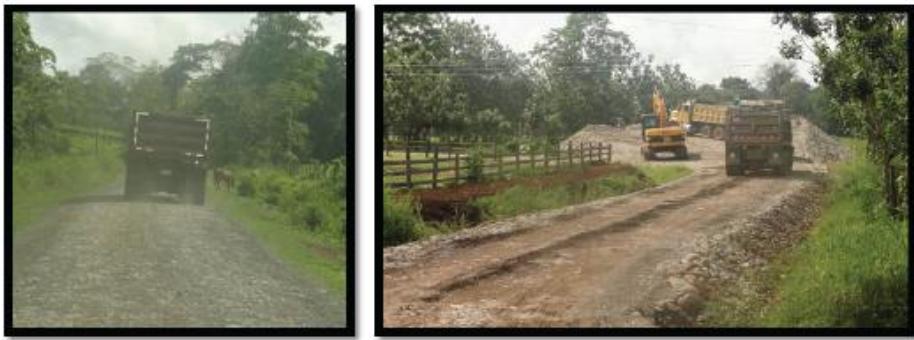
F9. The route is generally in good condition.

F10. Machinery and stored supplies were observed.

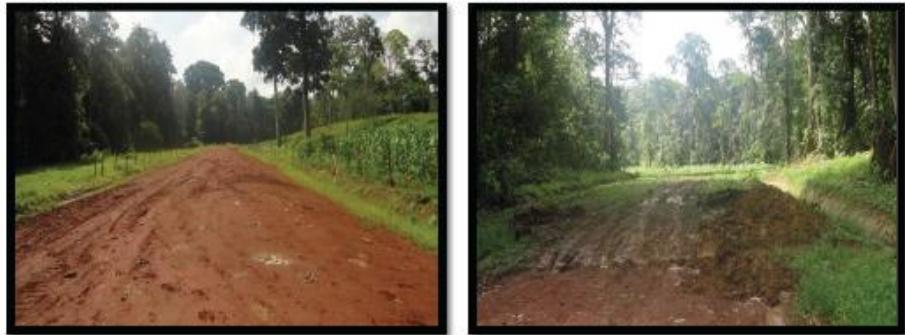
F11. Paths with compacted earth.

F12. Dirt roads where water has accumulated making transit impossible. Impact on the forest can be observed.

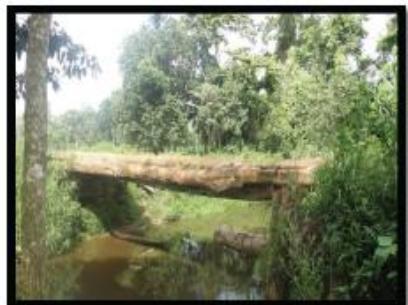
F13. Different bridges on wooden pillars can be observed.

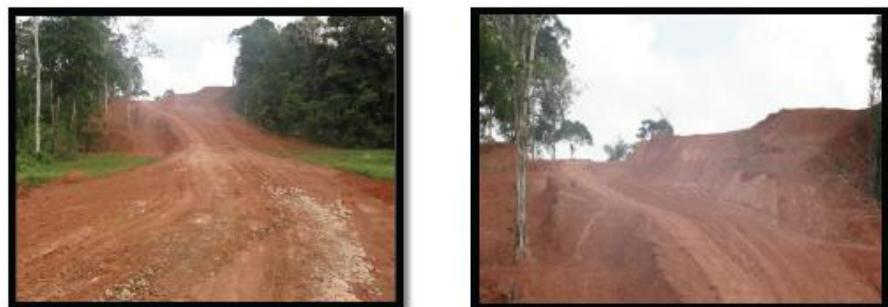
F14. A dirt road with no drainage; as it was not based on plans, disorganized cuts and fills were carried out.

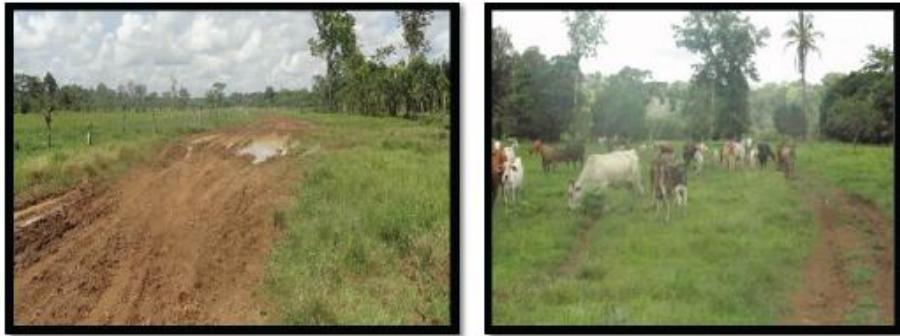
F15. An approximately 10 kilometer stretch which basically consists of paths between lots; transit along this road is very difficult even with 4x4 vehicle.

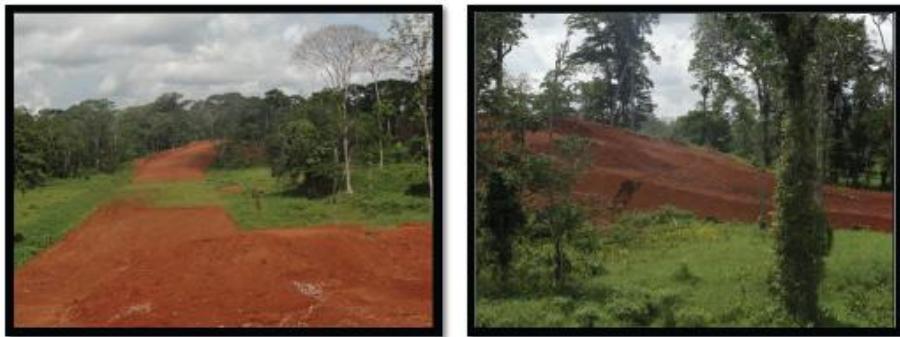
F16. Deforestation and impact on the zone's wetlands are evident.

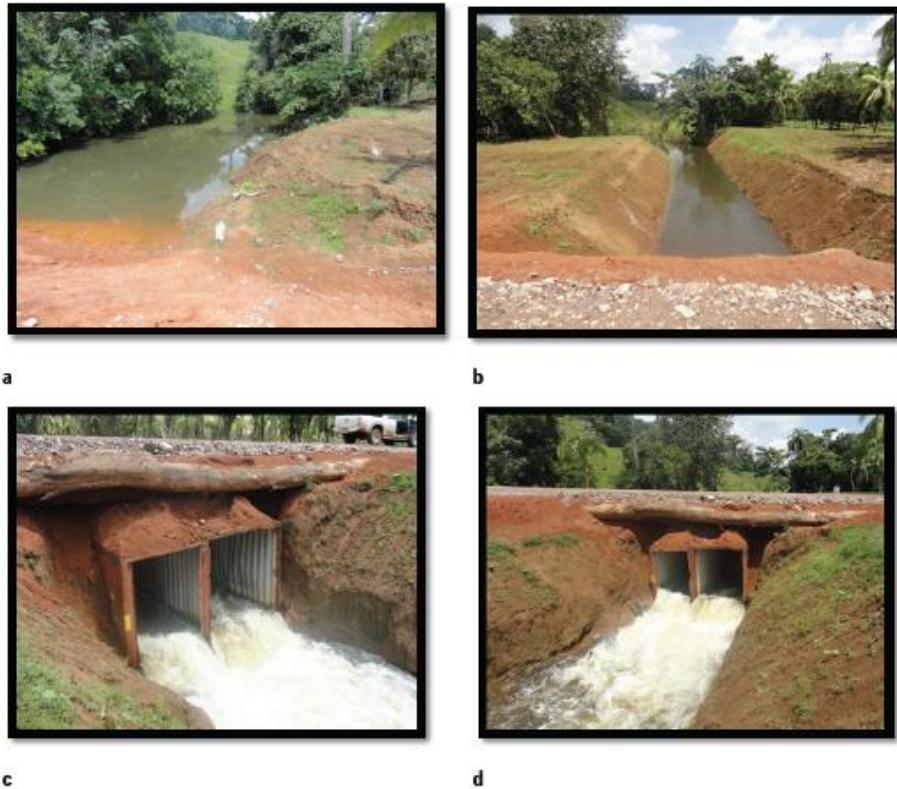
F17. Evident in the first photo (a) is the obstruction of the natural flow of the river; the second photo (b) shows the construction of a canal for re-routing the flow of the river; the last two photos (c and d) show the construction of a bridge where wooden logs and two container trailers used for drainage are part of the structure; bulging can be seen; bulging in the walls of the container trailers can also be seen.

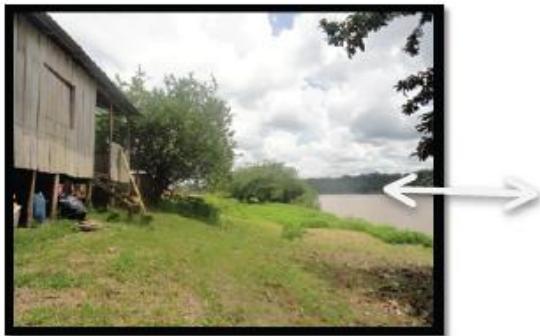
F18. There are stretches of the road where its path is very close to the bank of the Río San Juan, these stretches of the road should be re-evaluated.

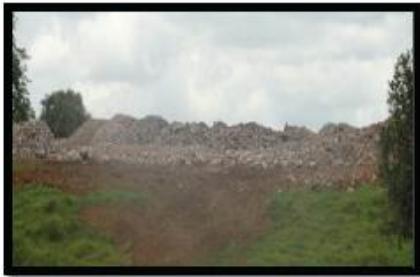
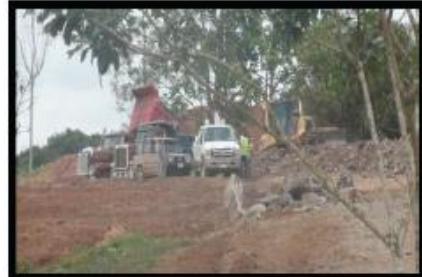
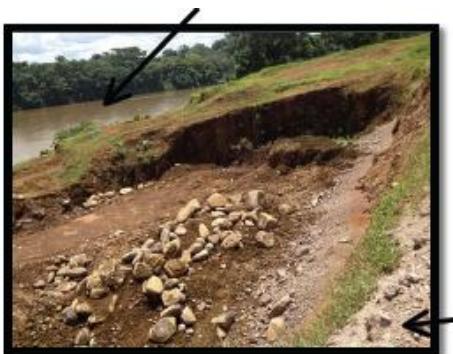
F19. Materials used are only meters away from the Río San Juan; very big boulders can be observed as well as piles of broken boulders. Here, what is apparently a trench is located between the Río San Juan and the road, several meters from the river. These situations should be evaluated.

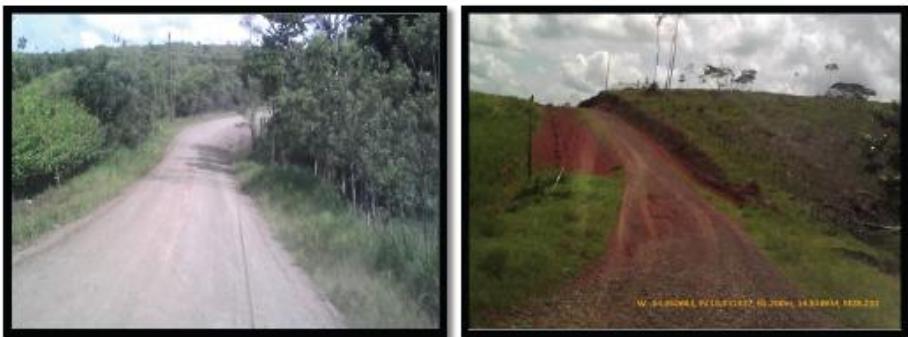
F20. Lack of maintenance to the drainage canals.

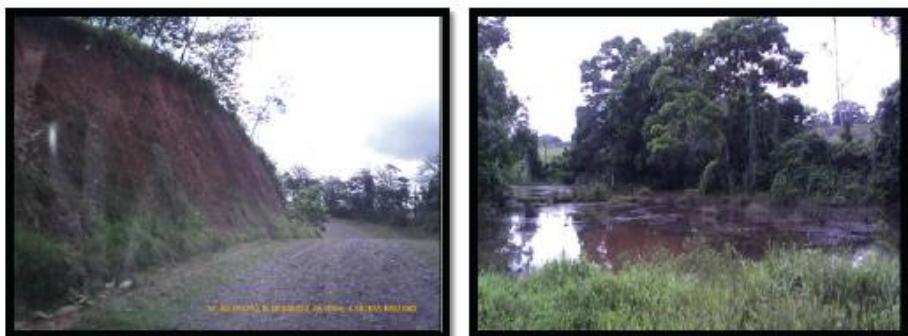
F22. Slope approximately six meters in height with an almost vertical slope.

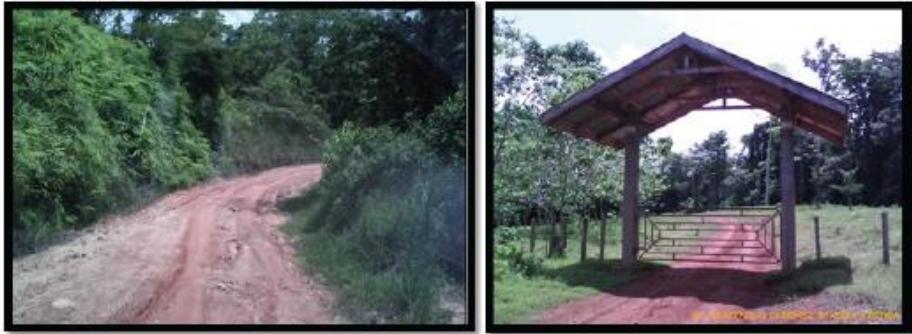
F24. Areas with cracks and holes and no drainage.

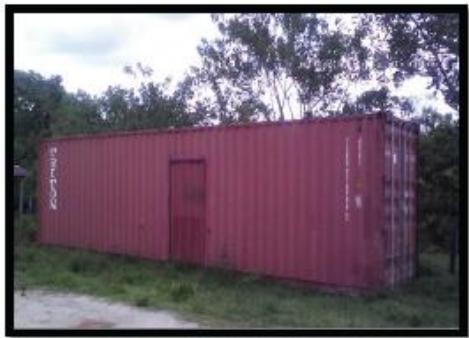
F26. There is a trailer container on the road approximately one kilometer before reaching Tiricias.

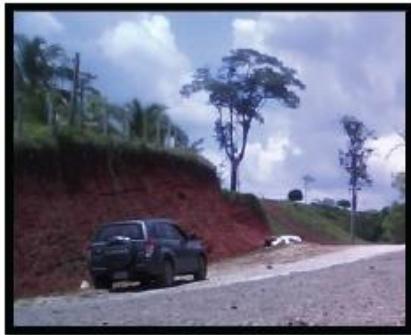
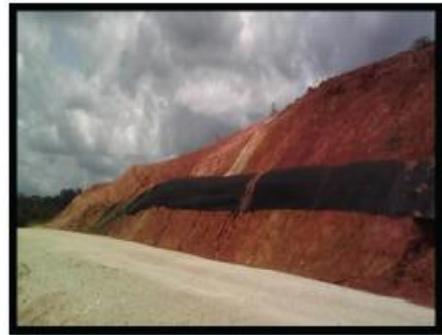
F27. There are huge slopes with high peaks in this area and no protection whatsoever.

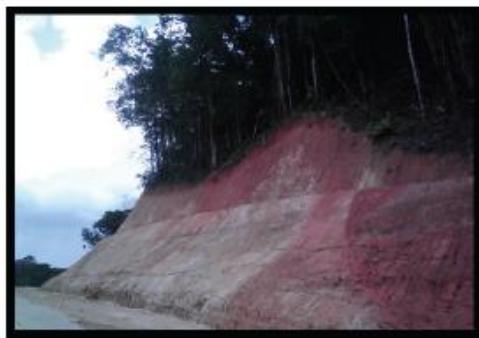
F.28. There are huge slopes with high peaks in this area and no protection whatsoever.

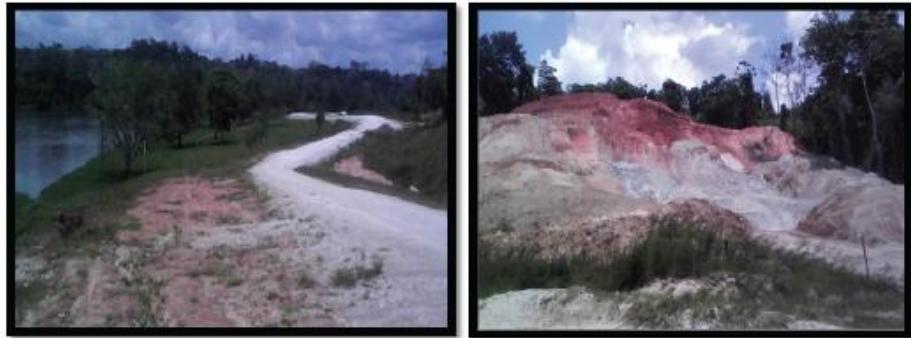
F29. In this area the recess from the Río San Juan is approximately 15 meters.

F30. In this area there is also a trench from which materials were extracted.

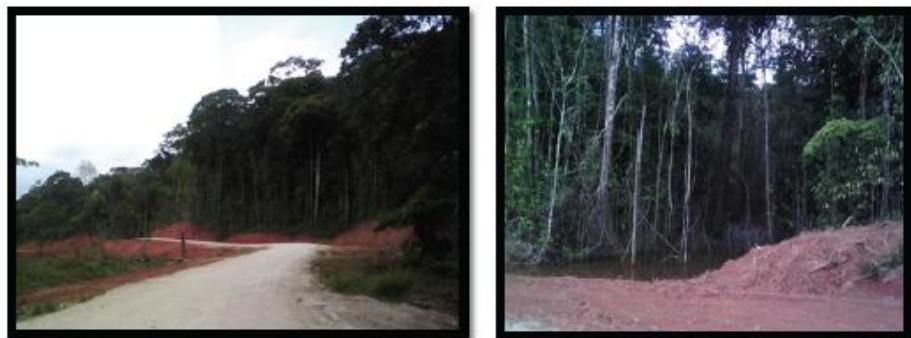
F31. Deforestation in wetlands area.

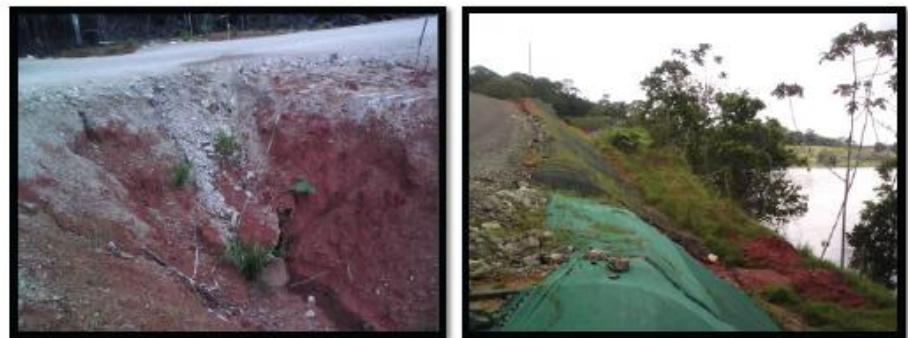
F32. Wooden logs are used to allow for the drainage of water.

F33. Recess from the river in this area should also be evaluated for compliance with the law.

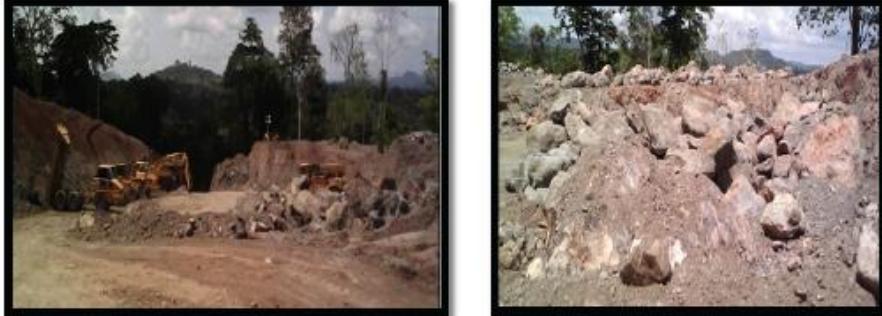
F35. Materials and machinery depot.

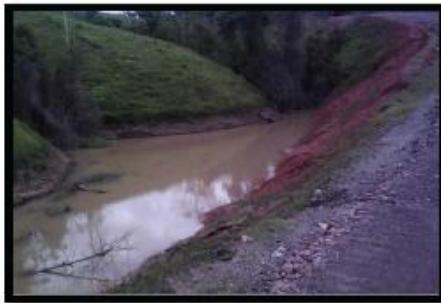
F34. Stagnant water with no drainage whatsoever.

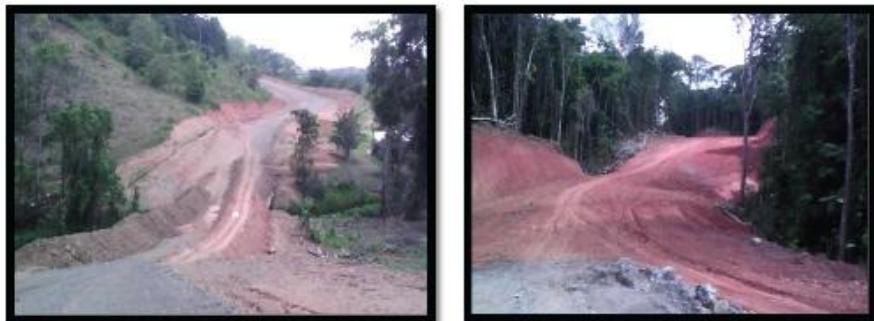
F36. Work in this area is incomplete.

F37. Gravel ends in this area. The dirt road is almost impossible to transit. Impact on the forest is noticeable.

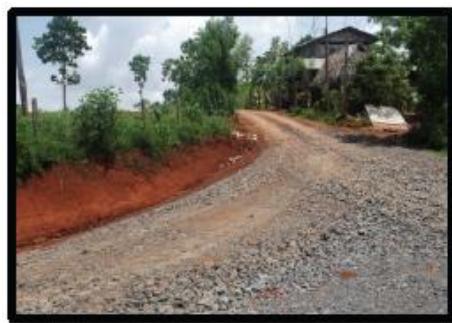
F38. Dirt road from Route 760 El Parque.

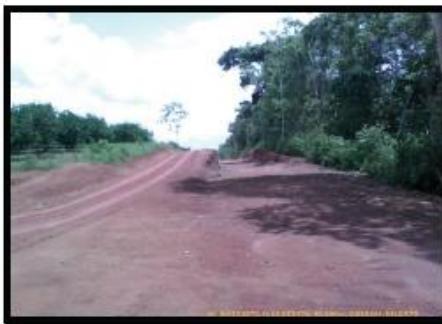
F39. Front-view of a stretch of the road where the earth is uneven.

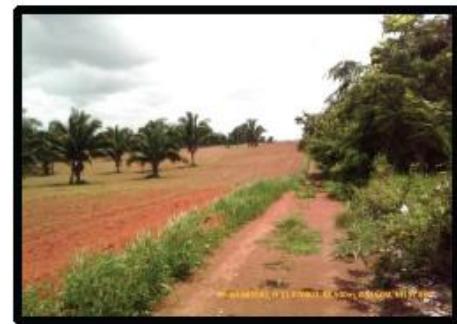
F40. A stretch of the road wide enough for only one vehicle.

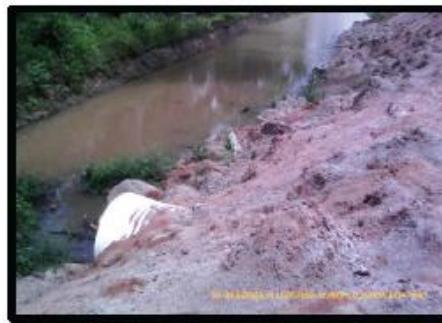
F41. Circular pipe serving as outlet for river water.

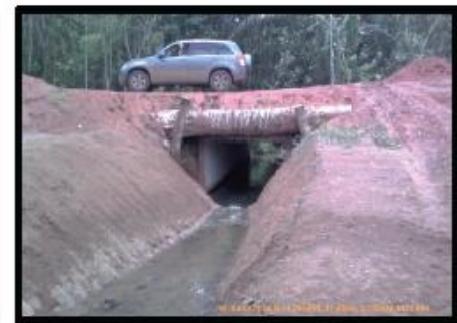
P42. A stretch of the road wide enough for only one vehicle.

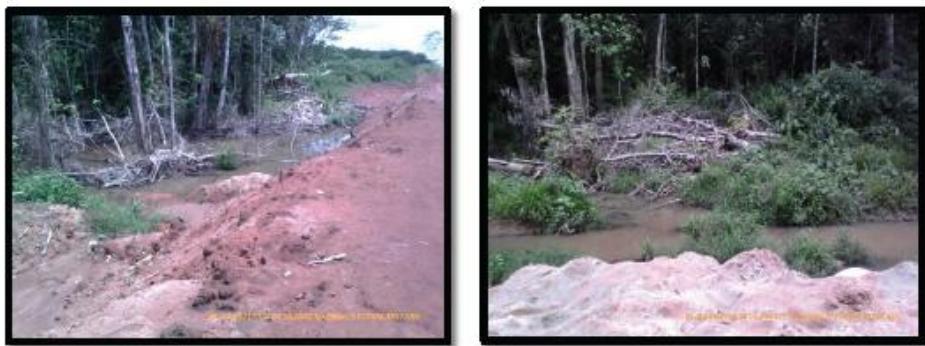
F43. Stagnant water and deforestation.

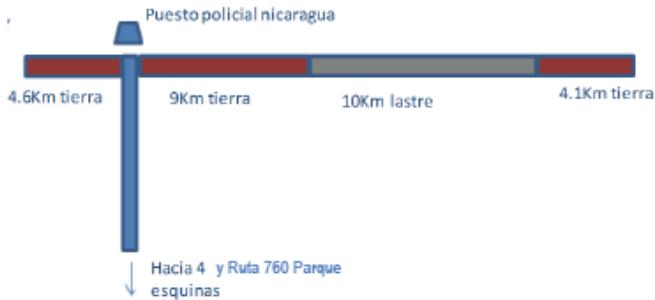
Diagram No. 6. Construction details regarding areas of this stretch that was visited.

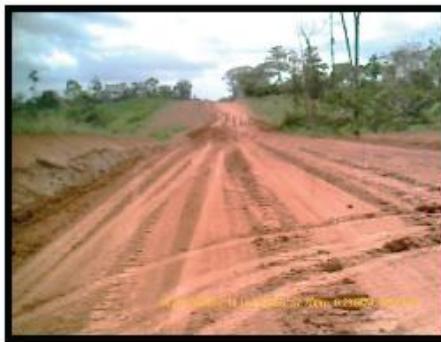
F44. View of a dirt stretch.

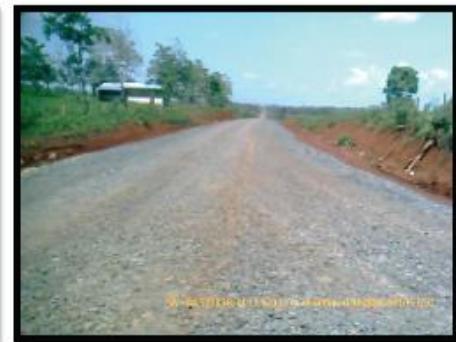
F45. View of a gravel stretch.

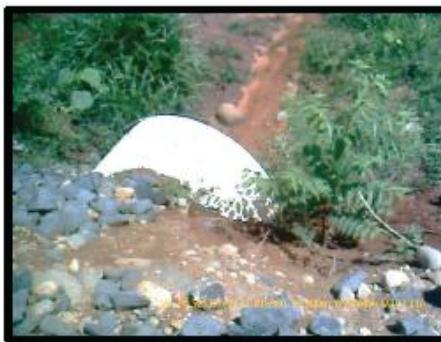
F46. Circular pipes serving as outlets for river water.

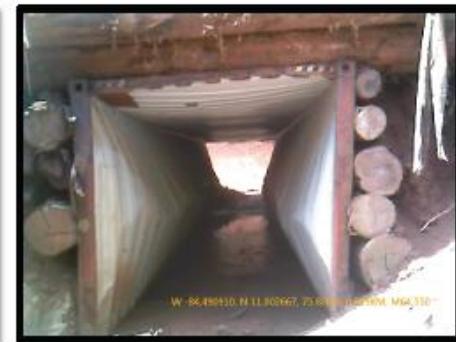
F47. Trailer container used as a bridge.

- 5.4 The lack of adequate drainage for channeling rainwater was observed. It can be foreseen that this situation can prematurely erode the work already done. It should be mentioned that in some areas trailer containers were used for greater drainage in the channeling of brooks. These trailer containers already reflect deterioration and are at risk of collapsing as reflected in the photographs included in this report.

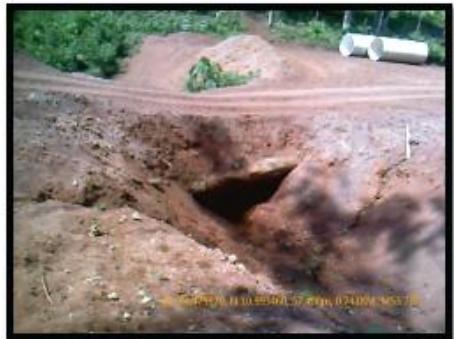
F48. Bridge and waterway with wooden logs.

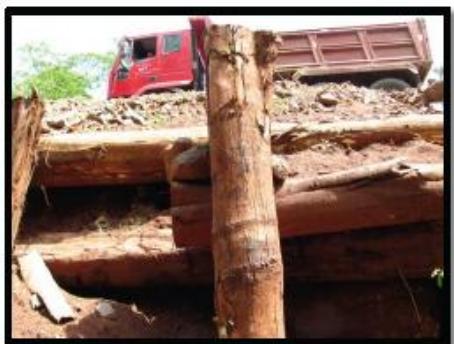
F49. Bridge being used for heavy machinery.

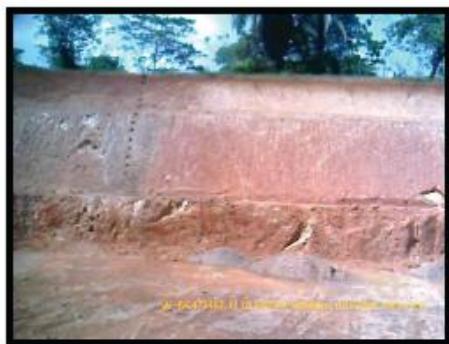
F50. Clearing of slope approximately six meters high.

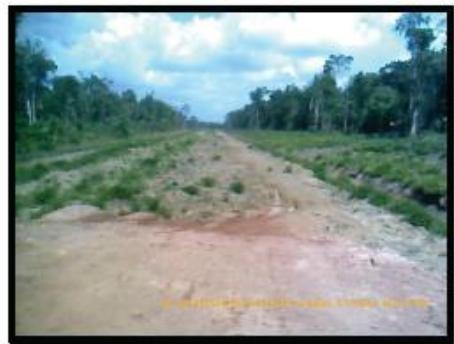
F51. End of the part of the road that can be transited.

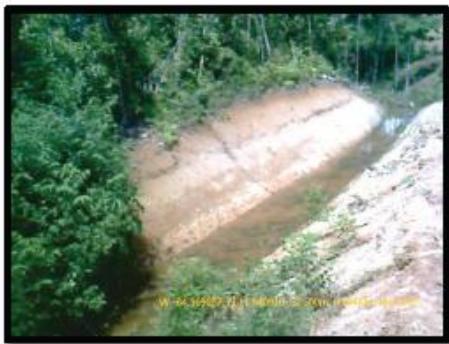
F52. Dirt drainage ditch serving as water outlet.

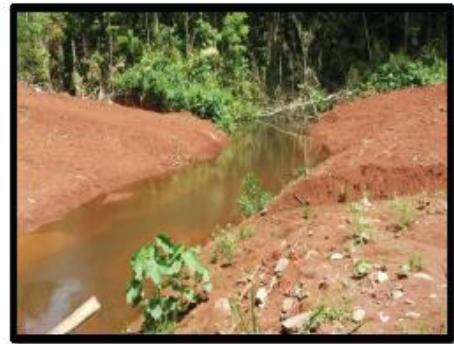
F53. Stagnant water present in some parts.
