# **Rudder removal from an AMEL Super Maramu 2000**

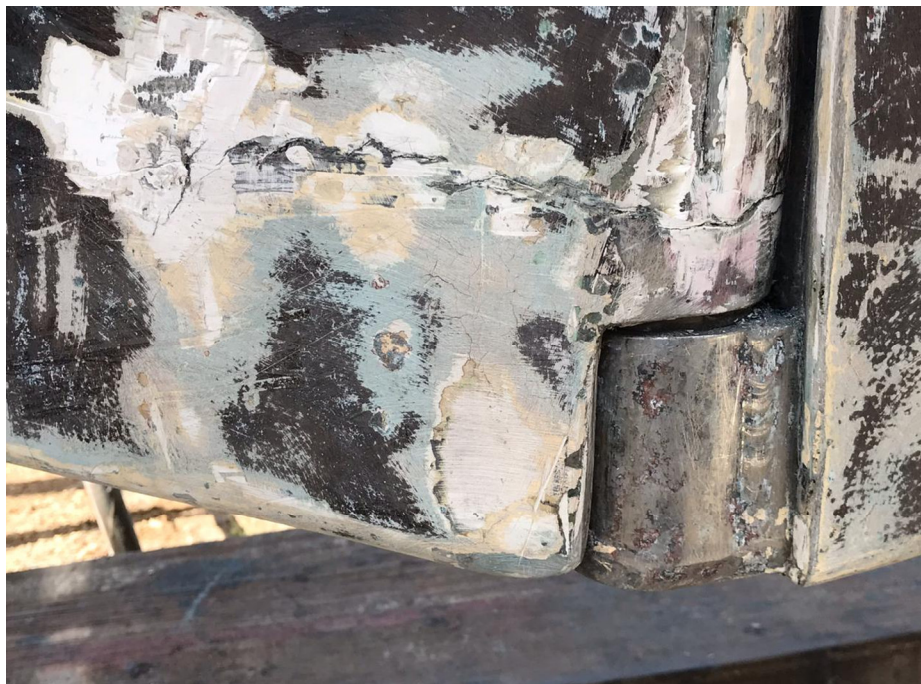
After sanding down the old antifouling I noticed that the rudder had some cracks at the bottom mounting.

Cracks in the rudder at the lower mounting at the starboard side which are going around to the port side:

Figure 1 - Cracks in the rudder at the bottom on starboard side

The answers were different: from “it is not necessary to repair”, “we sailed with those cracks 30,000NM and nothing happened” to “it has to be repaired”. I decided to repair these cracks because the rudder is one of the most important things aboard for safety.

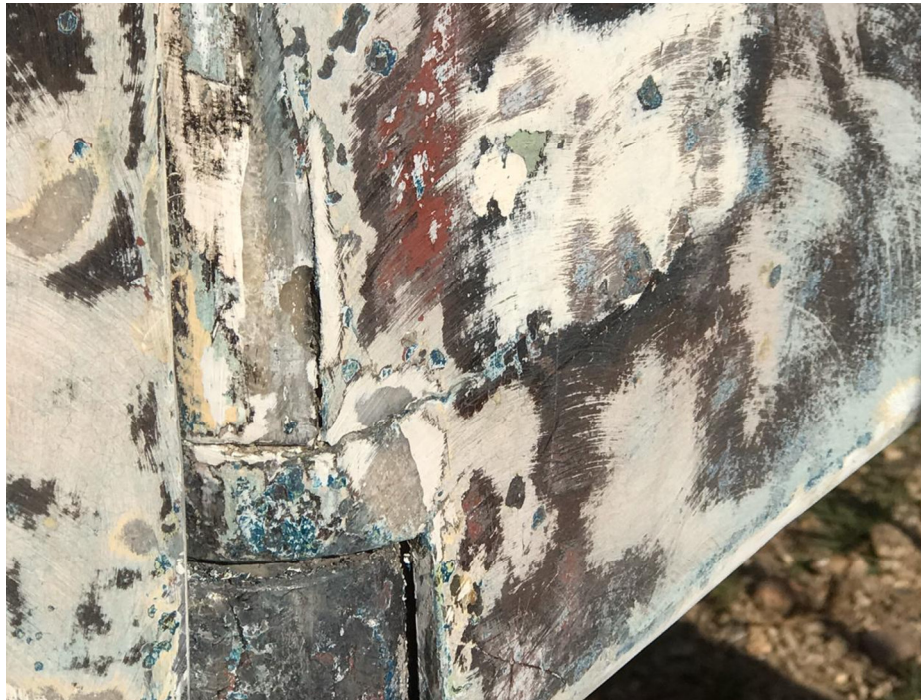
The cracks on the port side:

Figure 2 - Cracks in the rudder at the bottom on port side

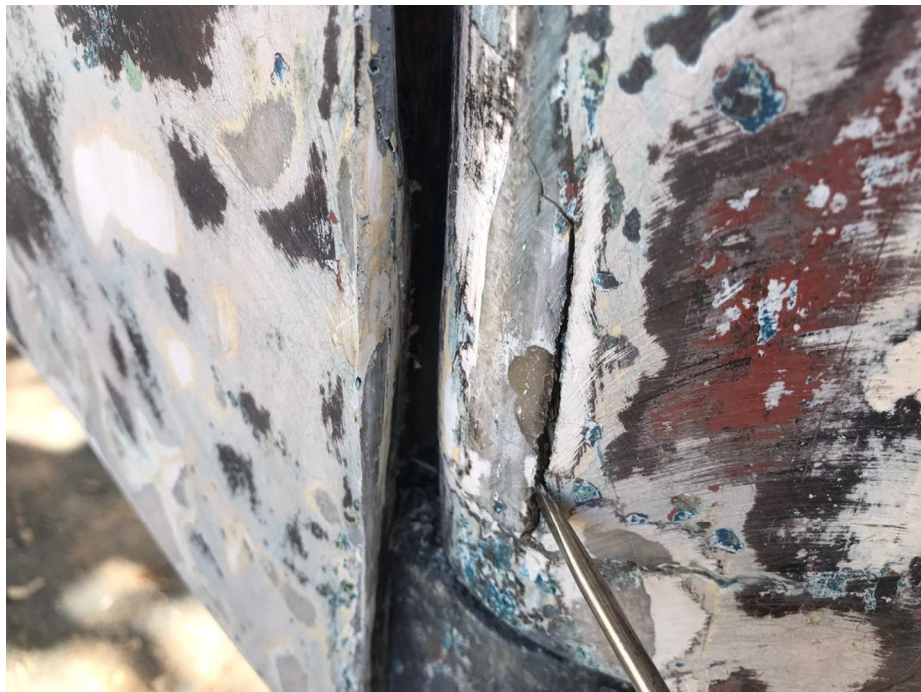
Figure 3 - Cracks in the rudder at the bottom on starboard side which could be easily opened with a screw driver

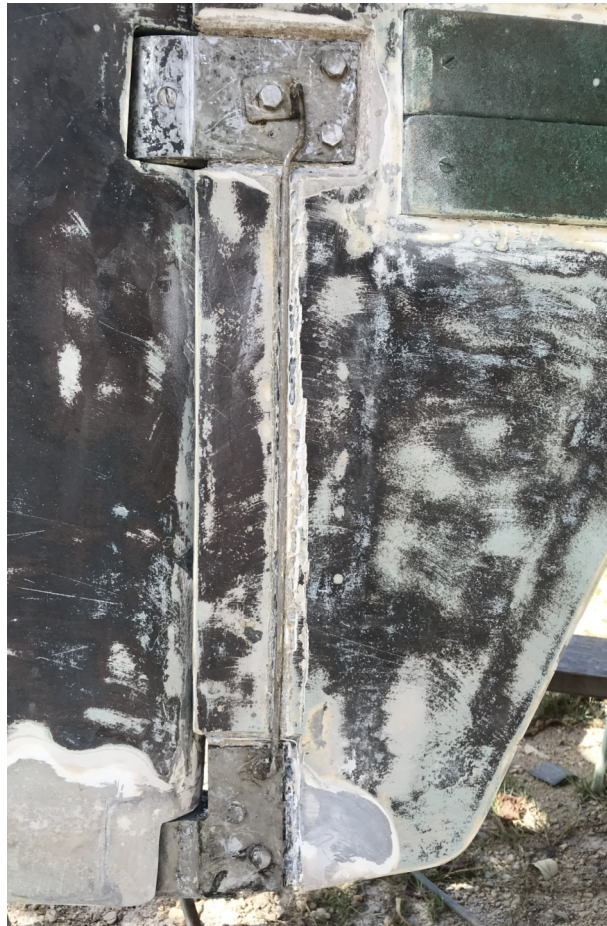
Figure 4 - Stainless steel pintle bearing (middle and bottom) of starboard side

Sand / grind down the GRP where the stainless steel pintle bearing (bottom) and intermediate bearing are bolted through. Be careful when you reach the screws not to sand them down.

To uncover the wire between the middle and lower mounting I used a ripping chisel and hammer:

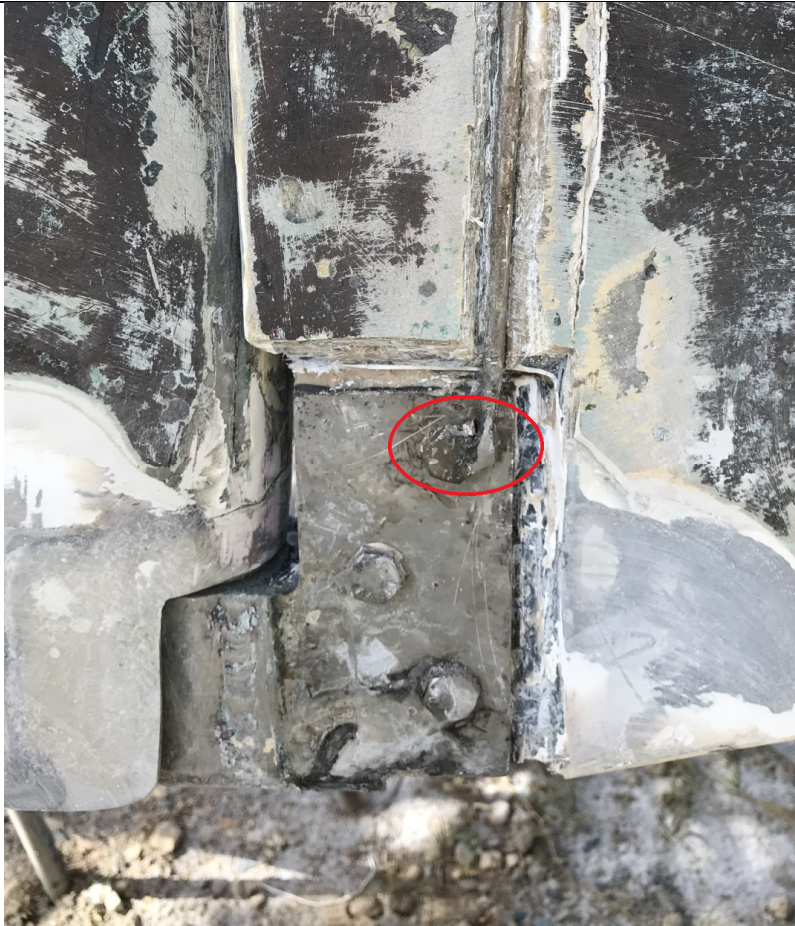
Notice that the wire is welded at the screw (of the lower mounting). Do not cut it, remove it complete (the wire with the screw):

**Figure 5 - Bottom bearing with welded wire on the mounting bolt**

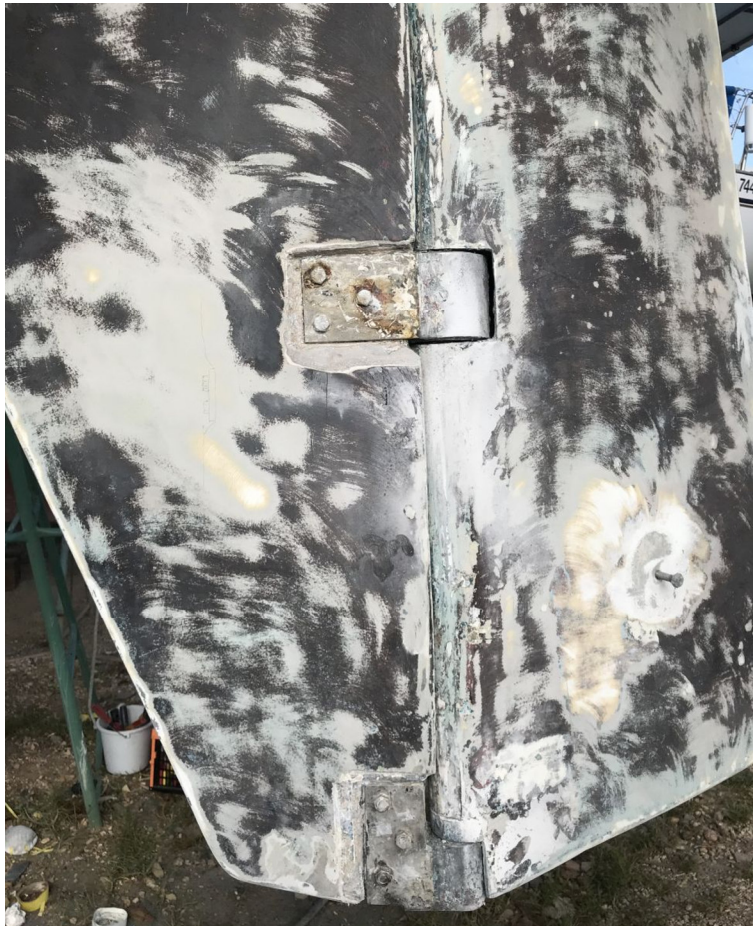
**Figure 6 - Stainless steel pintle bearing (middle and bottom) of port side**

Sand/grind down the surface until you see the mountings on the port side of the skeg:

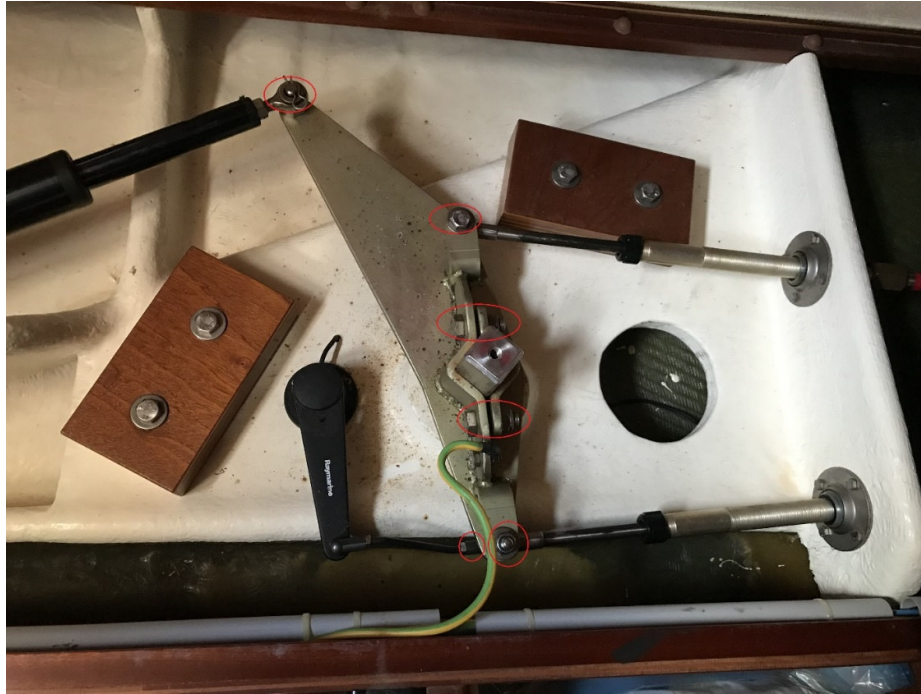
Figure 7 - The quadrant in the aft cabine which has to release from the top shaft

In the aft cabine remove the bolts and release the quadrant to release it from the shaft. It is not necessary to unscrew the grounding cable (yellow/green) linking to copper plate:

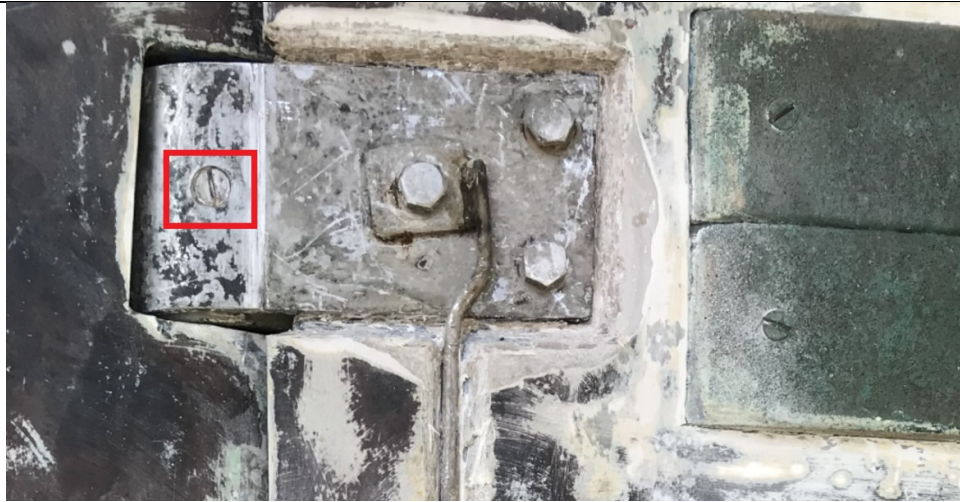
Figure 8 - Small bolts at the U-shaped middle bearing stainless steel stripe

**You need to open up the U-shaped middle bearing stainless steel stripe (see “Figure 10 - The opened up U-shaped middle bearing stainless steel stripe”).** For that you have to unscrew the small bolts.

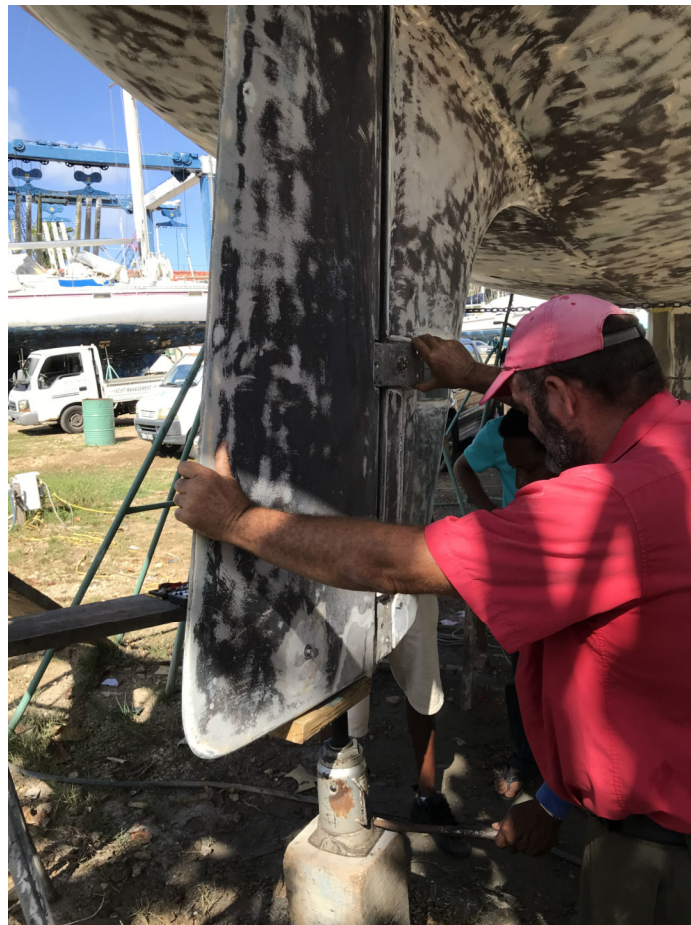
Figure 9 - Support the rudder with wooden blocks and a vehicle jack

Support the rudder with wooden blocks and a vehicle jack.

Then slowly drop down the rudder blade with the vehicle jack. Be sure that the rudder drop down w/o changing the angle/cranking the rudder until it is complete removed and you see the top of the shaft.

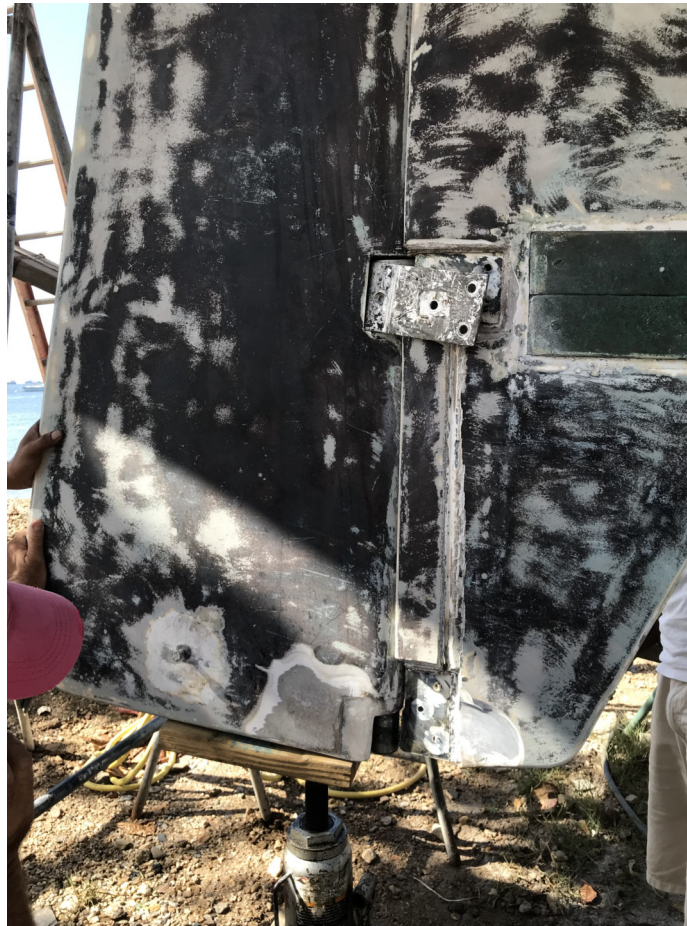
Figure 10 - The opened up U-shaped middle bearing stainless steel stripe

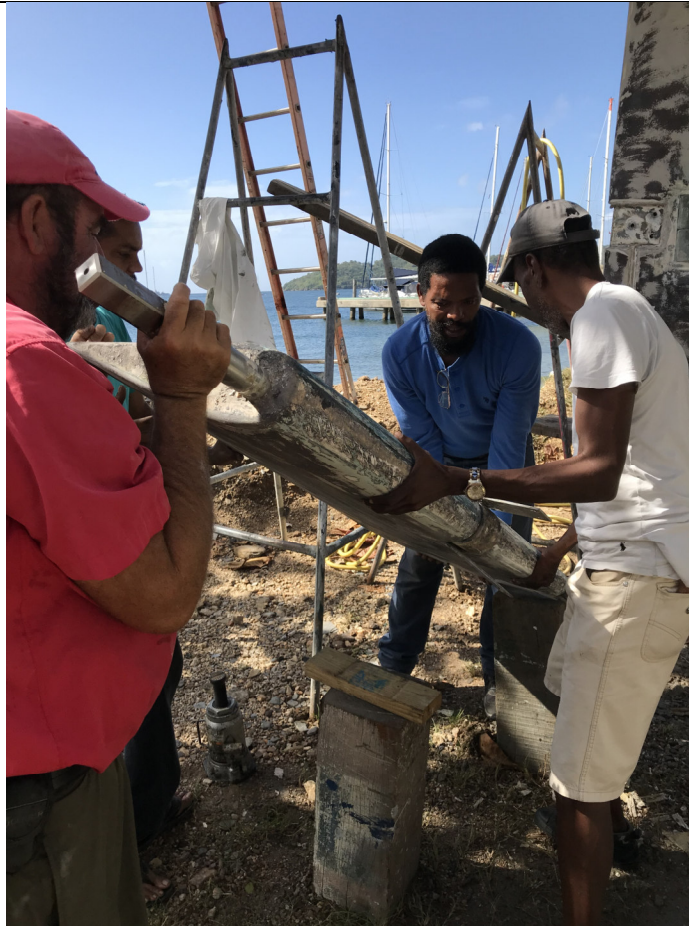
**Figure 11 - Removing the rudder carefully**

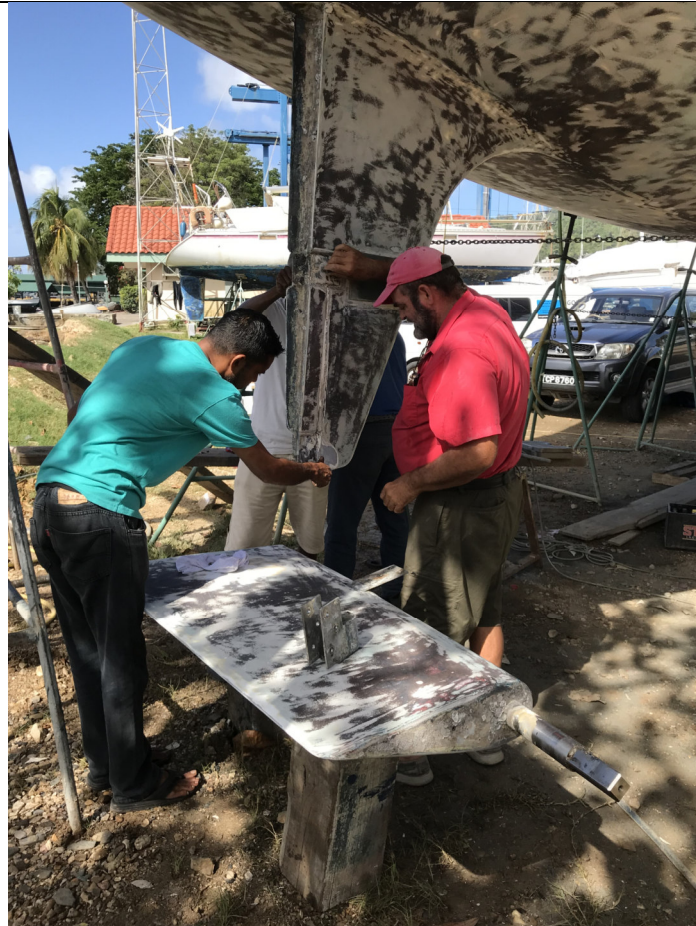
**Figure 12 - The removed rudder. Ready for detailed inspection/examination**

Lay down the rudder on a pallet of some wooden blocks. Now it is ready to inspect, check for more cracks, bubbles in the GRP and/or faulty repairs etc.

Also use the chance to inspect the skeg if there are also any cracks, faulty repairs etc.

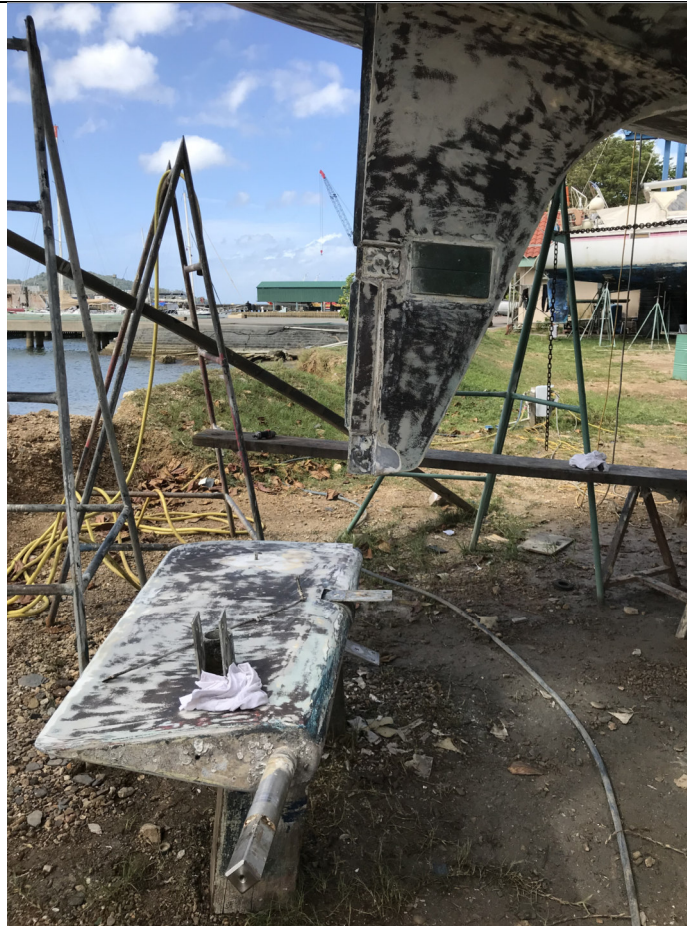
Figure 13 - Removed rudder with the bottom mounting and the wire with welded bolt

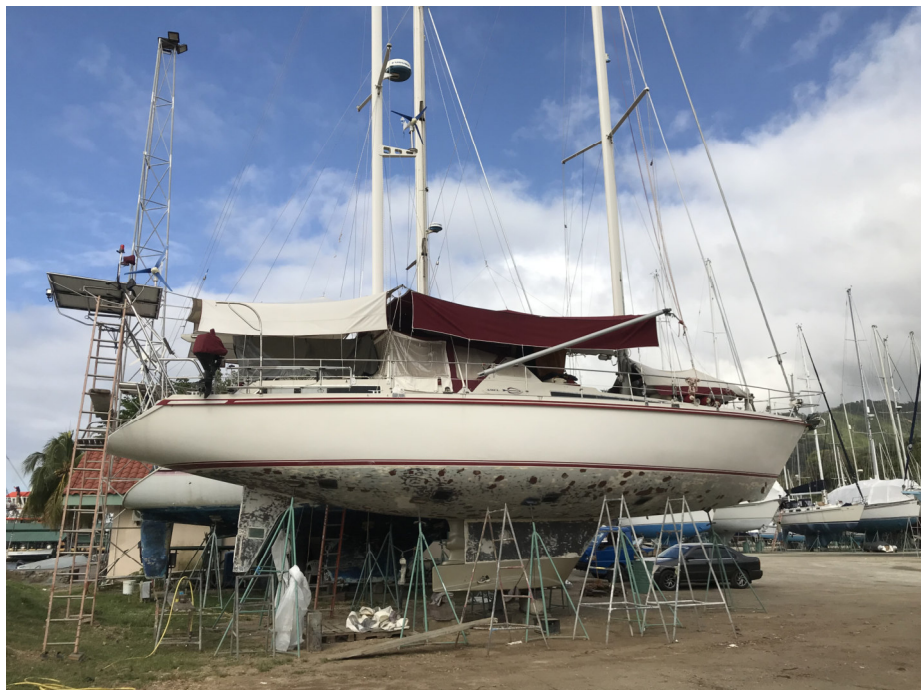
Figure 14 - Super Maramu 2000 Redline w/o rudder

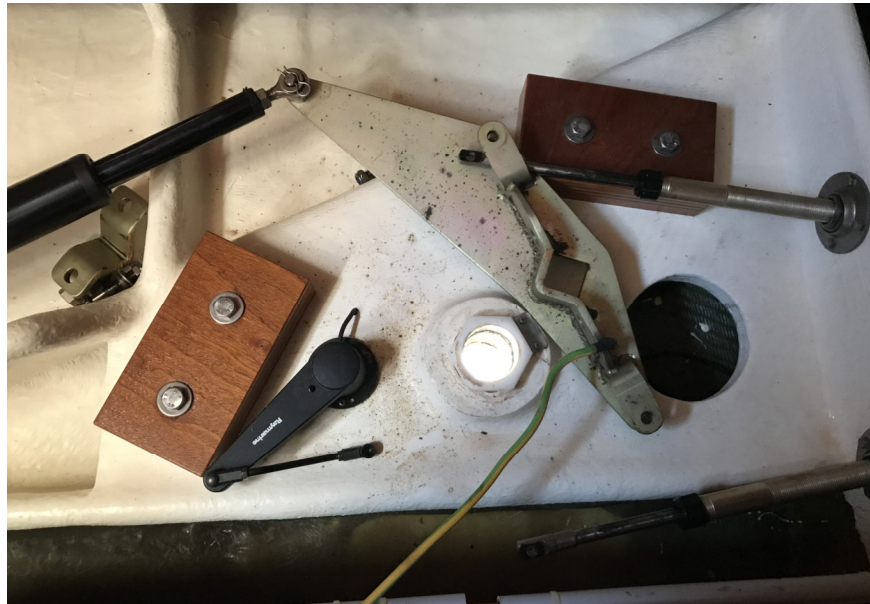
Figure 15 - The removed quadrant and the nylon nut

Under the quadrant is the nylon nut which has to unscrew. For that you have to unscrew the counter plate (see Figure 16 - Counter plate which has to unscrew first to remove the nylon nut). This counter plate at the nut is to stop it from turning and remove it.

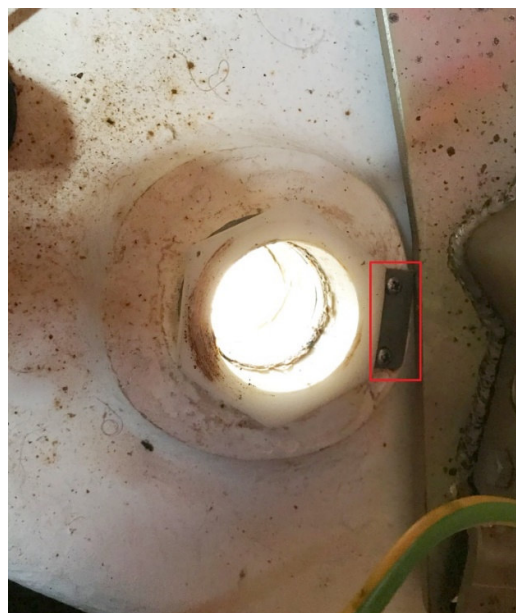
Figure 16 - Counter plate which has to unscrew first to remove the nylon nut

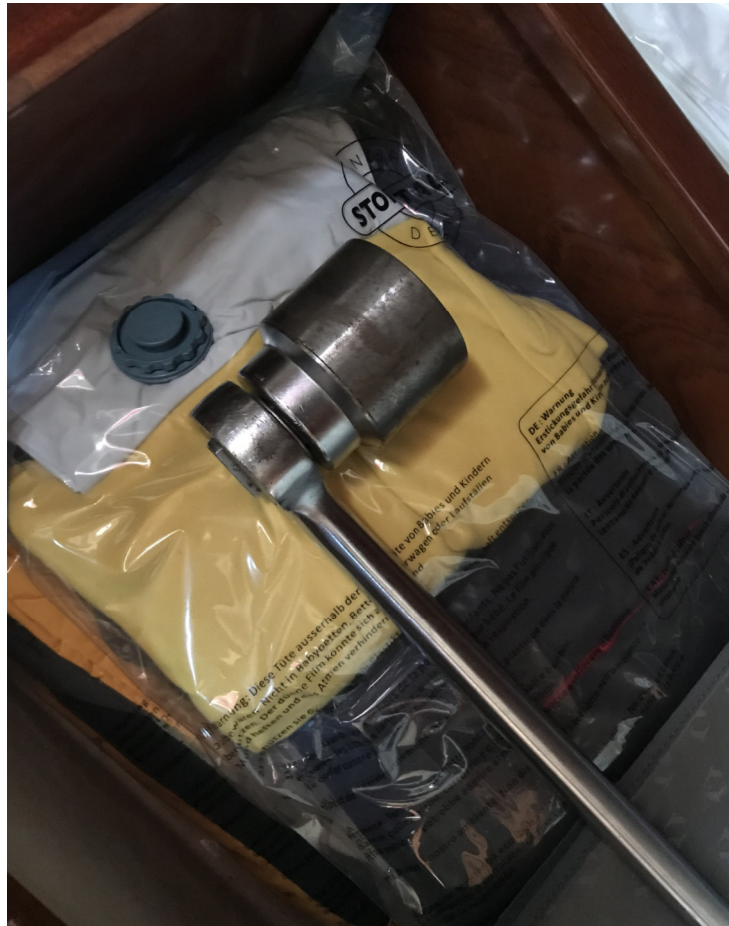
Figure 17 - I borrowed this wrench from a worker at the boatyard to unscrew the nylon nut. Later I received the AMEL tool for re-installing the nut.

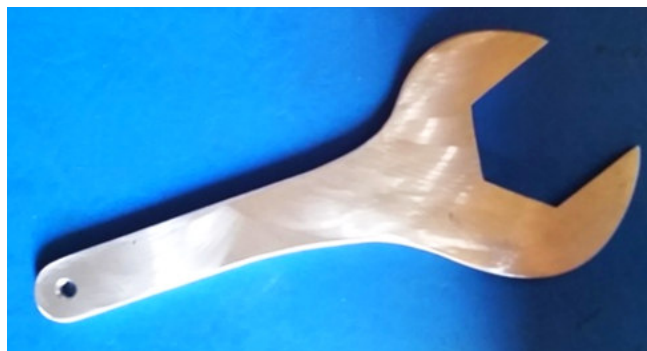
Figure 18 - AMEL tool for the nylon nut

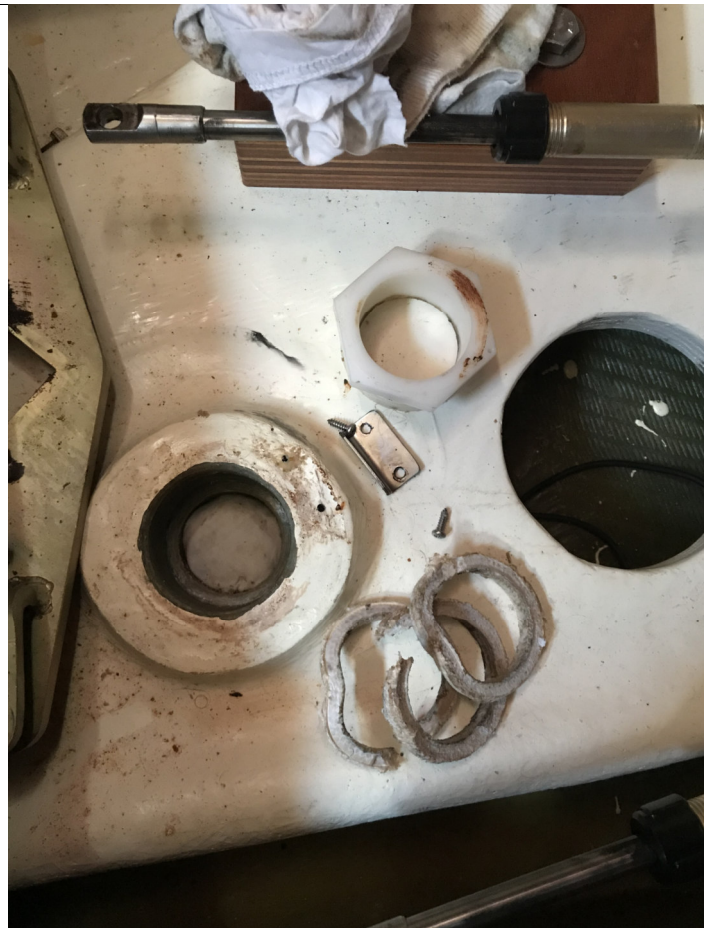
Figure 19 - Removed counter part, nylon nut and shaft packing

Under the nylon nut you will find 3 layers of packing for sealing. I took the chance to renew the shaft packing (see chapter 7.2 "inside").

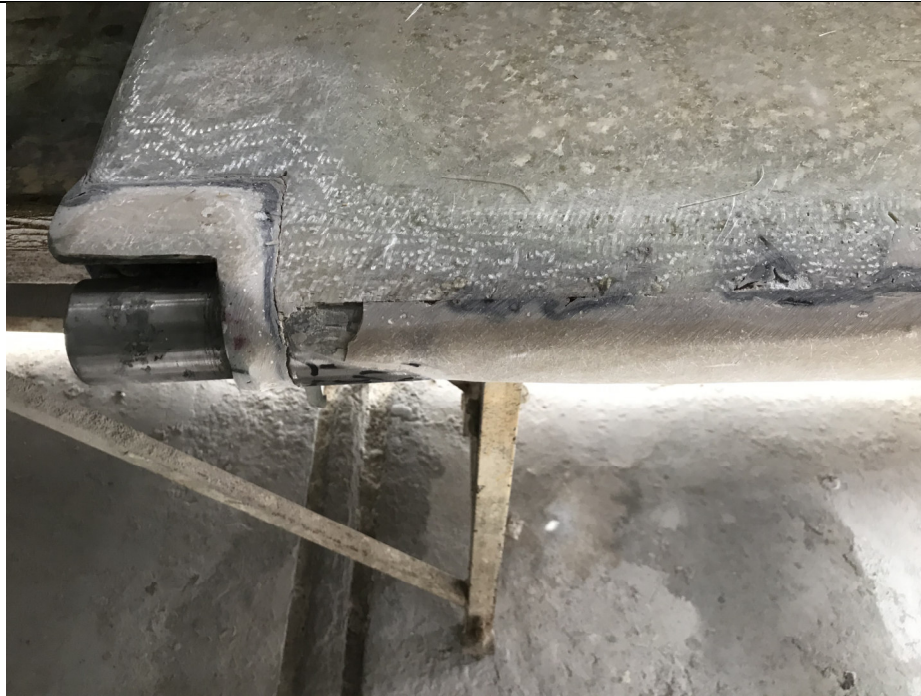
When sanding down to sane material the repair shop found out that the rudder had some bubbles in the GRP. They must be from the initial building.

Figure 20 - The rudder cleaned down to sane material (bottom with major cracks)

Do all necessary repairs using proper methods: clean down to sane material, rebuild using resin fiber cloth before protecting.

They used two layers of Biax fiberglass. One big layer for both sides. The layers were not cut in the front of the rudder: each fiberglass layer was placed around in the front of the rudder.

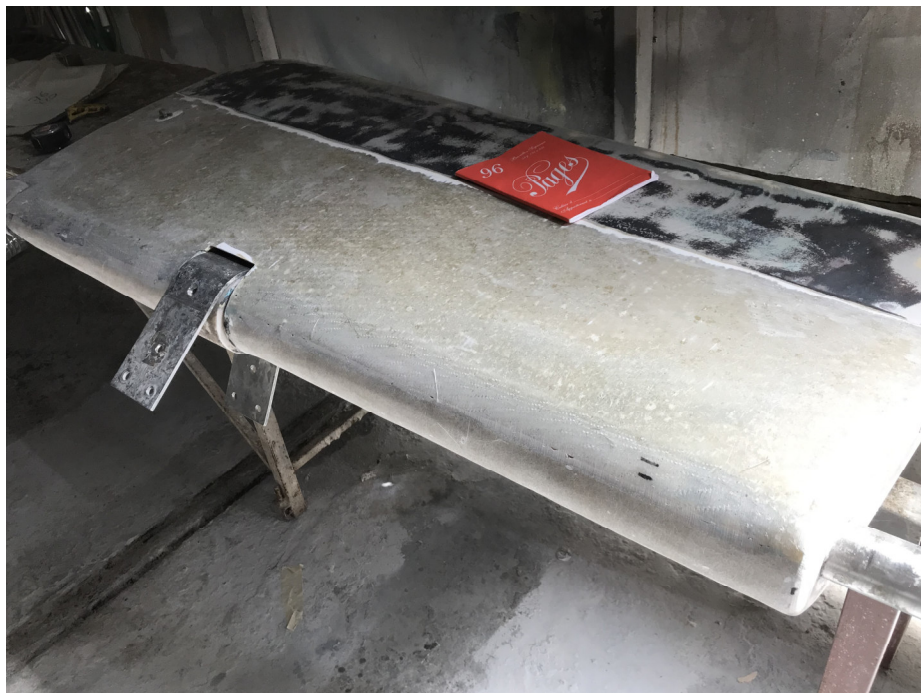
Figure 21 - The rudder cleaned down to sane material

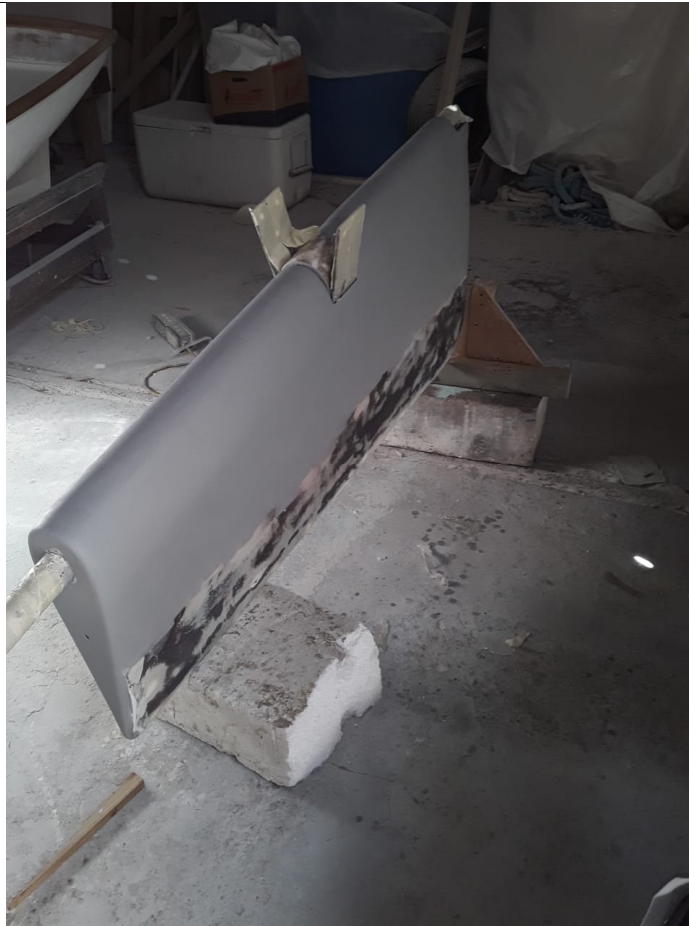
Figure 22 - The repaired rudder with first layer of epoxy primer

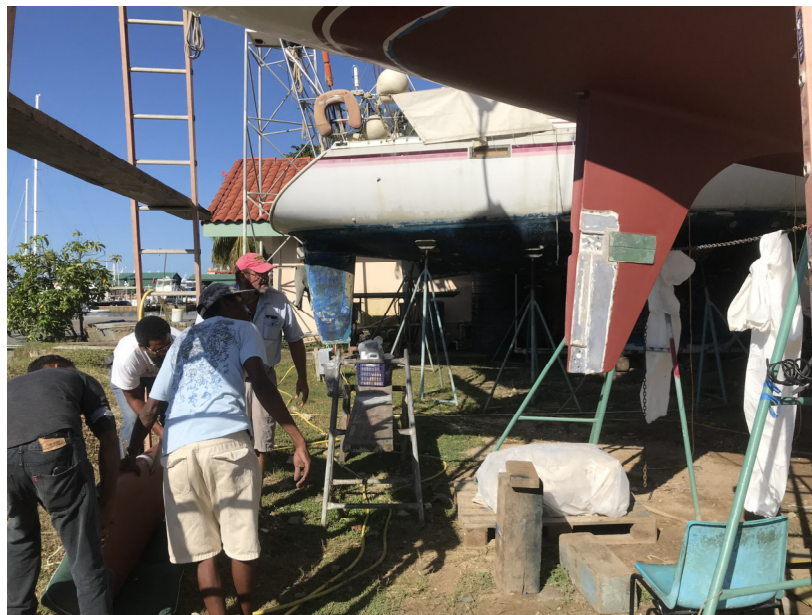
Figure 23 - The wooden block is in position for re-installation

Bring back the wooden blocks in their position to support the rudder. You need again as minimum 2 strong guys, better would be 3 guys.

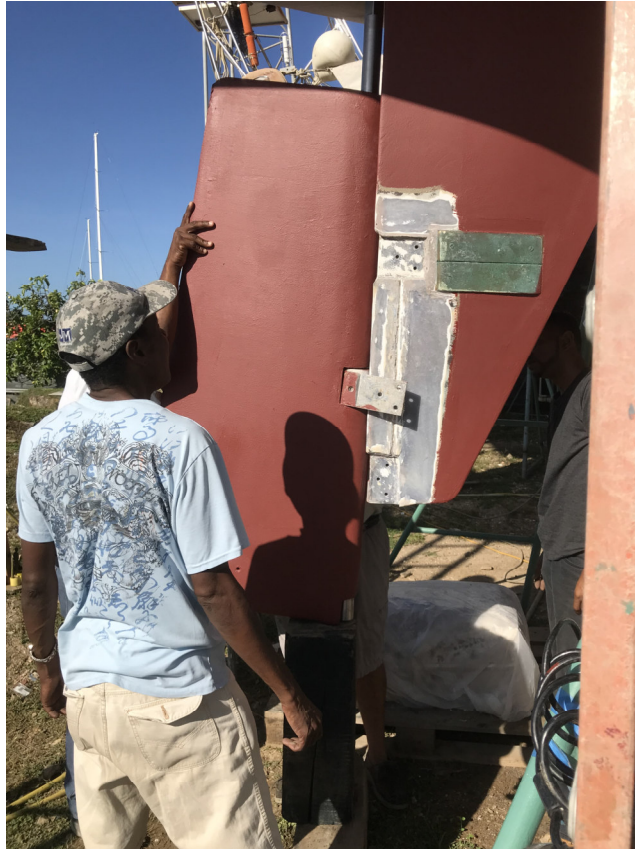
**Figure 24 - Bring the rudder on the wooden block**

Bring the rudder to the skeg and lay it on the wooden support. One person should hold the rudder all the time.

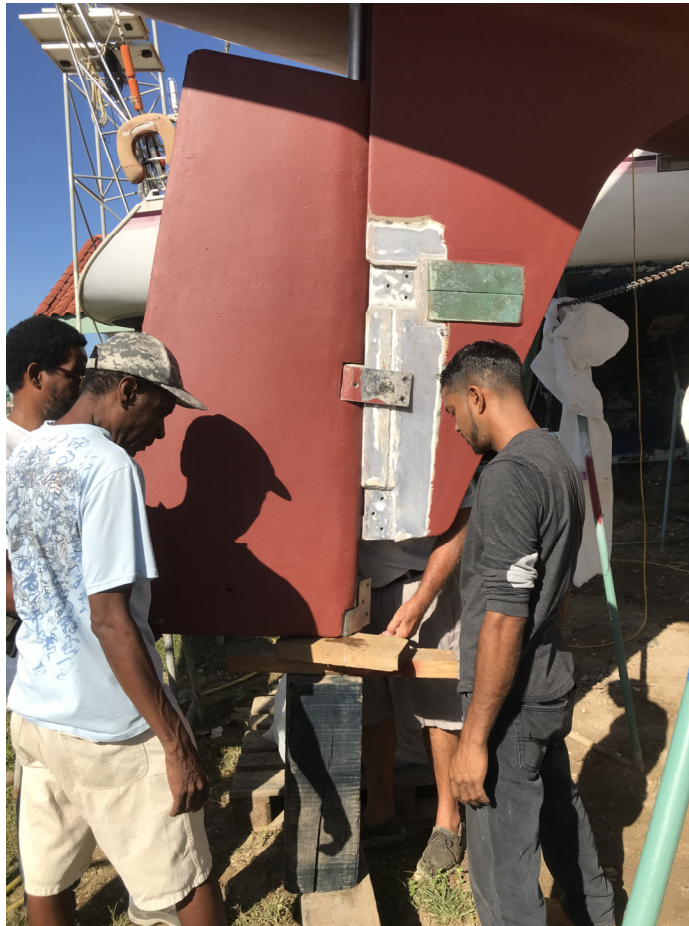
**Figure 25 - Bottom mounting bearing at the bottom of the rudder shaft**

Put the stainless steel mounting block back in place at the bottom of the shaft.

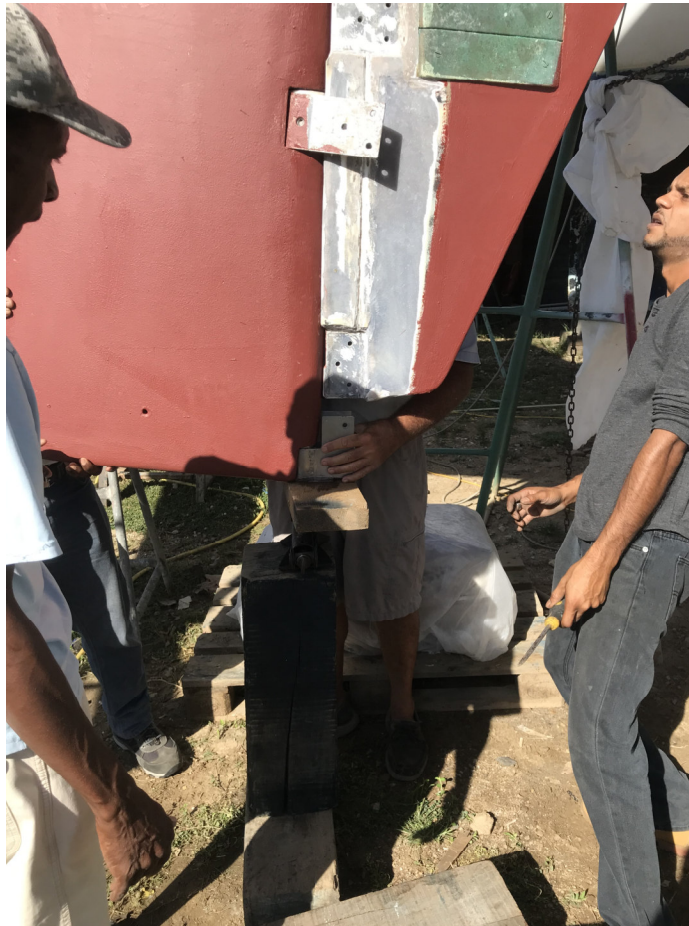
**Figure 26 - Vehicle jack between the wooden blocks**

Put the vehicle jack between the wooden blocks.

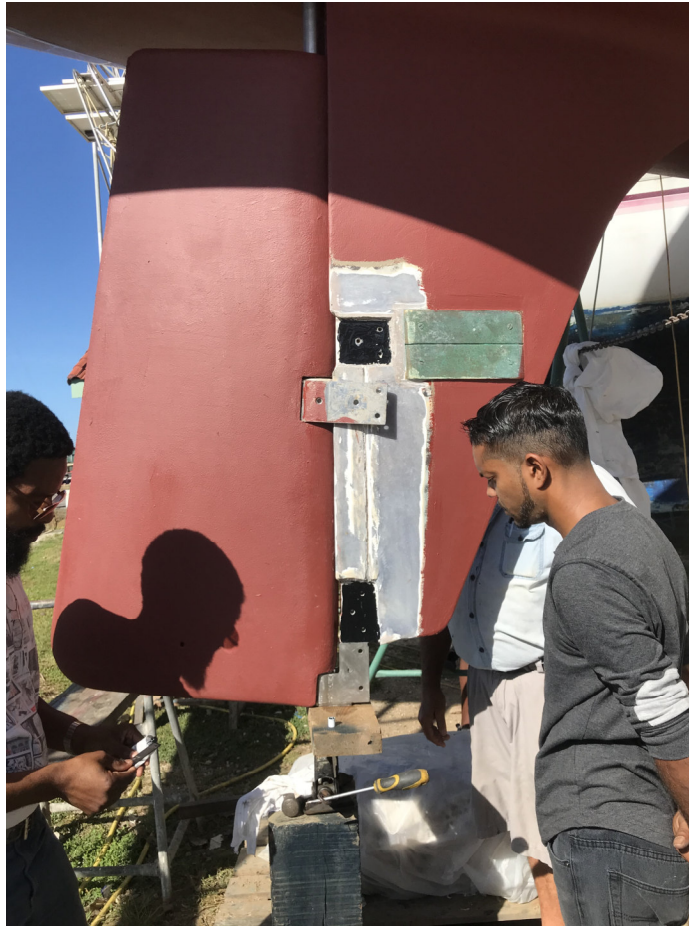
**Figure 27 - Applied sealant at the bearing areas**

Apply sealant at the areas where the stainless steel bearings has to mount. Use this sealant also for the bolts.

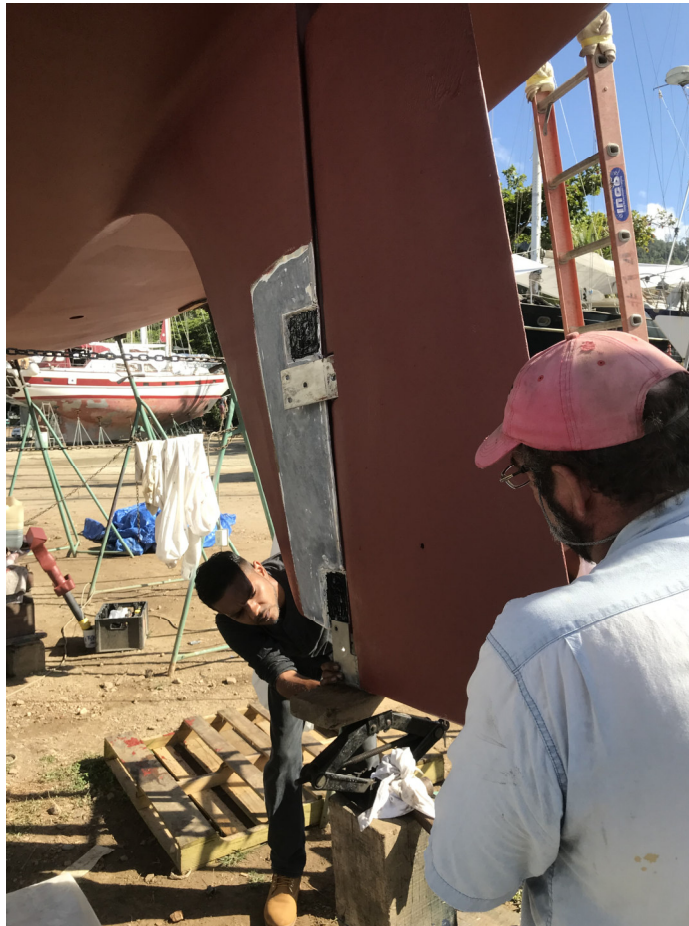
**Figure 28 - Liftung up the rudder in its final position**

Lift up the rudder with the vehicle jack in its correct position.

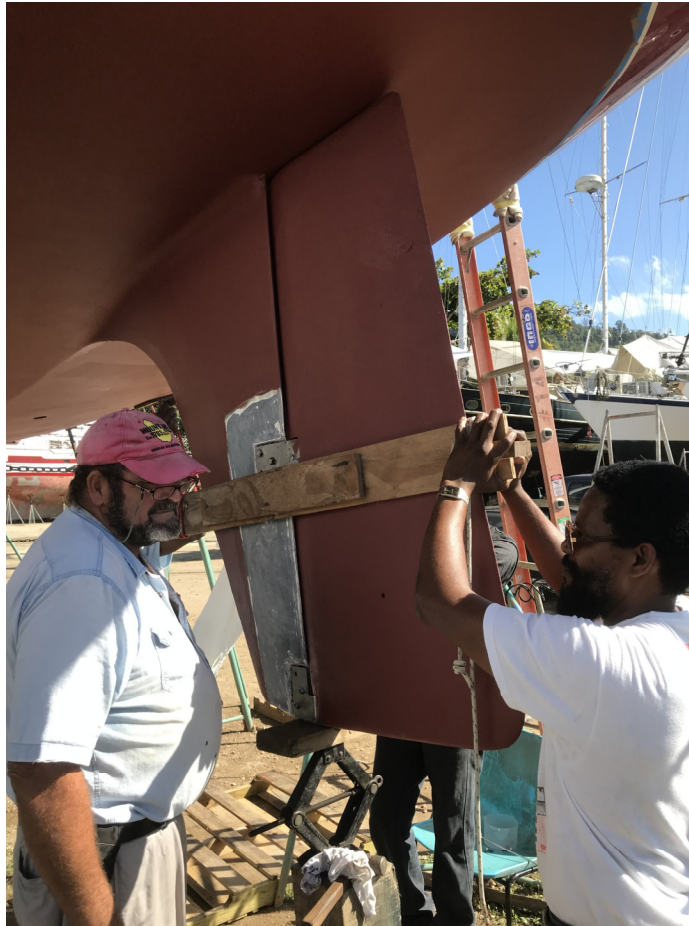
**Figure 29 - U-shaped middle bearing stainless steel stripe Squeezed with wooden planks**

The opened U-shaped middle bearing stainless steel stripe has to squeeze so that it is possible to mount with the bolts. We used long wooden planks tied at each ends together.

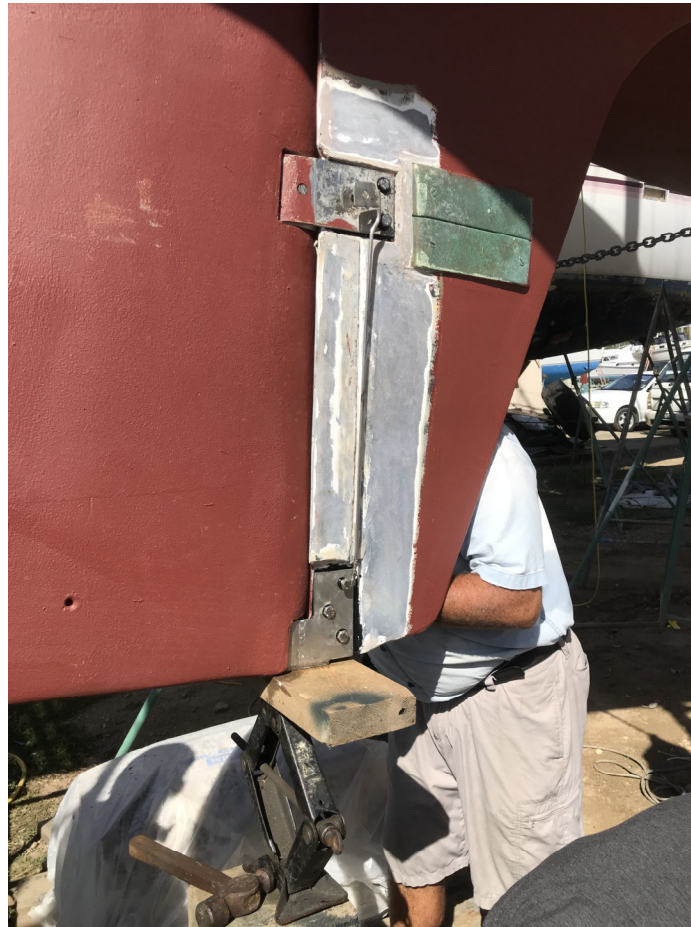
**Figure 30 - Installed bolts for the bearings**

Install the bolts back with marine sealant.

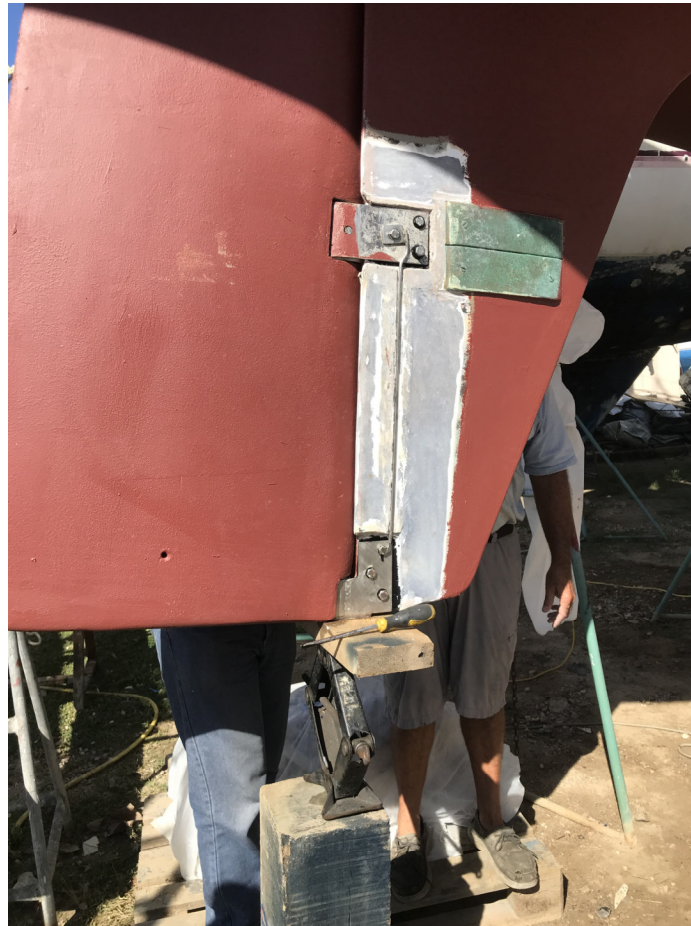
**Figure 31 - The re-installed rudder**

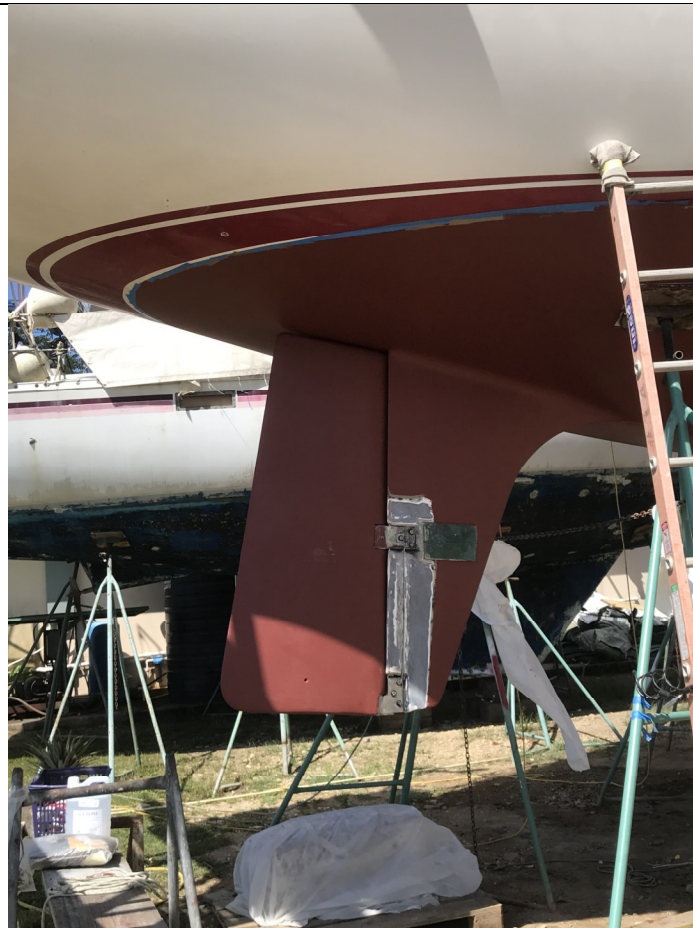
Figure 32 - The re-installed rudder

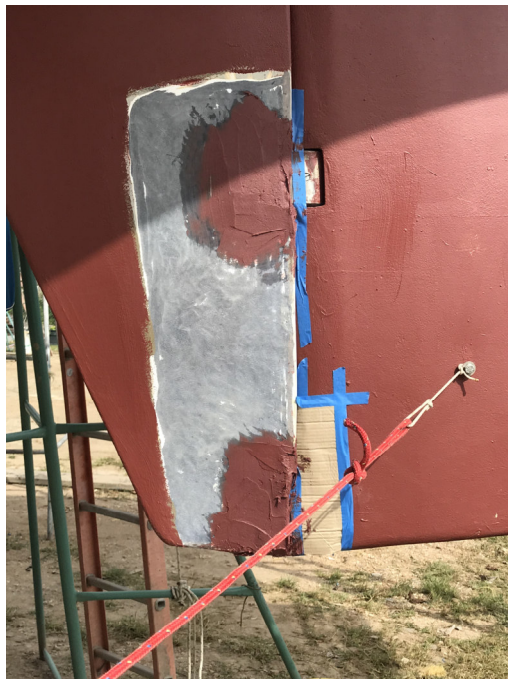
Figure 36 - First layer of Epoxy primer on port side

1. First I used epoxy primer to fill the area of the bearings and the wire. Sand it down to nearly the final shape.
2. Then I overlayed the areas with a fiberglass mat and sanded as-well.
3. Use the epoxy primer for a last final adjustment of the final shape.
4. Paint it with epoxy primer and than with antifouling.

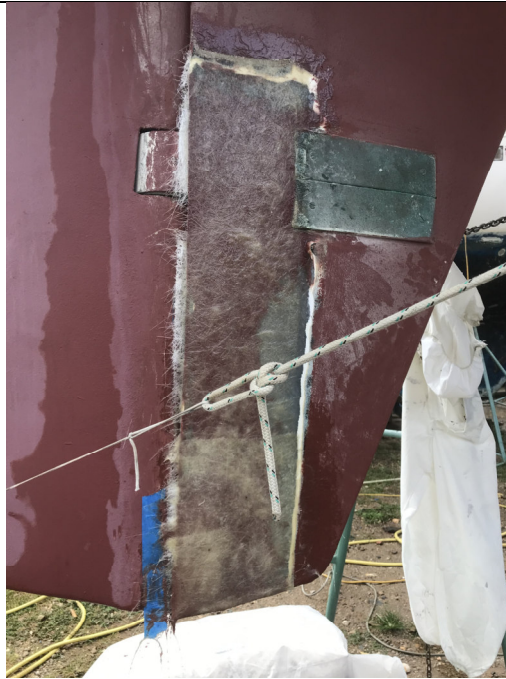
Figure 37 - One layer of fiberglass matts on starboard side

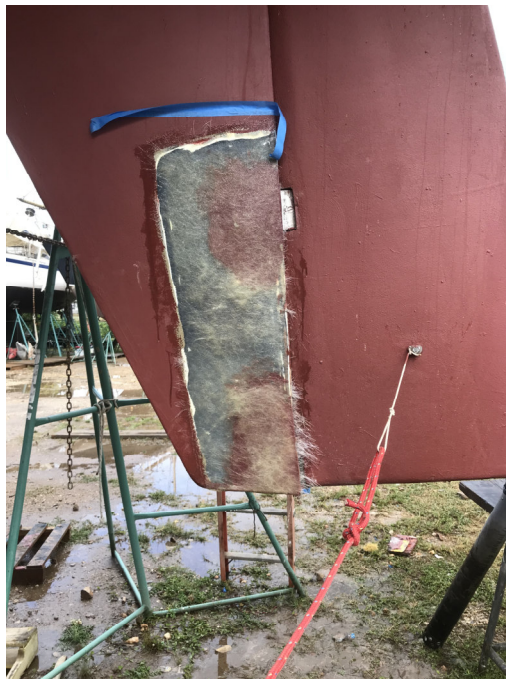
Figure 38 - One layer of fiberglass matts on starboard side
