## Tourniquet 3D Printed Backplates – Breakage Report

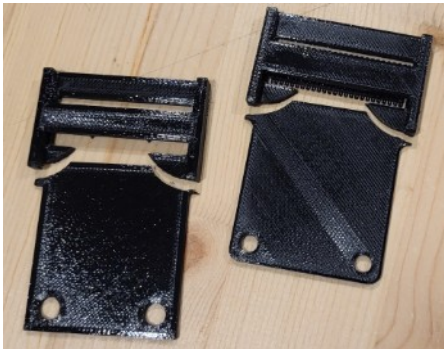
Breakage Pattern Photo:

The cooling bed causes the printed parts to contract, and the thinness of the backplates means that there is more bed adhesion. So, instead of being able to contract, the backplates develop micro-fractures at the weakest points of the part (where the thick and thin areas join), and are more apt to break there. When the backplates are taken off of a cooled bed, the breakage rate is usually 25% - 100%. Although, this can fluctuate based on filament and ambient temperature as well.

The difference between the hotbed and the ambient temperature of the space is the biggest factor in the backplate breakage. When there is a bigger difference between the two, and a faster speed from hot to cool, the more breakage occurs.

The difference in temperature from the top shelf of the printer cube in the Glia Canada lab is about 2-4 degrees hotter than the lower shelf. The breakage rate of backplates printed on the top shelf printers is approximately 75-85%, whereas when printed on the lower shelf, the breakage rate is approximately 4-12%. This may also be due to the top shelf having a fan which speeds up the cooling of the hotbed after printing.

Use the best filament you can. Black is preferable, as any white pigment added can make it more brittle.

Nozzle temp is best at 230 degrees.

Bed temp is best at 85 degrees.

Ambient temp is best at 75 degrees.
