Sierra College Penetration Test Report for Challenge Lab

2.0 Report - High-Level Summary

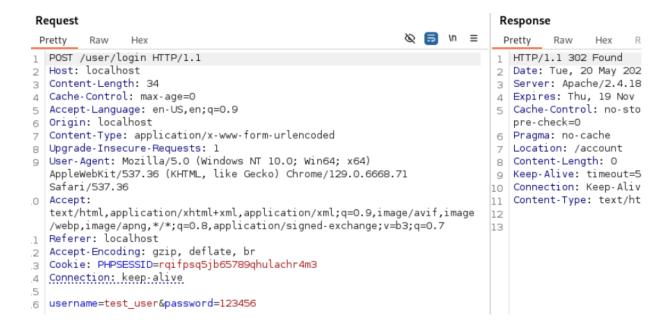
Initial login attempts failed due to a 400 Bad Request referrer header issues.

Using **Burp Suite**, the login request was intercepted, and the following headers were modified to bypass the referrer validation check, which allowed us to login to the web app.

The login creds used were default for this application and granted us access to most functions of the web app. With this we were able to Use Authenticated OS command injection to read remote files as well as gain reverse shell into the system.

- Disable default accounts or restrict them via sudoers.
- Patch the Hackazon application or remove it from production use.
- Implement input validation/sanitization to prevent command injection.
- Monitor referer headers and employ CSRF protection.
- Harden cron permissions and audit user access levels.
