How to calibrate a spiral out of chain warning.

By: Ghulam Murtaza

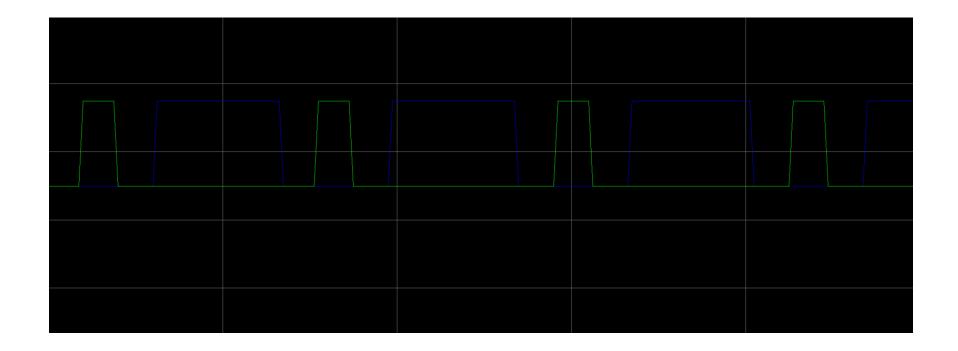
Observe the green marker on the live trend graph:

If the green marker moves to the right, and the sensor is shifting away from the center.

Your goal is to align the green marker in between the two blue markers, which indicates optimal sensor alignment.

In that case, try rotating the sensor anticlockwise instead.

Continue fine-tuning the rotation until the green signal consistently stays centered between the blue edges.

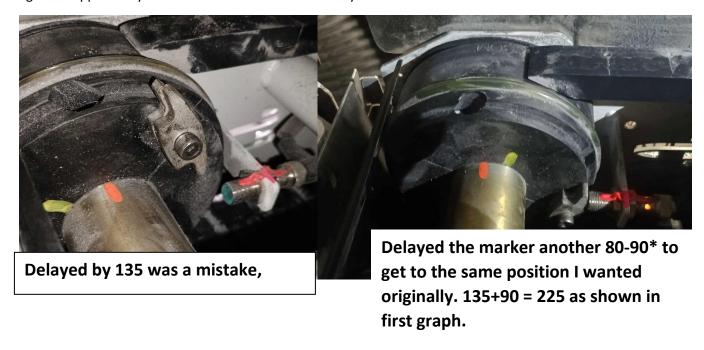
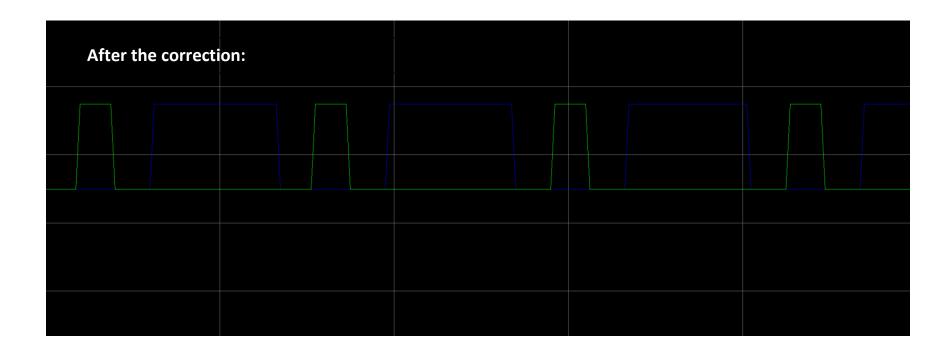
I got the opportunity to correct the mistake the next day
