JDR Restoration & Remodeling

Type of Loss: Water Damage

Date Inspected: 7/2/2024 12:00 PM

Restoration/Service/Remodel

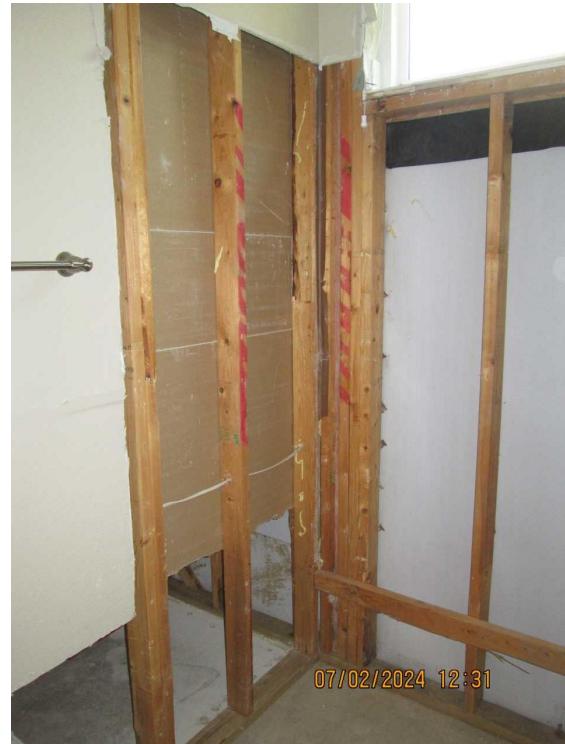
Bathroom

Tub, tile surround, cement board and insulation removed during mitigation

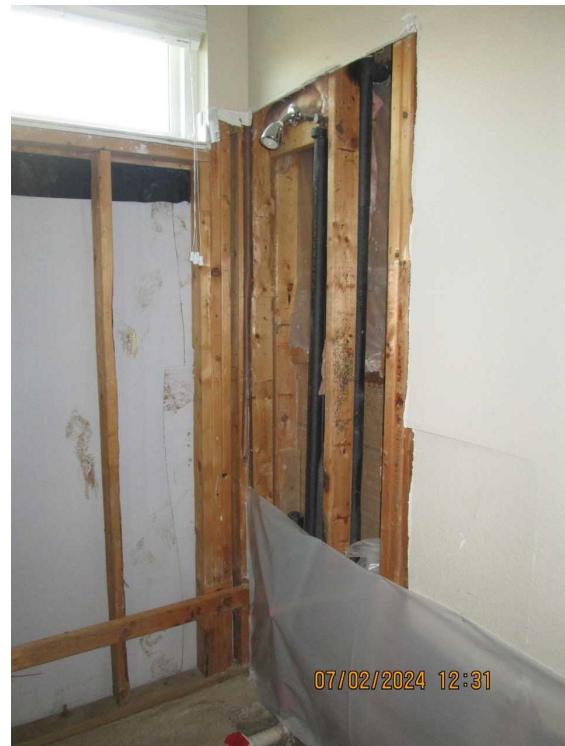
12 12-IMG_9958

Bathroom

Tub, tile surround, cement board and insulation removed during mitigation

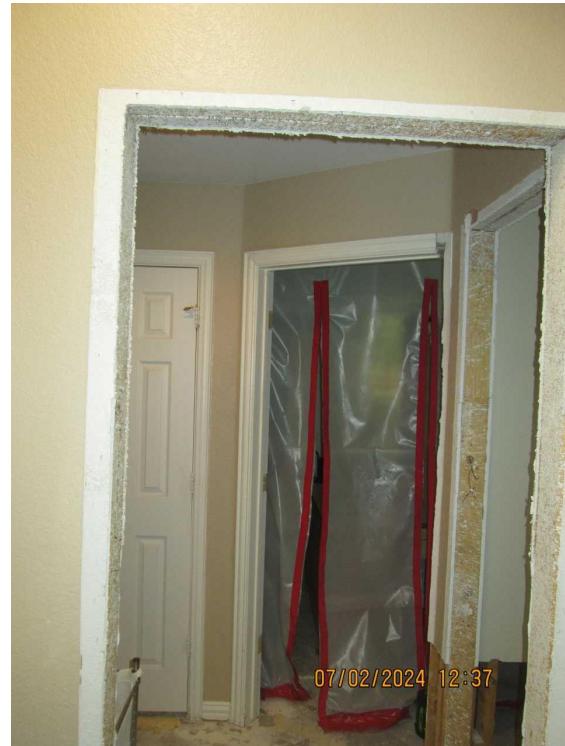
22 22-IMG_9971

Laundry Room

Door jamb removed during mitigation

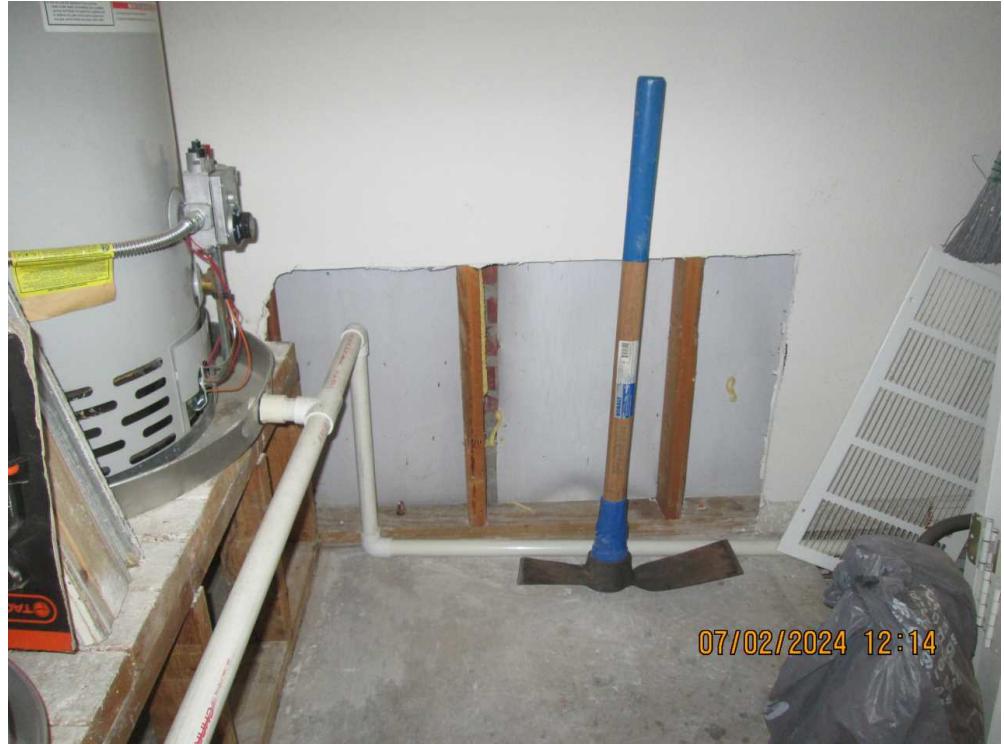
Garage
Baseboard, drywall and insulation
removed during mitigation

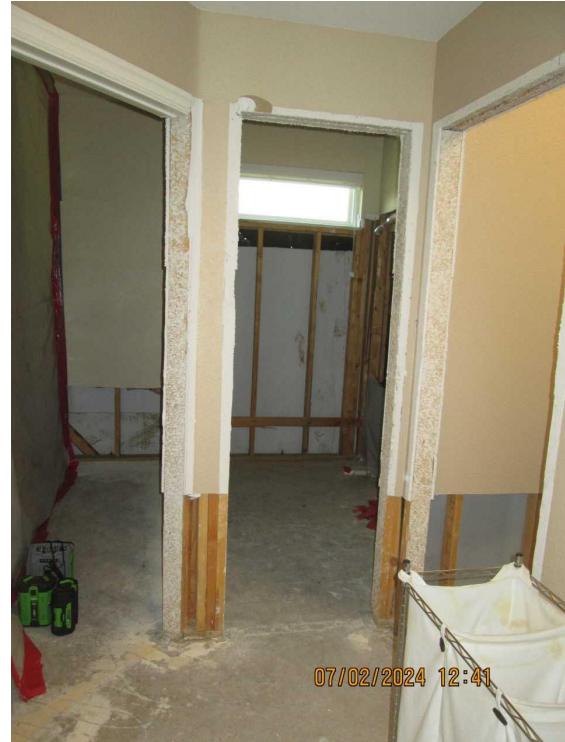
Hallway
Baseboard, drywall and carpet
removed during mitigation

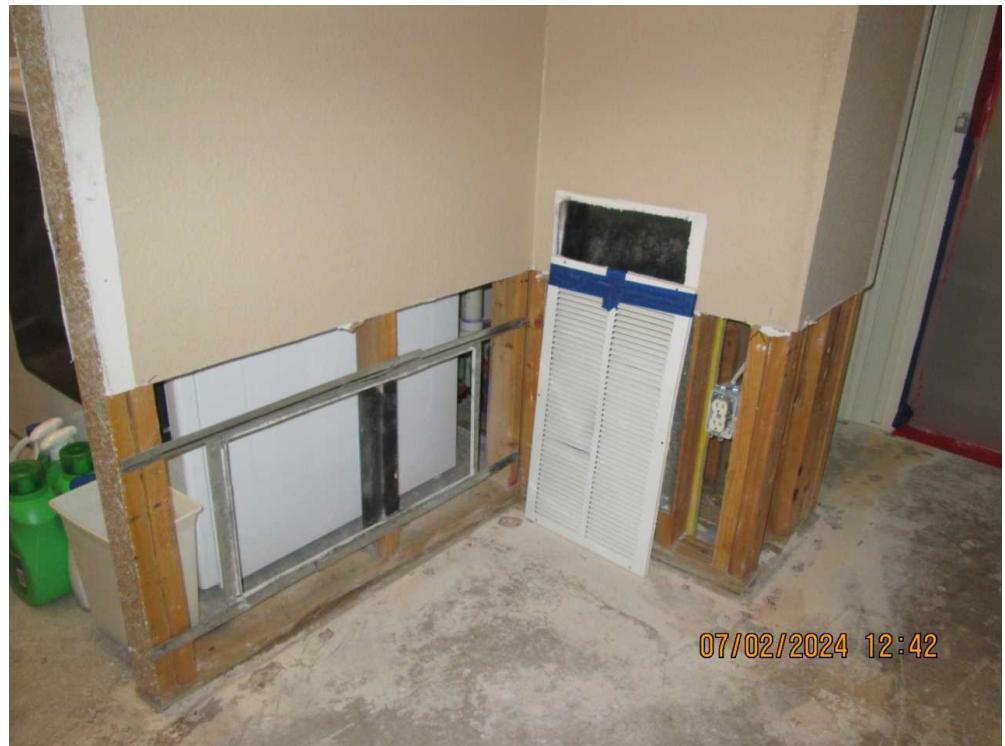
38 38-IMG_9974

Hallway
Baseboard, drywall and carpet
removed during mitigation

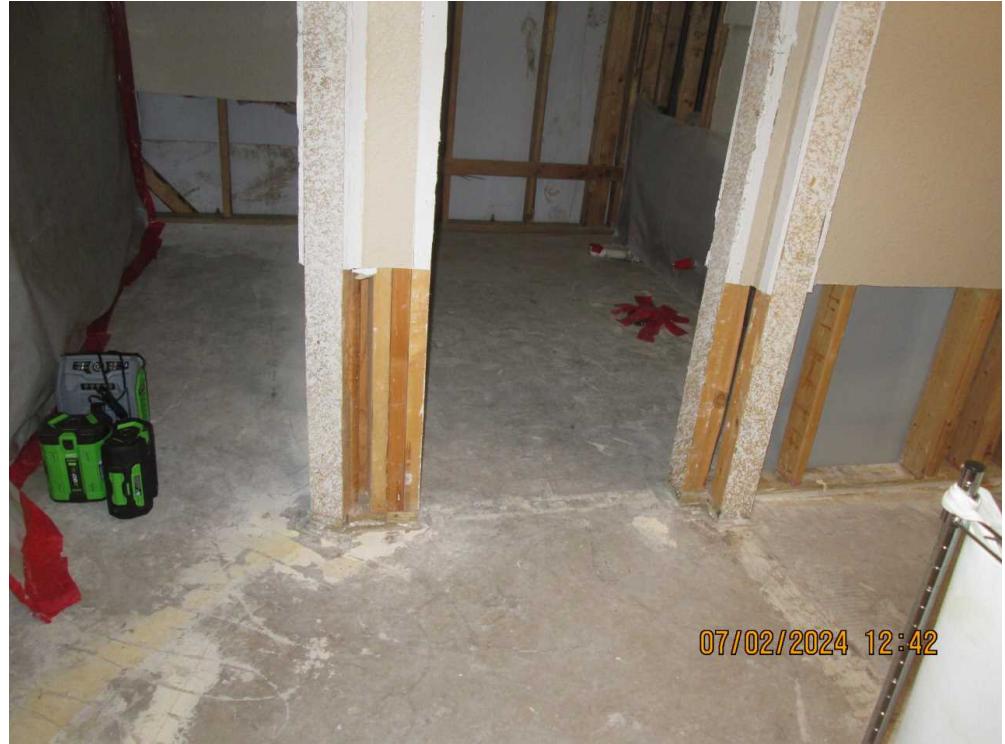
Hallway
Baseboard, drywall and carpet
removed during mitigation

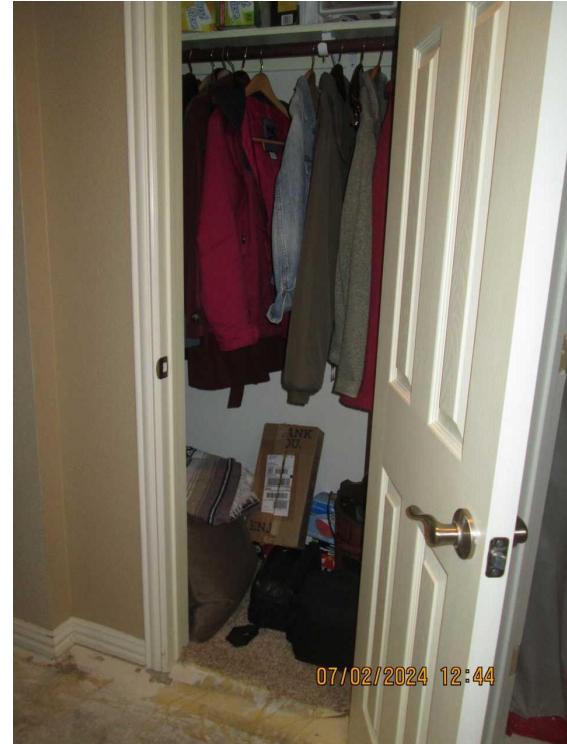
Coat Closet
Carpet is continuous with Hallway
