JDR Restoration & Remodeling

Type of Loss: Water Damage

Date of Loss:
Date Inspected: 9/19/2024 11:40 AM

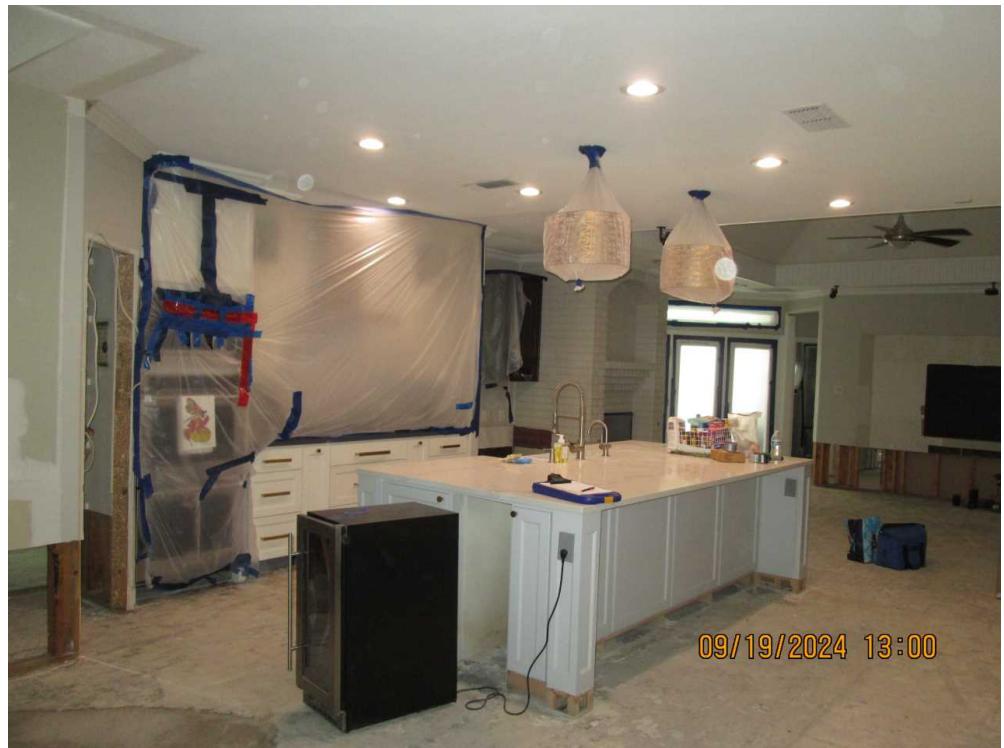
Kitchen

Drywall, baseboard and engineered wood flooring removed during mitigation

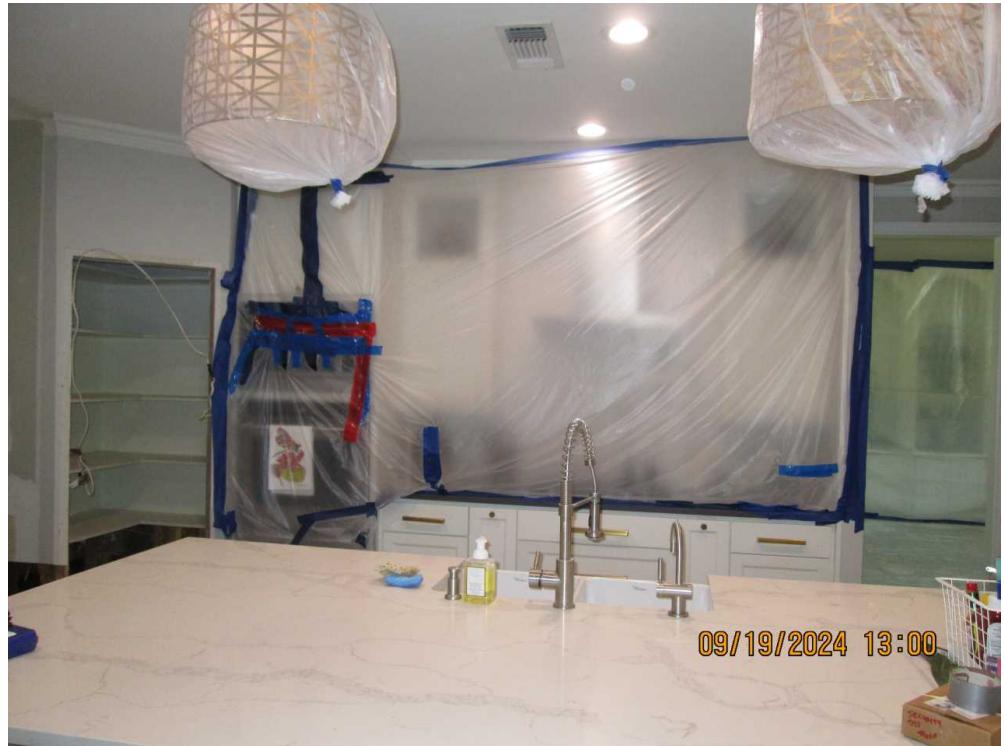
4 4-IMG_2902

Drywall, baseboard and engineered wood flooring removed during mitigation

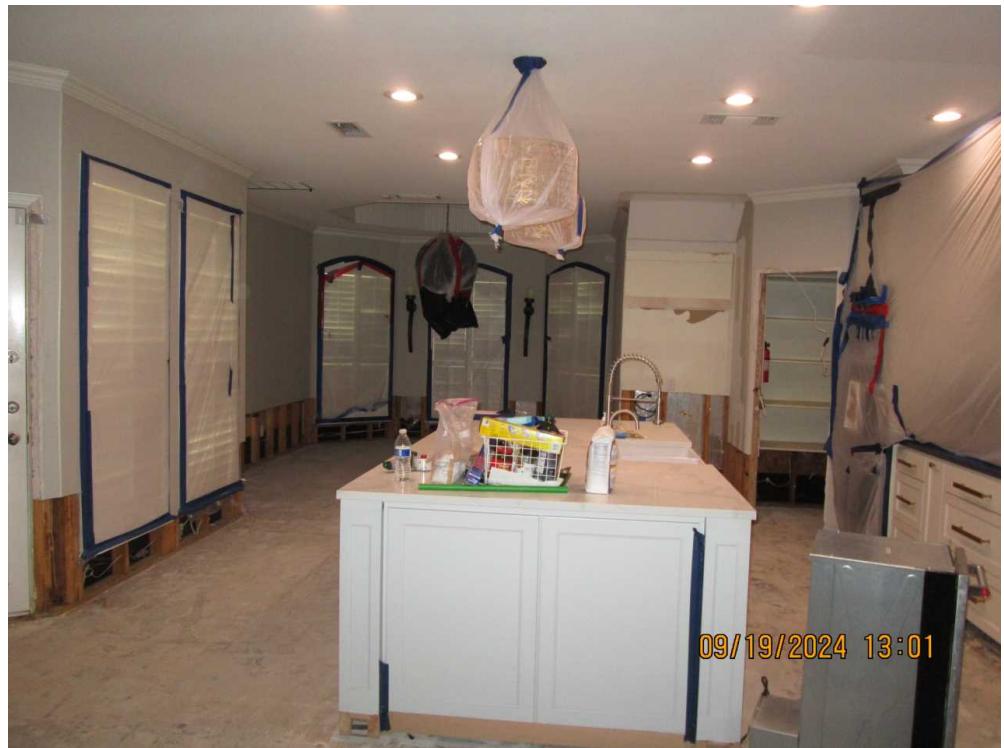
Kitchen

Drywall, baseboard and engineered wood flooring removed during mitigation

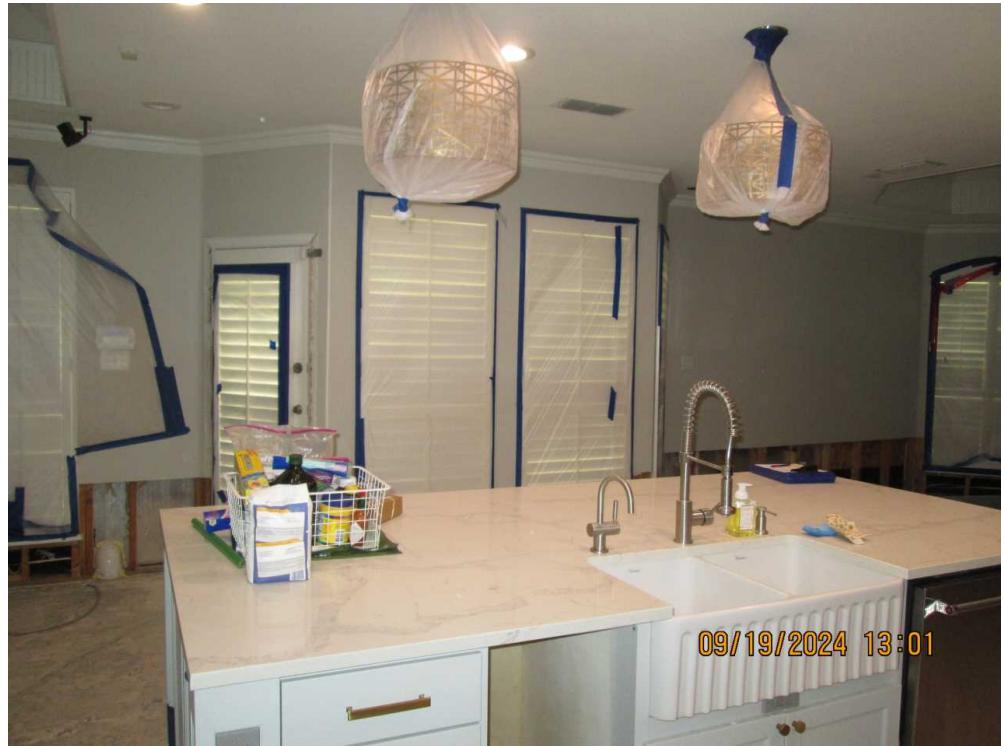
6 6-IMG_2904

Drywall, baseboard, insulation and engineered wood flooring removed during mitigation

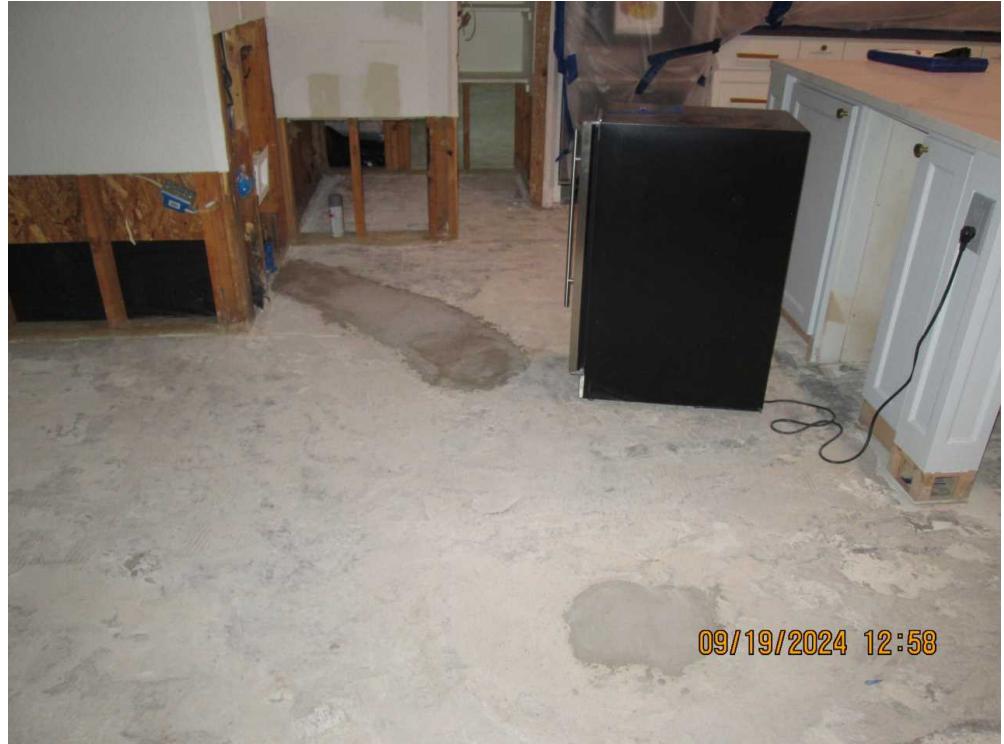
Showing area of plumbing leaks
below slab

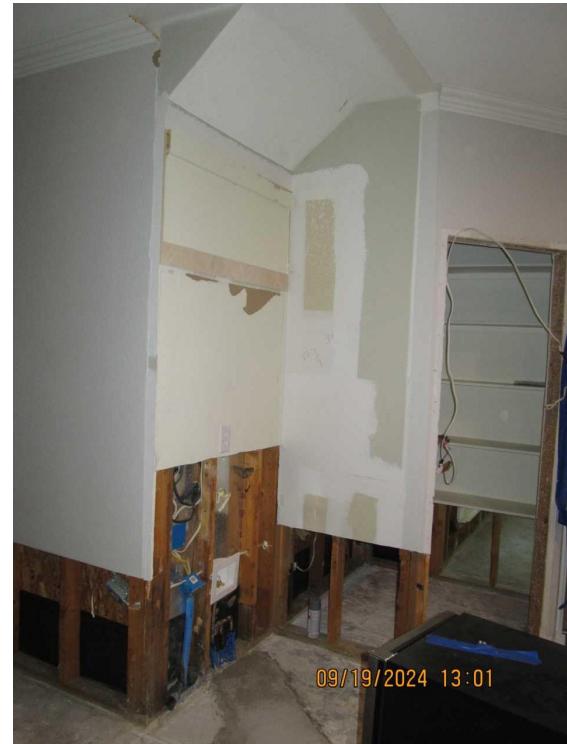
Kitchen

Full height cabinet around refrigerator
was removed during mitigation

Replace full height cabinet for refrigerator

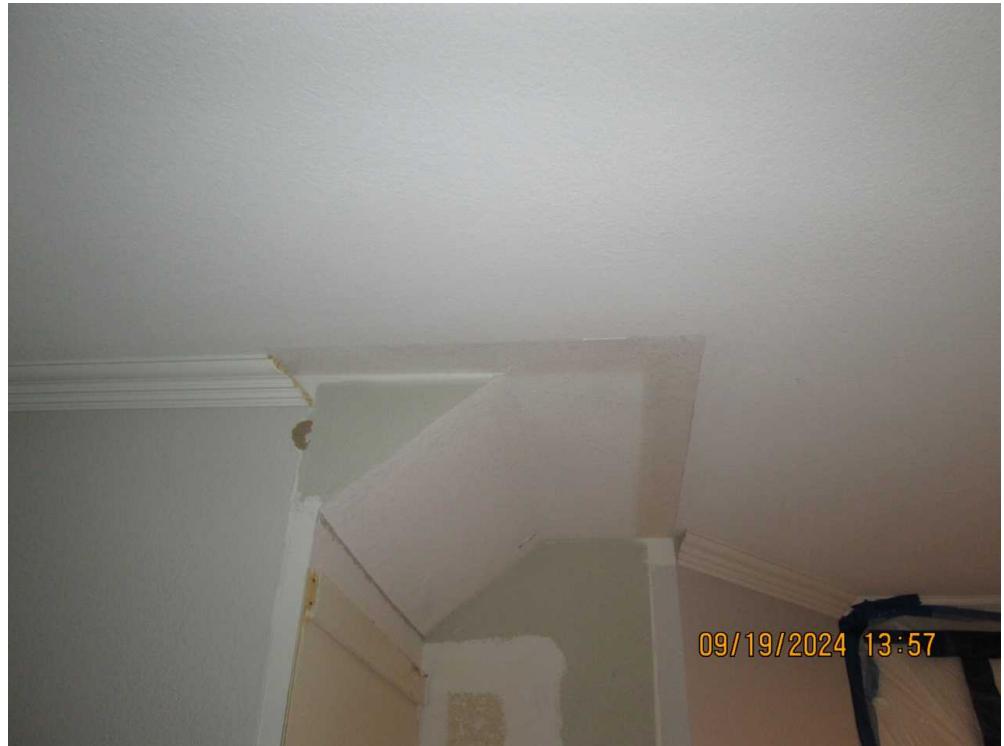
Kitchen
Crown molding removed during
mitigation

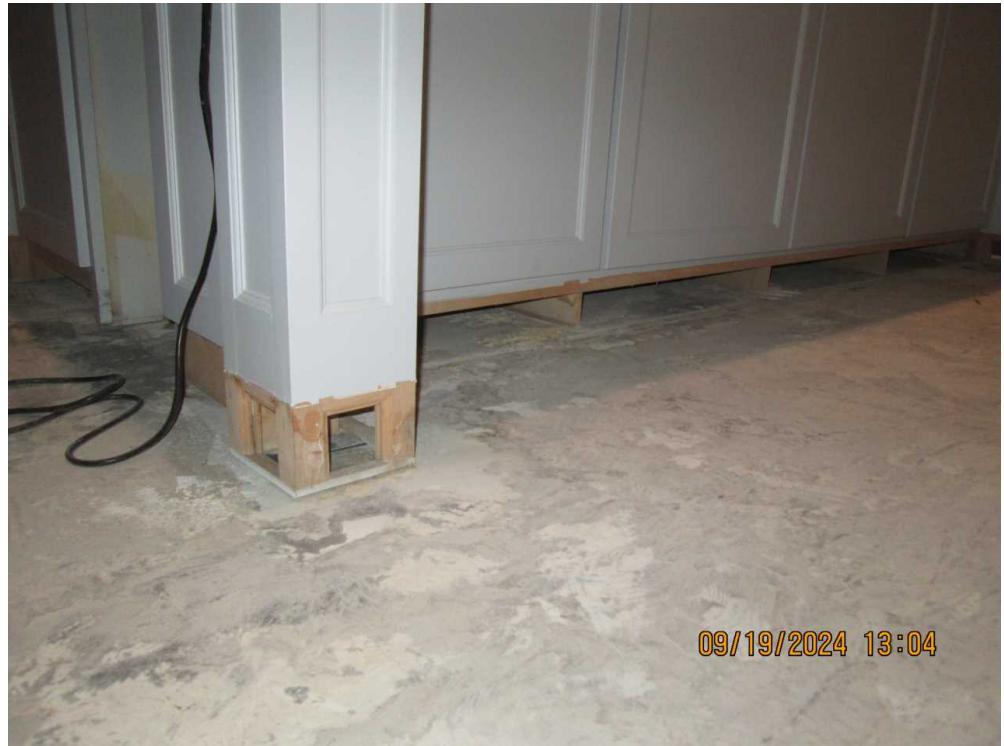
10 10-IMG_2906

Kitchen
Toe kick on island removed during
mitigation

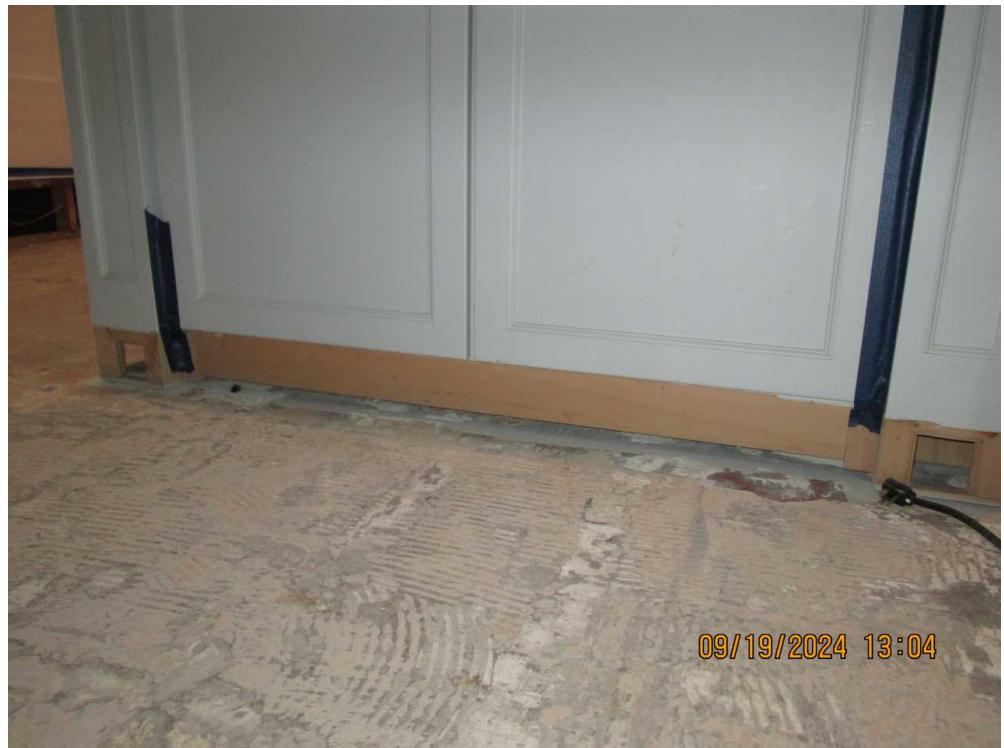
Kitchen

Toekick on island removed during mitigation

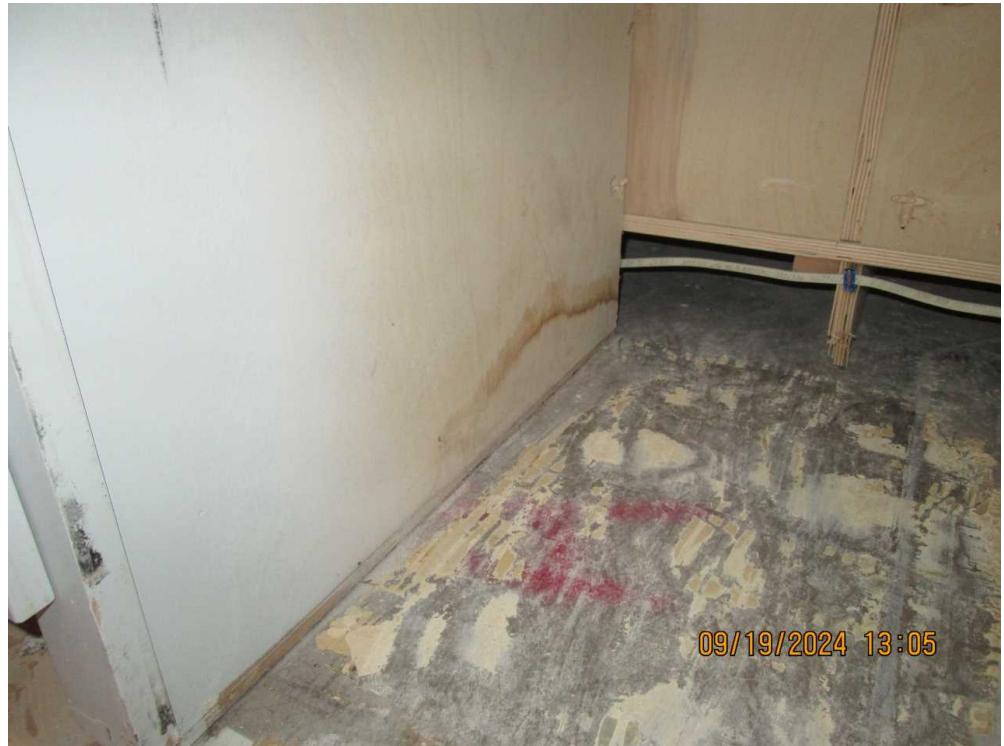
Water damage to island cabinet from plumbing leak

Island cabinet measures 9.5 LF x 4.83 LF and was custom built by Fricks Custom Cabinets. Price may be updated when bid to replace it has been received from the mfr.

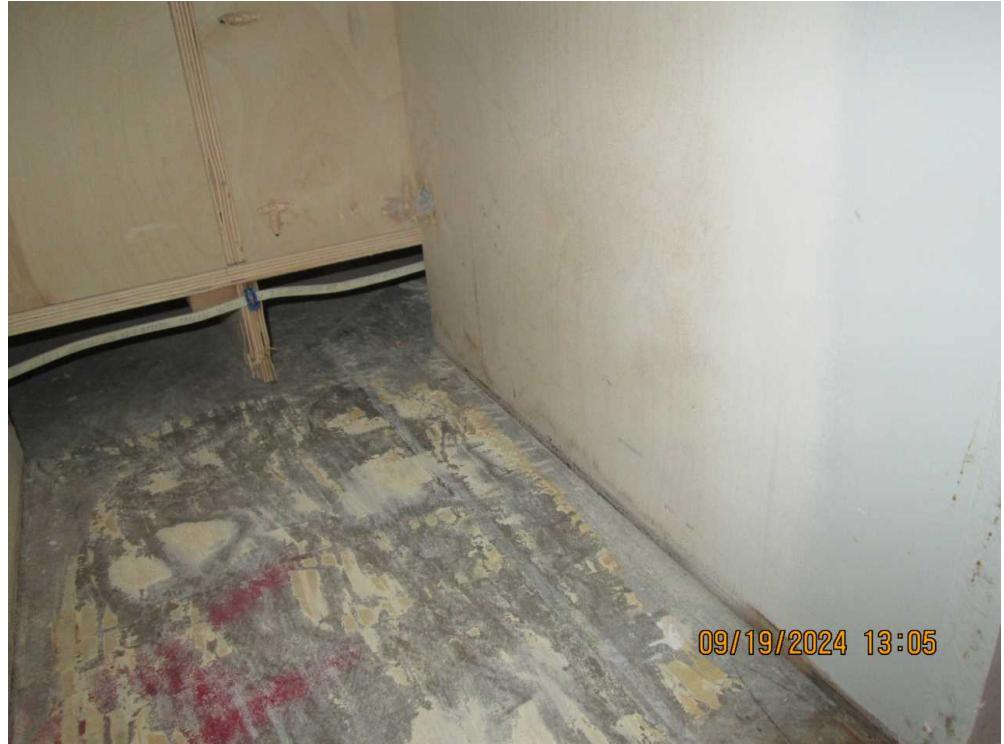
Water damage to island cabinet from
plumbing leak

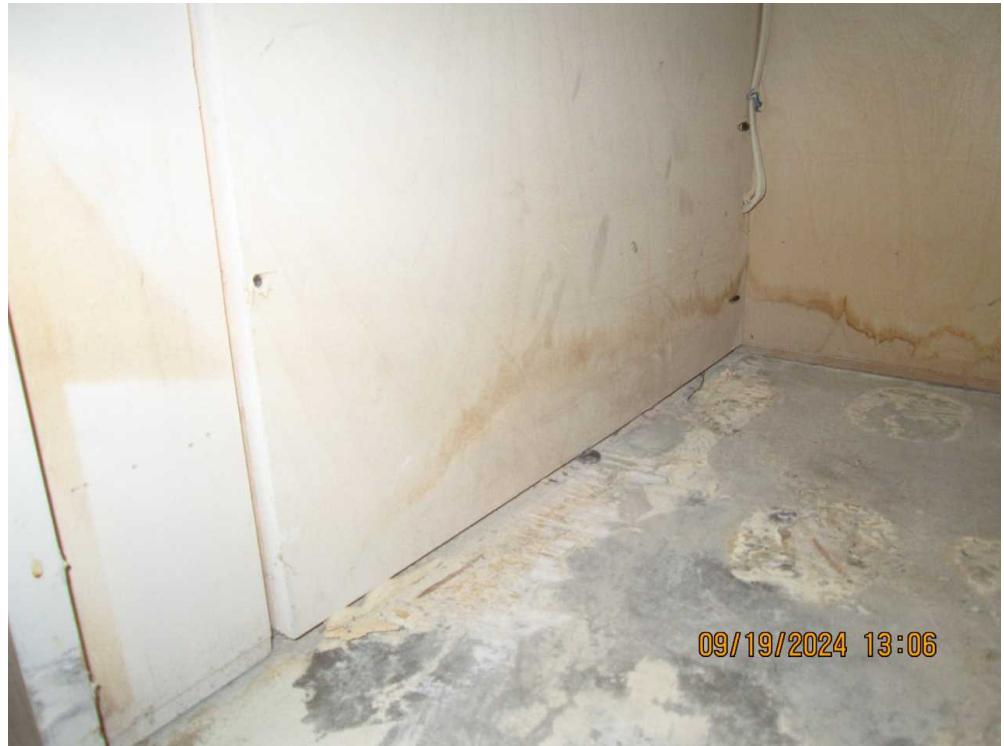
Water damage to island cabinet from
plumbing leak

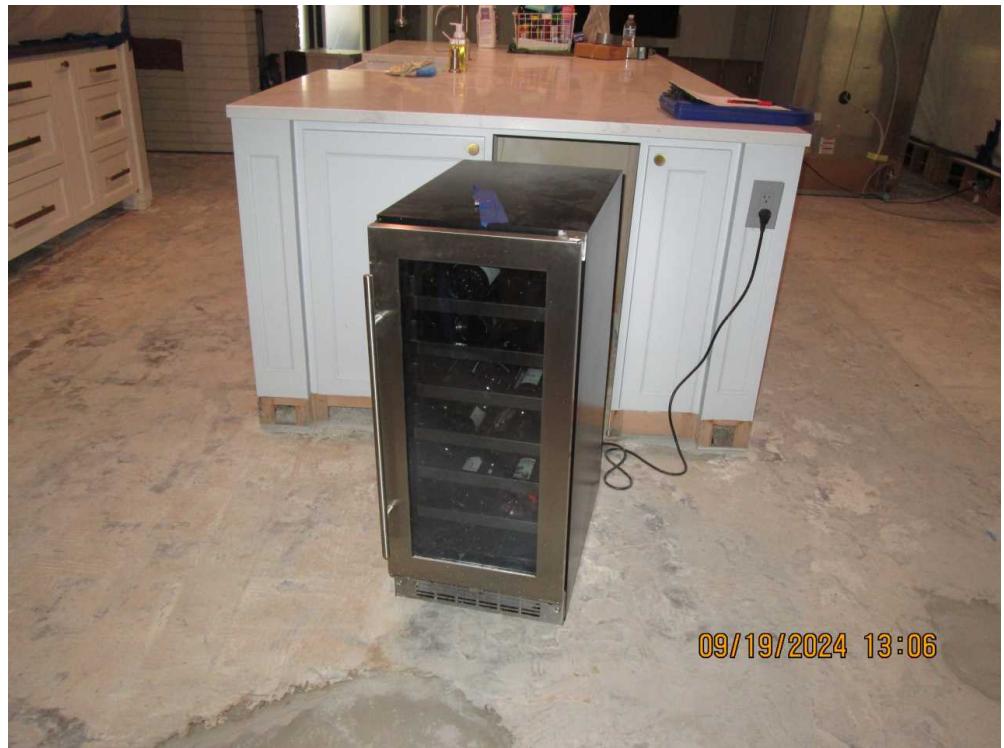
Kitchen

Wine cooler detached during
mitigation

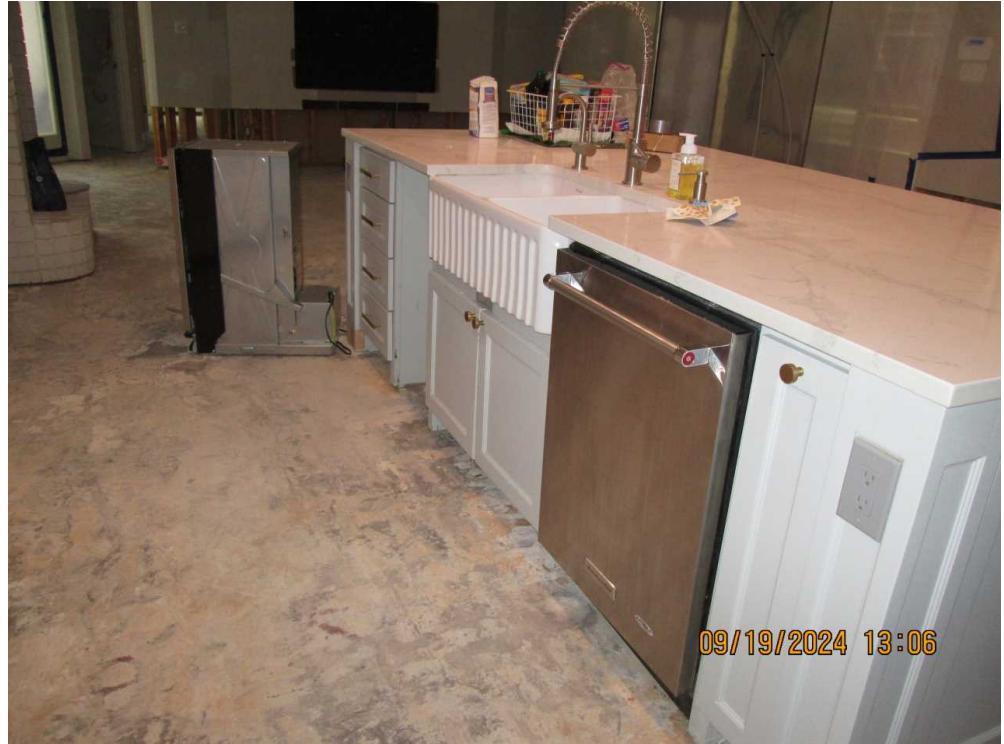
Kitchen

Trash compactor detached during mitigation

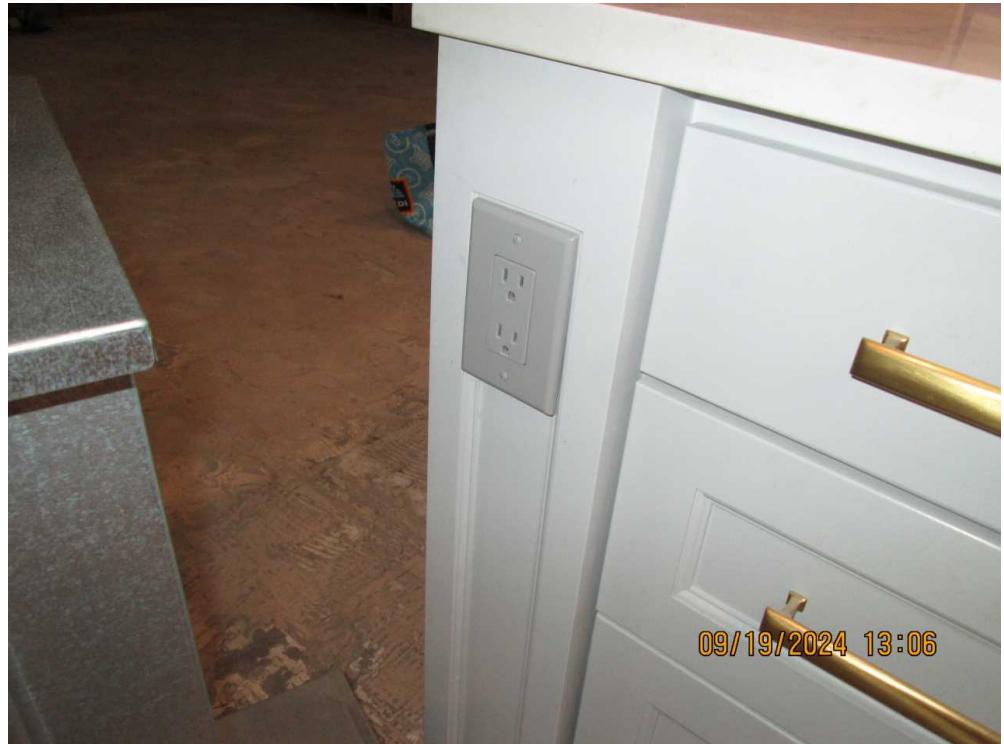
Electrical outlets will need to be detached and reset to allow for replacement of island cabinet

24. Outlet or switch - Detach & reset	3.00 EA		0.00	22.81	0.00	13.68	82.11
Electrical outlets will need to be detached and reset to allow for replacement of island cabinet

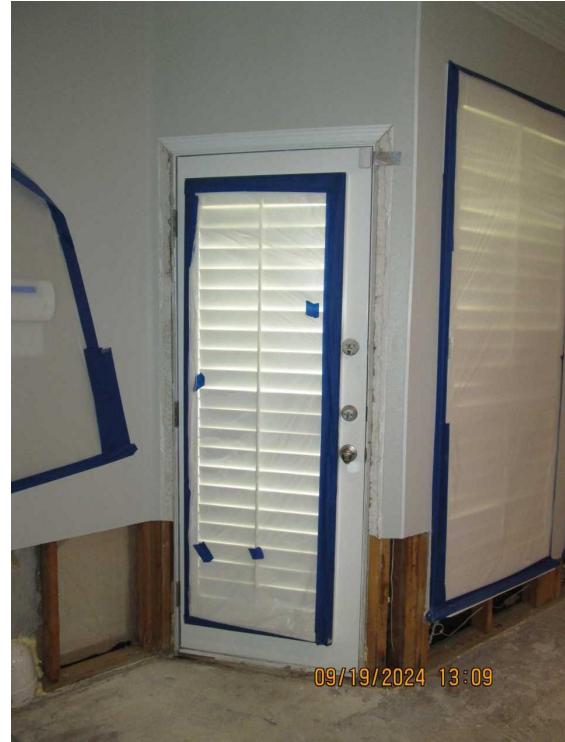
Kitchen
Door casing removed during
mitigation

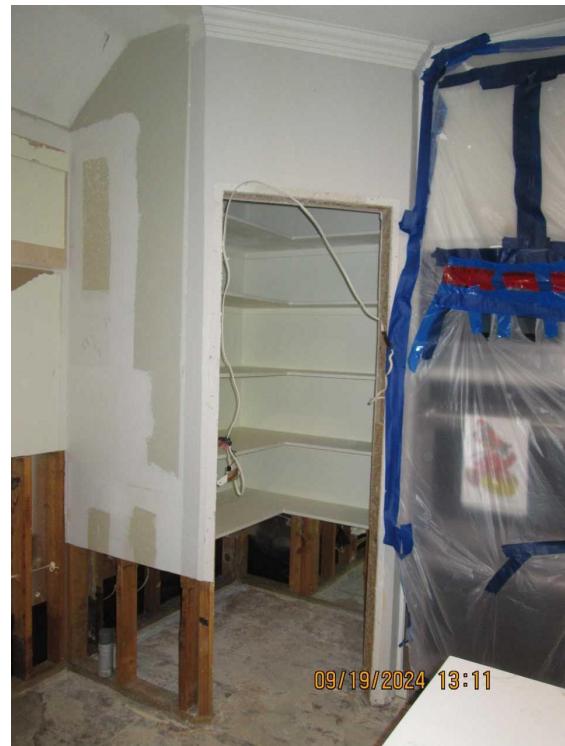
20 20-IMG_2919

Pantry
Door detached; door jamb, drywall,
baseboard, insulation and engineered
wood flooring removed during
mitigation

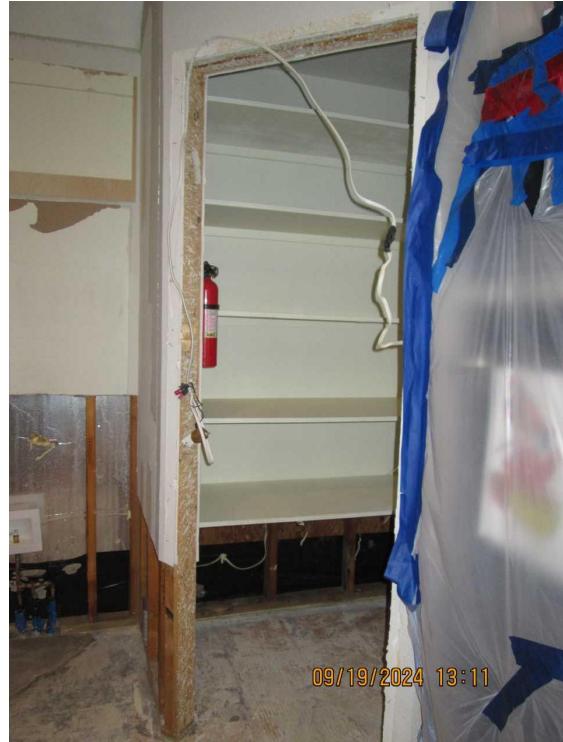
Pantry

Door-activated light switch detached
during mitigation

DESCRIPTION	QTY	RESET	REMOVE	REPLACE	TAX	O&P	TOTAL
69. Door jamb switch (open-on / close-off)	1.00 EA		0.00	87.16	1.73	17.78	106.67
70. On site door prep. for full mortised hinges - Labor only	1.00 EA		0.00	102.27	0.00	20.46	122.73

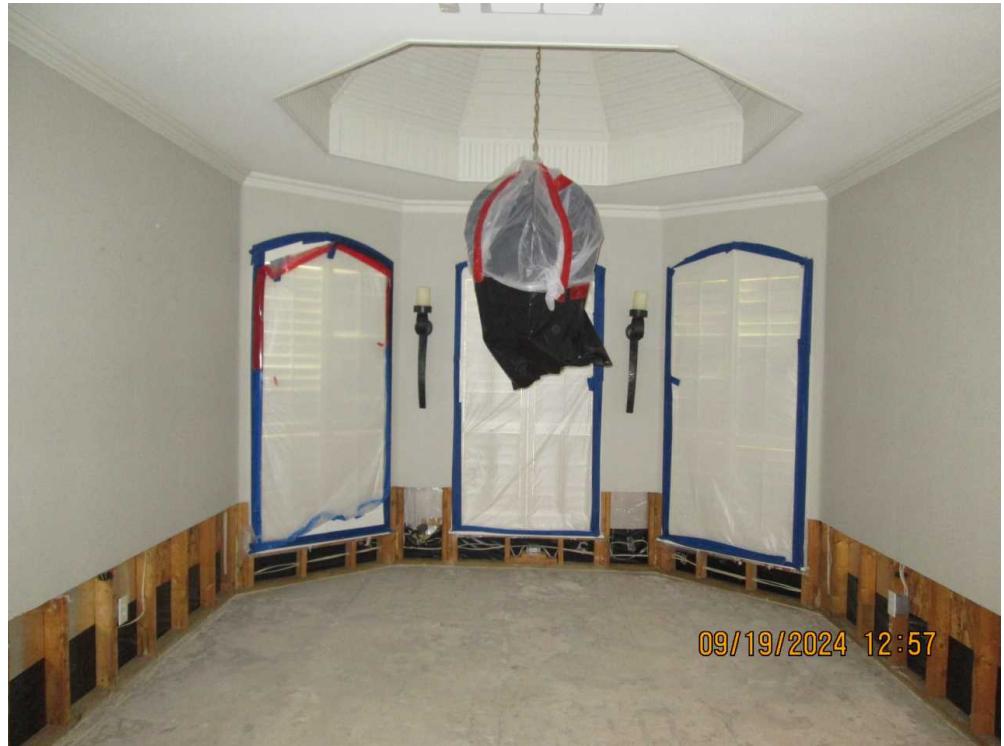
22 22-IMG_2895

Drywall, baseboard, insulation and
engineered wood flooring removed
during mitigation

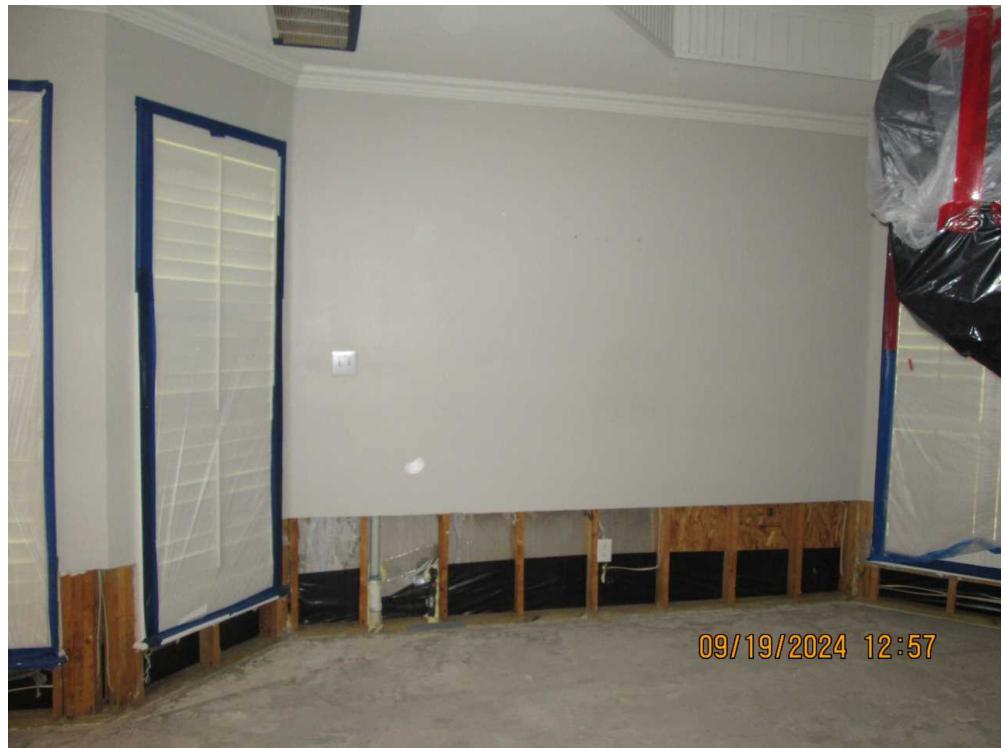
Dining Room

Drywall, baseboard, insulation and
engineered wood flooring removed
during mitigation

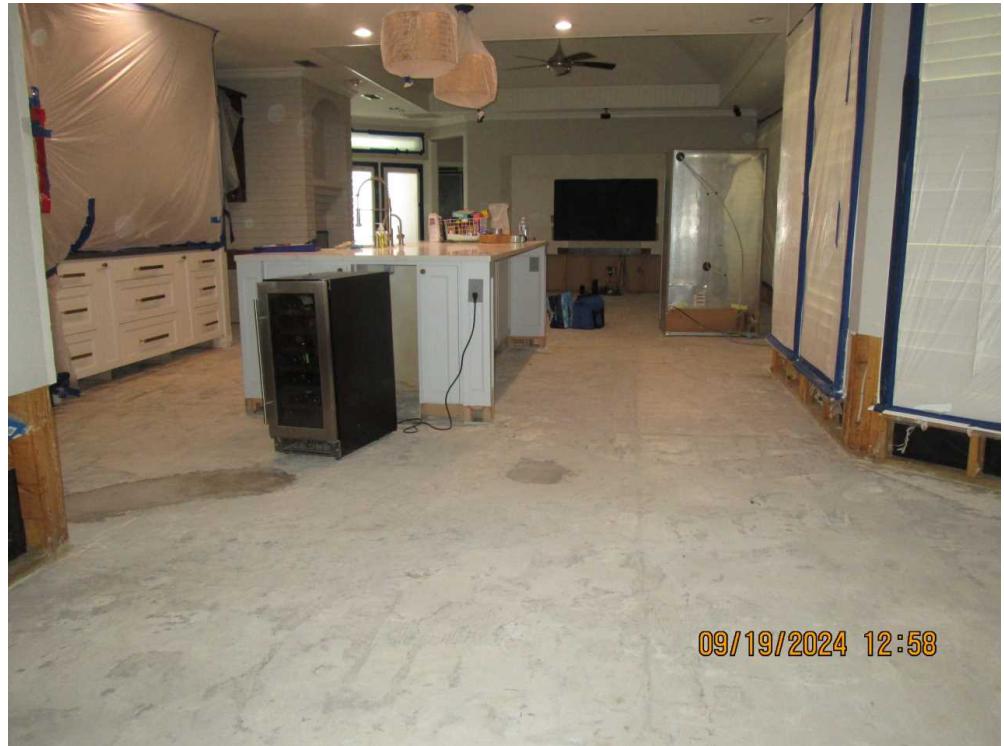
24 24-IMG_2897

Drywall, baseboard, insulation and
engineered wood flooring removed
during mitigation

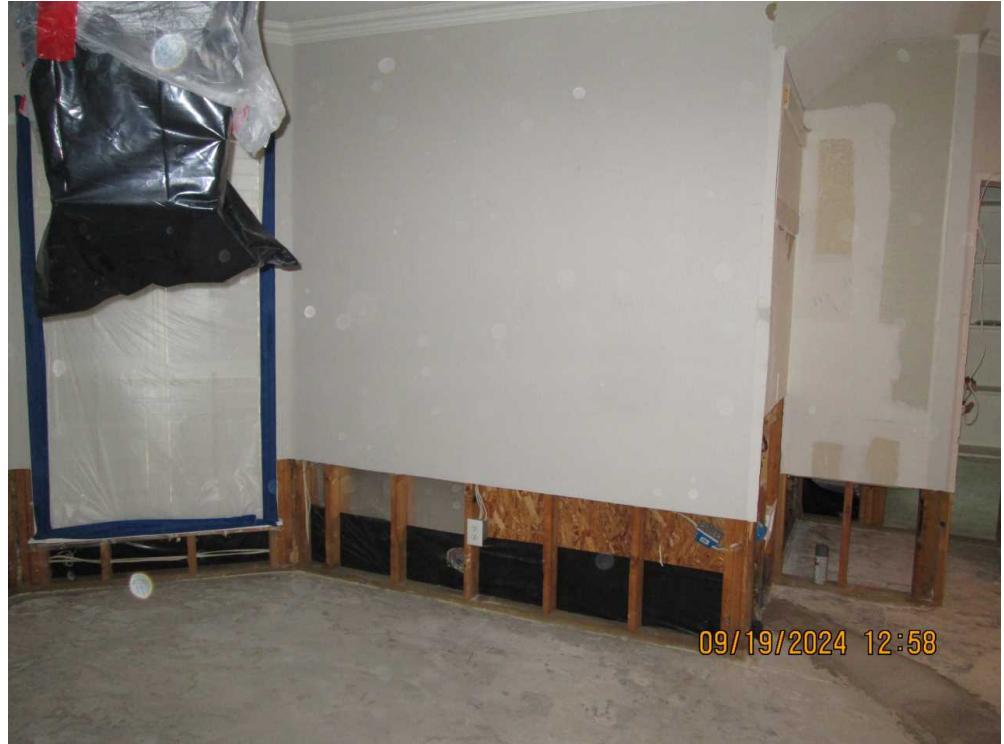
Dining Room

Drywall, baseboard, insulation and
engineered wood flooring removed
during mitigation

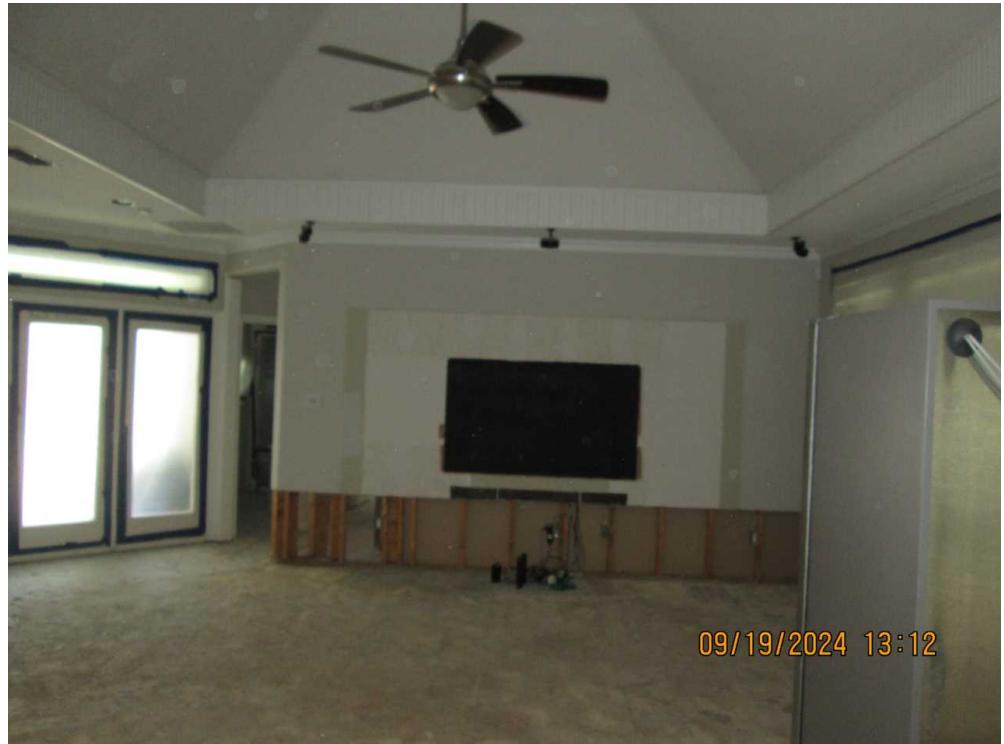
26 26-IMG_2922

Drywall, baseboard, insulation and
engineered wood flooring removed
during mitigation

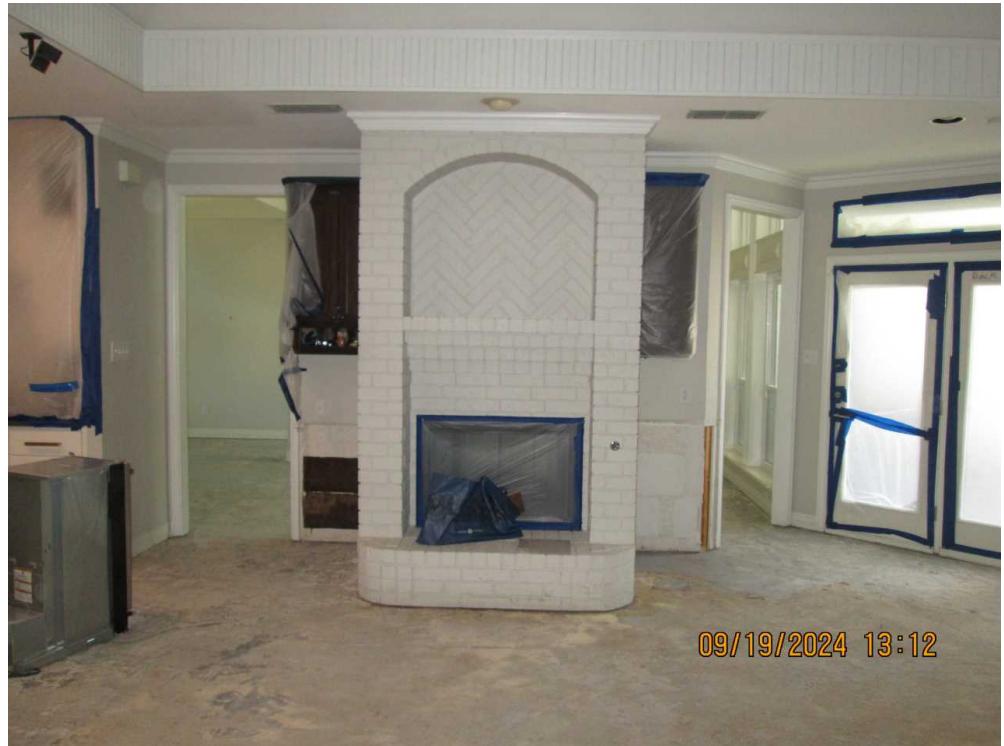
Family Room

Base cabinets on either side of fireplace and engineered wood flooring removed during mitigation

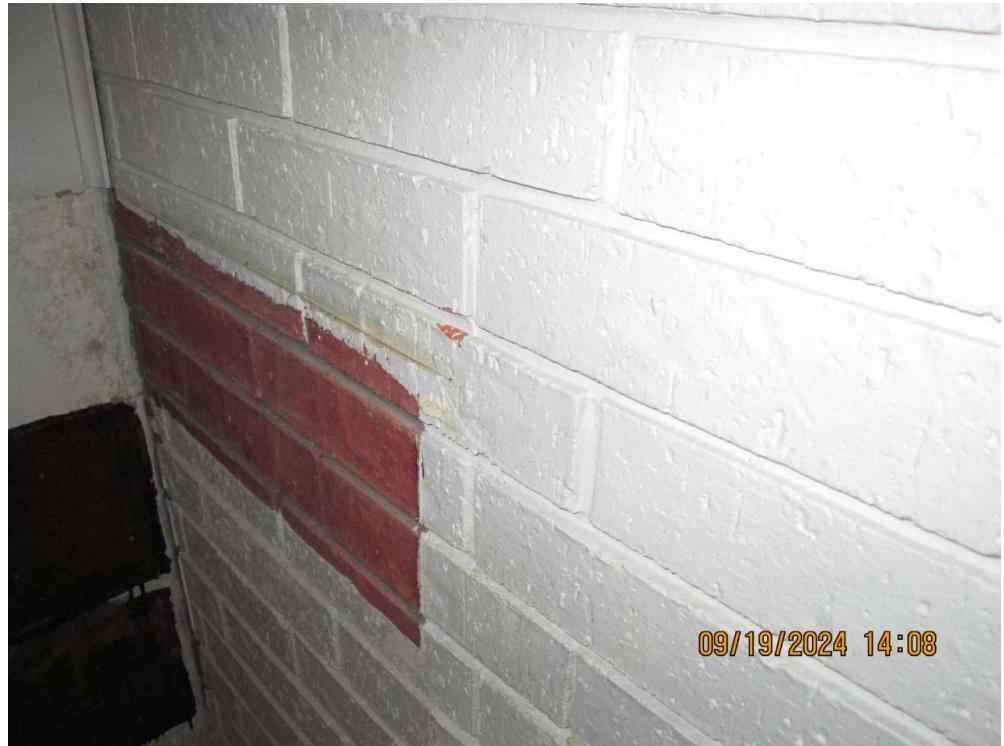
Paint on fireplace chipped while countertop was being removed during mitigation

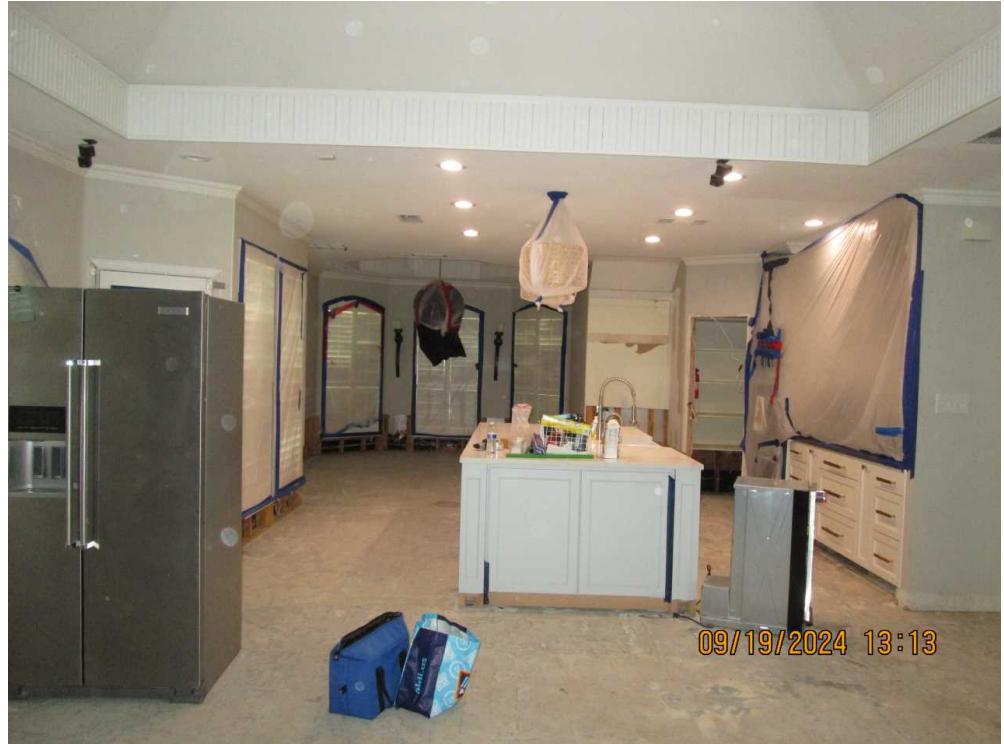
Family Room
Engineered wood flooring removed
during mitigation

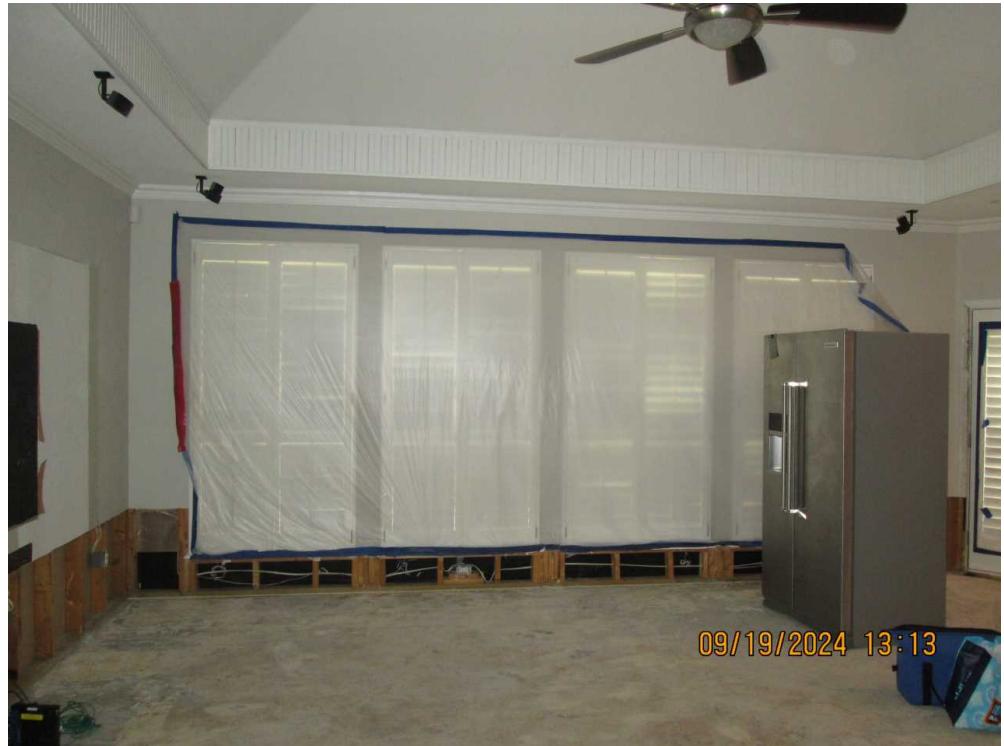
30 30-IMG_2925

Family Room
Drywall, baseboard, insulation and
engineered wood flooring removed
during mitigation

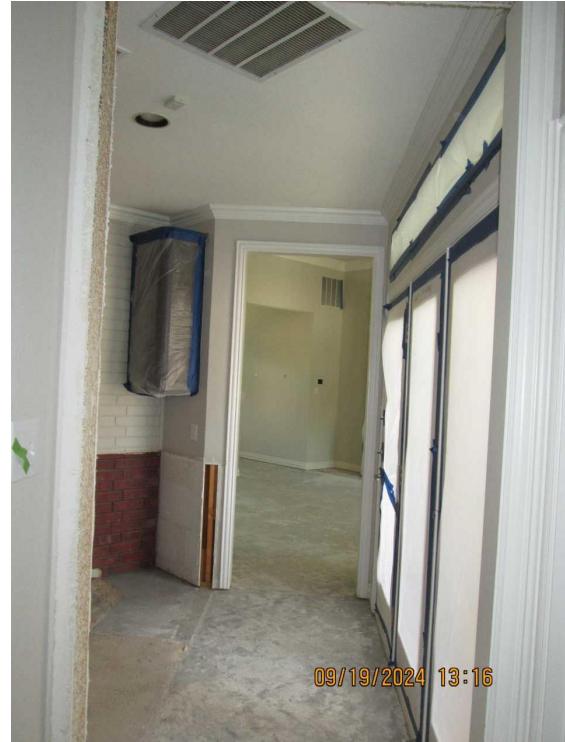
Hallway 3

Drywall, baseboard and ceramic tile
flooring removed during mitigation

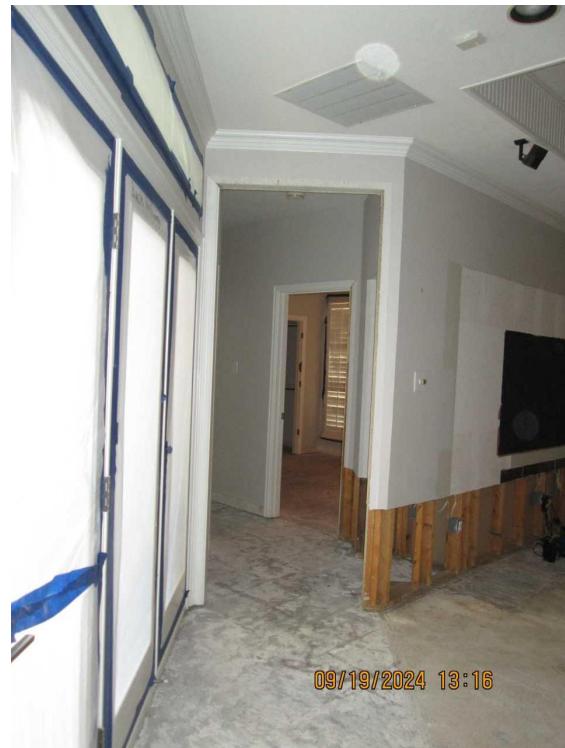
32 32-IMG_2927

Door jamb removed during mitigation

117. Door opening (jamb & casing) - 32"to36"wide - paint grade	1.00 EA	0.00	179.36	10.40	37.96	227.72	
Replace door jamb in opening between sections of Hallway 3

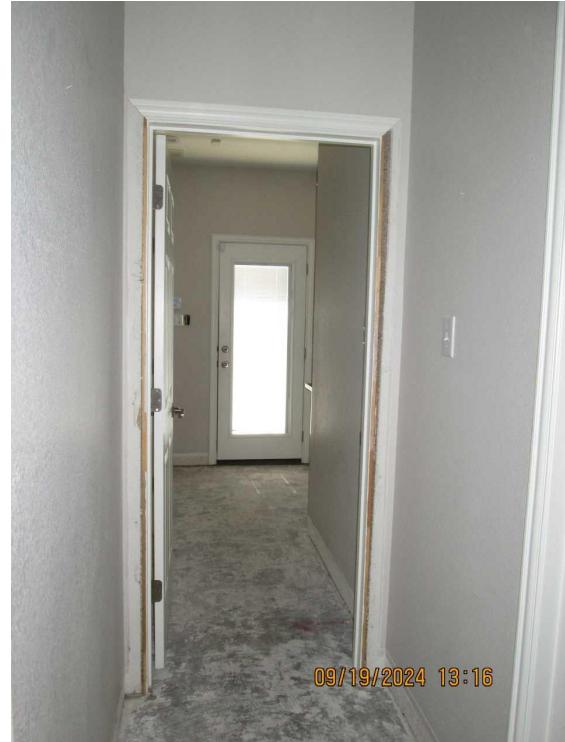
Hallway 3
Casing on Laundry Room door,
baseboard and ceramic tile flooring
removed during mitigation

118. Casing - 2 1/4"	34.00 LF	0.00	2.51	4.04	17.86	107.24	
Replace casing on outside of door to Bedroom 1 and Laundry Room							
119. Paint door/window trim & jamb - 2 coats (per side)	7.00 EA	0.00	43.21	3.21	61.14	366.82

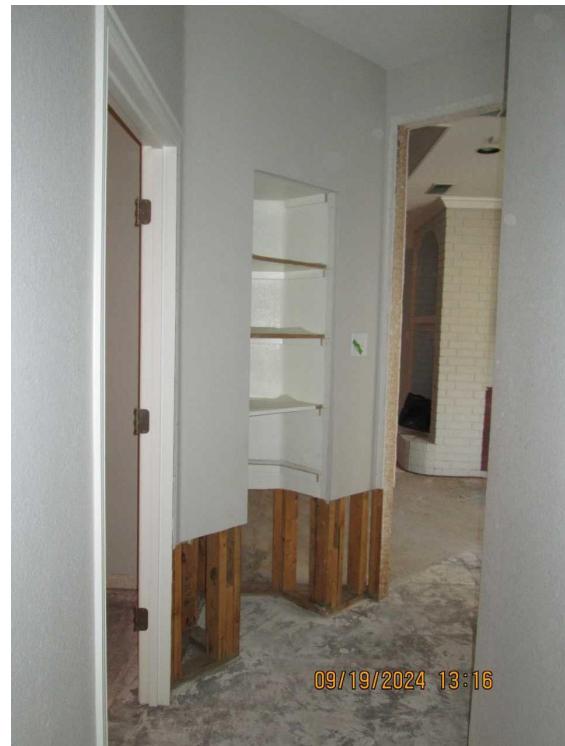
34 34-IMG_2930

Hallway 3
Linen Cabinet face detached; drywall,
baseboard, ceramic tile flooring
removed during mitigation

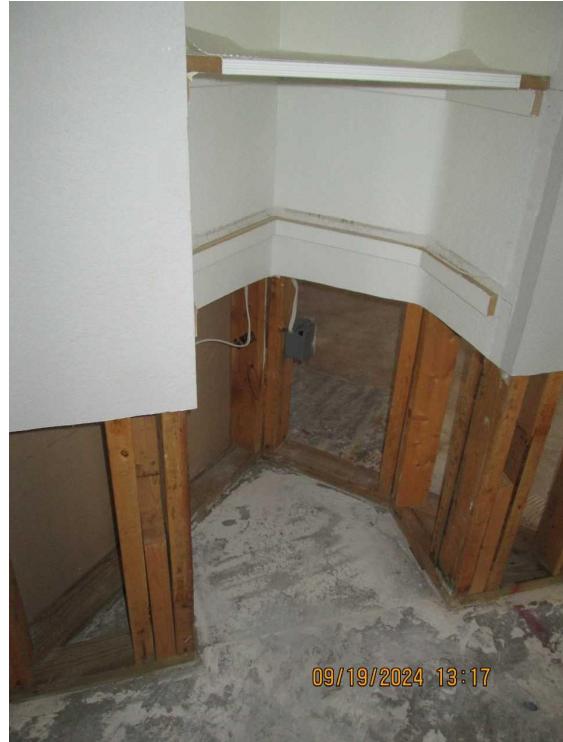
Face and shelf detached; drywall,
baseboard and ceramic tile flooring
removed during mitigation

DESCRIPTION	QTY	RESET	REMOVE	REPLACE	TAX	O&P	TOTAL
128. Shelving - Detach & reset	3.00 LF		0.00	8.66	0.01	5.20	31.19
Reset two shelves including one on bottom							
129. Seal & paint closet shelving - linen closet	1.00 EA		0.00	122.19	1.31	24.70	148.20
130. Cabinetry - full height unit - Reset	2.75 LF		0.00	41.93	0.00	23.06	138.37
Reset cabinet face							
131. Seal & paint full height cabinetry - faces only	2.75 LF		0.00	38.92	0.81	21.56	129.40
132. Cabinet knobs or pulls - Detach & reset	3.00 EA		0.00	2.64	0.00	1.58	9.50
Totals: Linen Cabinet					2.13	76.10	456.66

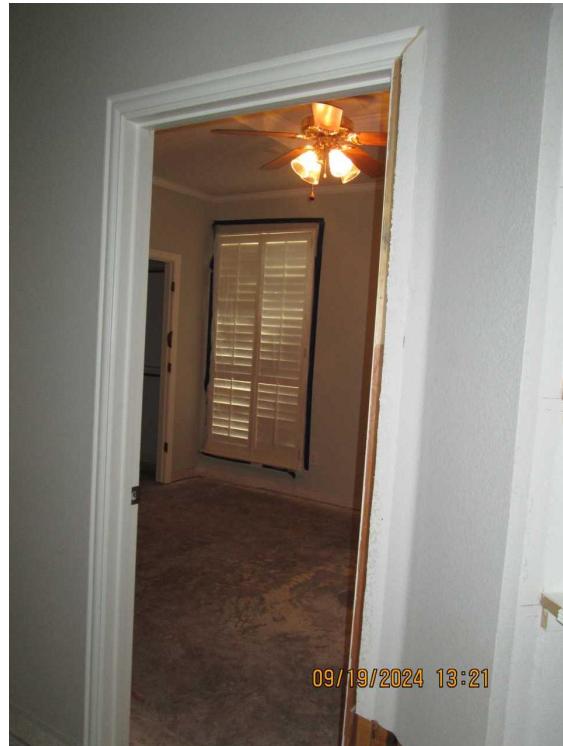
36 36-IMG_2934

Casing on Bedroom 1 door removed
during mitigation
