JDR Restoration & Remodeling

Type of Loss: Water Damage

Date of Loss:
Date Inspected: 9/19/2024 11:40 AM

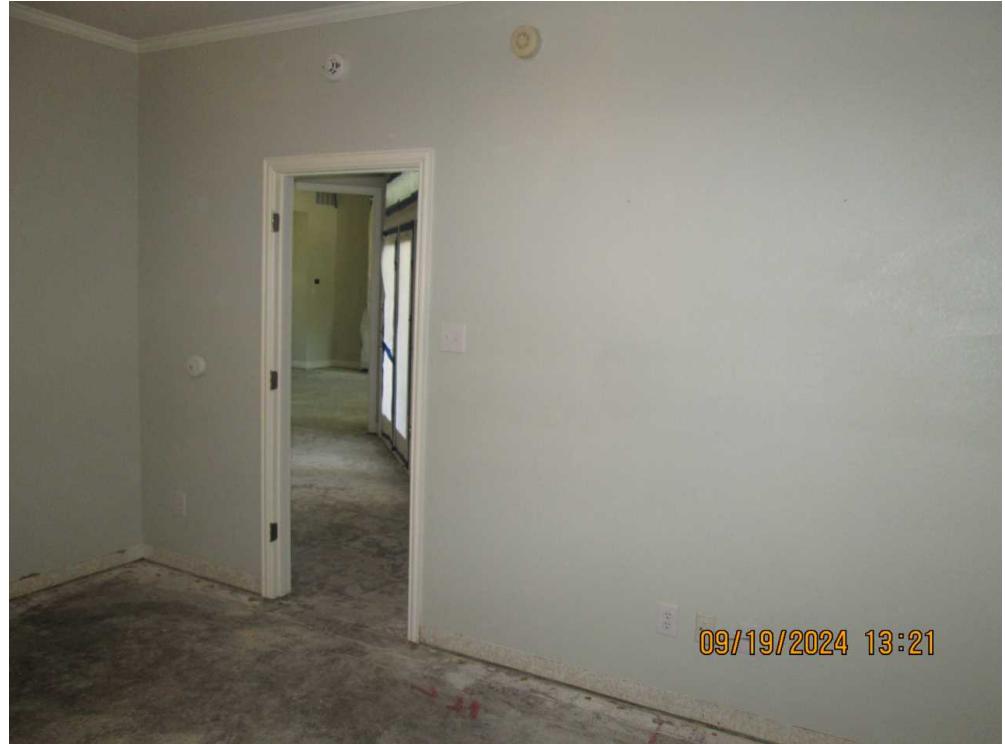
Bedroom 1
Baseboard and engineered wood
flooring removed during mitigation

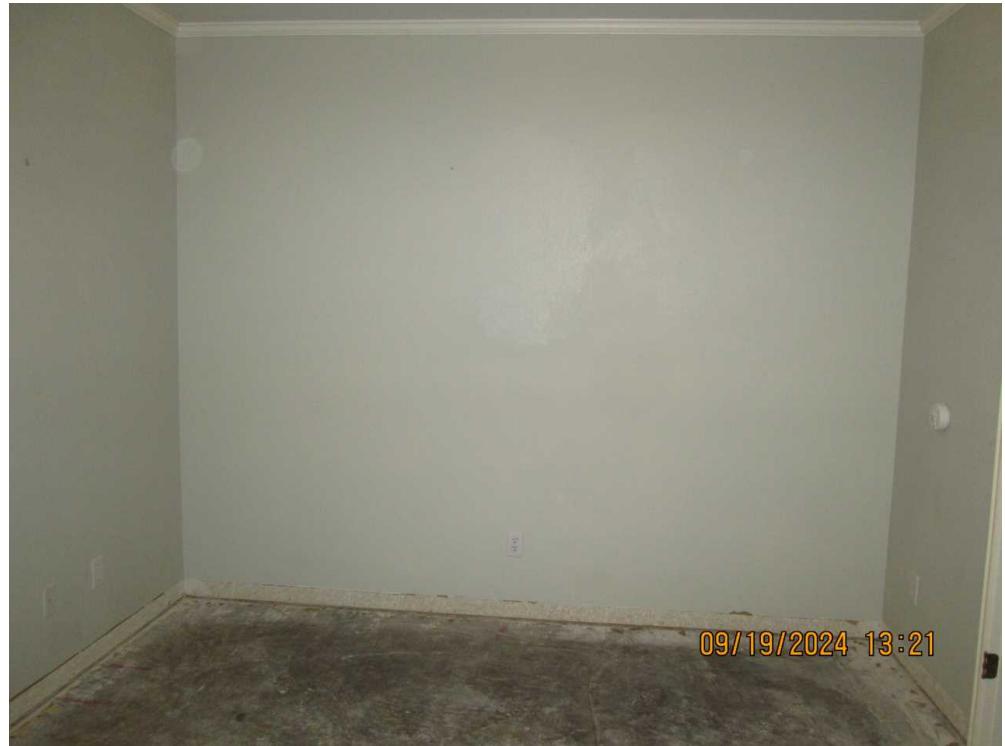
38 38-IMG_2937

Bedroom 1
Baseboard and engineered wood
flooring removed during mitigation

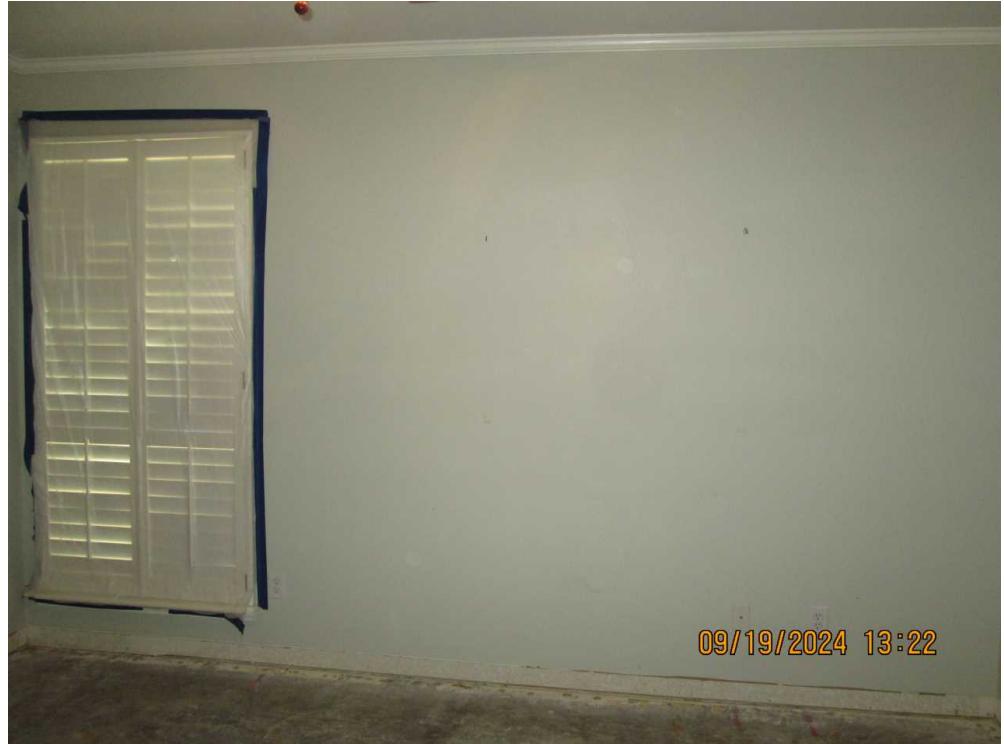
Bedroom 1
Baseboard and engineered wood
flooring removed during mitigation

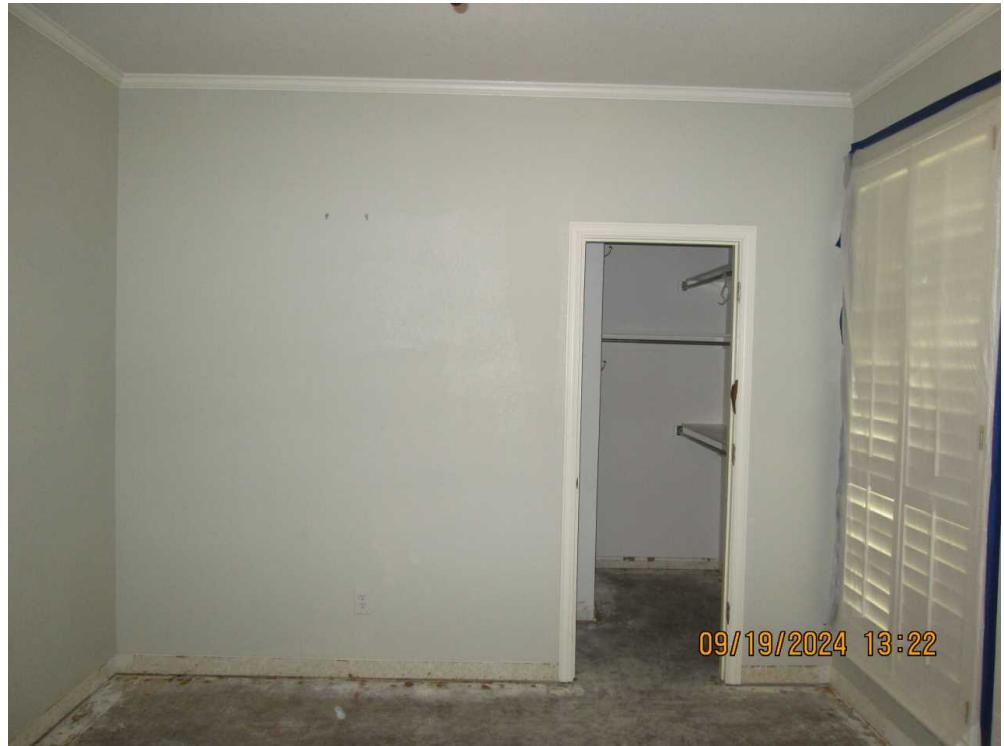
40 40-IMG_2939

Bedroom 1
Baseboard and engineered wood
flooring removed during mitigation

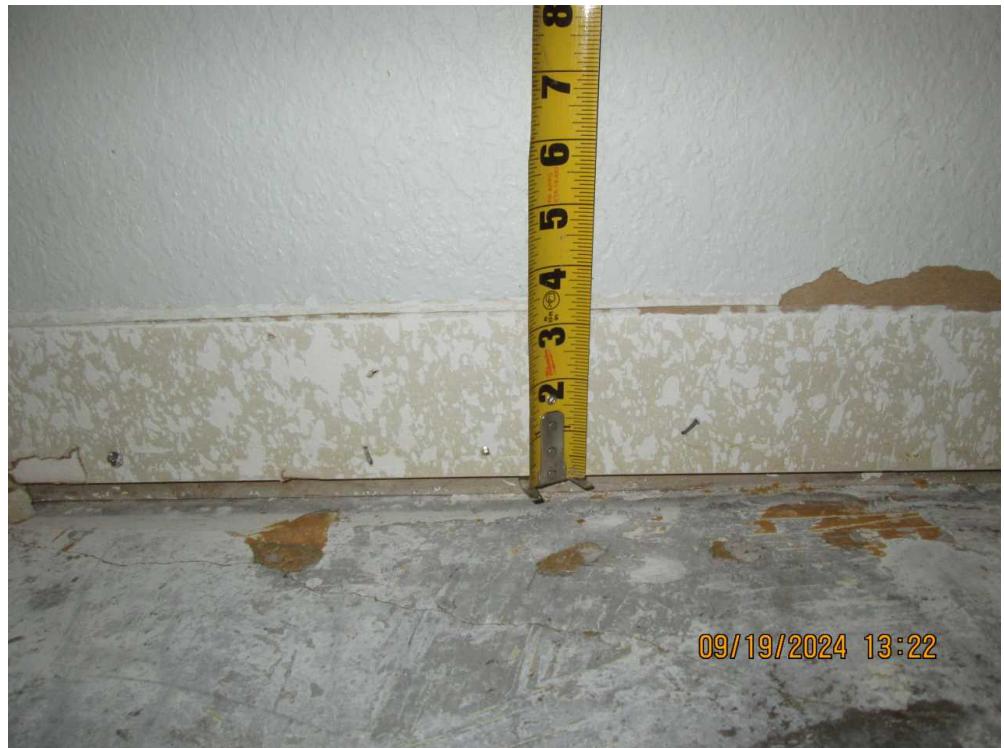
Paint on drywall damaged while
baseboard was being removed during
mitigation

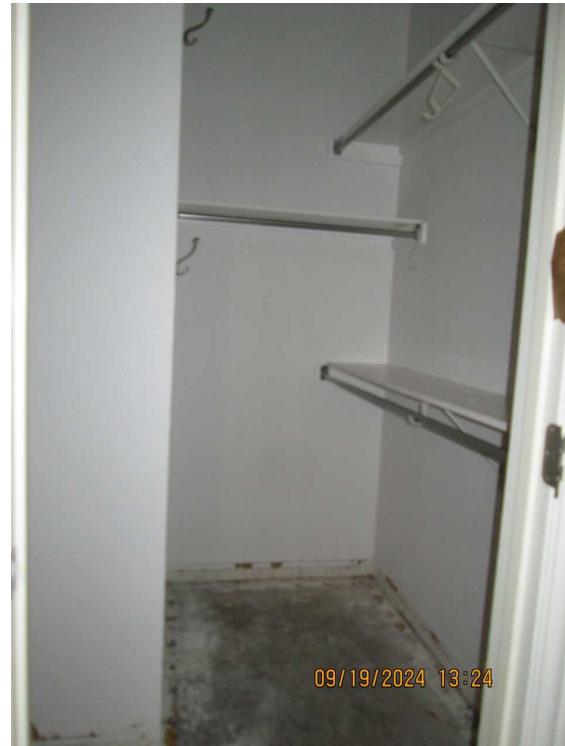
Bedroom 1 Closet

Baseboard and engineered wood
flooring removed during mitigation

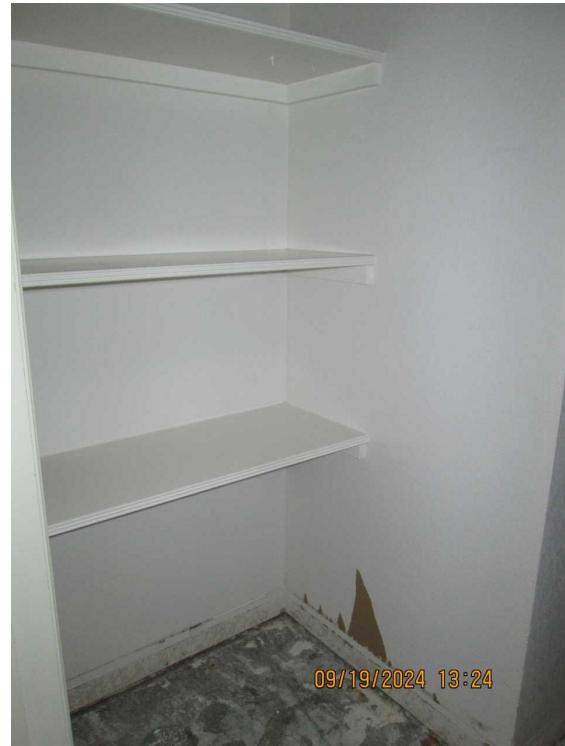
Bedroom 1 Closet
Baseboard and engineered wood
flooring removed during mitigation

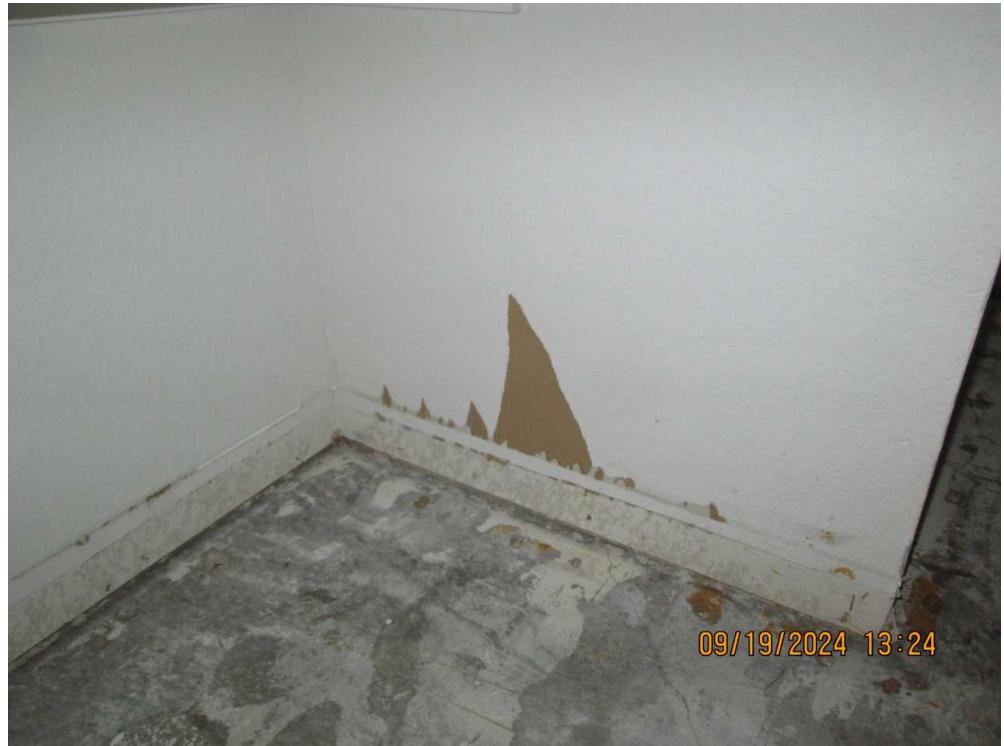
Bedroom 1 Closet
Paint on drywall damaged while
baseboard was being removed during
mitigation

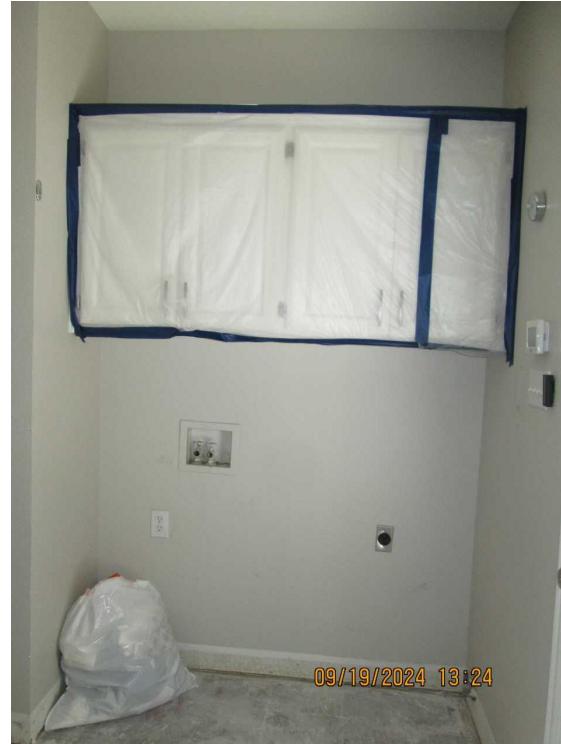
Laundry Room
Baseboard and ceramic tile flooring
removed during mitigation

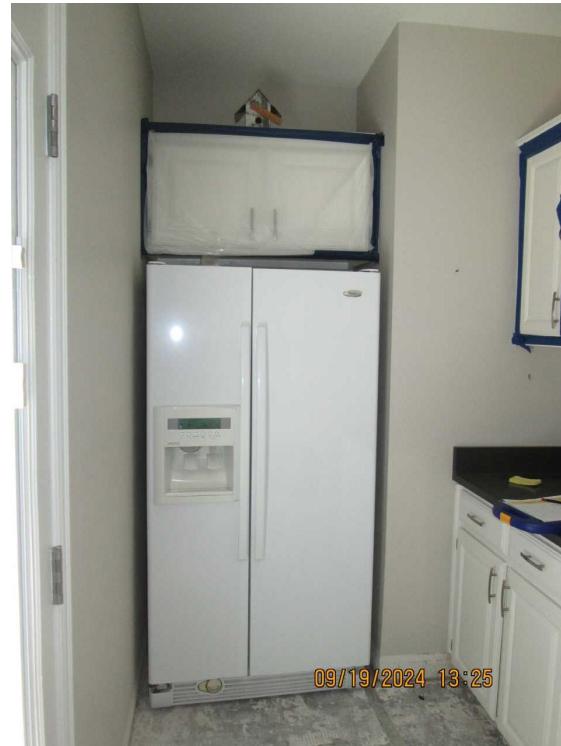
Laundry Room
Baseboard and ceramic tile flooring
removed during mitigation

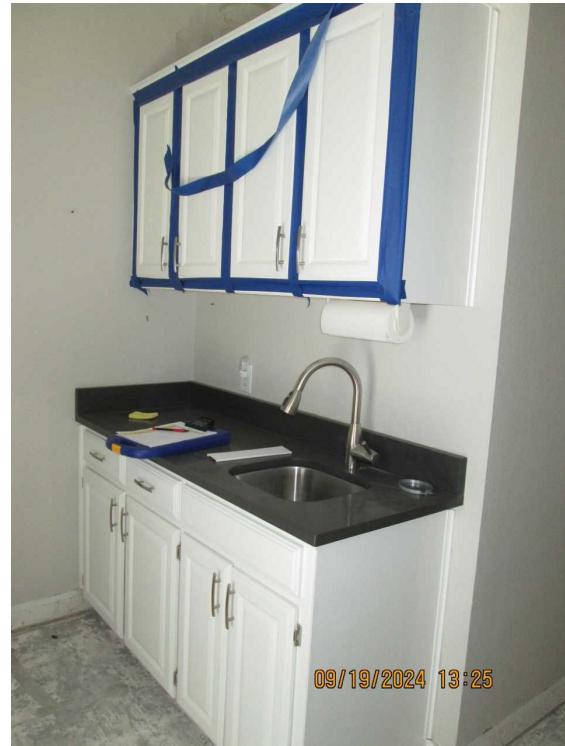
Laundry Room
Baseboard and ceramic tile flooring
removed during mitigation

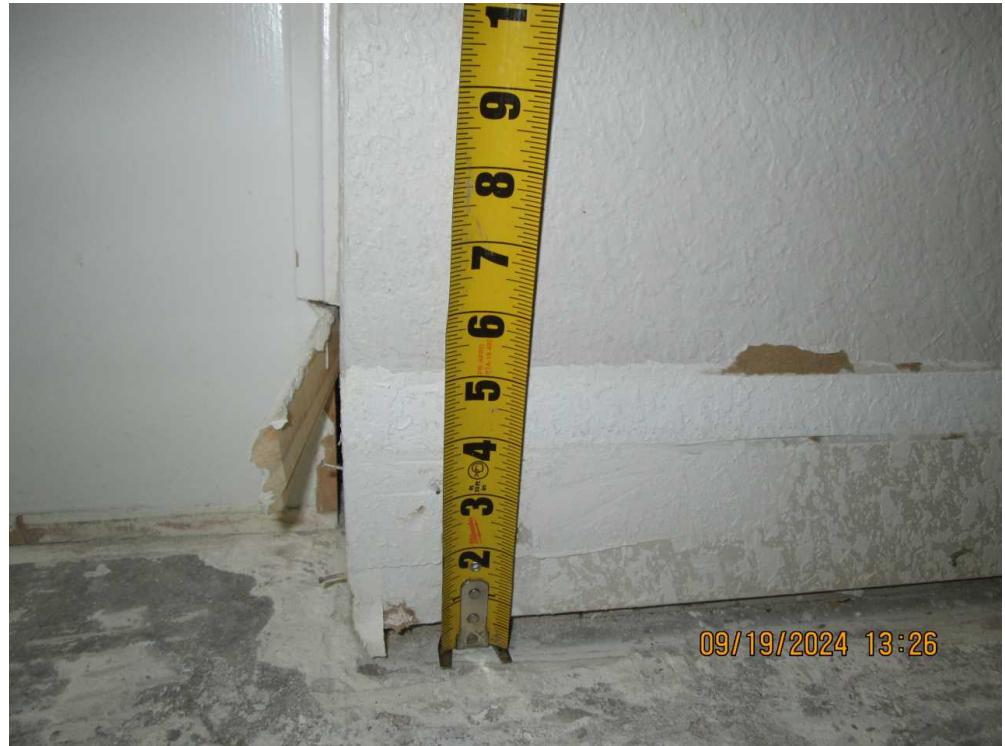
Laundry Room
Paint on drywall damaged while
baseboard was being removed during
mitigation

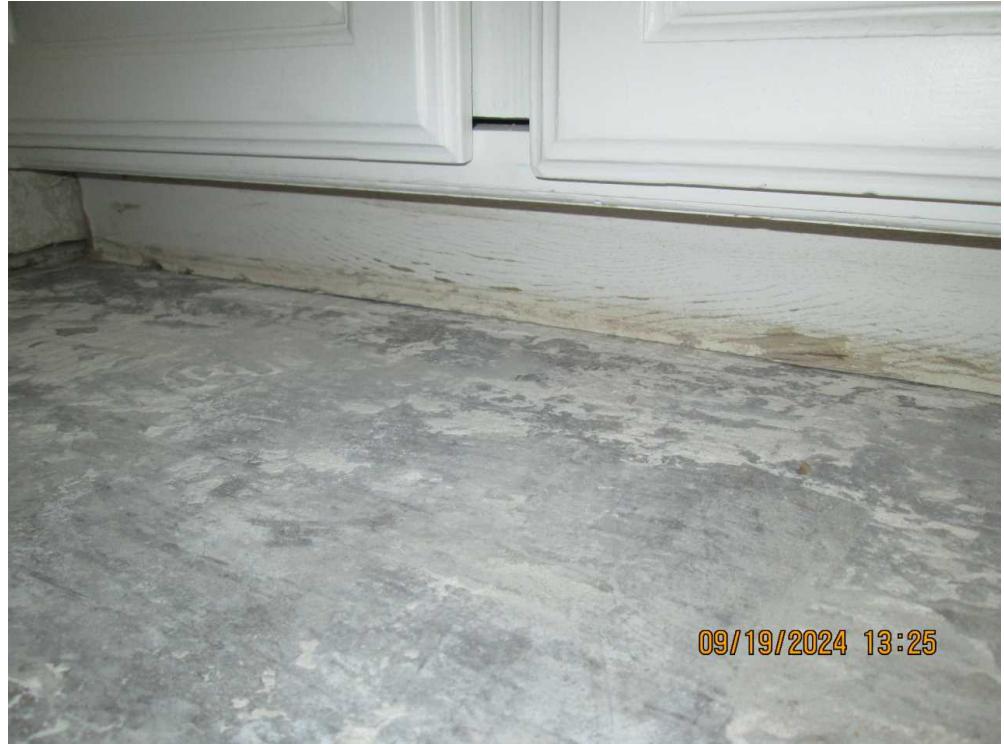
Water damage to toe kick; quarter round removed during mitigation

180. R&R Toe kick - unfinished wood - 1/2"	5.00 LF		2.27	8.69	1.46	11.28	67.54
181. Paint toe kick	5.00 LF		0.00	1.22	0.03	1.22	7.35
182. Quarter round - 3/4"	7.00 LF		0.00	1.99	0.62	2.90	17.45
Replace quarter round on base of cabinet

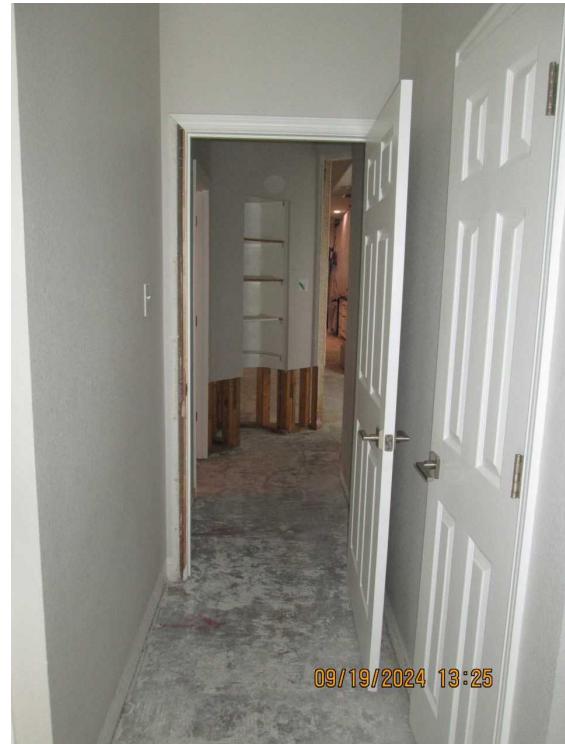
Laundry Room

Baseboard, door casing and ceramic tile flooring removed during mitigation

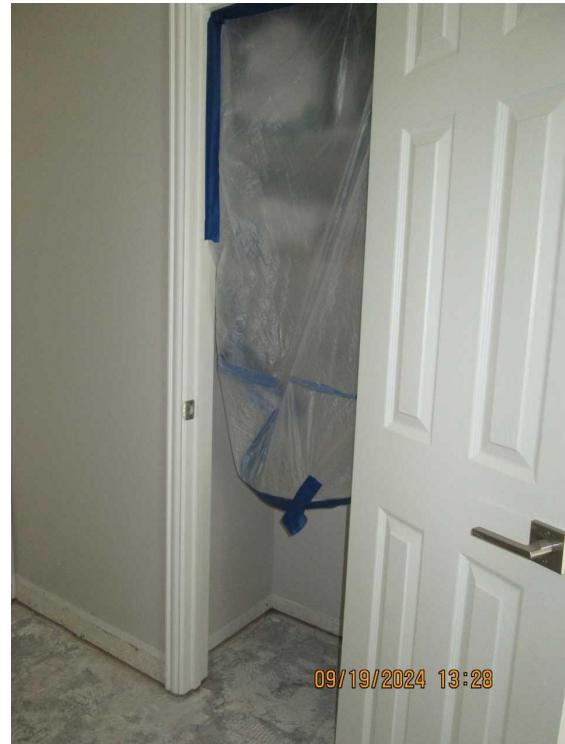
Laundry Room Closet
Baseboard and ceramic tile flooring
removed during mitigation

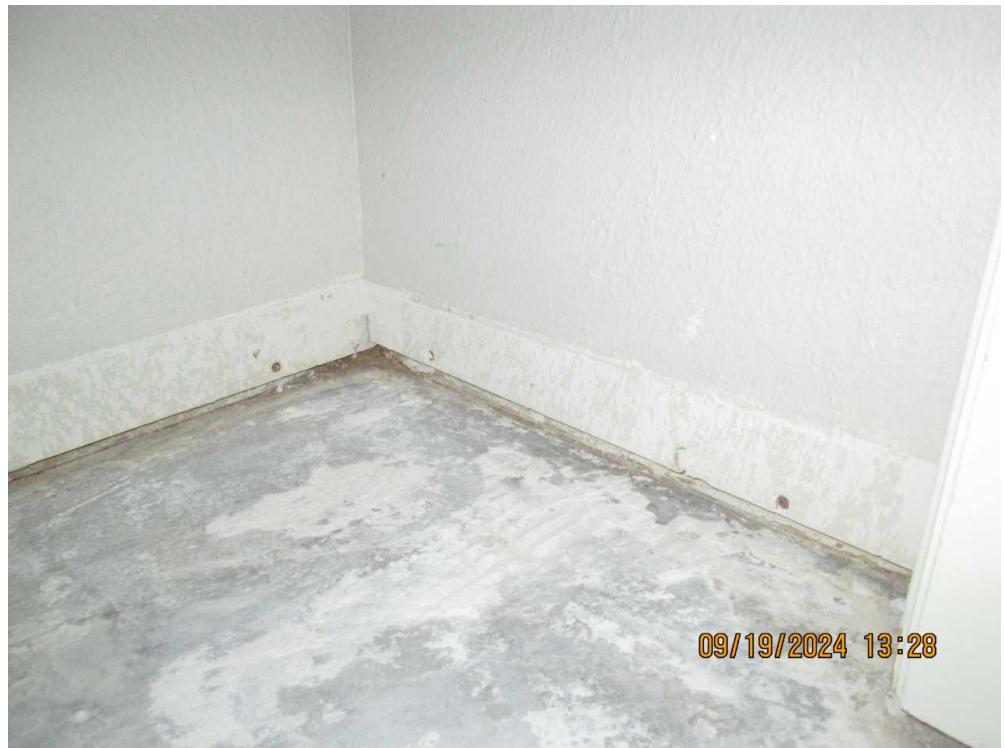
Laundry Room Closet
Baseboard and ceramic tile flooring
removed during mitigation

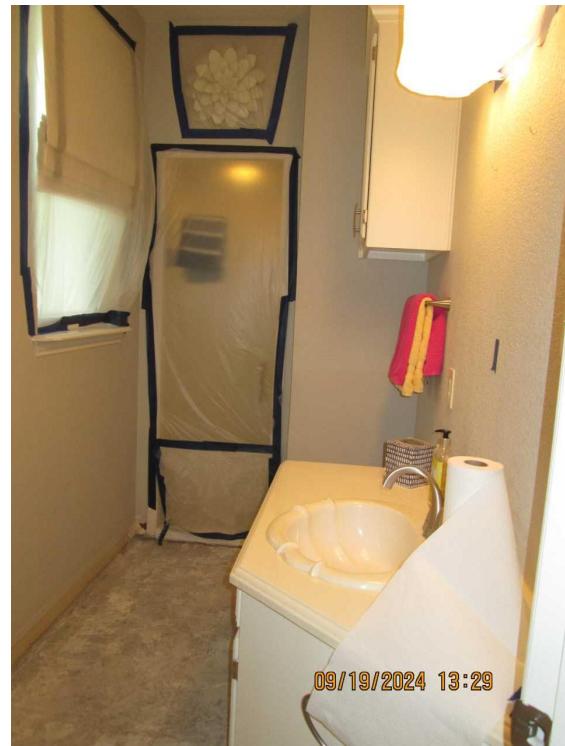
Bathroom

Baseboard and ceramic tile flooring
removed during mitigation

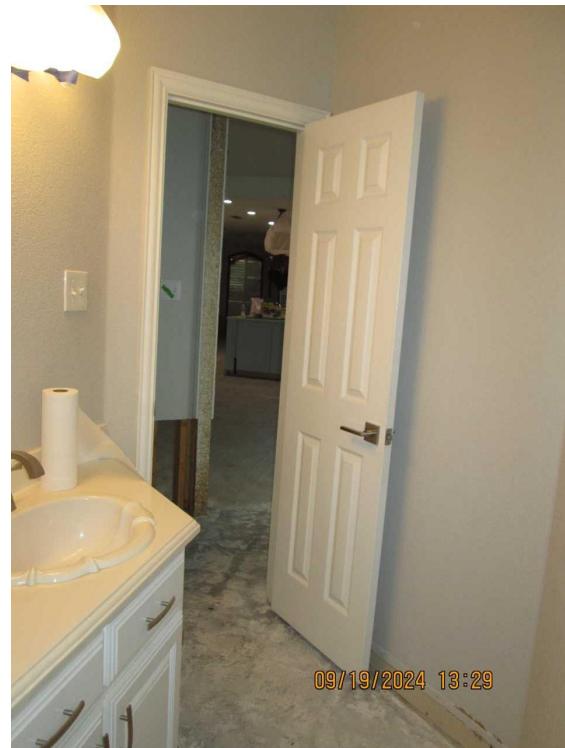
Bathroom

Baseboard and ceramic tile flooring
removed during mitigation

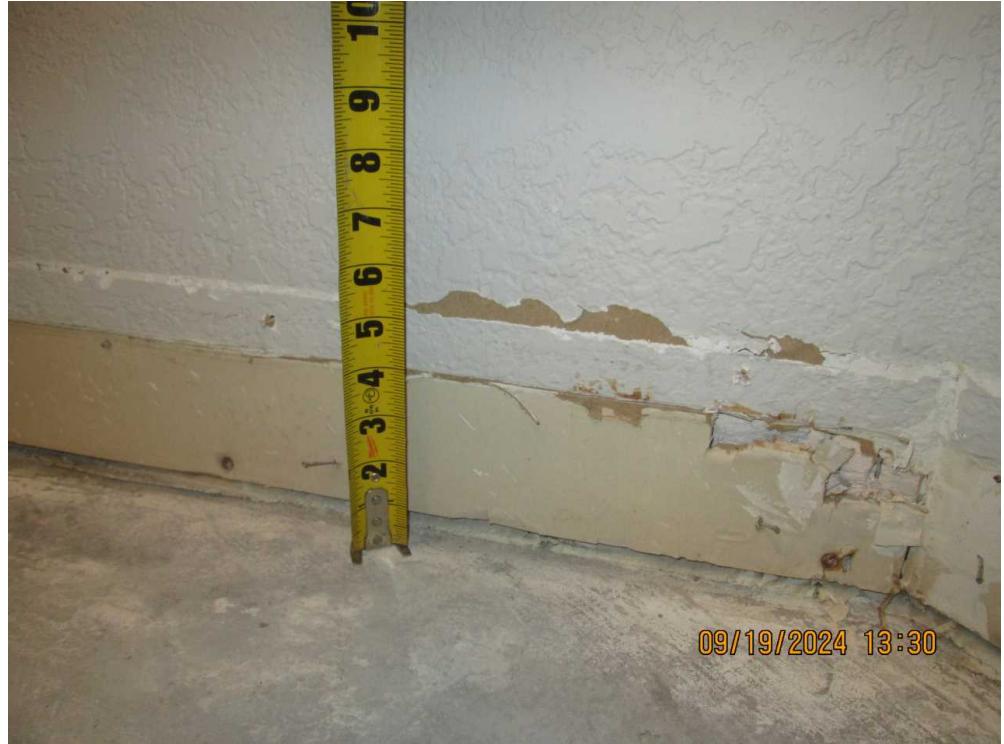
Paint on drywall damaged while
baseboard was being removed during
mitigation

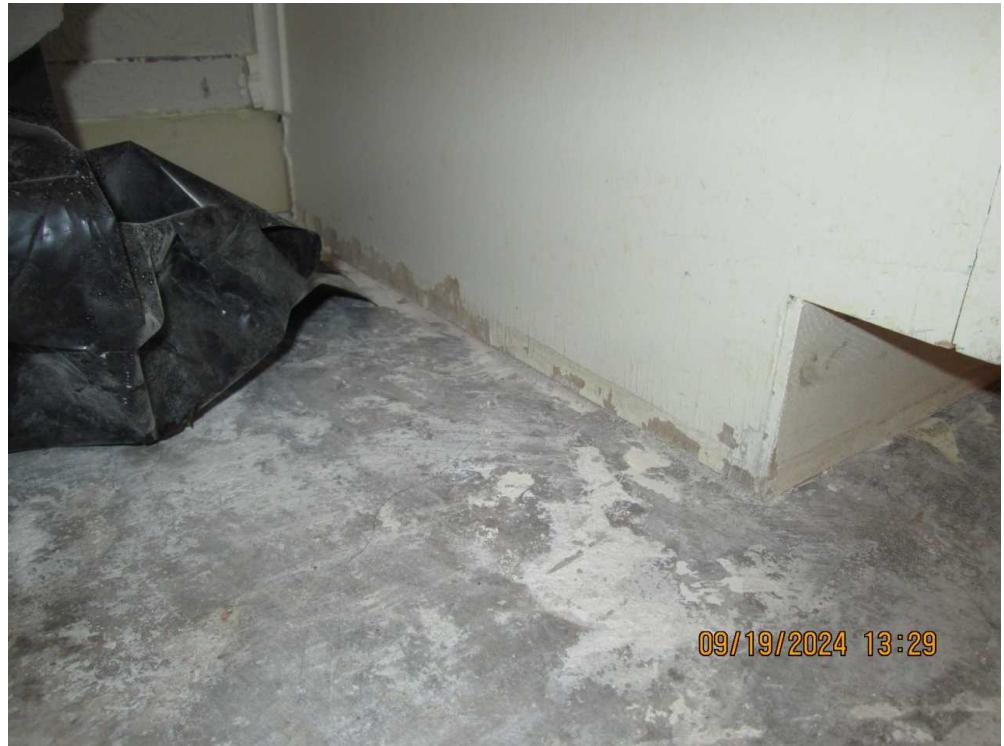
Water damage to vanity

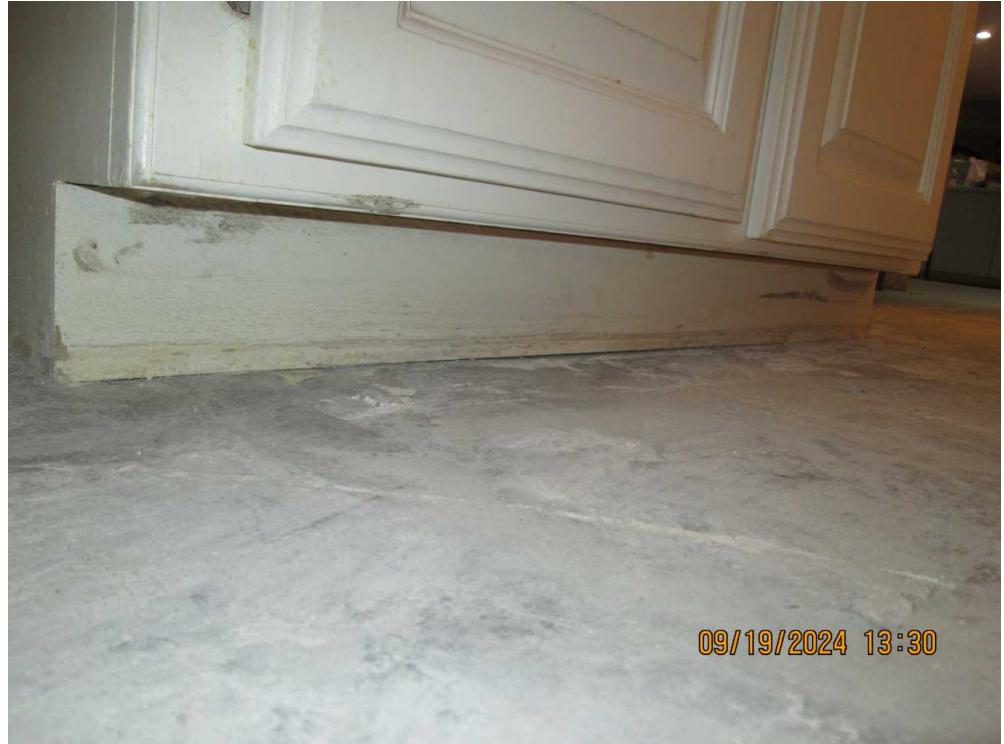
Water damage to vanity

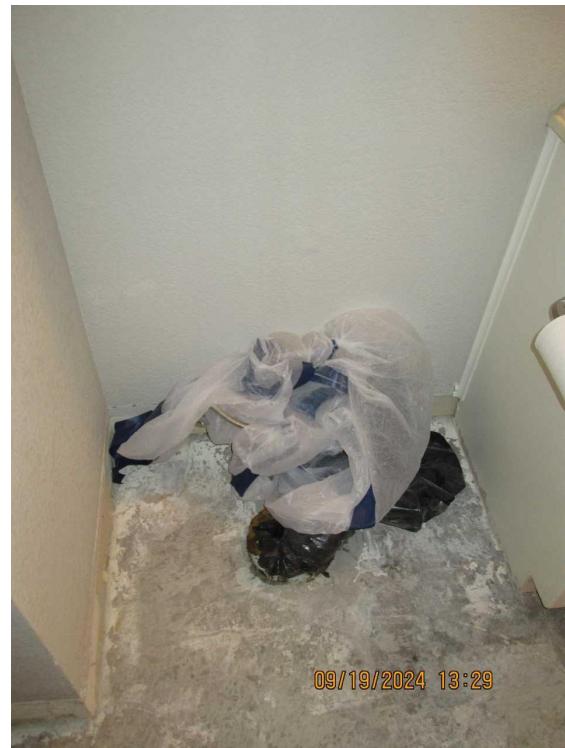
Bathroom

Toilet detached during mitigation

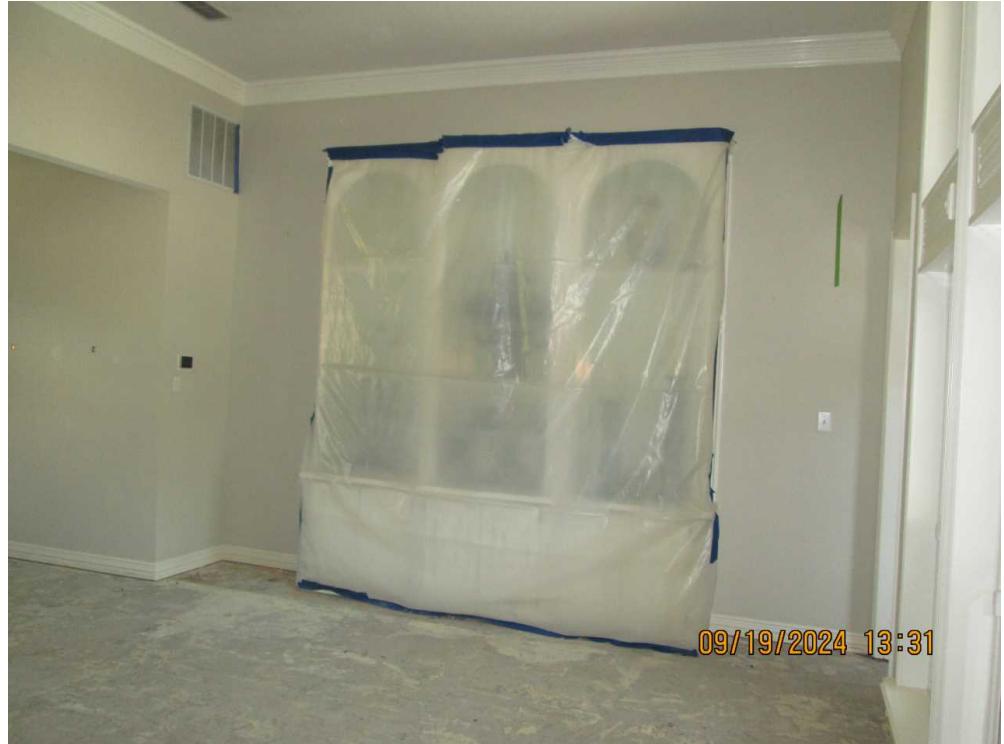
Formal Living Room
Engineered wood flooring removed
during mitigation

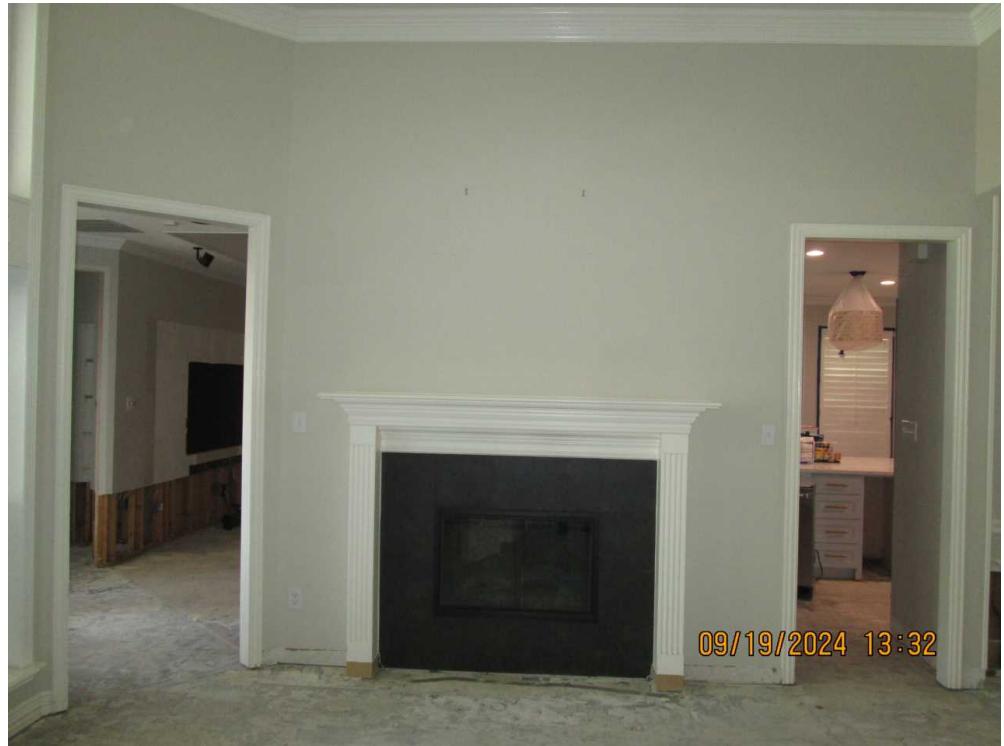
Formal Living Room
Engineered wood flooring removed
during mitigation

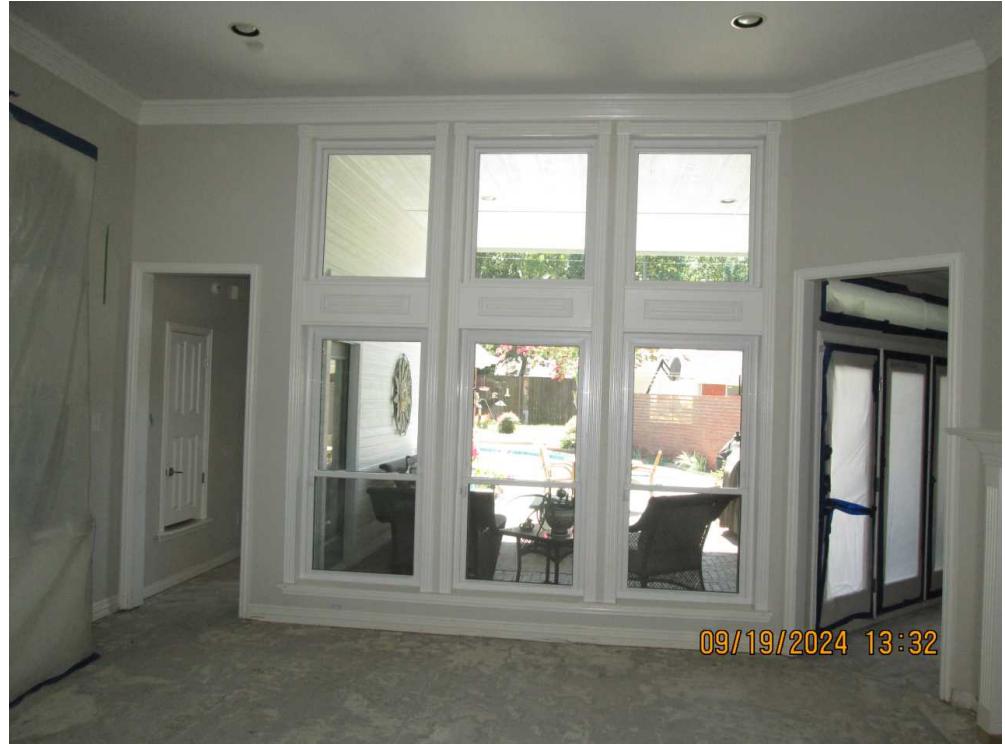
Formal Living Room
Engineered wood flooring removed
during mitigation

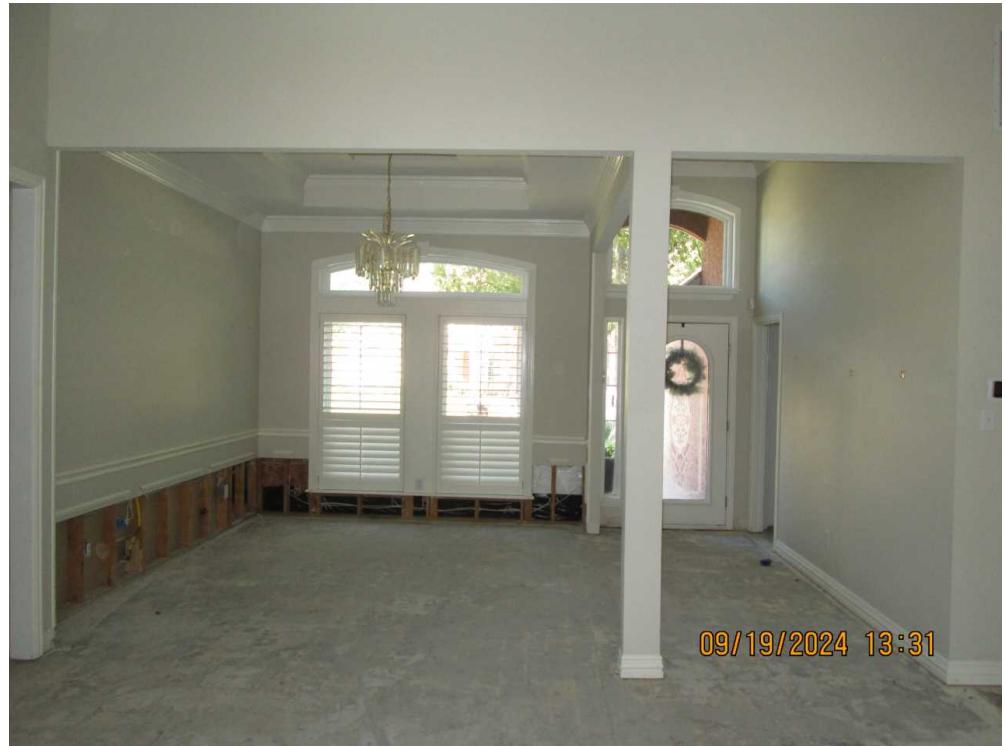
Formal Living Room
Engineered wood flooring removed
during mitigation

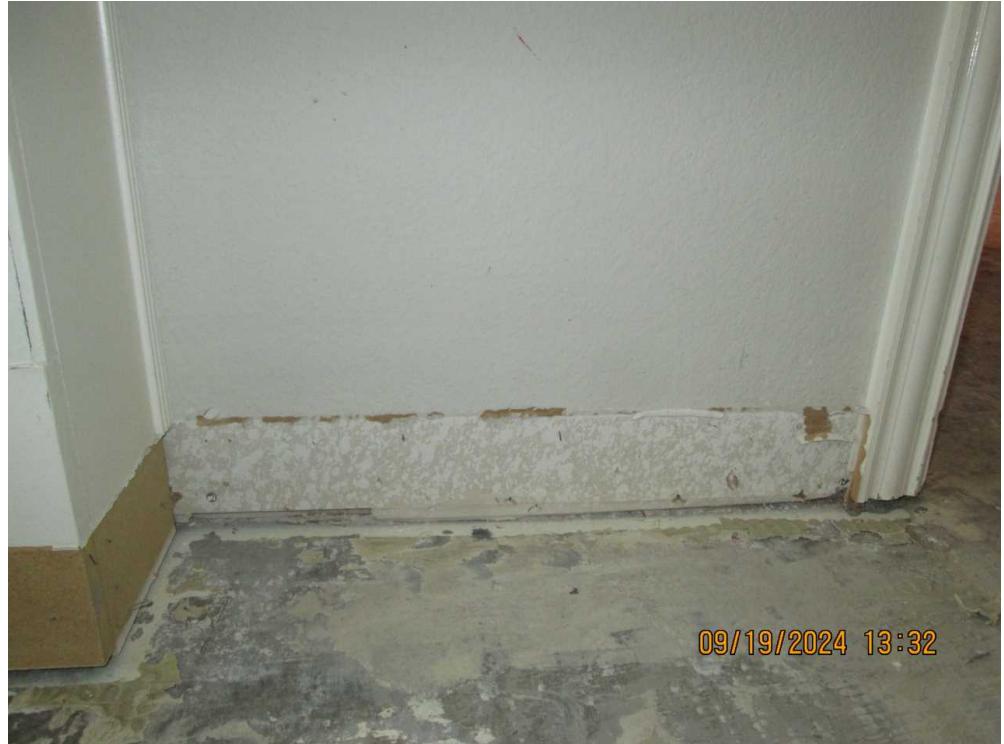
Formal Living Room
Paint on drywall damaged while
baseboard was being removed during
mitigation

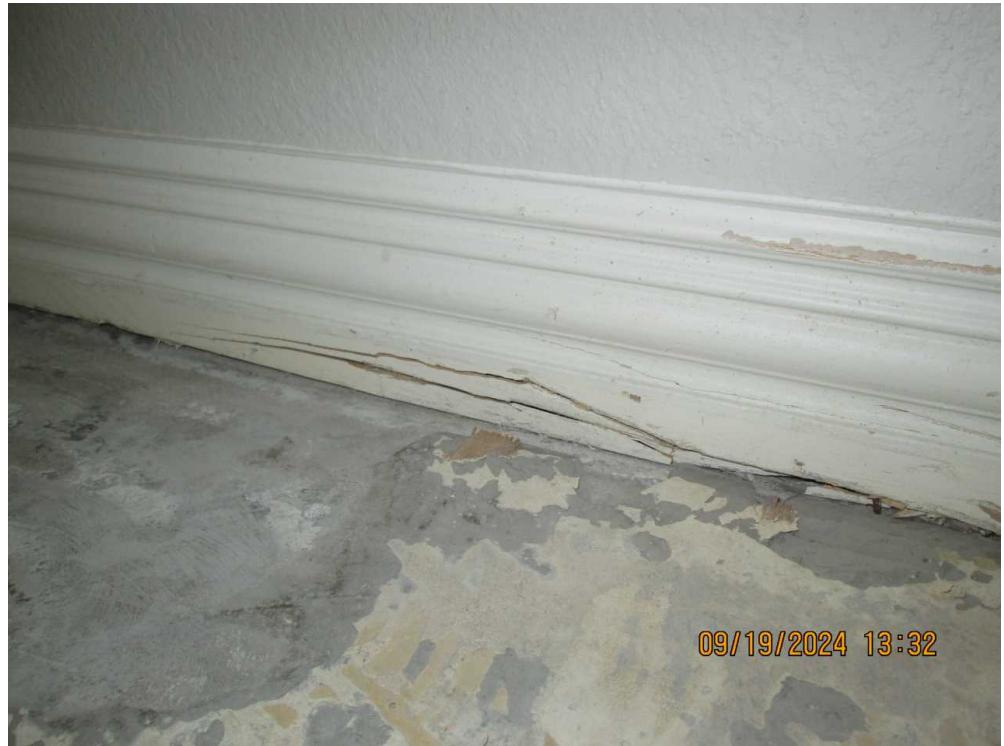
Formal Living Room
Baseboard damaged during mitigation

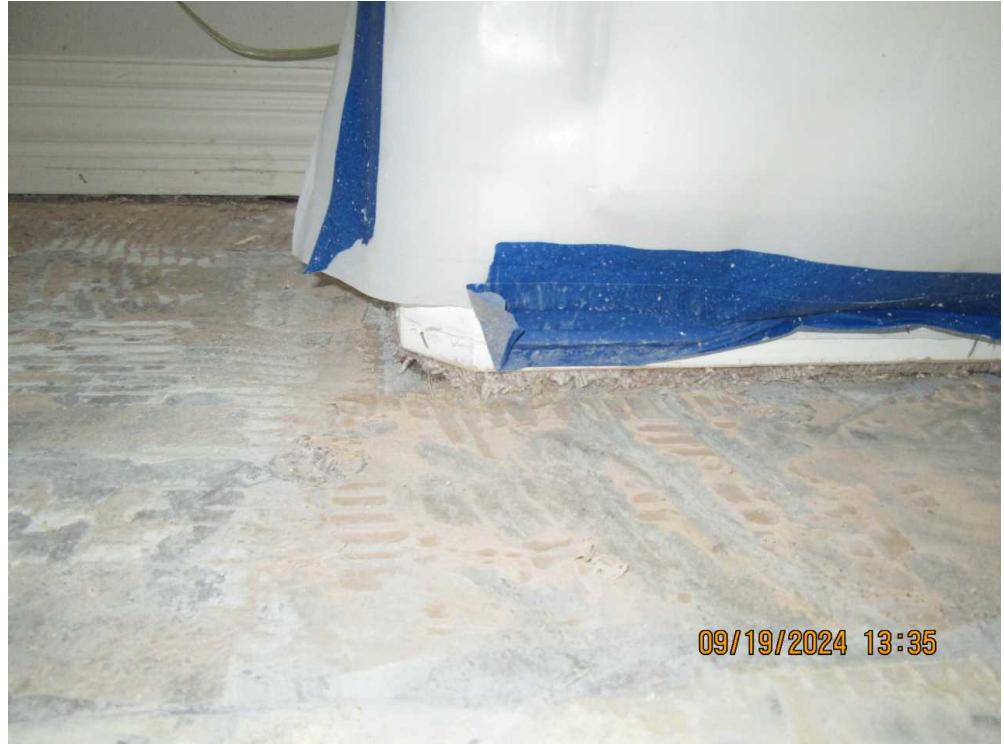
Formal Living Room
Carpet underneath bookcase was not removed when flooring was replaced with engineered wood

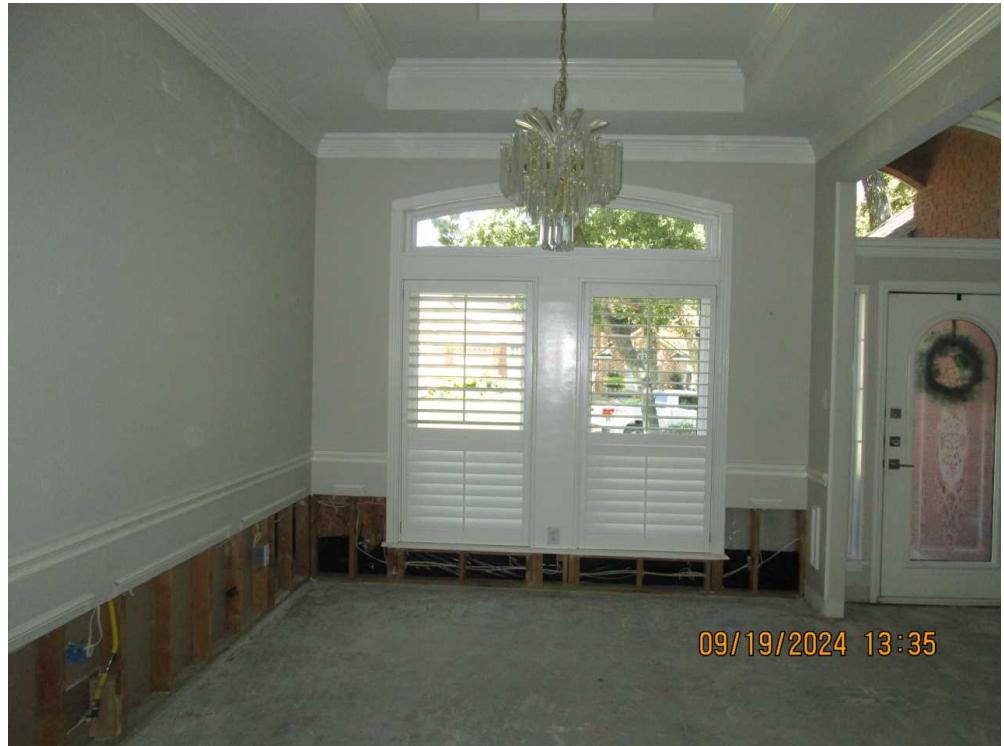
Formal Dining Room
Drywall, baseboard, insulation and
engineered wood flooring removed
during mitigation

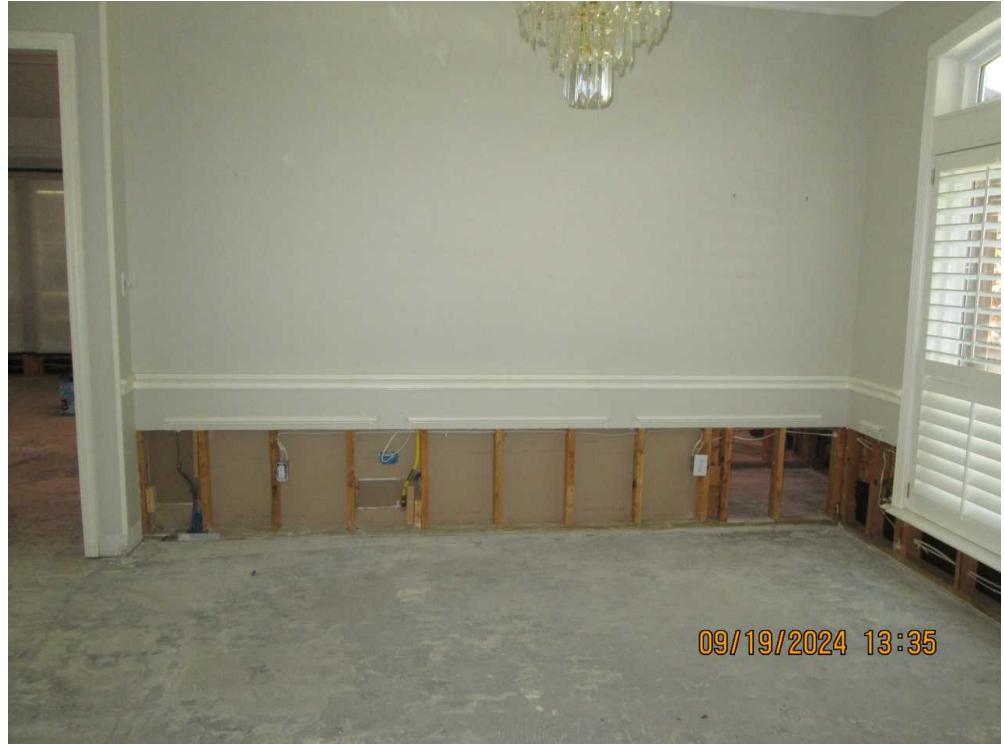
Formal Dining Room
Drywall, baseboard, insulation and
engineered wood flooring removed
during mitigation

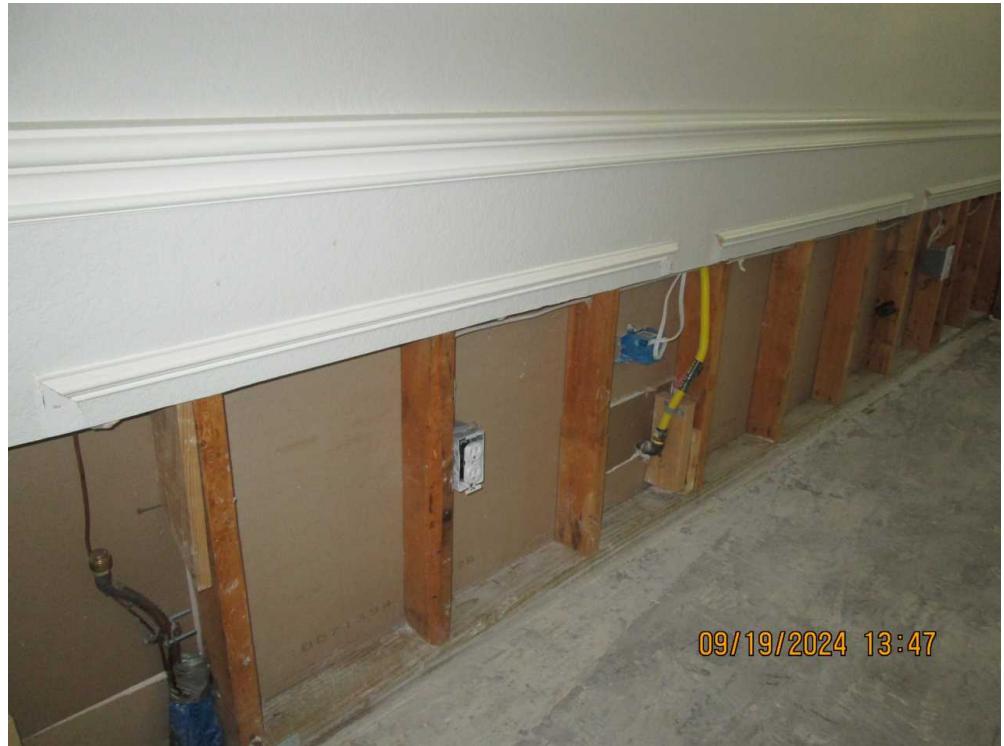
Formal Dining Room
Wall molding removed during
mitigation

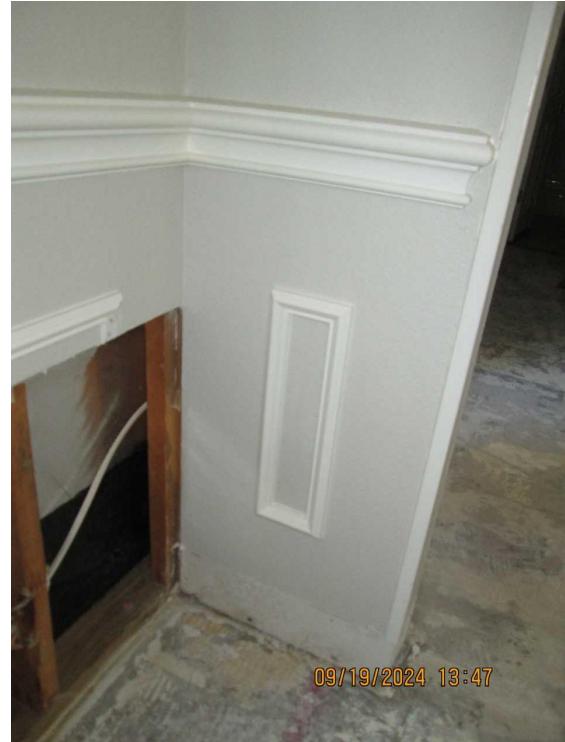
Formal Dining Room
Wall molding removed during
mitigation

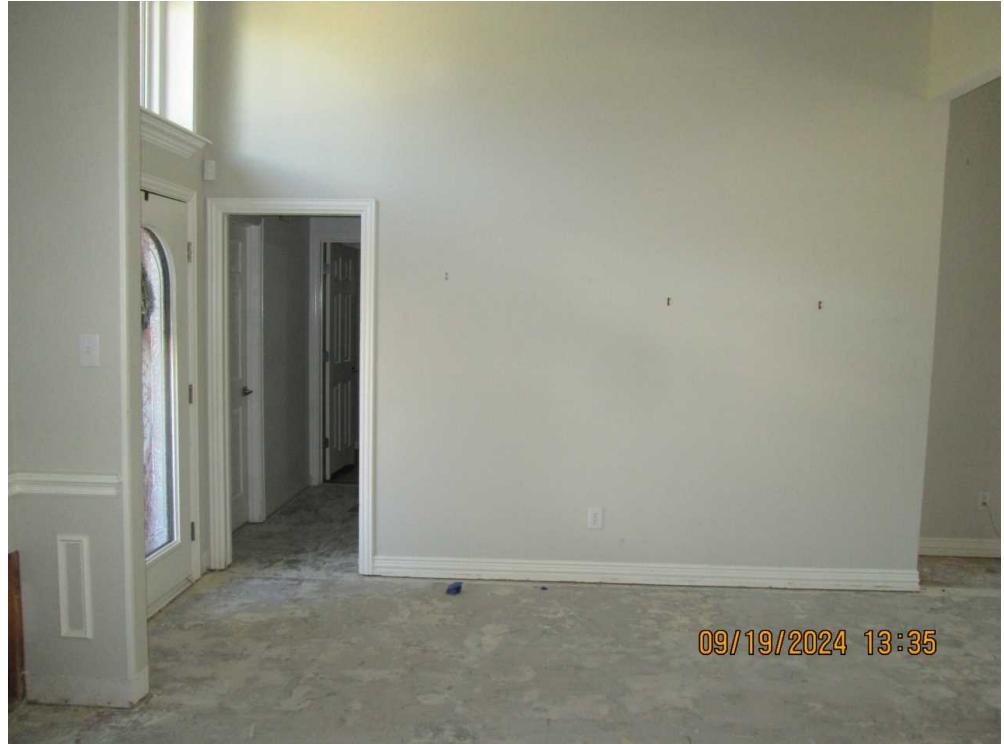
Entry

Engineered wood flooring removed
during mitigation

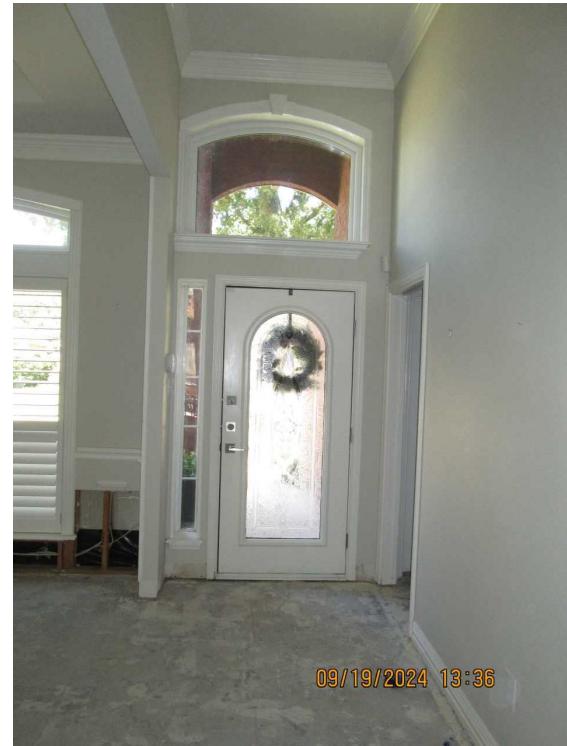
Entry

Engineered wood flooring removed
during mitigation
