JDR Restoration & Remodeling

Type of Loss: Water Damage

Date of Loss:
Date Inspected: 9/19/2024 11:40 AM

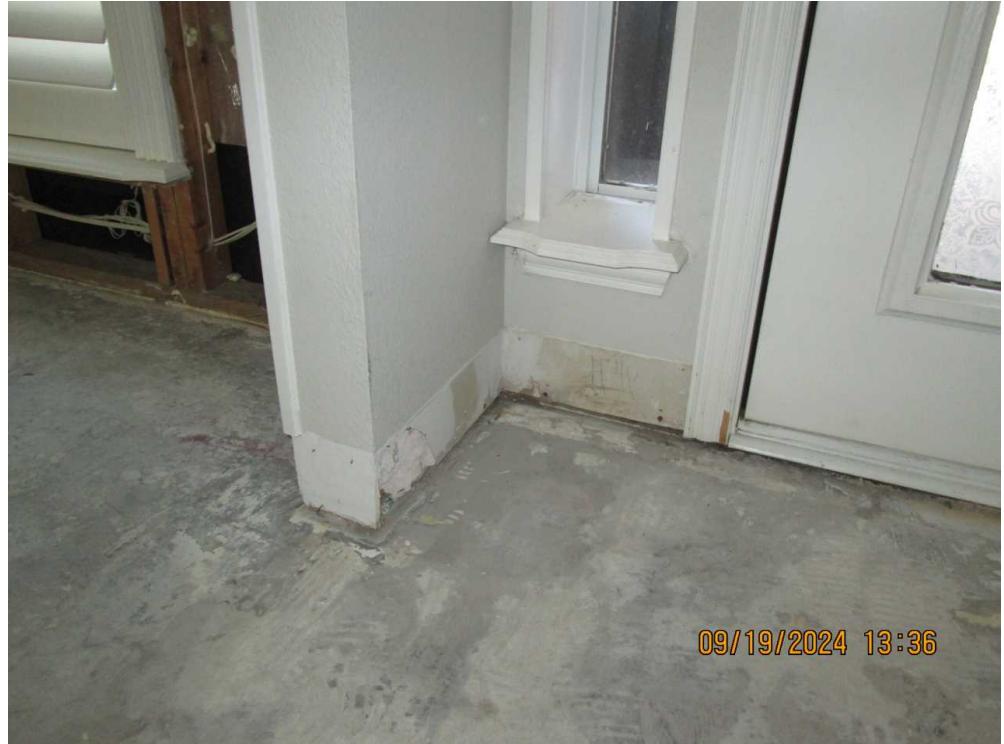
Entry

Baseboard partially removed during mitigation

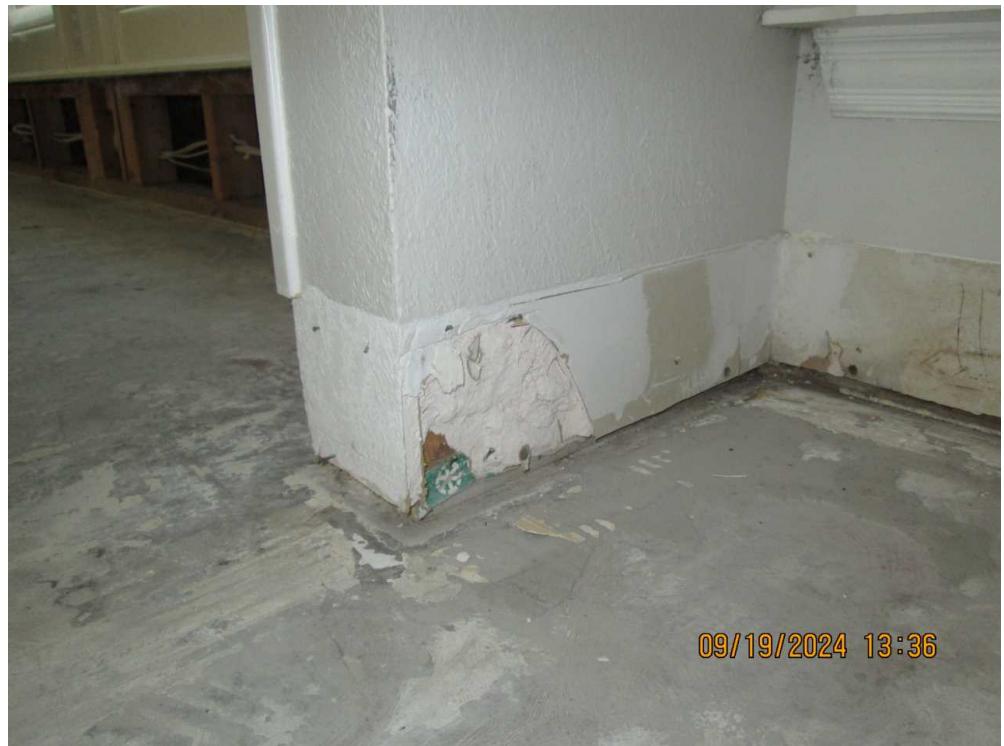
Drywall damaged while baseboard was being removed during mitigation

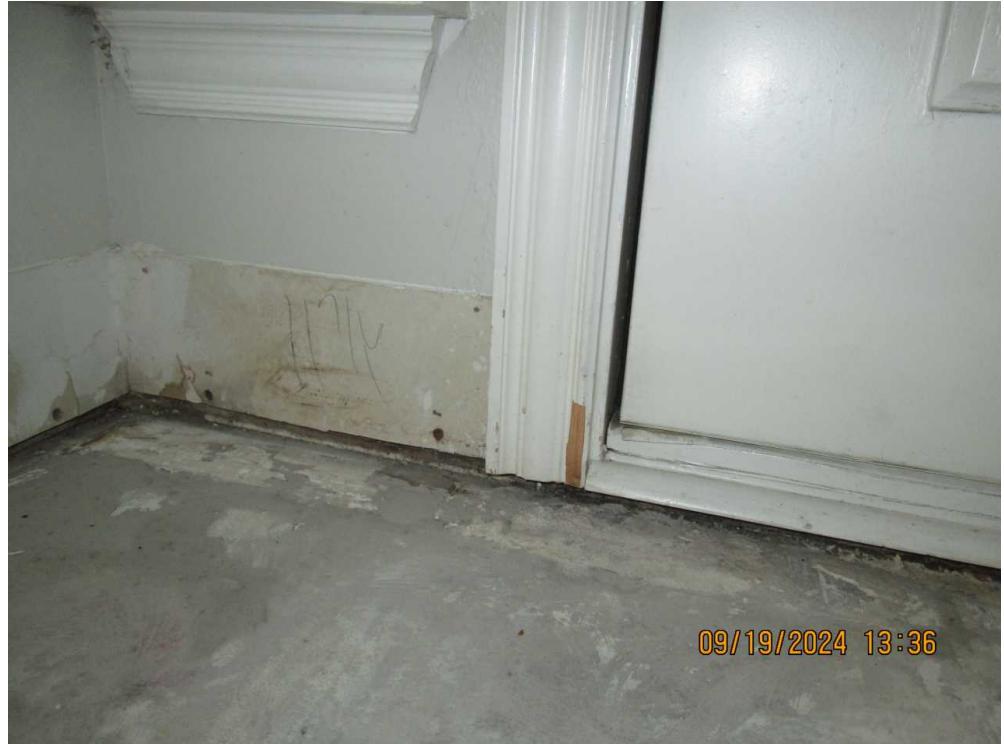
Door casing damaged while
engineered wood flooring was being
removed during mitigation

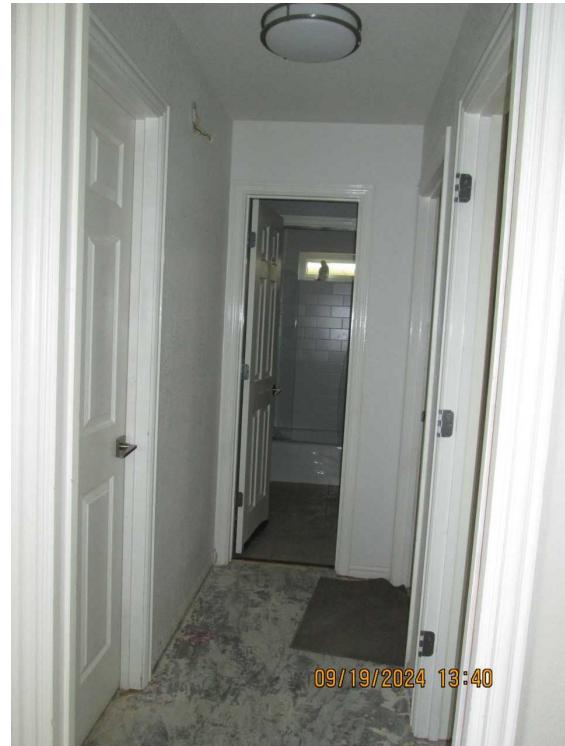
Hallway 2

Baseboard and engineered wood
flooring removed during mitigation

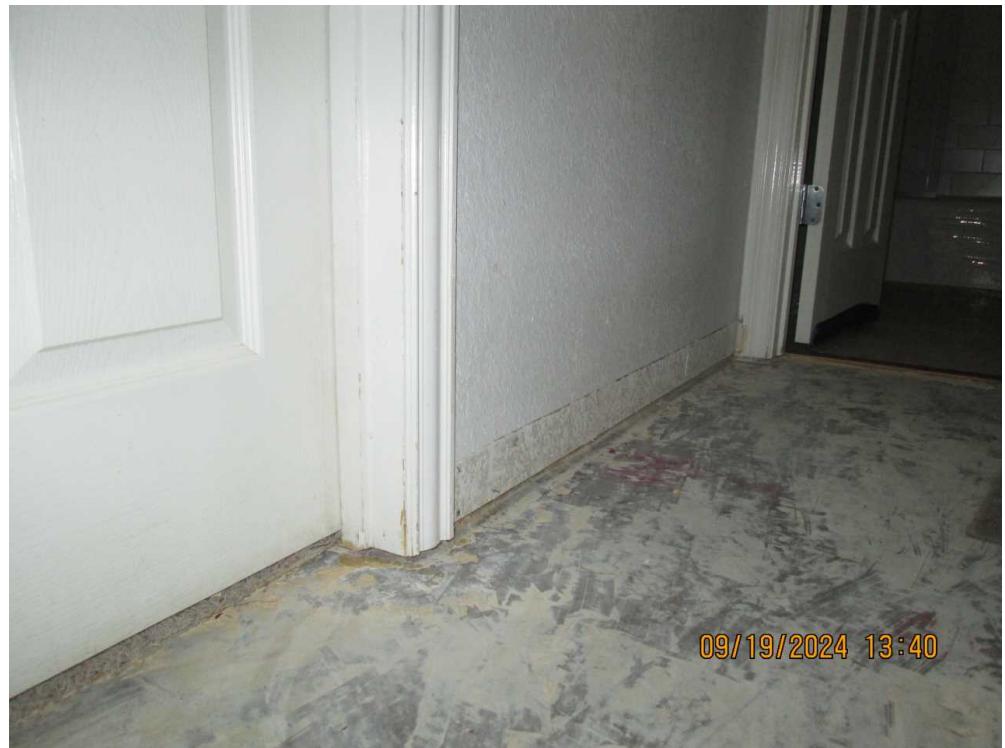
Hallway 2

Baseboard and engineered wood
flooring removed during mitigation

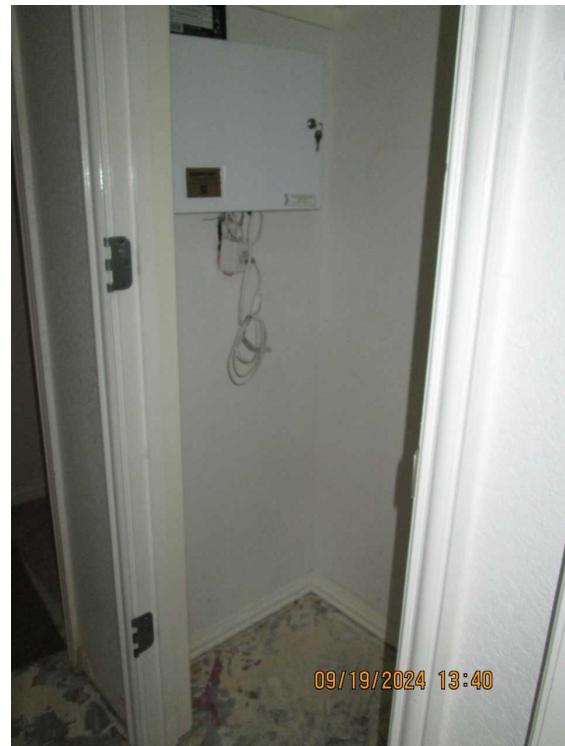
Coat Closet

Engineered wood flooring removed
during mitigation

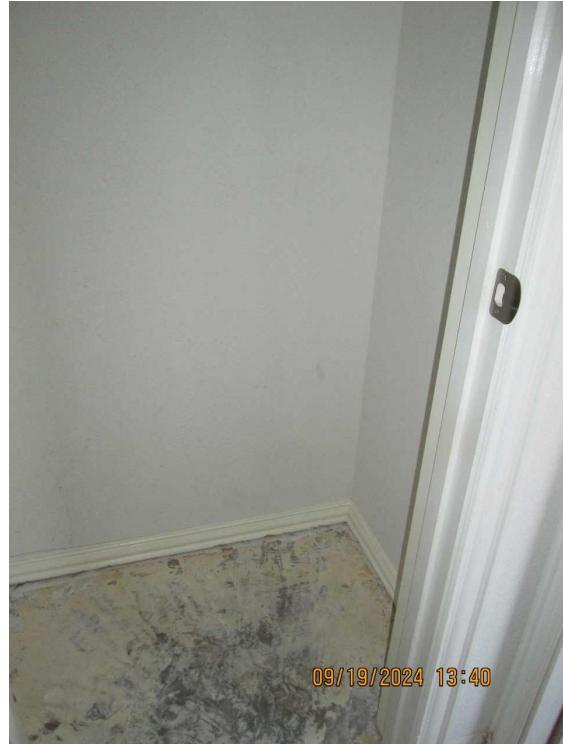
Coat Closet
Engineered wood flooring removed
during mitigation

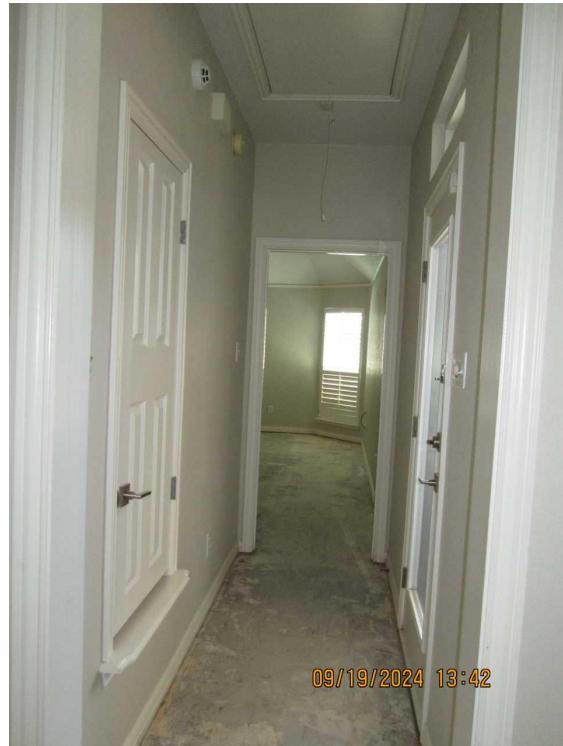
Hallway 1
Quarter round and engineered wood
flooring removed during mitigation

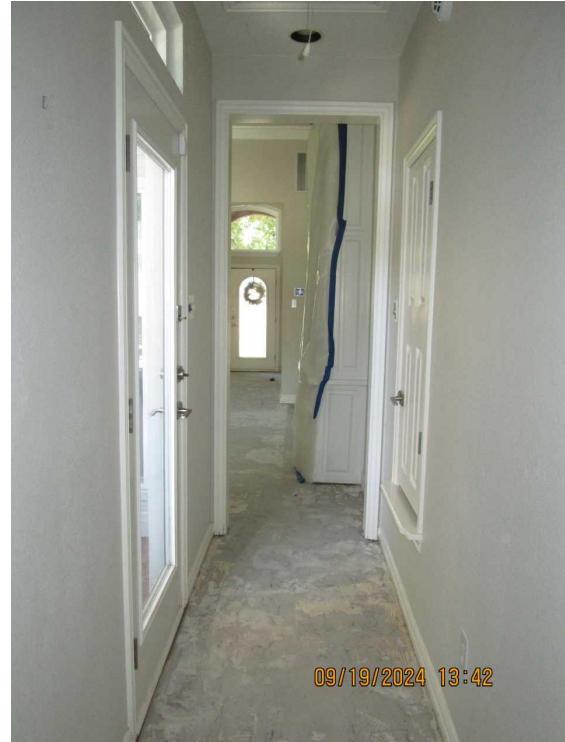
Hallway 1

Quarter round and engineered wood
flooring removed during mitigation

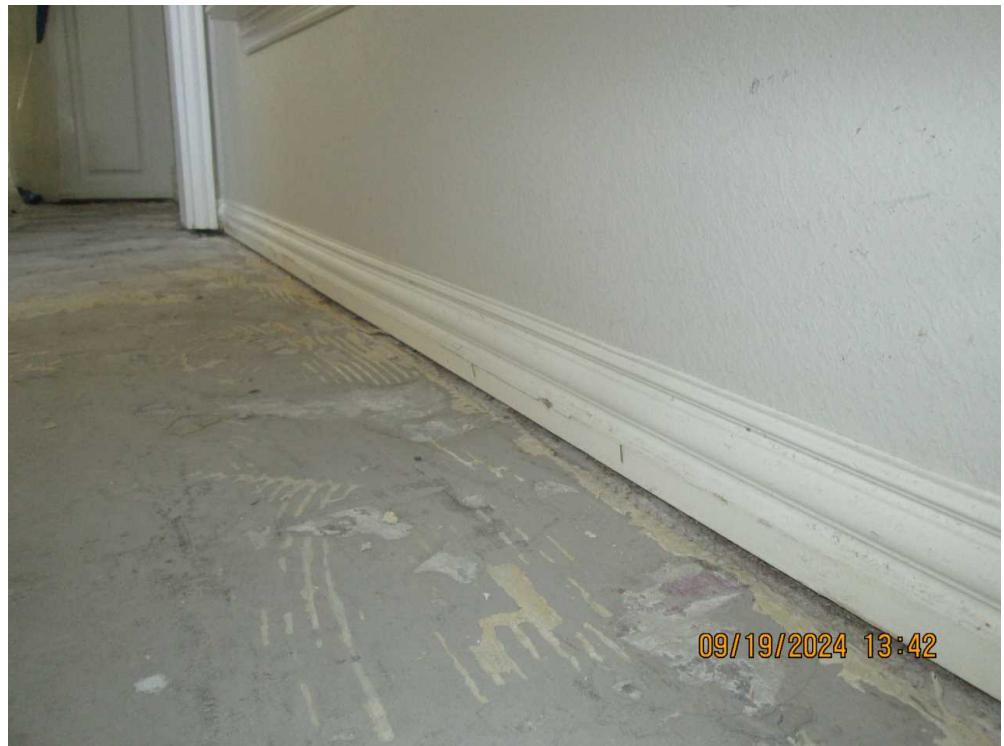
Hallway 1

Quarter round and engineered wood
flooring removed during mitigation

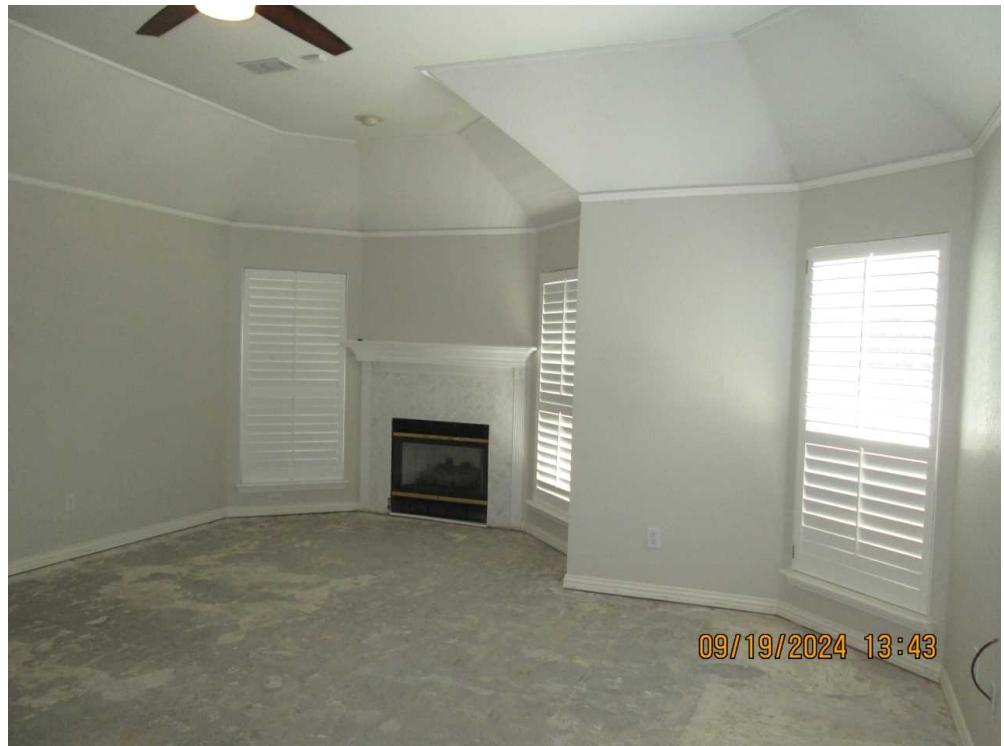
Primary Bedroom

Quarter round and engineered wood
flooring removed during mitigation

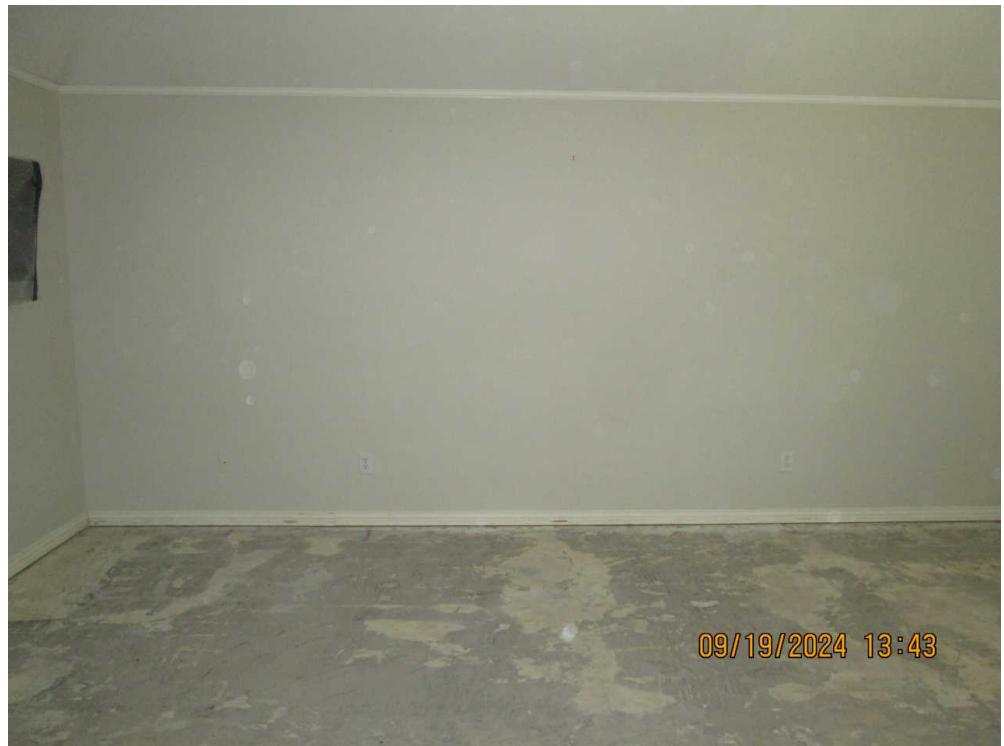
Primary Bedroom

Quarter round and engineered wood
flooring removed during mitigation

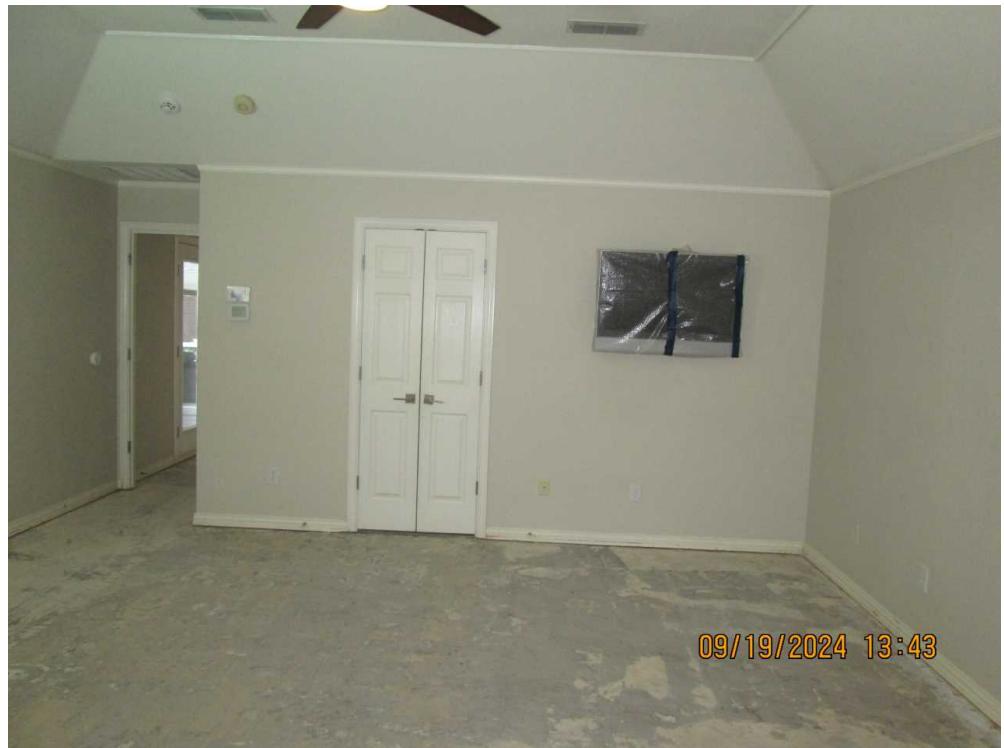
Primary Bedroom

Quarter round and engineered wood
flooring removed during mitigation

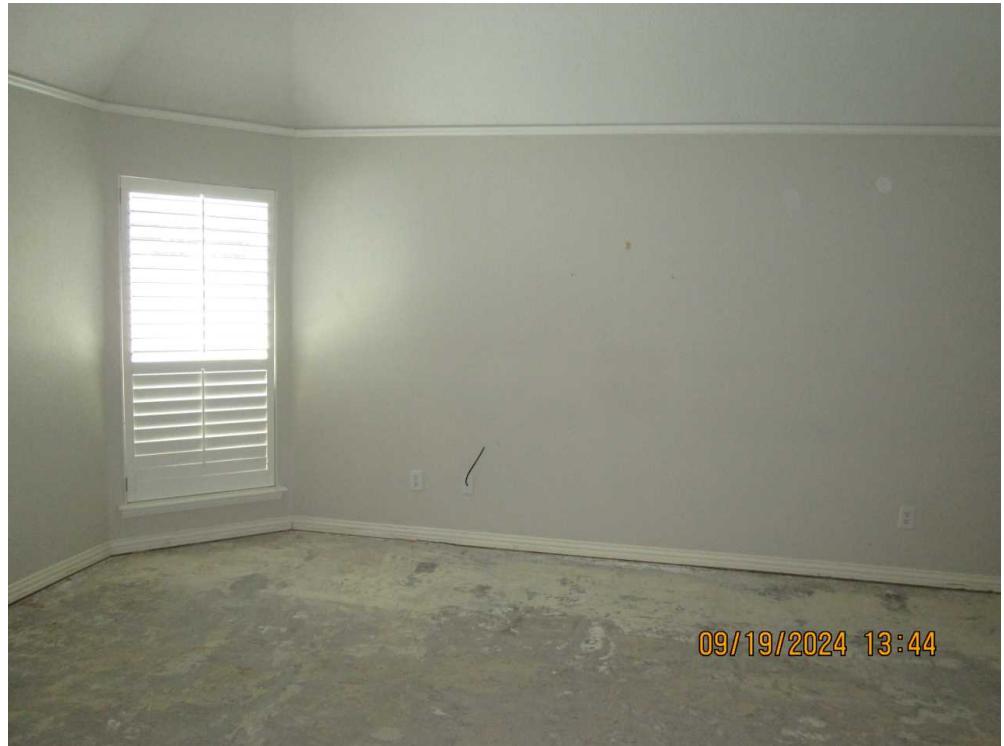
Primary Bedroom

Quarter round and engineered wood
flooring removed during mitigation

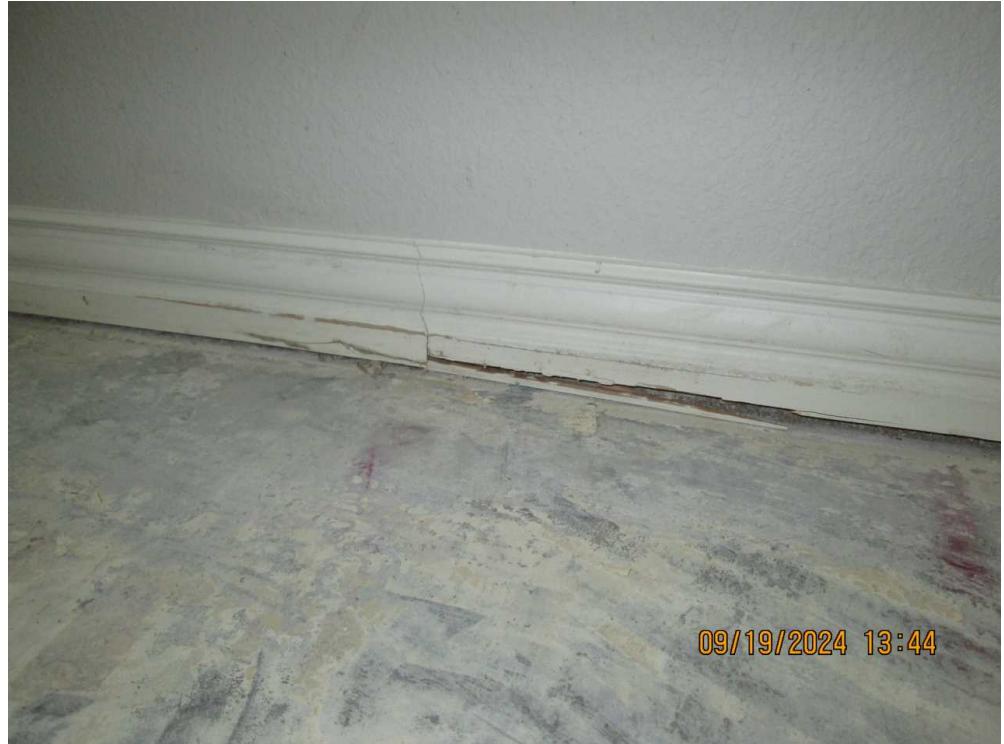
Primary Bedroom
Baseboard damaged while quarter
round was being removed during
mitigation

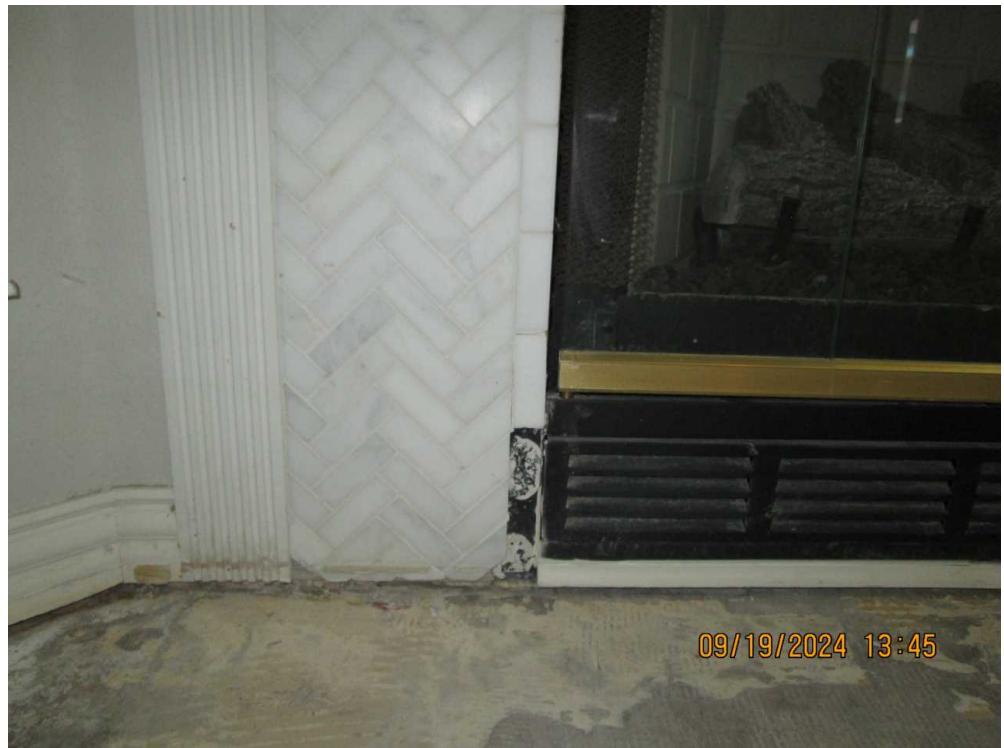
Primary Bedroom
Tile border on fireplace damaged
during mitigation

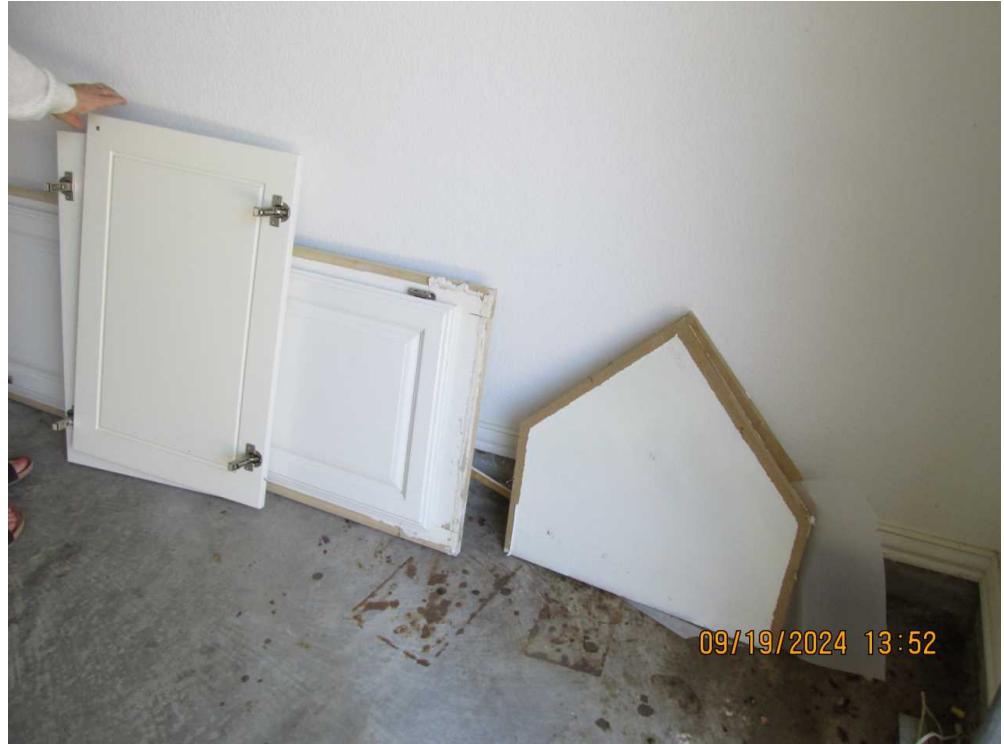
Linen Cabinet
Face and shelf that was detached
during mitigation

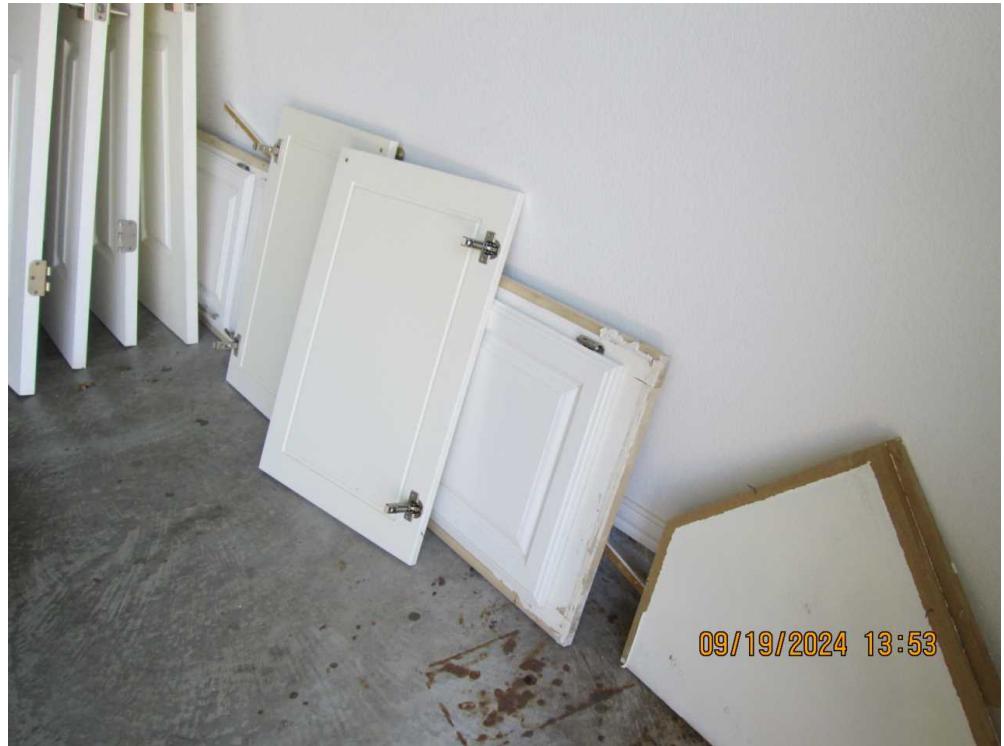
Linen Cabinet
Face and shelf that was detached
during mitigation

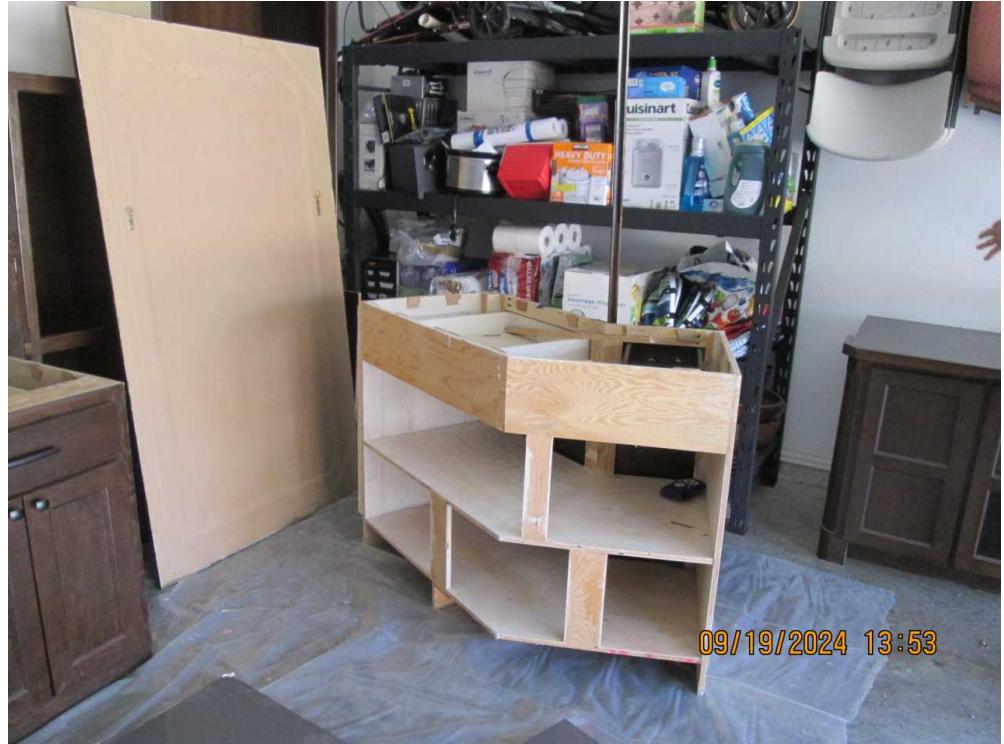
Family Room
Base cabinets and countertops that
were detached during mitigation

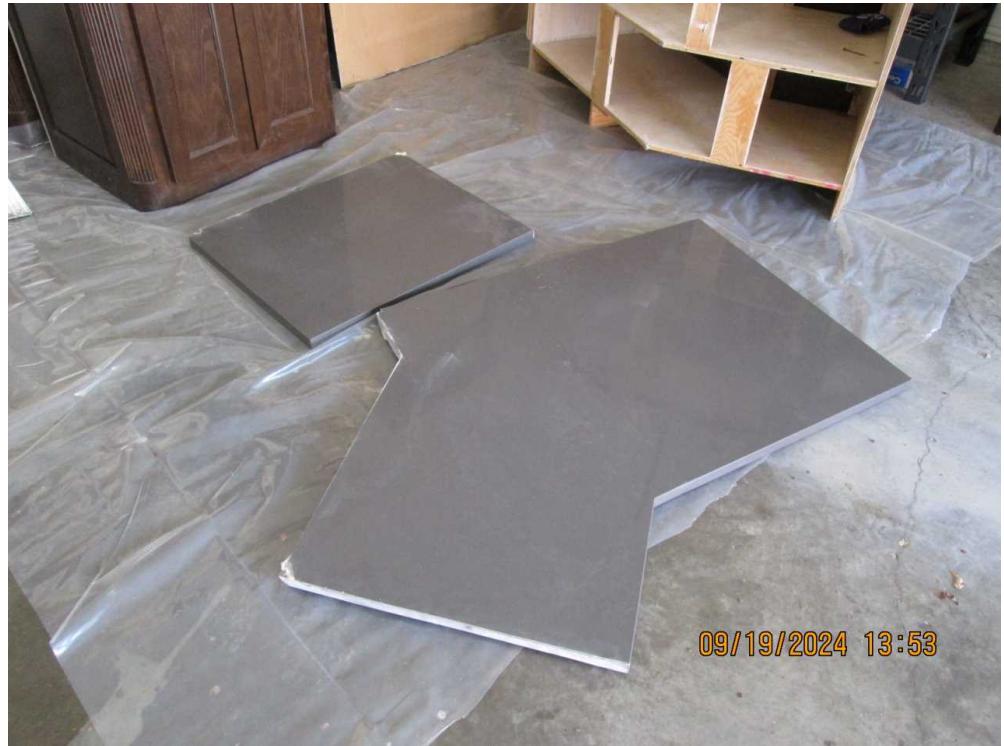
Family Room
Base cabinets and countertops that
were detached during mitigation

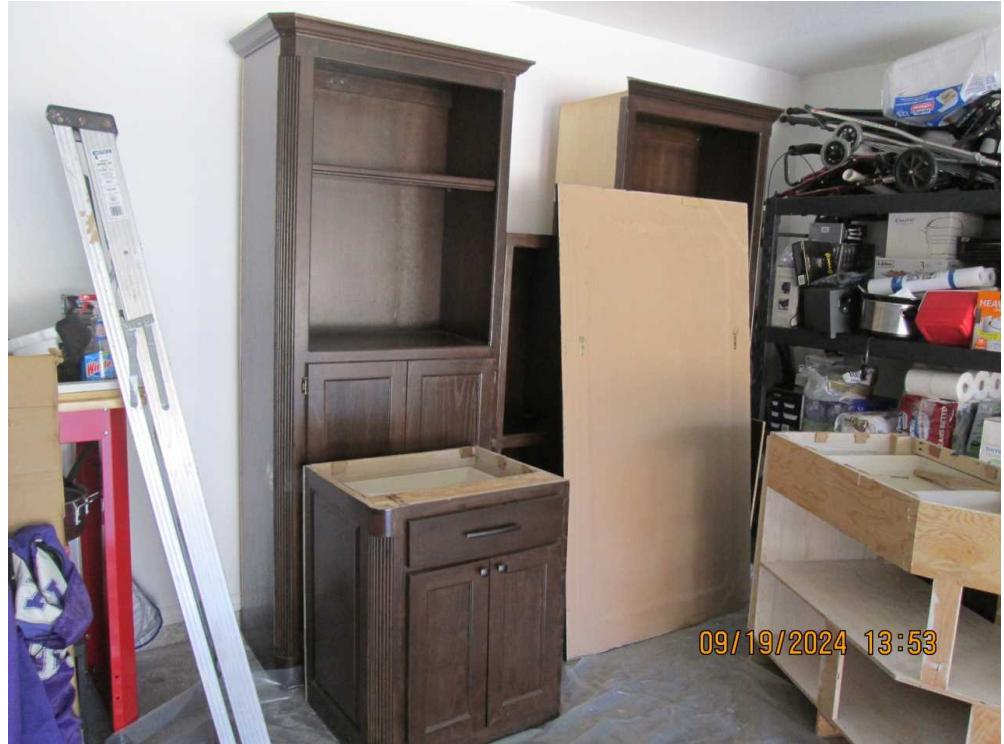
Family Room
Entertainment center that was
detached during mitigation

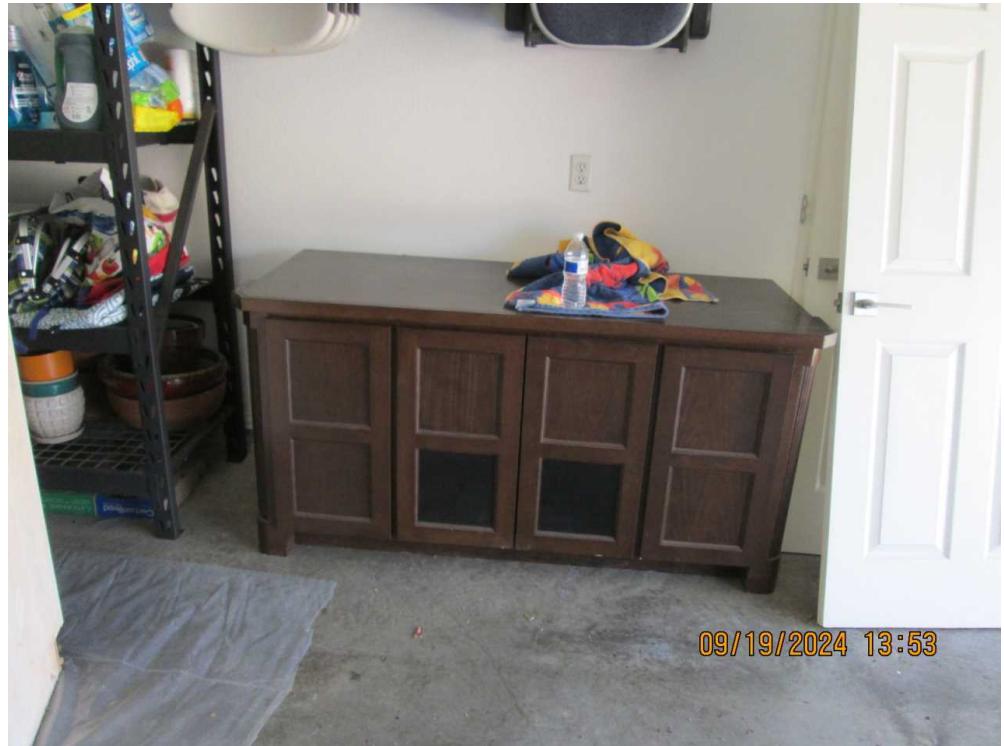
Family Room
Entertainment center that was
detached during mitigation

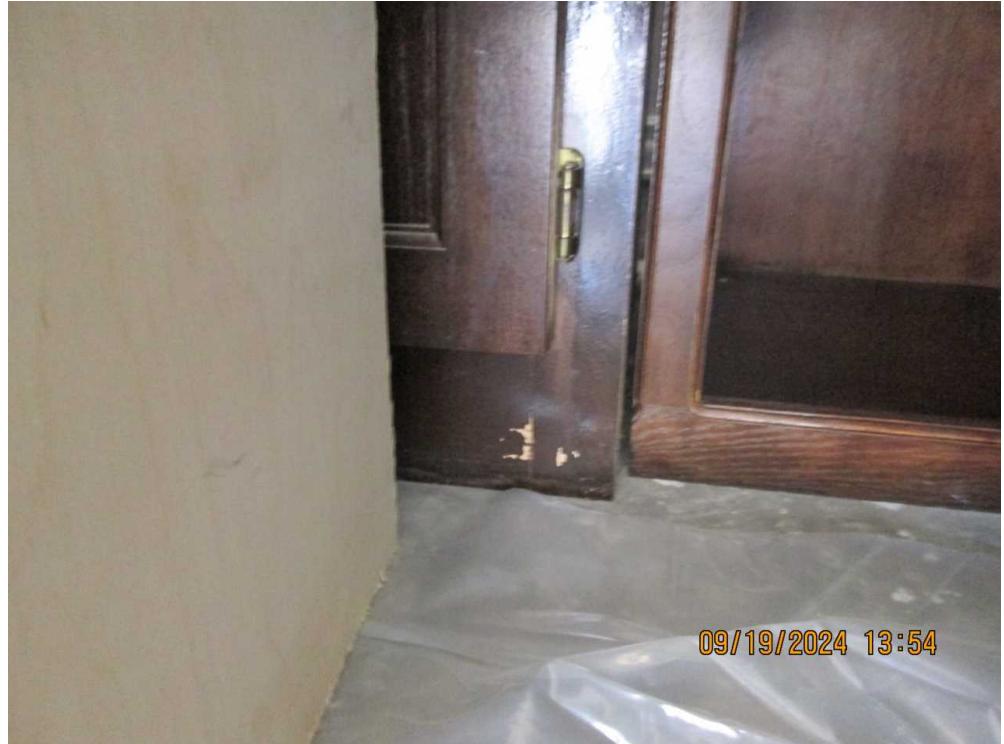
Family Room
Stain on entertainment center
damaged during mitigation

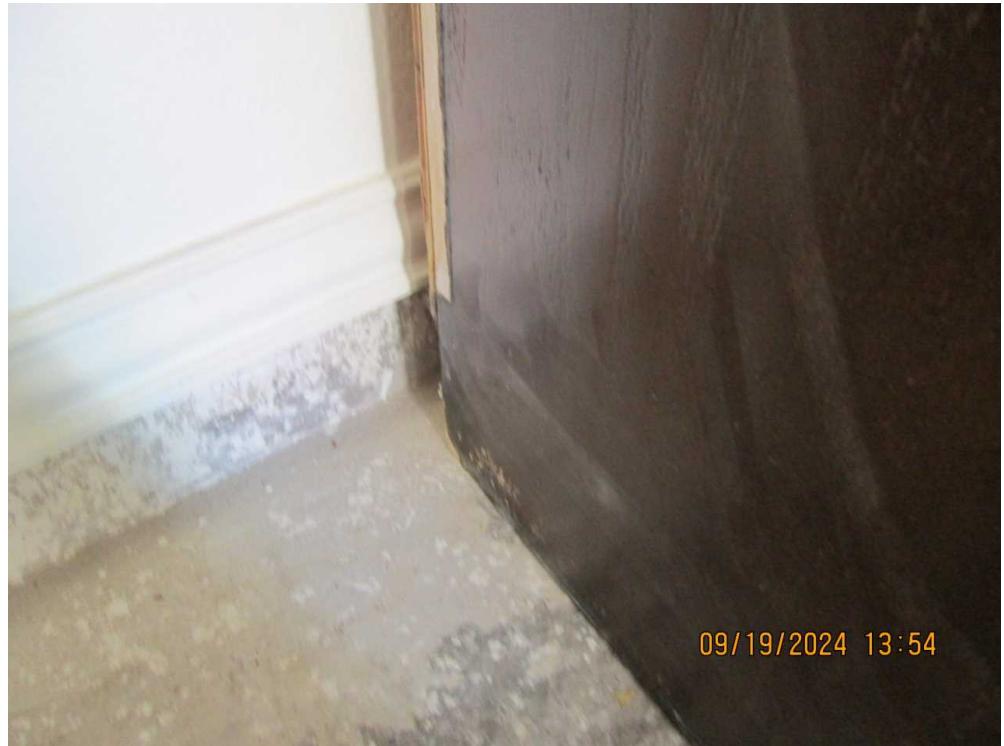
Family Room
Stain on entertainment center
damaged during mitigation
