JDR Restoration & Remodeling

Type of Loss: Water Damage

Date Inspected: 7/2/2024 12:00 PM

Restoration/Service/Remodel

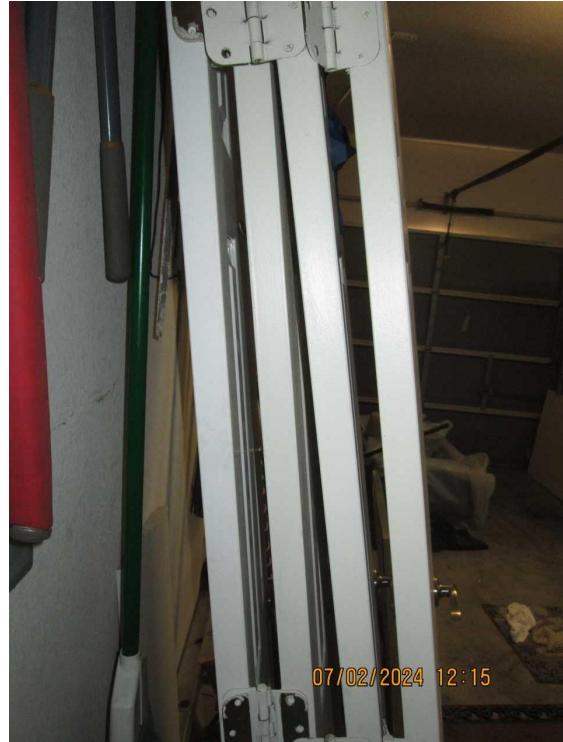
Doors that were detached during mitigation

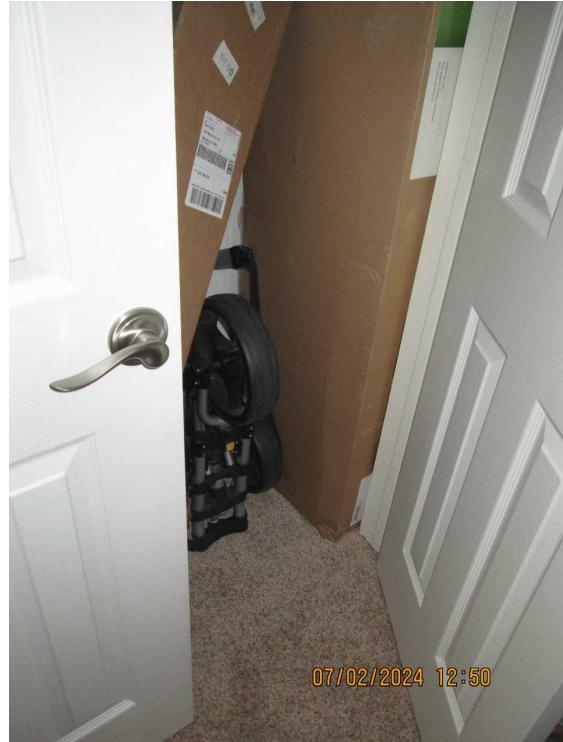
Carpet is continuous with Bedroom 1

DESCRIPTION	QTY	RESET	REMOVE	REPLACE	TAX	O&P	TOTAL
151. R&R Carpet pad	12.17 SF		0.13	0.67	0.54	2.06	12.33
152. Remove Carpet	12.17 SF		0.30	0.00	0.00	0.74	4.39
153. Carpet	13.99 SF		0.00	3.88	3.44	11.54	69.26
Carpet is continuous with Bedroom 1							
15 % waste added for Carpet							
154. Content Manipulation charge per hour	1.00 HR		0.00	57.21	0.00	11.44	68.65
Totals: Bedroom 1 Closet					3.98	25.78	154.63
