JDR Restoration & Remodeling

Type of Loss: Water Damage

Date Inspected: 7/2/2024 12:00 PM

Restoration/Service/Remodel

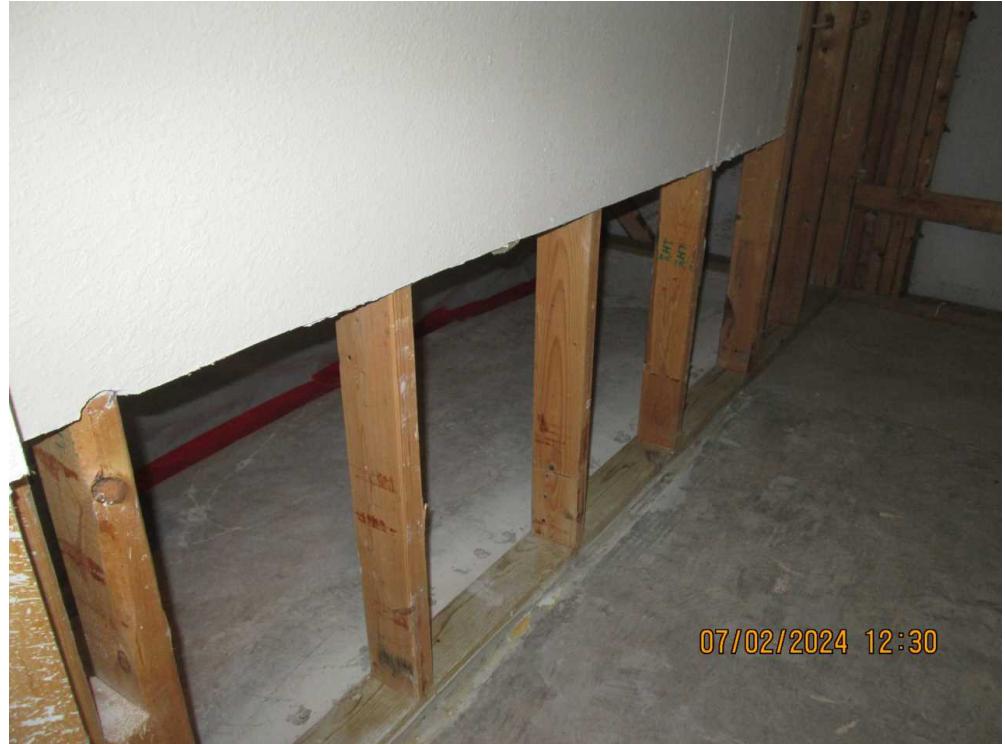
6 6-IMG_9954

Bathroom

Baseboard, drywall and ceramic tile
flooring removed during mitigation

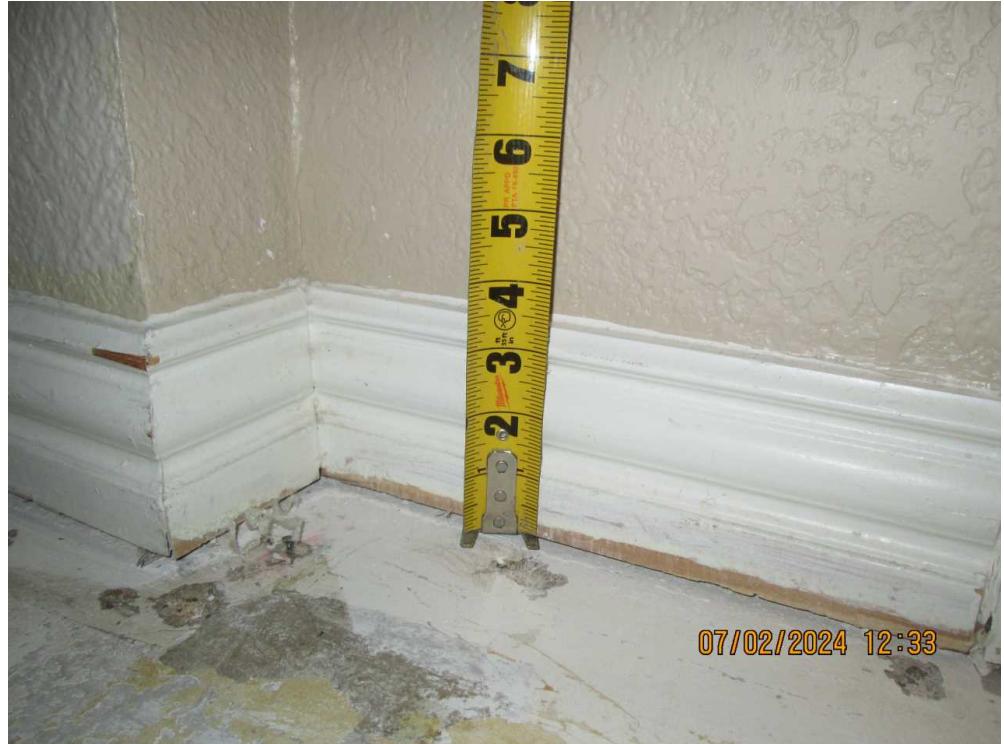
Bathroom
Baseboard is 3.25" tall

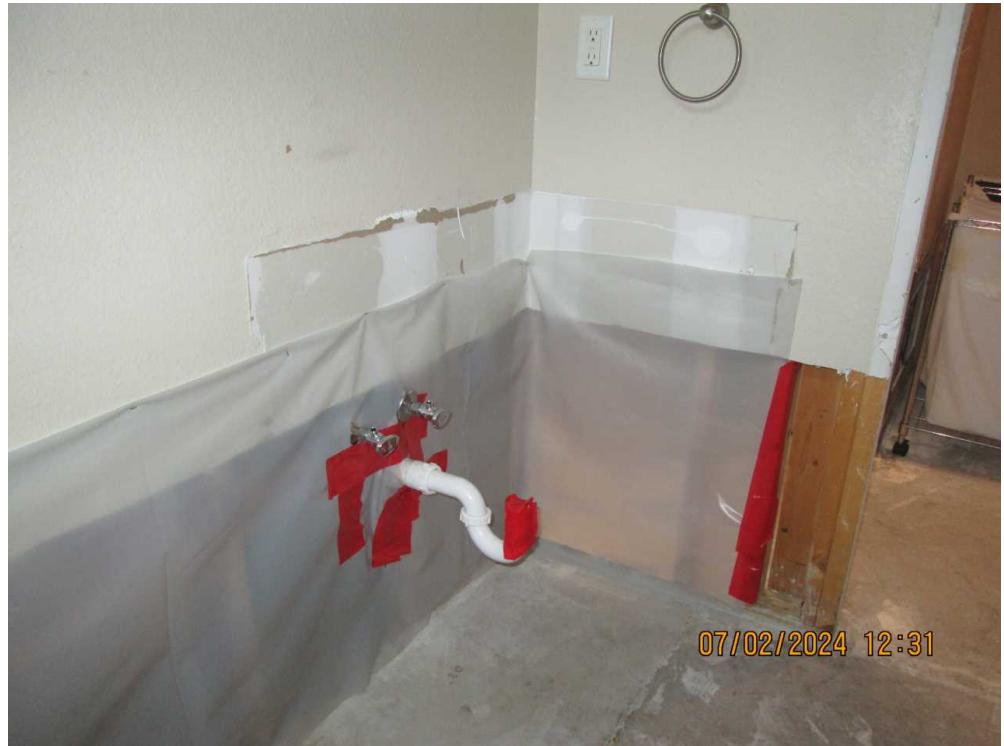
8 8-IMG_9956

Bathroom
Vanity and drywall removed during mitigation

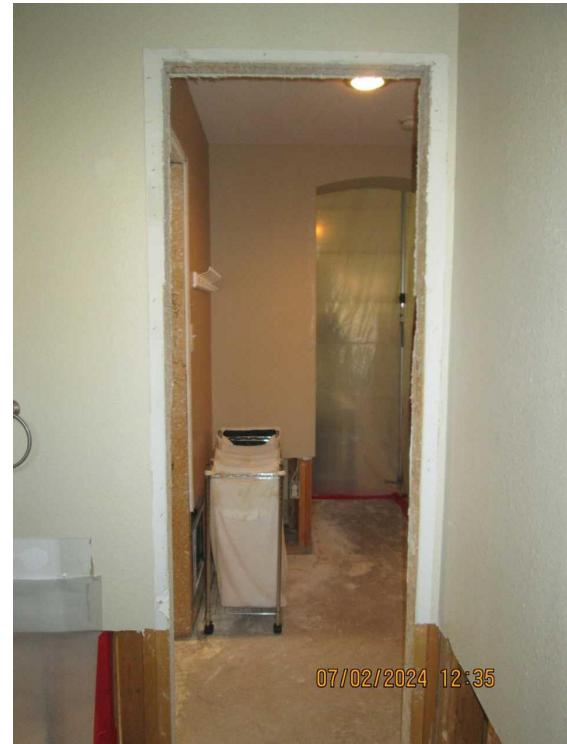
10 10-IMG_9965

Bathroom
Door jamb removed during mitigation

32. Door hinges (set of 3) and slab Detach & reset	1.00 EA		0.00	29.94	0.00	5.98	35.92
Door hinges will need to be detached and reset to allow replacement of jamb

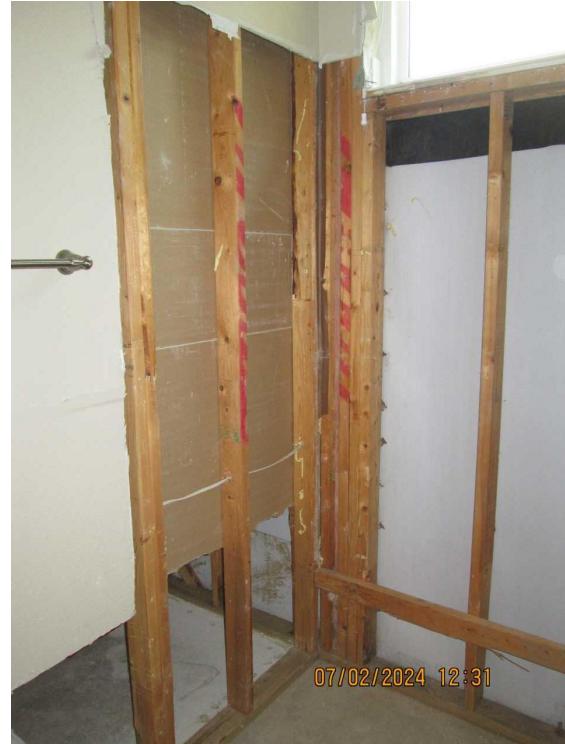
Bathroom

Tub, tile surround, cement board and insulation removed during mitigation

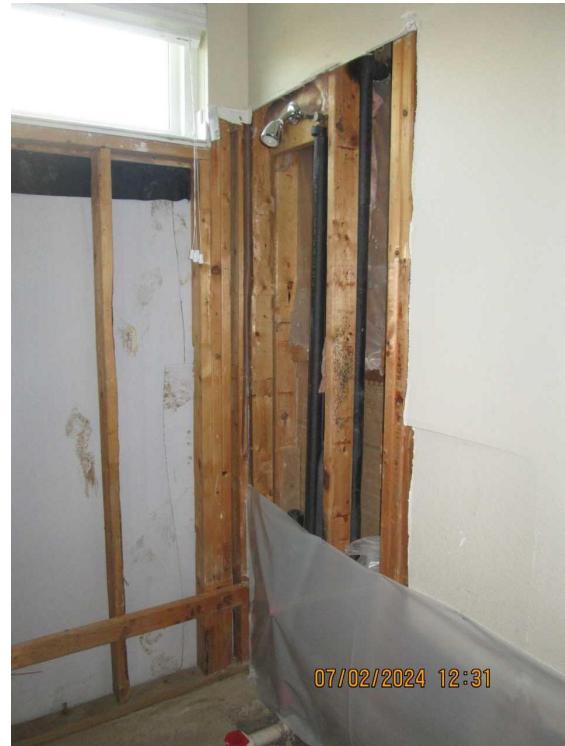
12 12-IMG_9958

Bathroom

Tub, tile surround, cement board and insulation removed during mitigation

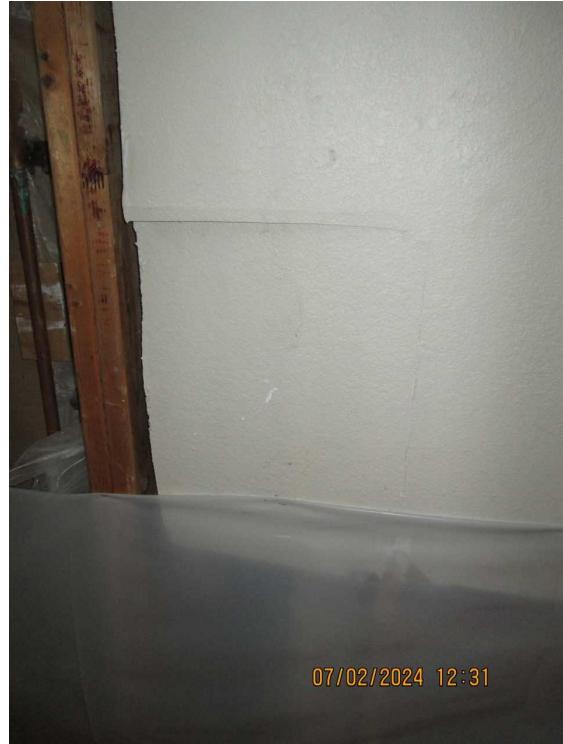
Bathroom

Drywall damaged while tub surround was being removed during mitigation

DESCRIPTION	QTY	RESET	REMOVE	REPLACE	TAX	O&P	TOTAL
7. 1/2" - drywall per LF - up to 2' tall	11.50 LF		0.00	12.79	1.40	29.70	178.19
8. R&R 1/2" drywall - hung, taped, floated, ready for paint	8.00 SF		0.46	3.14	0.44	5.84	35.08
Replace drywall that was damaged while tile tub surround was being removed during mitigation

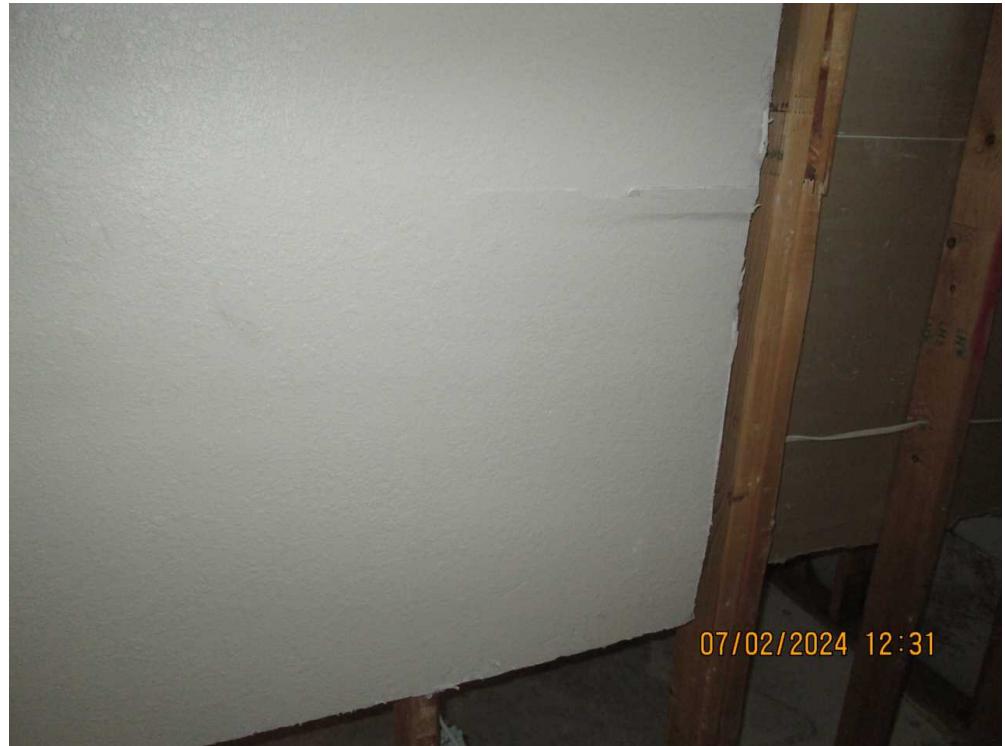
14 14-IMG_9960

Bathroom

Drywall damaged while tub surround was being removed during mitigation

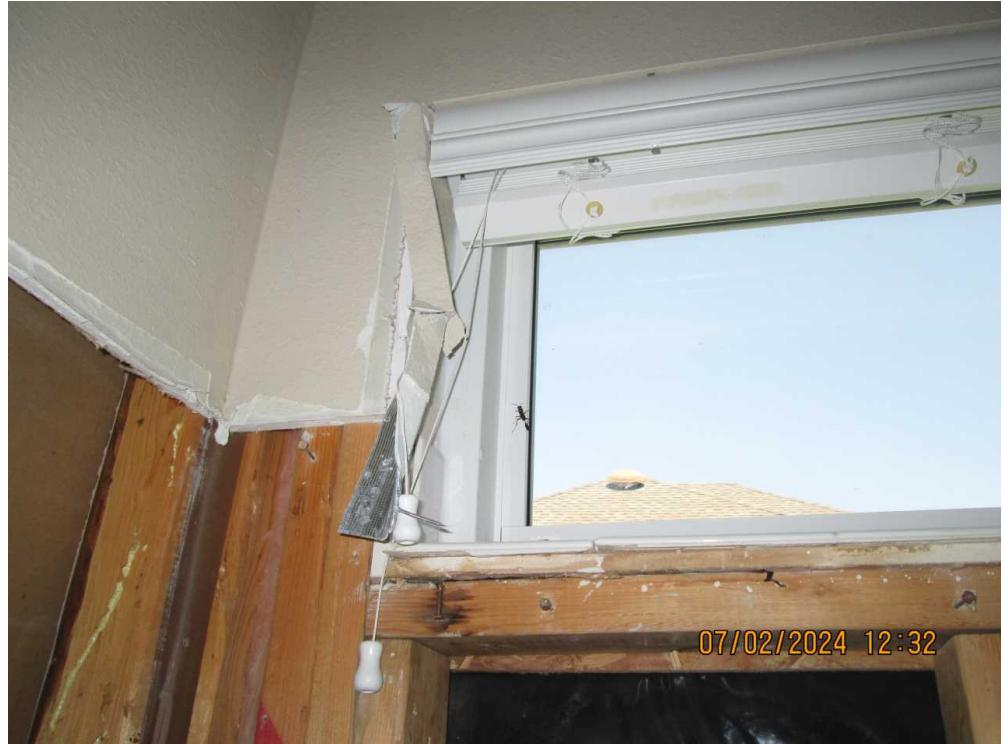
Bathroom

Drywall in window return damaged
while tub surround was being
removed during mitigation

9. R&R Drywall window return - up to 6"	4.00 LF		0.46	11.18	0.42	9.38	56.36
Repair drywall return on both sides of window							
10. Texture drywall - light hand texture	38.75 SF		0.00	1.25	0.26	9.74	58.44
Additional SF needed to blend in with surrounding texture

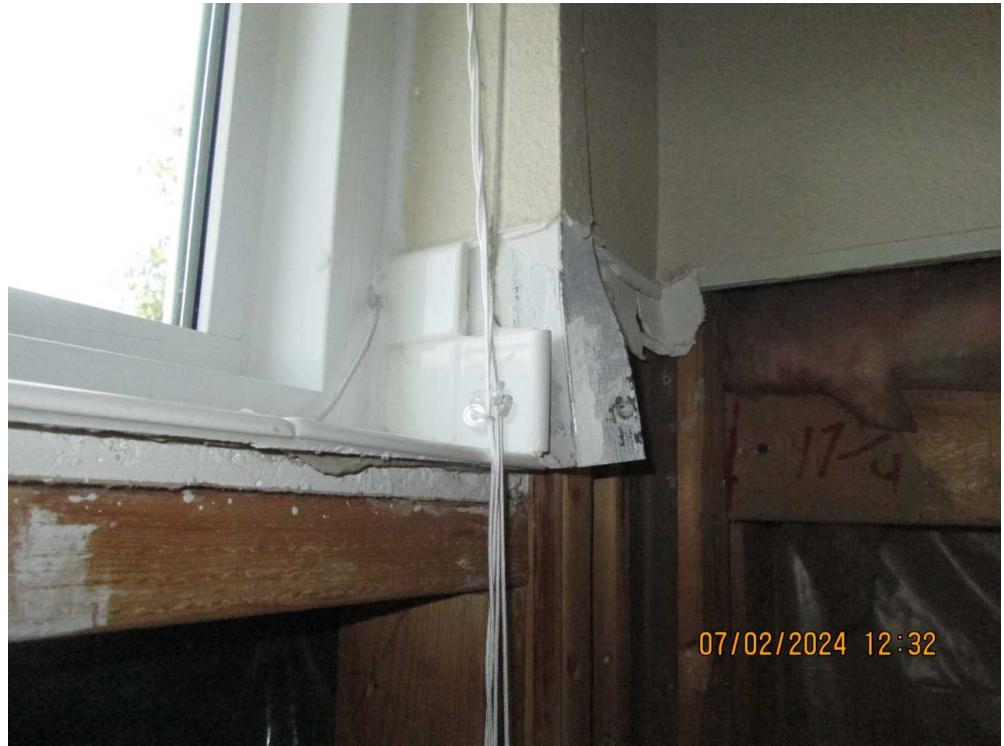
16 16-IMG_9963

Bathroom

Tile tub surround also covered
window sill

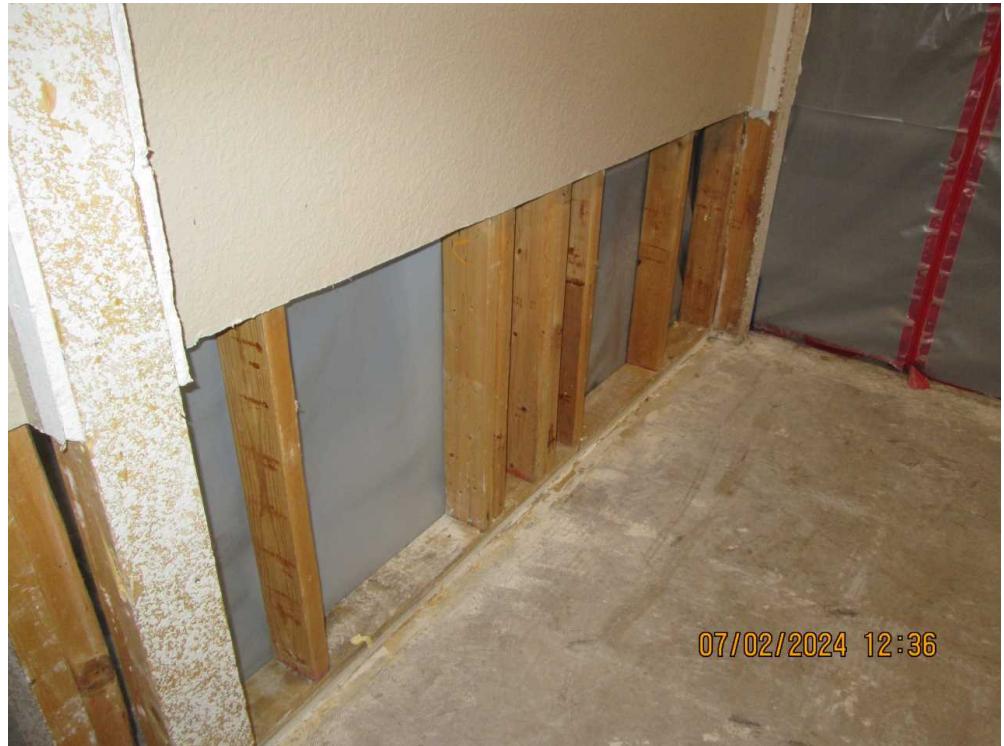
Laundry Room

Baseboard, drywall, insulation and
ceramic tile flooring removed during
mitigation

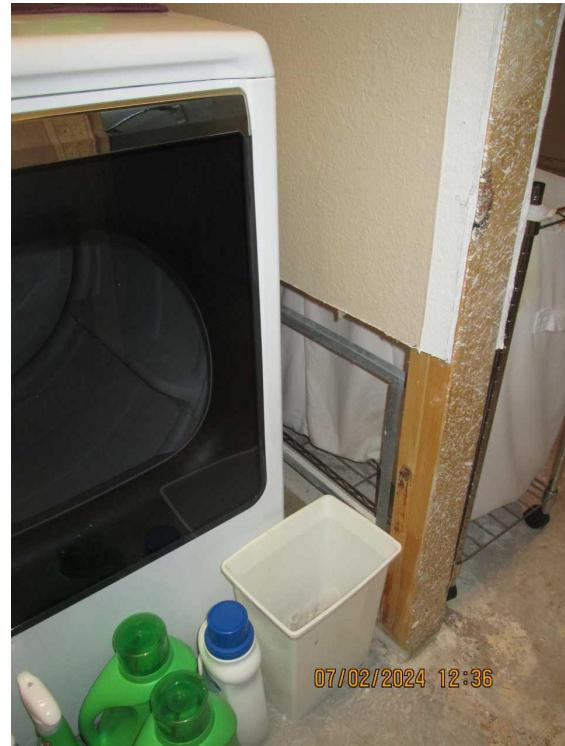
20 20-IMG_9969

Laundry Room

Baseboard, drywall and ceramic tile
flooring removed during mitigation

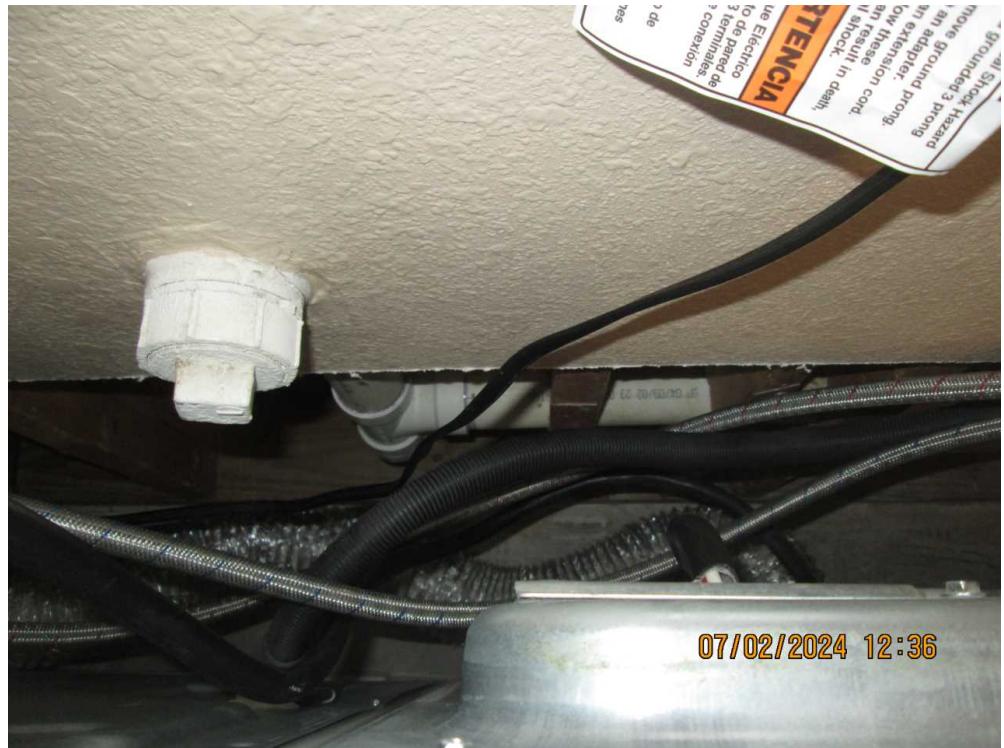
Laundry Room

Baseboard and drywall behind washer and dryer was removed during mitigation

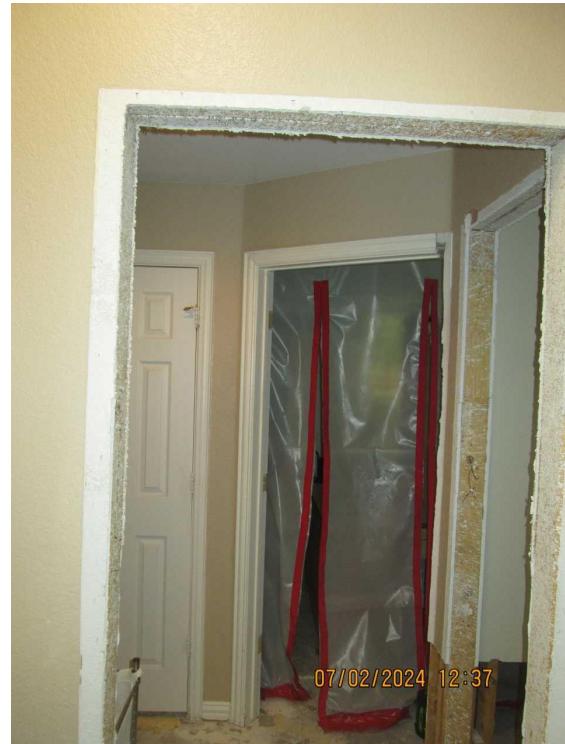
22 22-IMG_9971

Laundry Room

Door jamb removed during mitigation

71. Door hinges (set of 3) and slab Detach & reset	1.00 EA	0.00	29.94	0.00	5.98	35.92	
Door hinges will need to be detached and reset to allow replacement of jamb

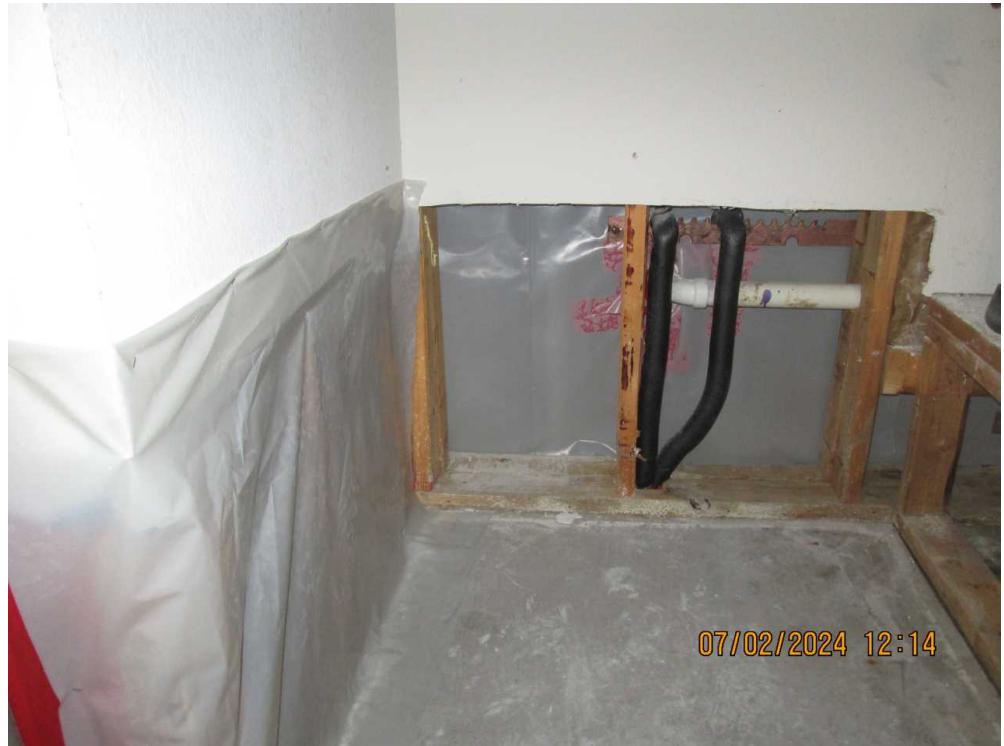
26 26-IMG_9942

Garage

Baseboard, drywall and insulation removed during mitigation

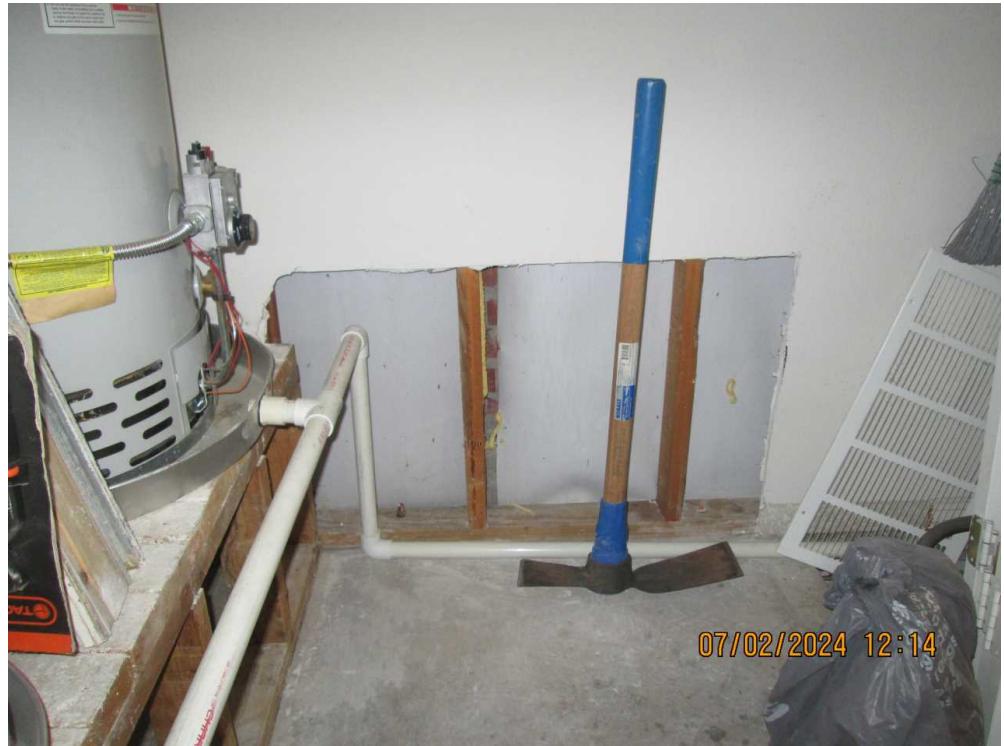
Garage
Baseboard, drywall and insulation
removed during mitigation

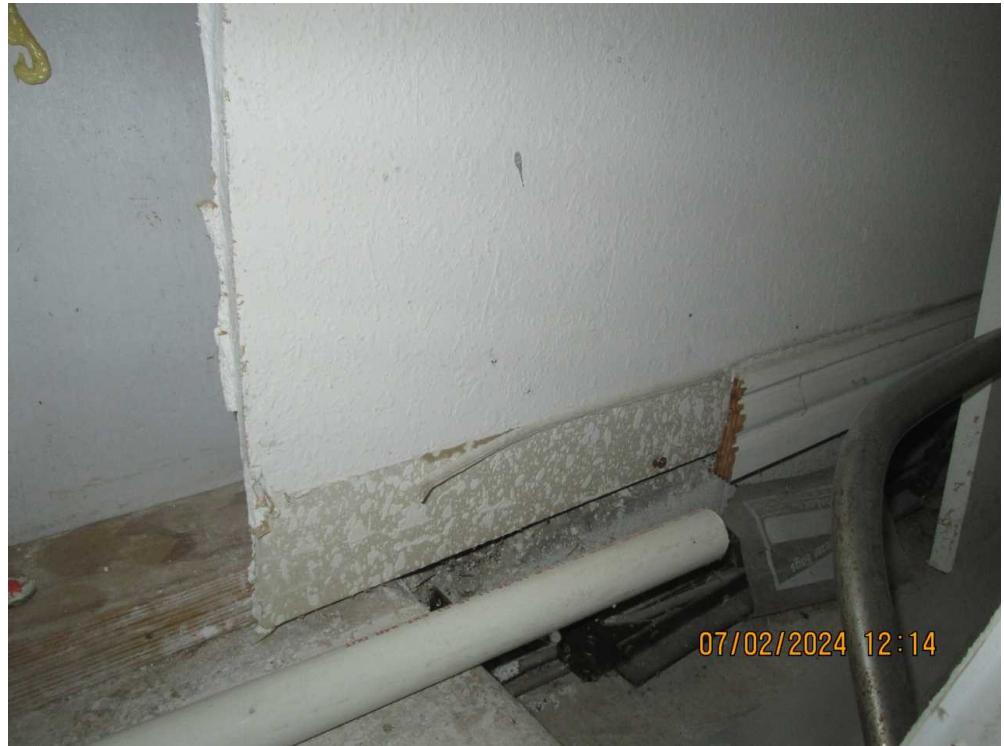
28 28-IMG_9946

Garage
Baseboard, drywall and insulation
removed during mitigation

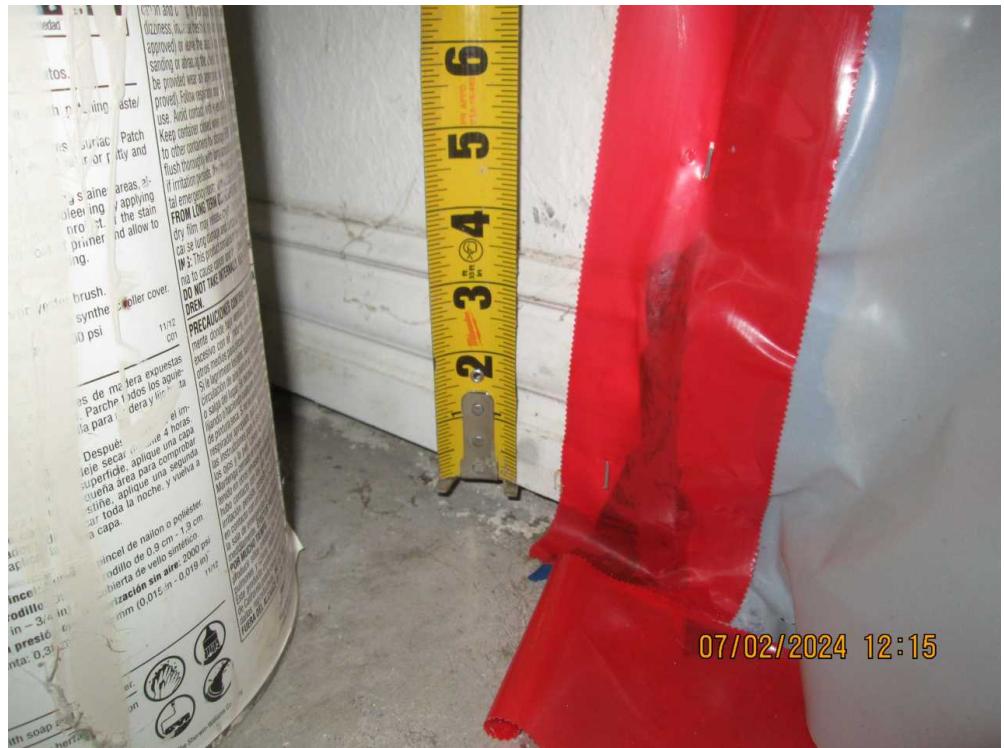
Garage

Baseboard is 3.25" tall

101. Baseboard - 3 1/4"	7.28 LF		0.00	3.94	1.14	5.96	35.78
102. Seal (1 coat) & paint (1 coat) baseboard	22.11 LF		0.00	2.08	0.26	9.26	55.51
103. Paint door/window trim & jamb 2 coats (per side)	1.00 EA		0.00	43.15	0.46	8.74	52.35
Paint door trim for Coat Closet in order to achieve a uniform repair with baseboard

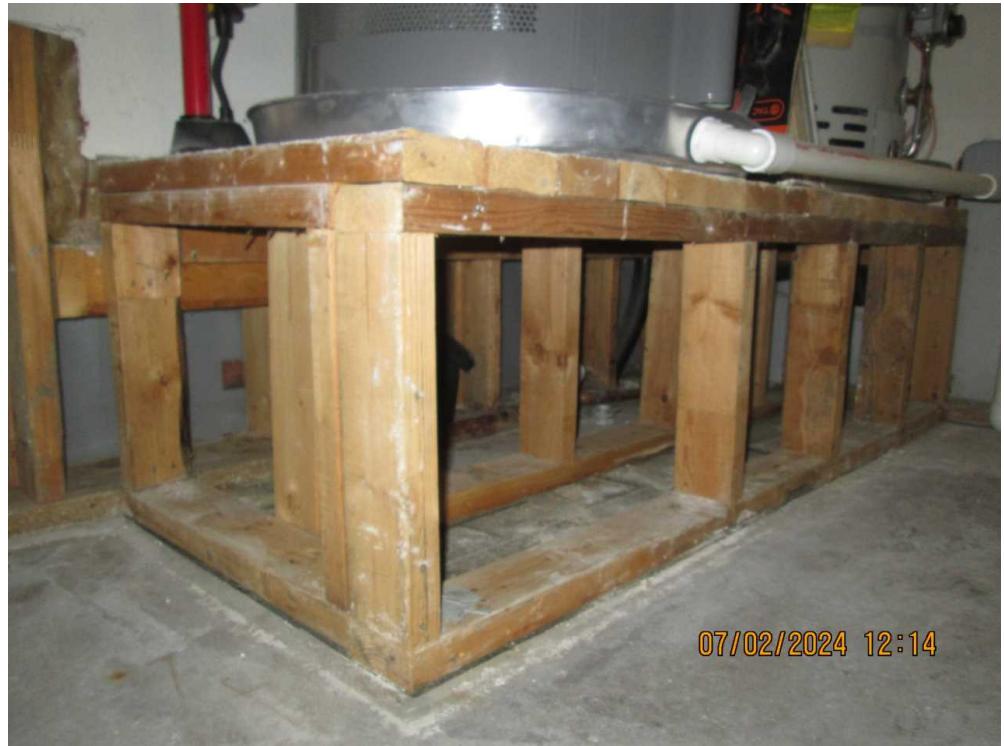
30 30-IMG_9943

Garage

Drywall on water heater riser and insulation in wall behind it were removed during mitigation

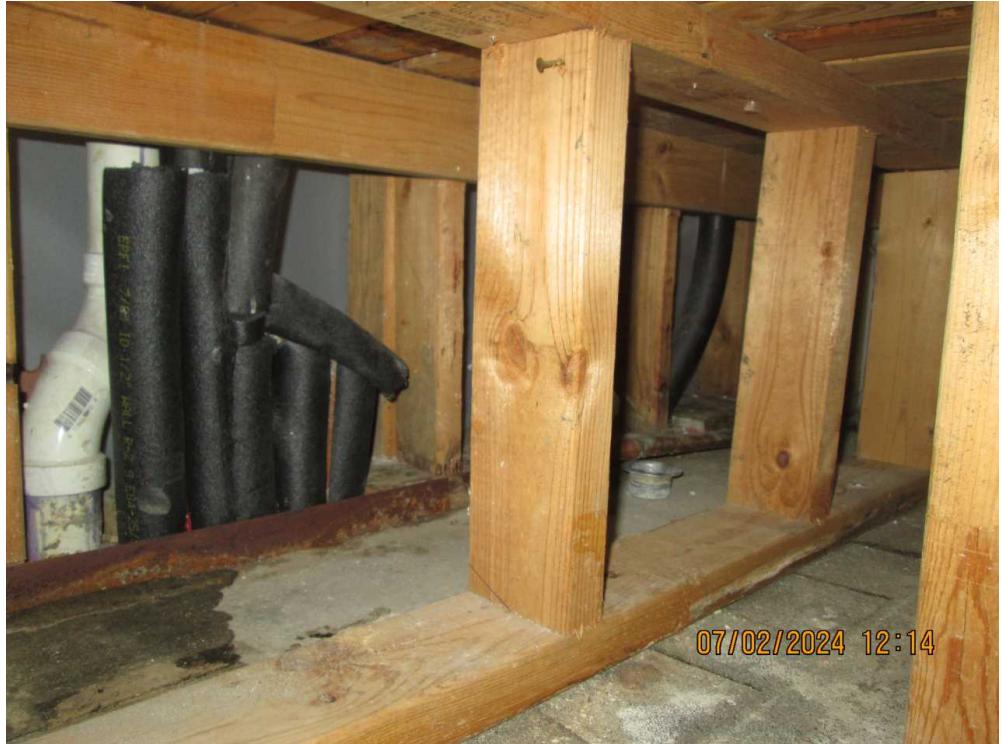
Garage

Drywall on water heater riser and insulation in wall behind it were removed during mitigation

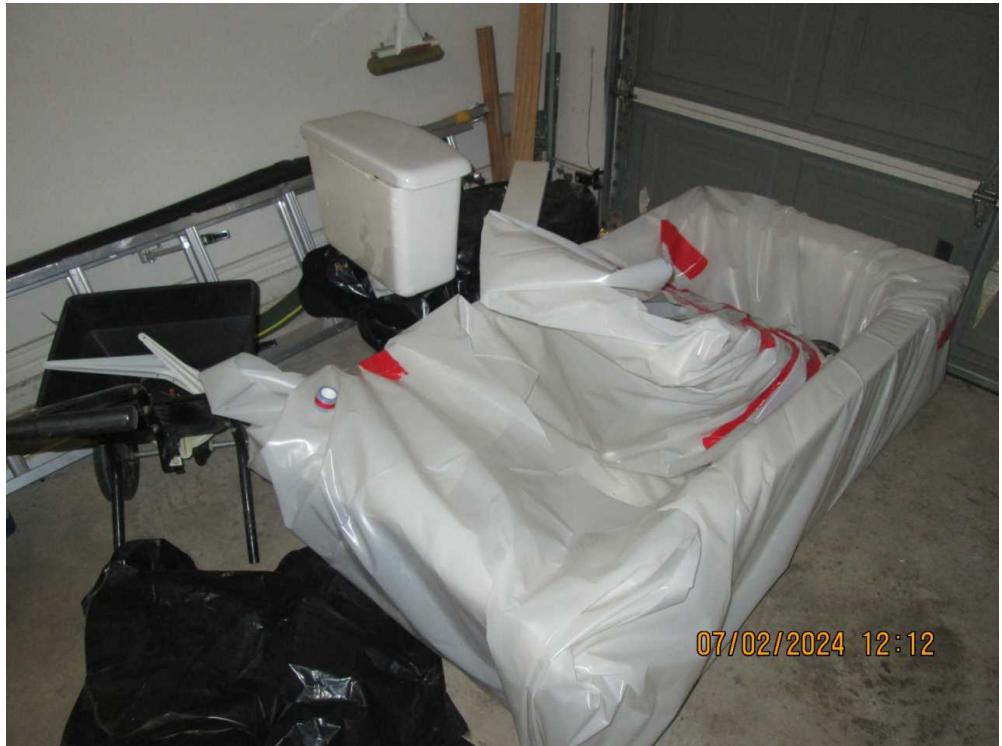
Garage

Tub and toilet that were detached during mitigation

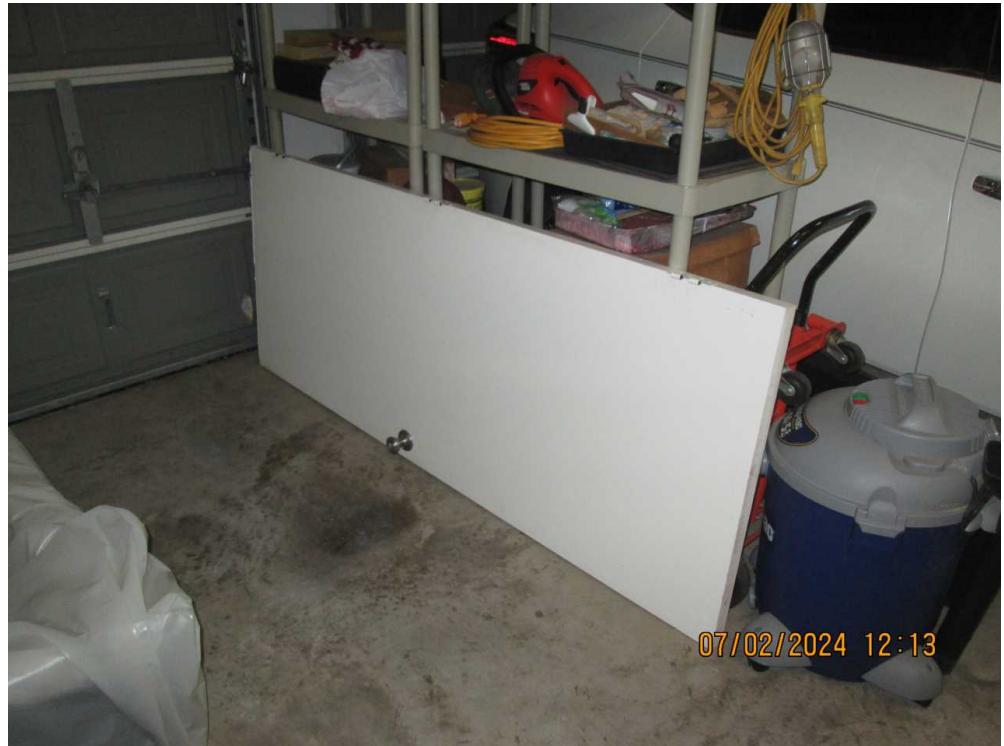
Garage
Door that was detached during mitigation

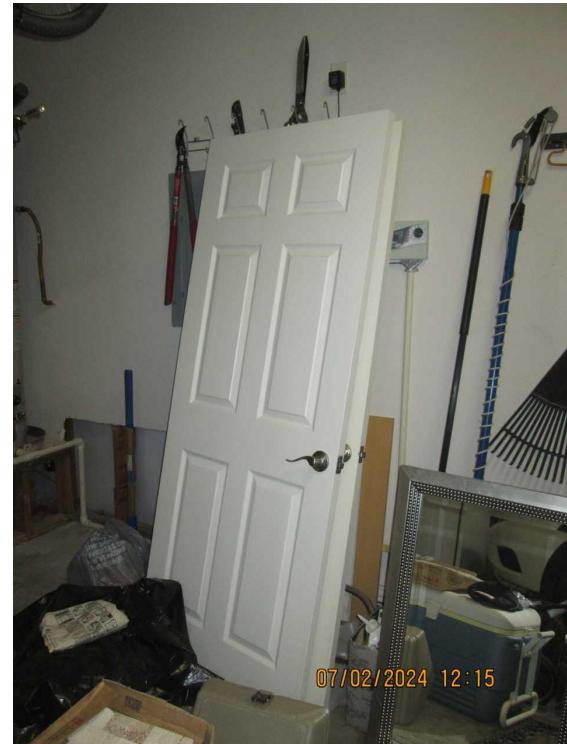
34 34-IMG_9949

Garage
Doors that were detached during mitigation

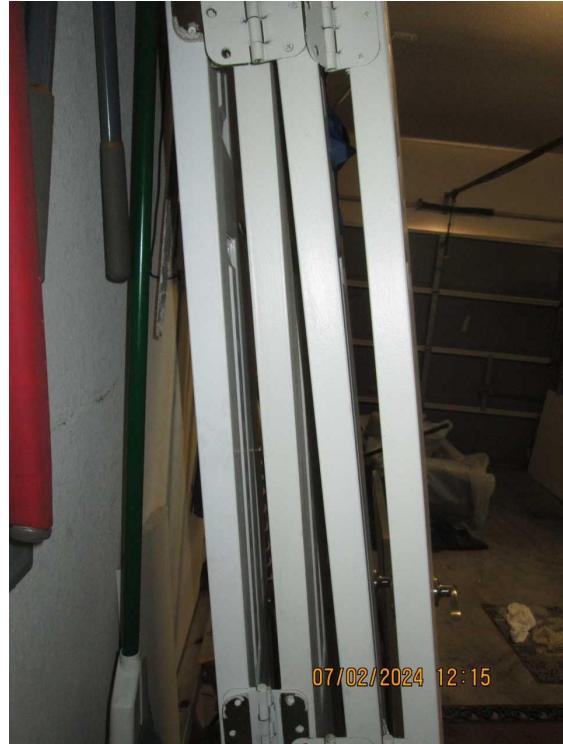
Garage

Doors that were detached during mitigation

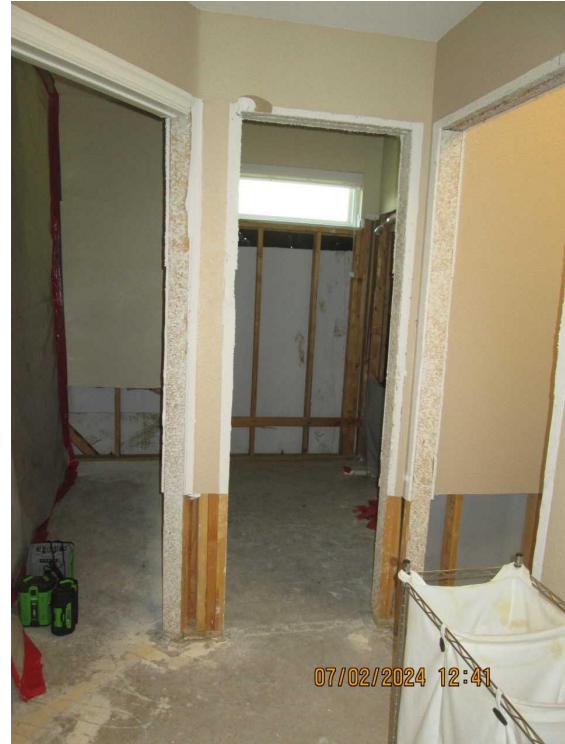
Hallway
Baseboard, drywall and carpet
removed during mitigation

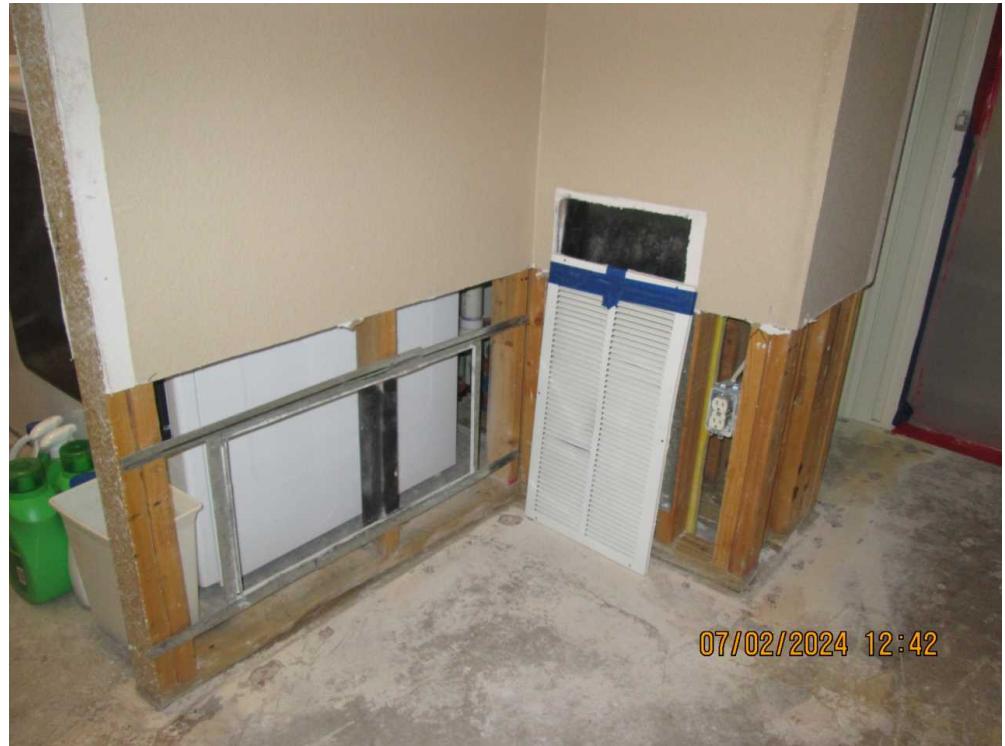
38 38-IMG_9974

Hallway
Baseboard, drywall and carpet
removed during mitigation

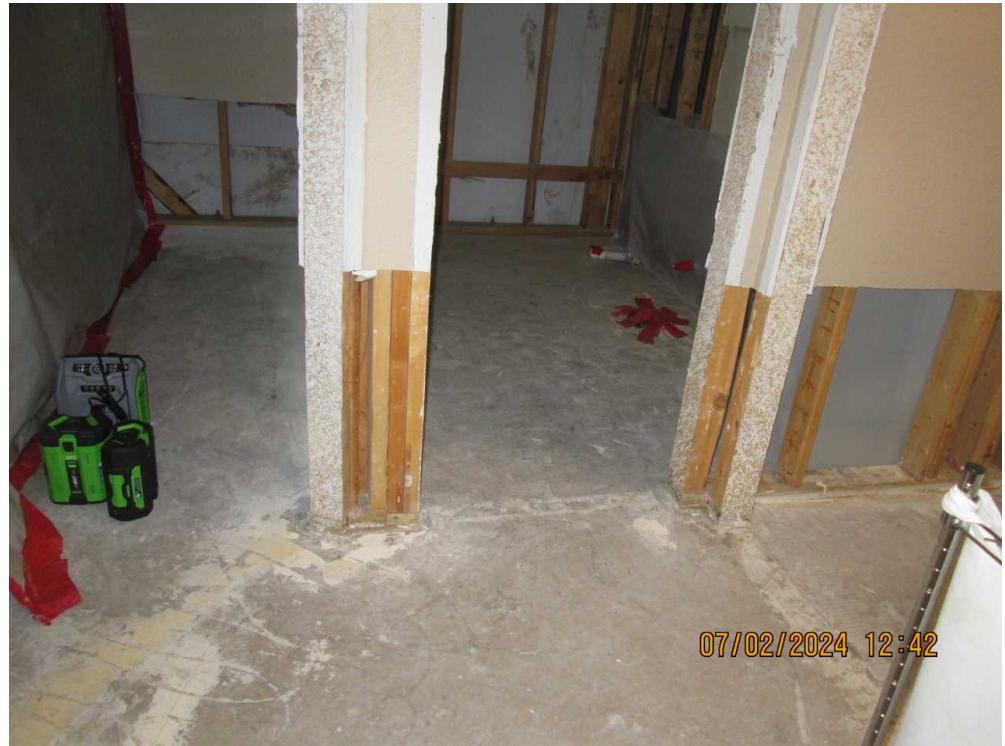
Hallway
Baseboard, drywall and carpet
removed during mitigation

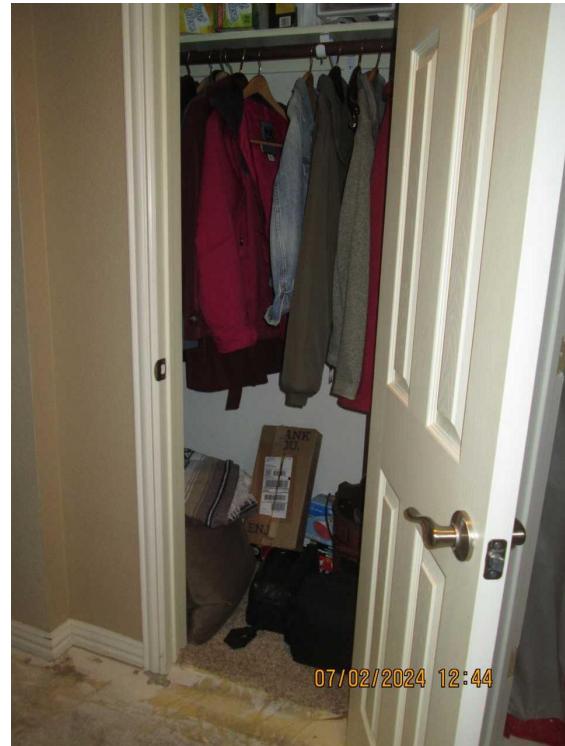
Coat Closet
Carpet is continuous with Hallway

DESCRIPTION	QTY	RESET	REMOVE	REPLACE	TAX	O&P	TOTAL
108. Remove Carpet	10.31 SF		0.30	0.00	0.00	0.62	3.71
109. Carpet	11.85 SF		0.00	3.88	2.91	9.78	58.67
Carpet is continuous with Hallway							
15 % waste added for Carpet.							
110. Content Manipulation charge per hour	1.00 HR		0.00	57.21	0.00	11.44	68.65
Totals: Coat Closet					3.37	23.58	141.48

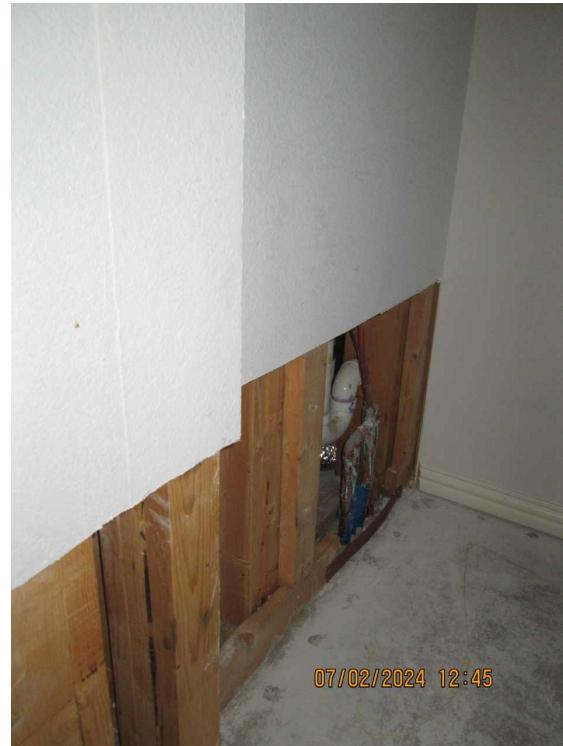
42 42-IMG_9978

Stair Closet

Baseboard, drywall and carpet were removed during mitigation

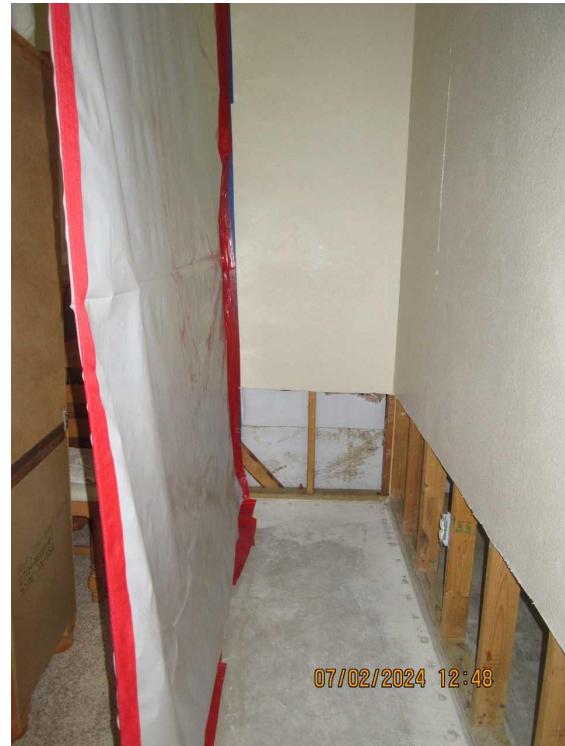
46 46-IMG_9982

Bedroom 1

Baseboard, drywall and carpet were partially removed during mitigation

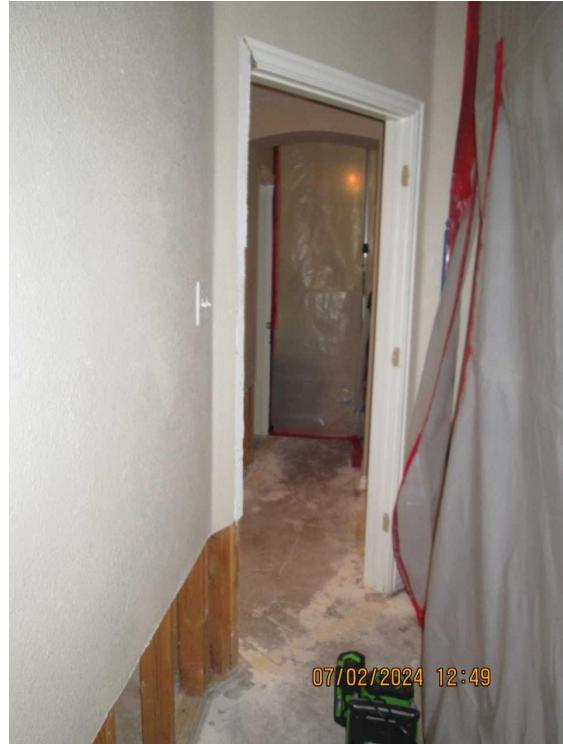
Bedroom 1

Baseboard, drywall, carpet and door jamb were partially removed during mitigation

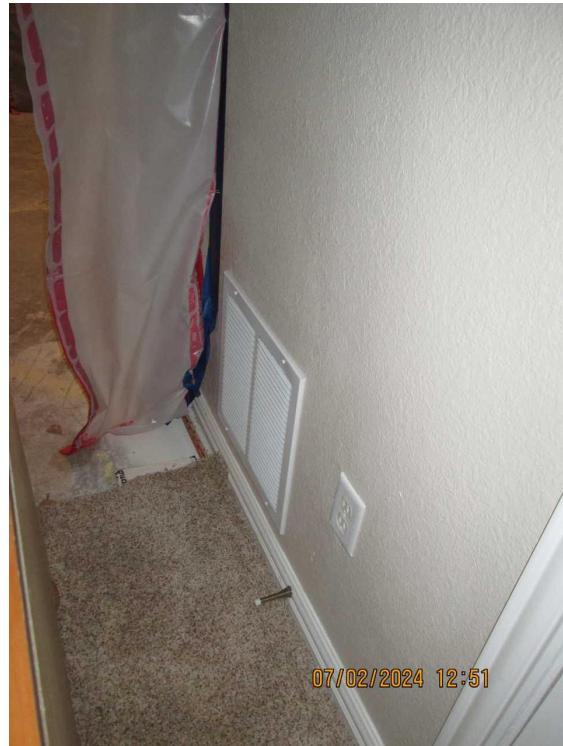
48 48-IMG_9986

Bedroom 1

Cold air return cover will need to be detached and reset to allow for painting of walls

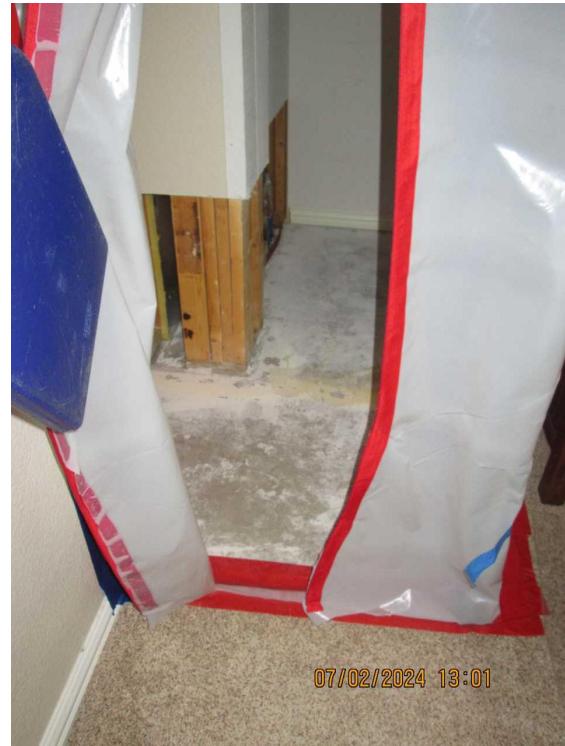
54 54-IMG_9990

Living Room

Baseboard, drywall and carpet
partially removed during mitigation

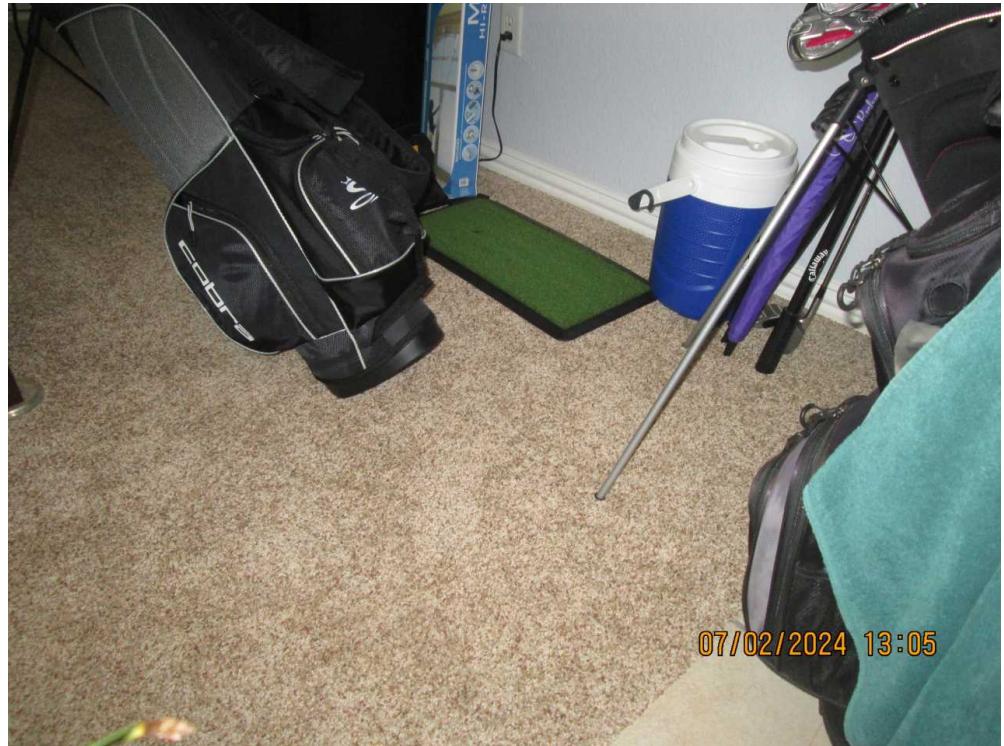
Formal Dining Room
Carpet is identical to that which is
installed in Living Room and Hallway

DESCRIPTION	QTY	RESET	REMOVE	REPLACE	TAX	O&P	TOTAL
172. R&R Carpet pad	142.08 SF		0.13	0.67	6.33	24.00	143.99
173. Remove Carpet	142.08 SF		0.30	0.00	0.00	8.52	51.14
174. Carpet	163.40 SF		0.00	3.88	40.17	134.84	809.00
Carpets is identical with that which is installed in Living Room, Hallway and Bedroom 1							
15 % waste added for Carpet.							
175. Content Manipulation charge per hour	1.00 HR		0.00	57.21	0.00	11.44	68.65
