ARLISS 2022 report

Submission date: November 21, 2022

Chapter 1 Mission Statement

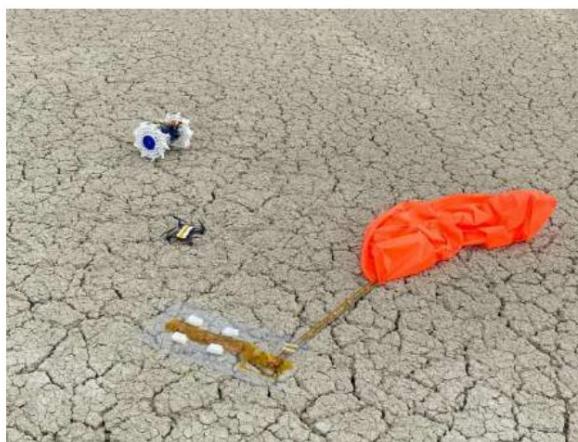
Figure 9.8 CanSat at discovery

- When discovered, the child unit was powered on and separated from the parent unit (Figure 9.8). Afterwards, we confirmed the operating sounds of the handset power-on mechanism and handset separation mechanism. The slave aircraft flew (Figure 9.9) and performed a sequence to determine the presence or absence of obstacles . After that, the main unit attempted to start GNSS guidance, but the left tire did not work, and the aircraft continued to run counterclockwise around the left tire. Although it got caught in the cloth of the parachute on the way (Figure 9.10), it escaped and continued traveling, stopping about 7 minutes after it was discovered. After that, I waited for about 20 minutes, but the train did not resume running , so I retired (Figure 9.11).

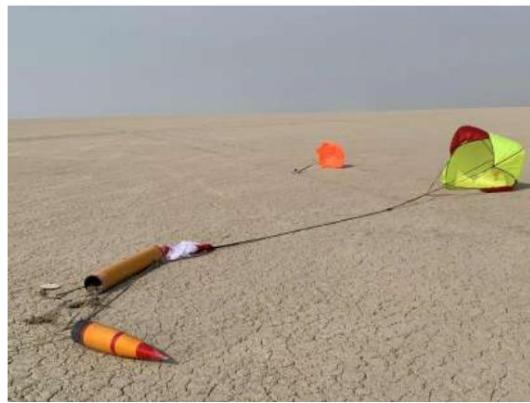
Figure 9.17 Rocket (front) and CanSat (back)

- The parachute was deployed, but the rocket disintegrated in the air and landed before reaching terminal velocity (Figure 9.17)
 - ÿ After landing, the motor was running, but the inner carrier was not deployed, and no further missions or driving were possible. I decided that I could not continue and retired. When the CanSat fell, it was exposed to rocket smoke, as shown in Figure 9.18. The entire inner carrier had turned white.

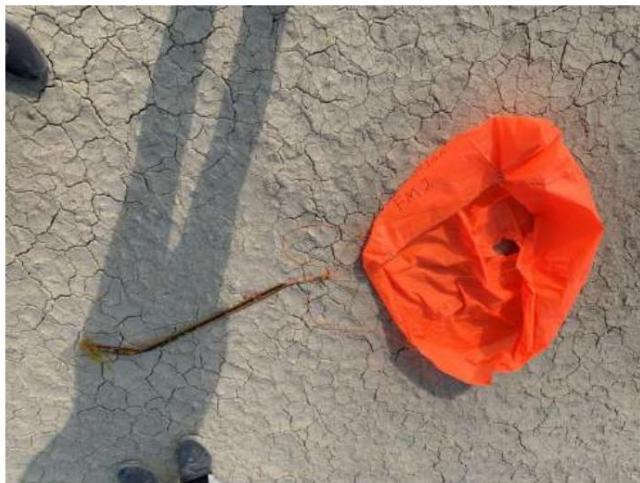
Figure 9.28 Parachute and part of the inner carrier

- After the CanSat was ejected from the rocket, the inner carrier was damaged (Figure 9.28) and the CanSat fell freely. At the landing point, the parent unit separated from the slave unit and ran, overturned in the ruts like a soft sandbox and executed a high-speed rotation (stuck escape mechanism) (Figure 9.29). After that, it ran again and got stuck again (Figure 9.30). The handset was discovered at the CanSat landing site, with the blade broken and the motor detached, as shown in Figure 9.31. The power to the handset was not turned on.

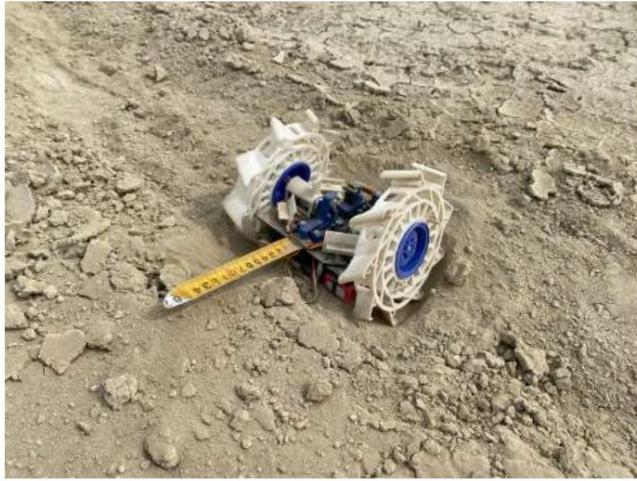
Figure 9.30 Master unit when retired

- One of the reasons why the main unit got stuck is that the motor holder was damaged by the landing impact after CanSat's free fall. This caused the motor to separate from the aircraft, making stable running impossible.

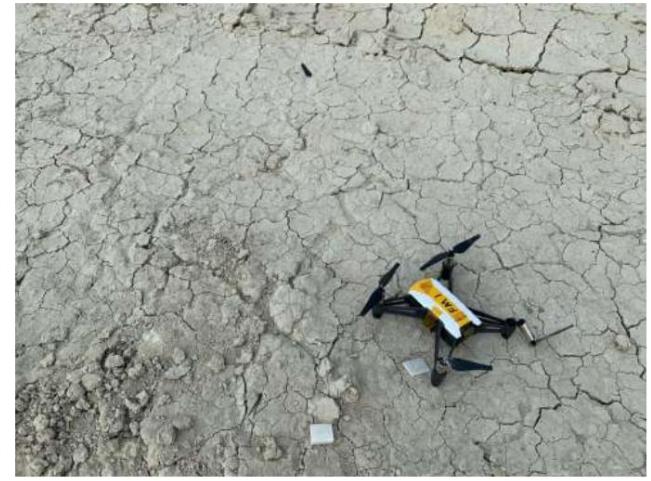
Figure 9.31 Child unit when discovered

- Regarding the fact that the handset could not be powered on, it is thought that the cause was that the handset separated from the base unit when it landed. As stated in the results, there was a crack in the arm used to hold the handset, making it possible to remove the handset from the base unit without turning the servo motor and operating the handset separation mechanism. This crack is thought to have been created upon landing due to the impact of free fall. Therefore, the slave unit jumped out from the parent unit, and it is thought that the slave unit was already separated when the slave unit's power-on mechanism

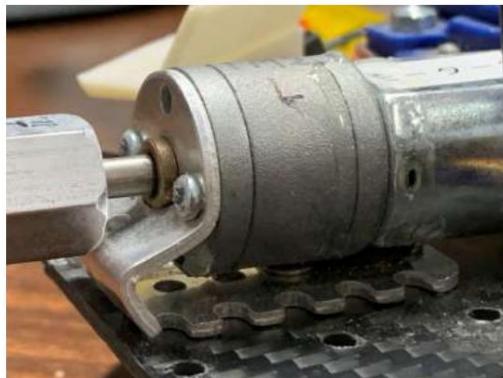
Figure 9.35 Motor bracket after first drop

arm opened. • Regarding the fact that the left tire did not work, the cause was that the motor of the left tire was ejected towards the inside of the aircraft, as stated in the results. It is thought that this caused the tires to also move towards the inside of the aircraft, making contact with the aircraft and becoming unable to rotate. The reason why the left tire motor flew out is thought to be because the left tire was placed downwards when the rocket was stowed and was affected by the impact of the rocket's separation.

Regarding the fact that CanSat was able to run even after a free fall, the first reason is thought to be that measures were taken to reduce the amount of deformation of the motor bracket, which allowed the tires to rotate even after receiving an impact. Since the motor bracket was deformed in the first and second drop tests (Figure 9.35), the direction of the motor relative to the motor bracket was rotated 90 degrees and fixed in the third drop test (Figure 9.36). Due to this measure, the amount of deformation of the motor bracket due to impact was small, and therefore the amount of movement of the motor protruding toward the inside of the aircraft was also small. Therefore, it is thought that the phenomenon where the tires got caught on the aircraft and stopped rotating did not occur. The second reason is thought to be that the tires absorbed the landing impact. Because the inner carrier disintegrated in the air, the large, flexible TPU tires were deployed when the aircraft landed.

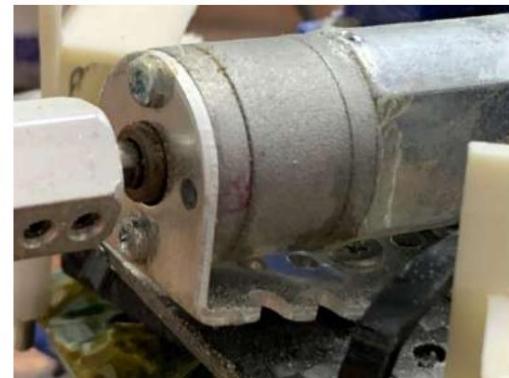
Figure 9.36 Motor bracket after third drop

- The reason why the CanSat was able to move even after it rolled over and rotated at high speeds is thought to be because the parts were firmly fixed to the body of the aircraft because adhesive was applied to each part and to the screw holes.
