# Robotic System for Monitoring Industrial Installations

AUTHOR  
**Duarte Santos**

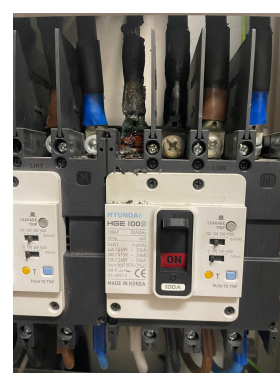
(a)

The system was validated at a transformer substation at ISEL, where two active electrical faults were successfully detected. The first, an oxidized cable (**Figure 4a**), reached a peak temperature of 184°C, exceeding the 153°C measurement ceiling of the professional handheld camera used as reference.

Figure 4: Thermal inspection of an oxidized cable
