An examination of Wi-Fi enabled Drone Security within IOT (Internet Of Things)

Examining through methodical investigation how poor **security** surrounding a popular device within the IOT ecosystem: the Wi-Fi enabled **drone**, pose a **threat** to the user.

CMP320, Ethical Hacking 3, U2- Mini Project

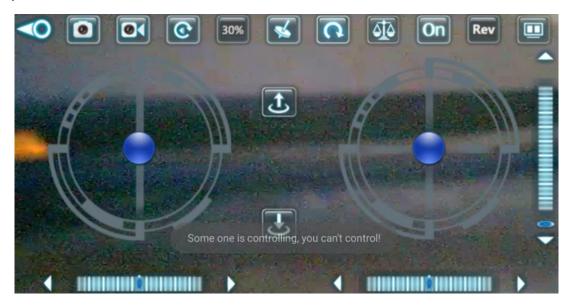
The CX-10W drone is designed to be used in a small area, however anyone within that area can view whatever the drone sees simply by connecting it. As seen in Figure 16 there is an alert displayed to the new user (not the original user) in the form of a toast which pops up alerting that another person is controlling the drone. The original user who is in control does not see anything alerting them to this new connection made by another device.

Figure 16, The toast given when by the application when the drone is controlled by another device.

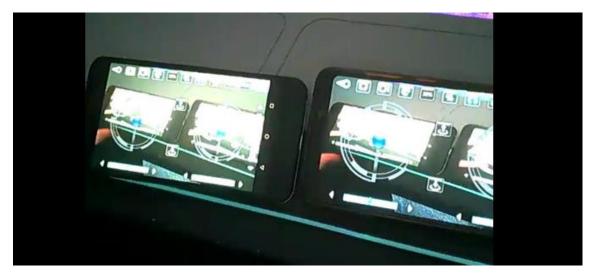
The attacker who is peeking has selected the option to take a picture, and although latency is an issue, the picture was saved to attacker's gallery. The user on the victim phone received no notification of either another user being connected, nor another user taking a picture or recording video.

Figure 17, although the drones camera quality is poor, nor the captured image as wide as the view might suggest, it can still be seen clearly that the same live image is being displayed on two separate screens.

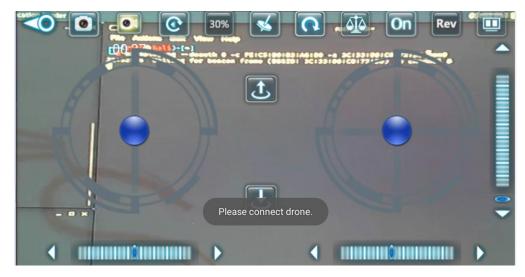
In Figure 25, a screen capture taken on the client (target device) can be seen. The drone was set up to record the moment the attack began. Although the image quality is poor, the first output from the attack can be seen. Video transmission from the drone stopped immediately as this happened and a toast to reconnect was displayed, indicating that the client had been successfully thrown from the network.

Figure 25, The view from the client as they are ejected from the network.

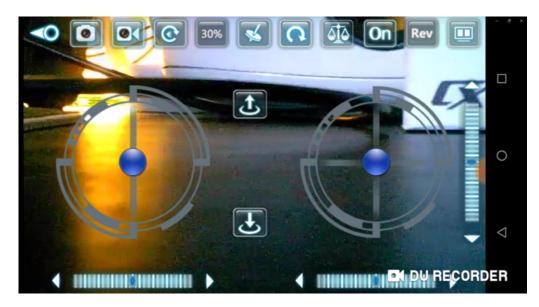
Figure 30, Assuming the attack has worked, the attacker will now have control of the drone.

As seen in Figure 30 it can be seen that the attacker's connection with the drone has been successfully reestablished and they have now "hijacked" control of the drone from the target. The drone is now theirs to control, assuming they drone did not plummet into an irretrievable position mid-flight. They may wish to simply fly the drone around or fly it back to them and take it for themselves.

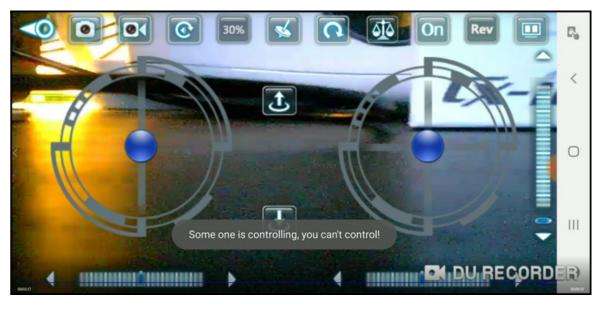
Figure 31, It can be seen that the roles have reversed and that the victim is the one now receiving the toast telling them that someone else has connected to their drone and that they cannot control it anymore
