September 6, 2016
Job Number: 1222-013
Façade Improvements Design Review
for 210 The Promenade North, Long Beach, CA

MEMORANDUM FOR THE RECORD

SUBJECT: Character-Defining Features and Façade Improvement
Submittal for 210 The Promenade North, Long Beach,
CA

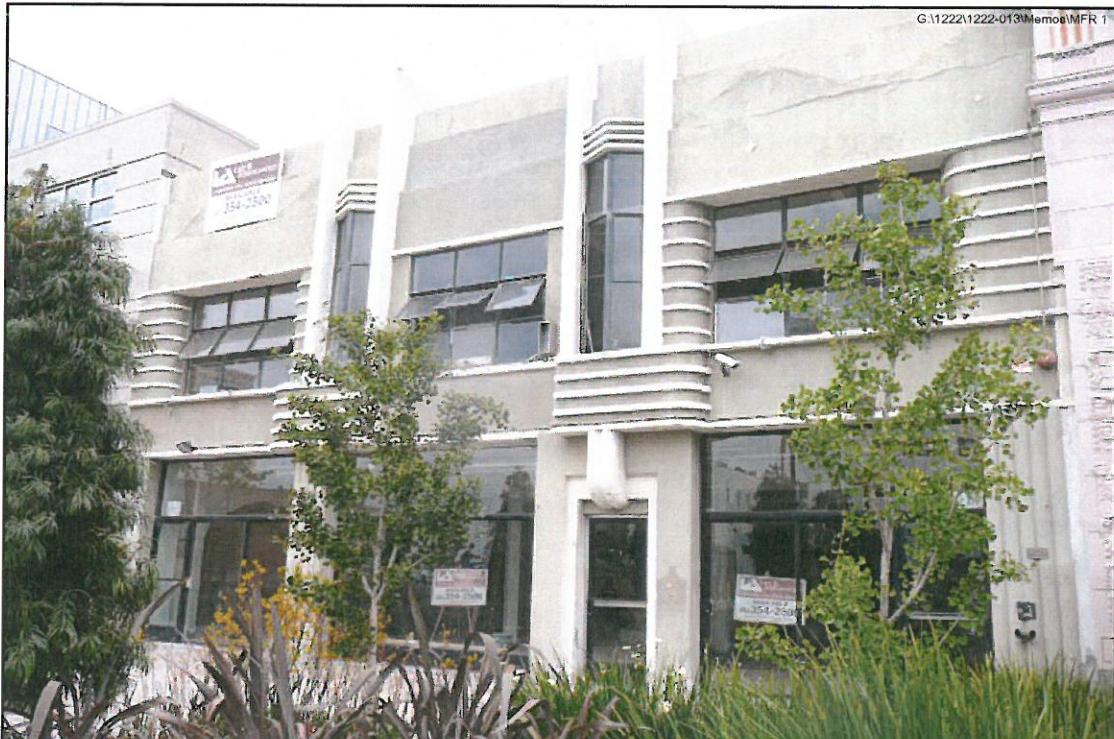
PHOTO 1
Façade

Setting and Orientation	Faces west towards the street-level pedestrian path known as The Promenade (Appendix A, <i>Site Photographs</i> ; Photo 1, <i>Façade</i>). It is sited at the southwest corner of the intersection of North Promenade and East Broadway.
Design	<p>Exemplifies character-defining features of the Art Deco style:</p> <ul style="list-style-type: none"> • Strong verticality • Emphasis on vertical projections and window channels • Geometric and stylized ornaments (chevrons, piping, and fluting) • Metal casement windows • Flat roof <p>Exemplifies elements associated with the Streamline Moderne style:</p> <ul style="list-style-type: none"> • Strong horizontality • Emphasis on curved corners and smooth exteriors • Horizontal grooves • Smooth, aerodynamic accents alluding to speed • Flat roof
Height and Massing	Characterized by two-story height, asymmetrical composition, and rectangular massing.

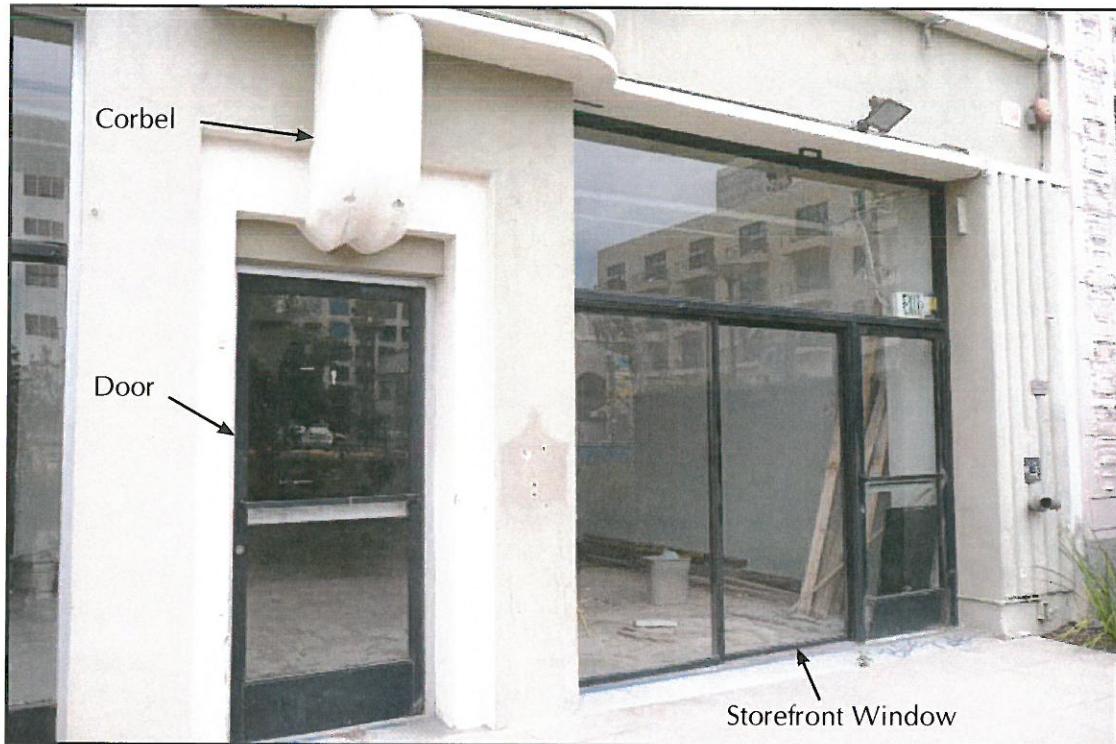
PHOTO 2
Storefront Windows and Door; Corbel

Also included in the plan for façade reconstruction is the installation of three new ground-level steel frame storefront windows and a new steel frame door. These features more accurately reflect the original building design than the current additions (please see Sheet No. A.7.0 in Attachment D, *Site Plan Review Elevation and Drawing of Façade Finishes* in Attachment E, *Façade Finishes*). As the existing store front windows and door were replaced in 1956, and likely again in 1992, these features are not original to the building, can be replaced without damaging the integrity of the building, and comply with the *Standards*.

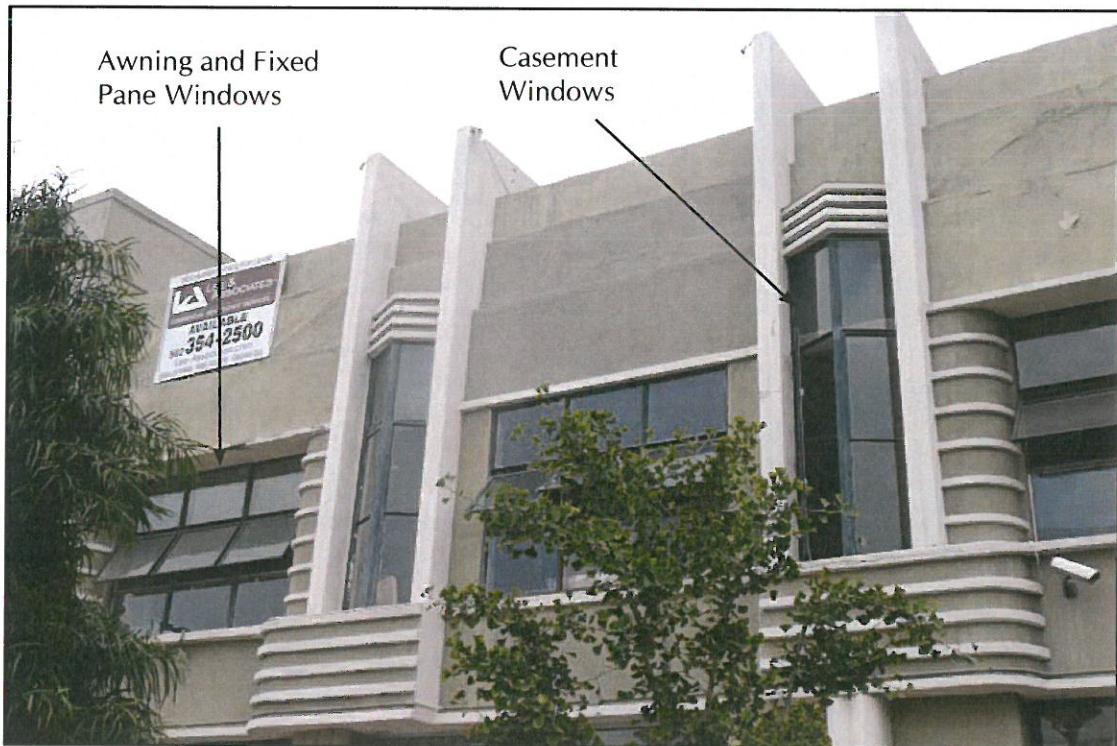
PHOTO 3
Casement and Awning Windows

In order to construct the three fixed casement windows, the existing central awning window would be removed. This window is not original, does not contribute to the Art Deco/Streamline Moderne style of the building, and is not a character-defining feature of the building. Additionally, non-original molding would be removed and replaced with plaster. The existing windows casement and original plaster would be restored.

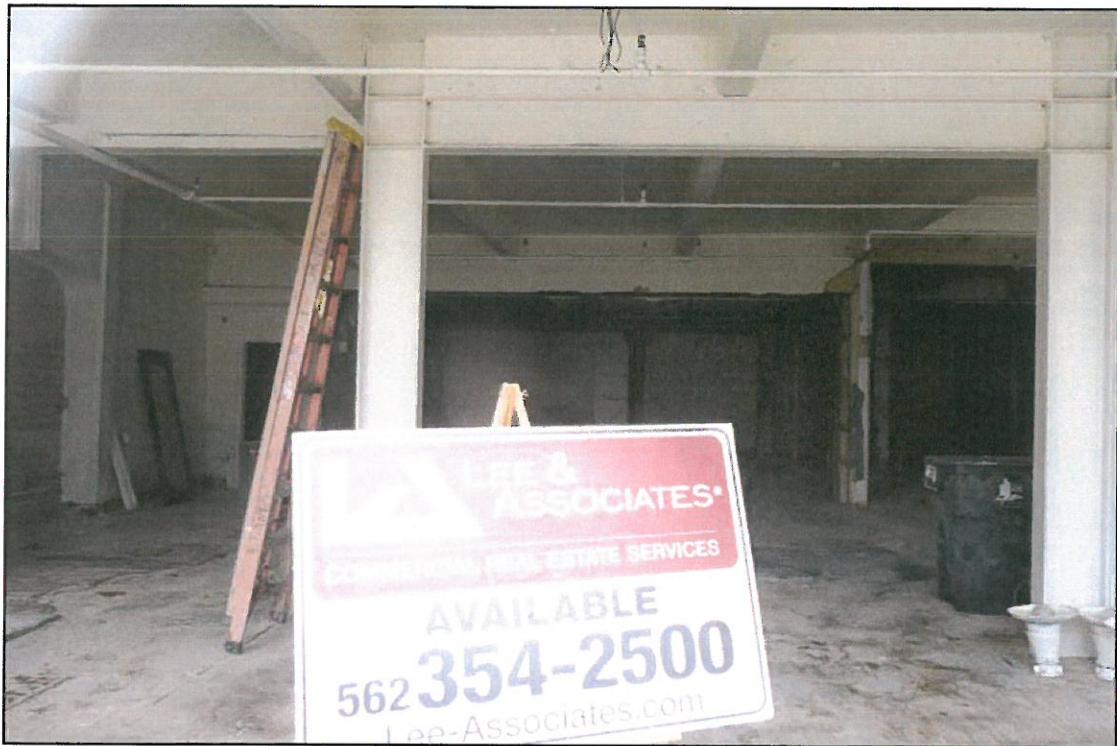
PHOTO 4
Interior Infrastructure

Interior Spaces and Features	The interior of the building has a concrete floor and brick walls covered with plaster. 'I-beams and other exposed structural components are visible (Appendix A, <i>Site Photographs</i> ; Photo 4, <i>Interior Infrastructure</i>).
