Loss of Thrust in Both Engines After Encountering a Flock of Birds and Subsequent Ditching on the Hudson River

US Airways Flight 1549

Airbus A320-214, N106US

NTSB/AAR-10/03
PB2010-910403

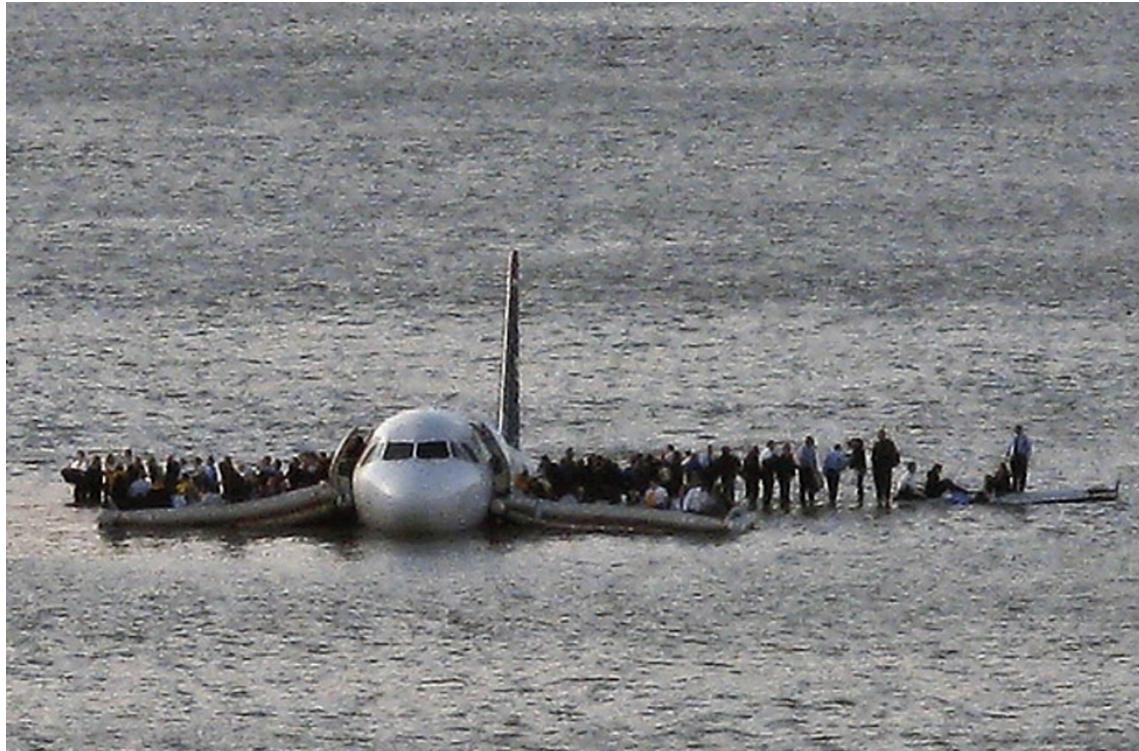
Within seconds after the ditching on the Hudson River, the crewmembers and passengers initiated evacuation of the airplane. Subsequently, all of the occupants were evacuated from the airplane and rescued by area responders. (See sections 1.15.5 and 1.15.6 for information about the emergency evacuation and response, respectively.) Figure 2 shows the airplane occupants on the wings and in the slide/rafts after the evacuation.

Figure 2. A photograph showing the airplane occupants on the wings and in the slide/rafts after the evacuation.

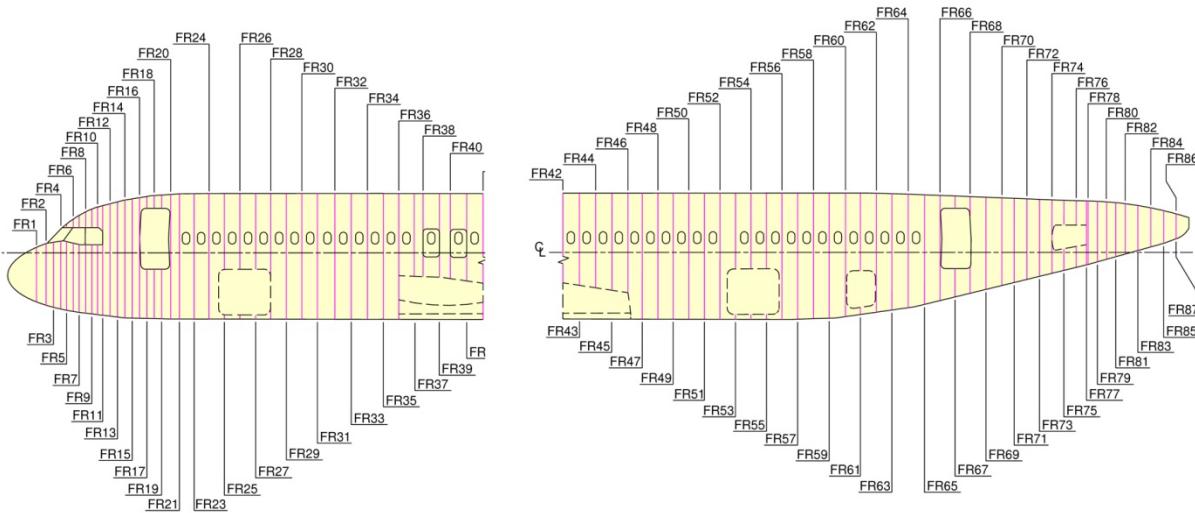
Figure 6. Diagram showing the A320 fuselage frame locations.

Specifically, portions of the left-side belly fairing aft of the wing were either fractured or missing. The right-side belly fairing was missing from FR37 to FR51. The lower left side of the rear fuselage was fractured between FR56 and FR64 and bent outward away from the airplane centerline. The lower right side of the rear fuselage was crushed and buckled inward from FR56 to FR70. The internal cargo structure was damaged, and the floor panels at FR57 were buckled upward.

The crossbeams from FR66 aft were sheared in the aft direction, but the longitudinal seat tracks remained in position. The lower third of the aft pressure bulkhead was sheared away, and the lower part of the fuselage was torn in the aft direction. The tail cone, including the APU, was separated from its attachment points to the fuselage, except for the right-side lower location, and no longer retained its conical shape.

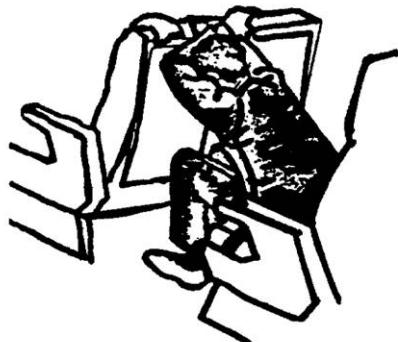
Figure 7. Passenger brace position shown in AC 121-24C.

Of the four passengers who sustained serious injuries, three received their injuries during impact. The two female passengers who sustained very similar shoulder fractures both described assuming similar brace positions, putting their arms on the seat in front of them and leaning over. They also stated that they felt that their injuries were caused during the impact when their arms were driven back into their shoulders as they were thrown forward into the seats in front of them. The brace positions they described were similar to the one depicted on the US Airways safety information card, which is shown in figure 8.

The brace positions shown on the US Airways safety information card were in accordance with current FAA guidance on brace positions contained in Appendix 4 of AC 121-24C, which states, "in aircraft with high-density seating or in cases where passengers are physically limited and are unable to place their heads in their laps, they should position their heads and arms against the seat (or bulkhead) in front of them." (See figure 7.)

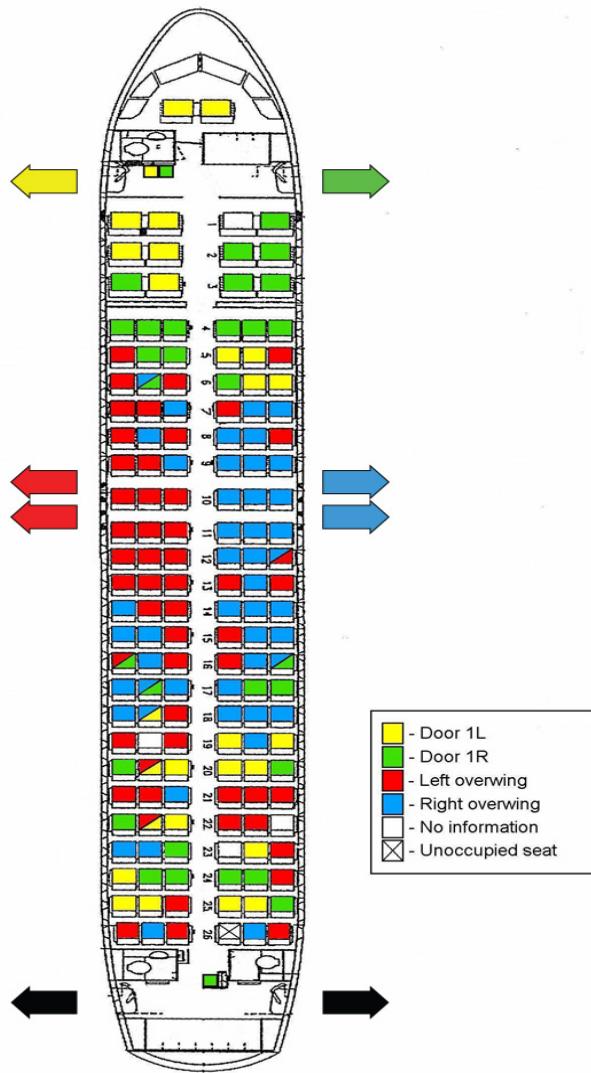
Figure 9. Occupant evacuation exit usage.

A female passenger was seated in 19E, which is a middle seat on the right side of the airplane and is indicated in blue in figure 9, with her 9-month-old son on her lap. During postaccident interviews, she indicated that, when the captain stated, “brace for impact,” the male passenger in 19F offered to brace her son for impact. The lap-held child’s mother stated that she thought the passenger in 19F “knew what he was doing,” and she gave her son to him. Neither the mother, the lap-held child, nor the passenger who held the child was injured. The mother stated that, after landing, the passenger gave her son back to her and that she evacuated onto the right wing.

Passengers and flight attendants reported that the evacuation was relatively orderly and timely. A review of passenger exit usage indicated that, in general, passengers from the forward and mid parts of the cabin evacuated through the exit closest to their seats. (See figure 9.) However, aft-seated passengers indicated that water immediately entered the aft area of the airplane after impact and that the water rose to the level of their seat pans within seconds; therefore, they were not able to exit from their closest exits because these exits were no longer usable. Most of the aft passengers initially attempted to go to the rear exits, but flight attendant B and several passengers began shouting for everyone to go forward because the rear exits were not usable. The passengers turned around and attempted to go forward up the aisle, but, because a line had formed for the overwing exits, they initially could not move forward.
