Precision Home Inspections & Toxic Testing

August 13th 2025, 8:30 am

INSPECTION DESCRIPTION: Home Inspection

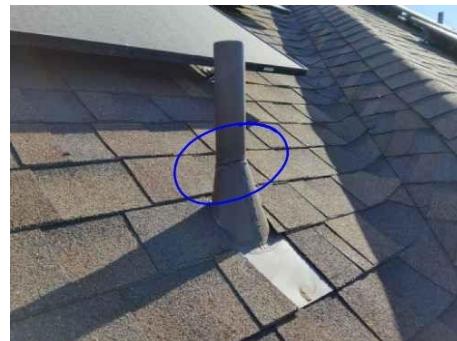
The sealant between the pipe and the boot is falling apart. This can allow water down into the attic and home area. Recommend adding more sealant.

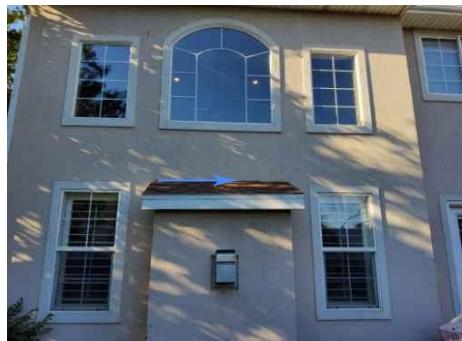
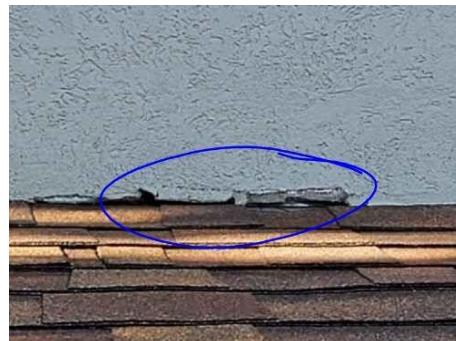
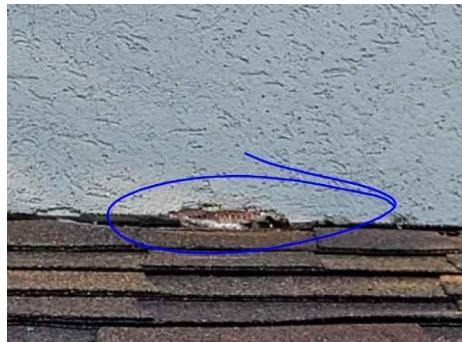
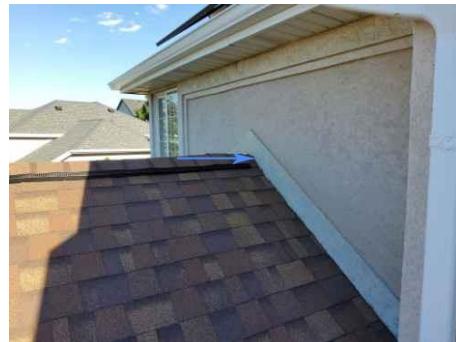
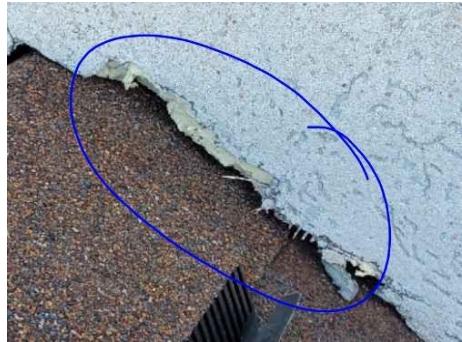
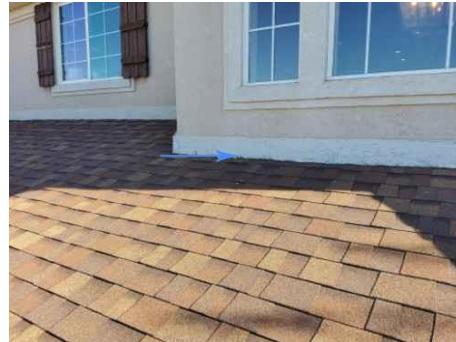
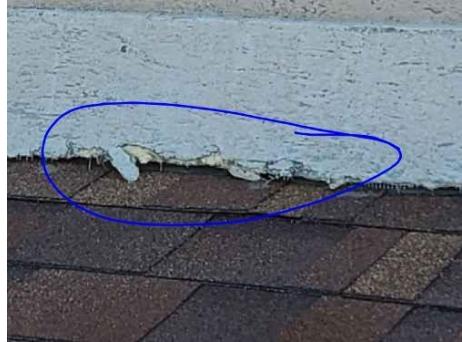
The stucco is falling apart on the north and south side of the house above the chimney flue. This can allow water behind it causing water damage
Recommend further evaluation/repairs by a qualified siding contractor.

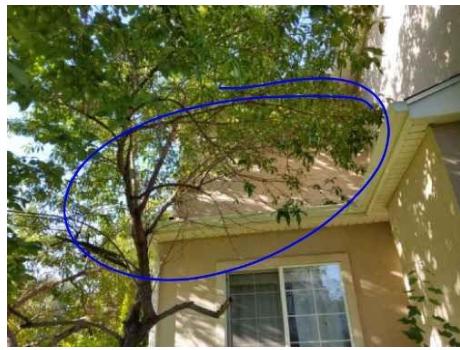
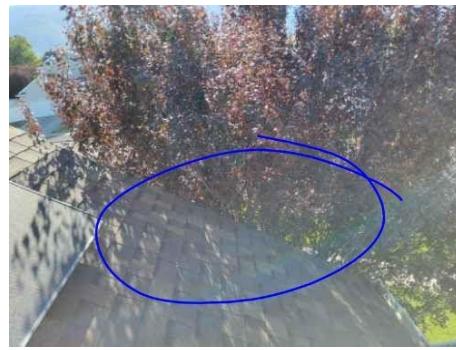
It is recommended that shrubs and overhanging trees have a minimum of 12" clearance to prevent damage to the house.

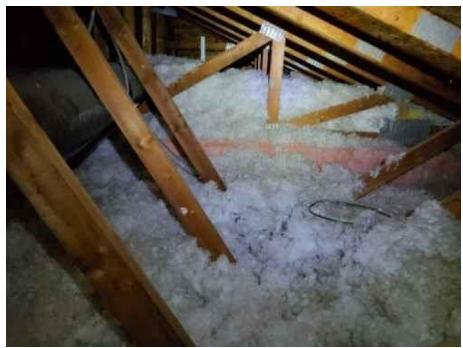
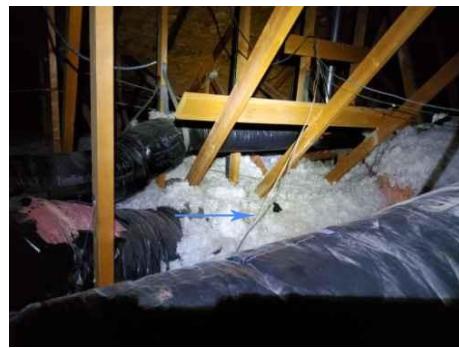
Attic insulation in colder climates like Utah should be around 14 to 16 inches deep. The insulation is about 16 inches deep.

There's a water stain in the insulation. It was not wet at the time of the inspection. It looks as though it would have come from an old turtle vent which has been replaced. Continue to monitor, if condition deteriorates contact a qualified contractor.

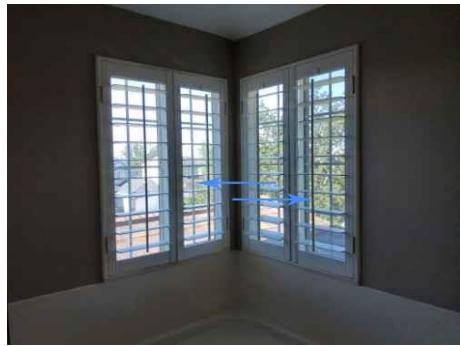
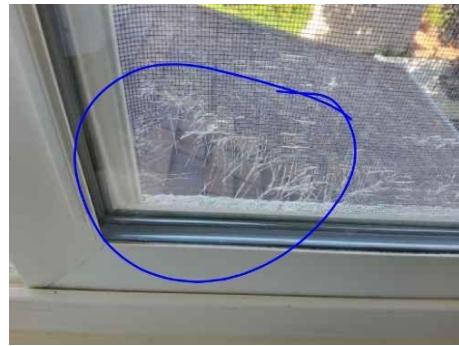
The west window screen is falling apart and the south window is missing the screen. Recommend repair/replacement by a qualify window contractor.

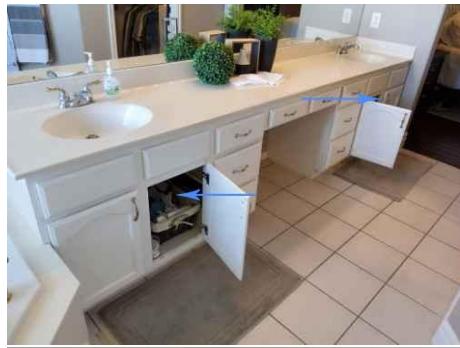
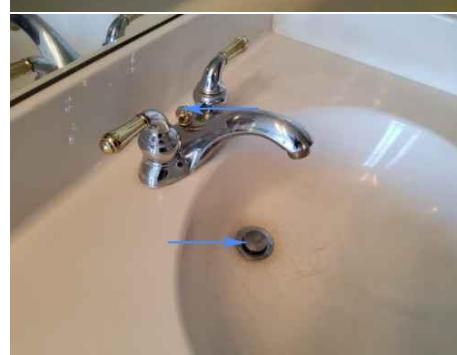
I am unable to turn some of the shut-off valves on the supply lines. They should turn very easily. I do not attempt to force them because they may break.

The north sink is starting to crack.

The stopper on the north sink does not function properly. It does not stop the water from going down the drain.

Recommend further evaluation from a qualified plumber or handyman.

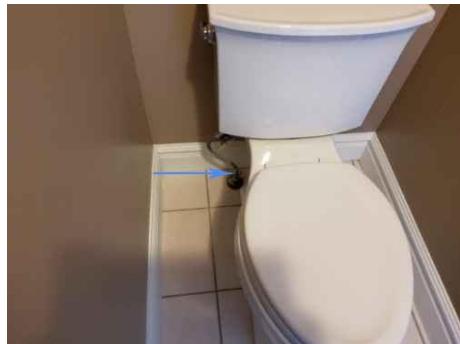
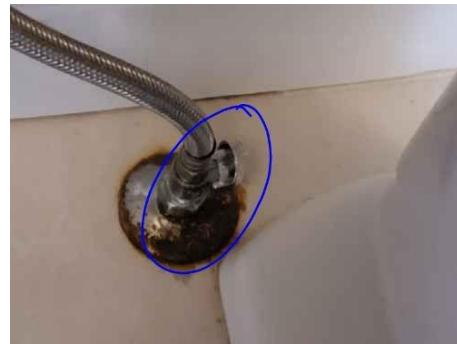
I am unable to turn the shut-off valve on the supply lines. They should turn very easily. I do not attempt to force them because they may break.
Recommend further evaluation from a qualified plumber or handyman.

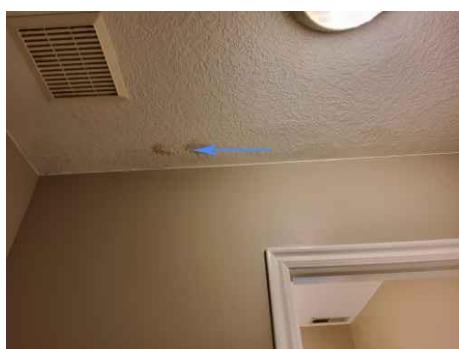
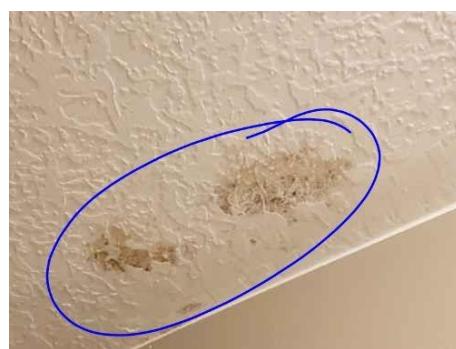
The ceiling in the room above the toilet has the appearance of mold growth. Recommend treating with mold control.

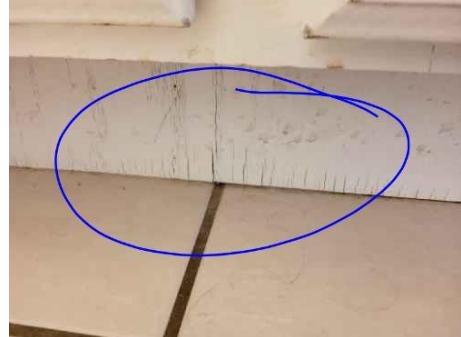
The base of the cabinets have signs of water damage. It was not wet at the time of the inspection. Continue to monitor, if condition deteriorates contact a qualified contractor.

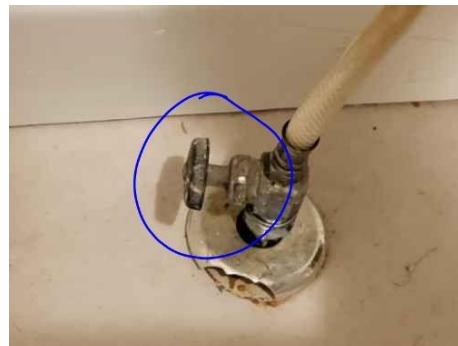
I am unable to turn the shut-off valve on the supply lines. They should turn very easily. I do not attempt to force them because they may break.

Recommend further evaluation from a qualified plumber or handyman.

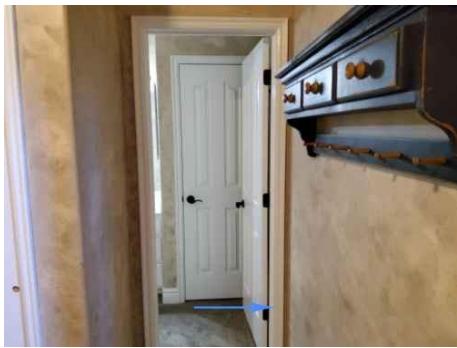
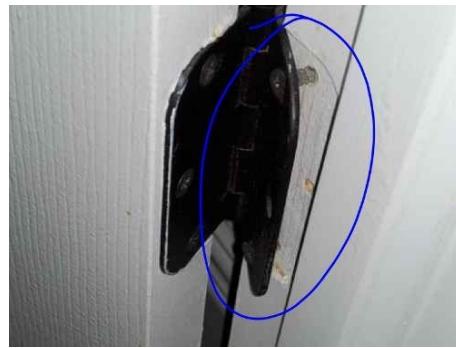
The bottom hinge is loose. Recommend repair/replacement by a homeowner or handyman.

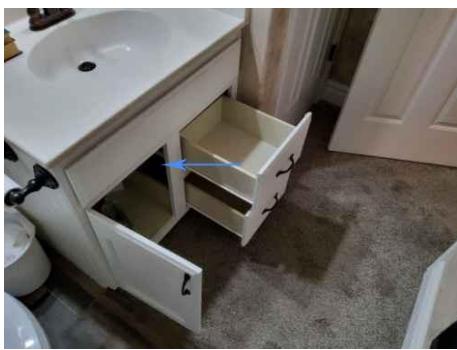
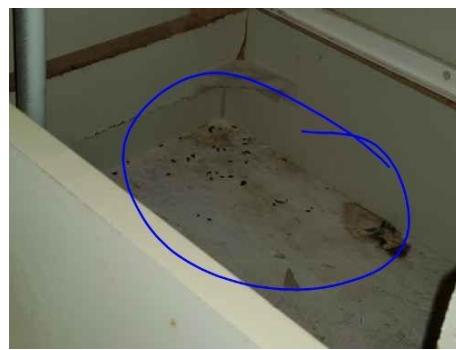
There are mouse droppings under the sink behind the drawers.
Recommend further evaluation/repairs by a qualified pest contractor.

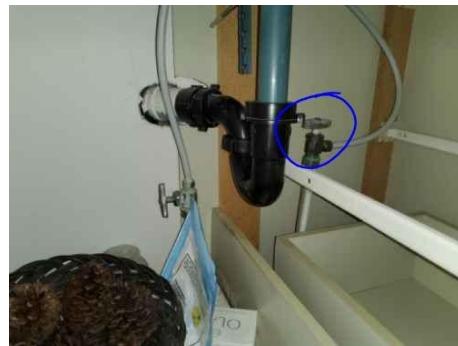
I am unable to turn the shut-off valve on the supply lines.
They should turn very easily. I do not attempt to force them because they may break.
Recommend further evaluation from a qualified plumber or handyman.

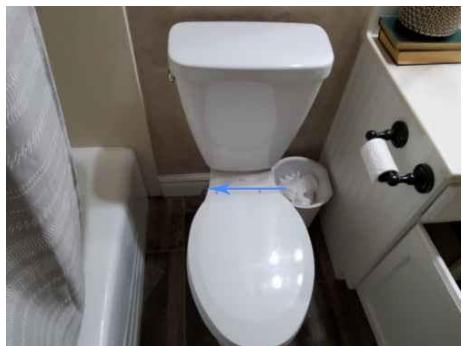
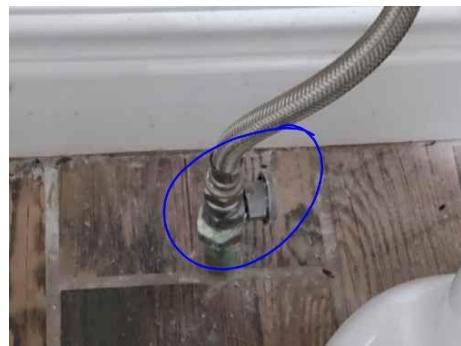
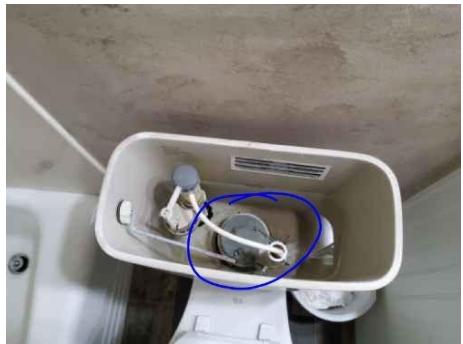
I am unable to turn the shut-off valve on the supply lines. They should turn very easily. I do not attempt to force them because they may break.

The flapper inside the tank is not functioning properly which is allowing water to go inside the toilet bowl constantly and will cause the toilet to continually flush on its own.

Recommend further evaluation from a qualified plumber or handyman.

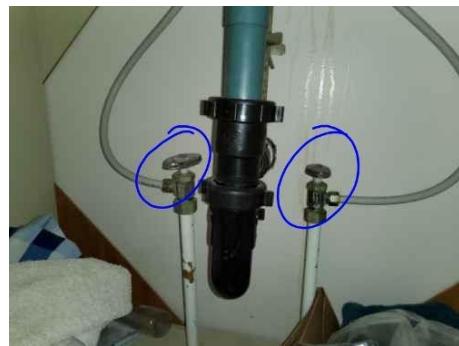
I am unable to turn the shut-off valve on the supply lines.
They should turn very easily. I do not attempt to force them because they
may break.
Recommend further evaluation from a qualified plumber or handyman.

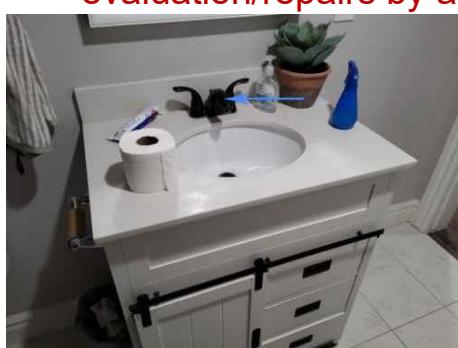
When I turn the hot water onto the sink I could hear what sounded like pipe banging and then the water just turned off. The water would then turn on in short bursts and then off again. Recommend further evaluation/repairs by a qualified plumbing contractor.

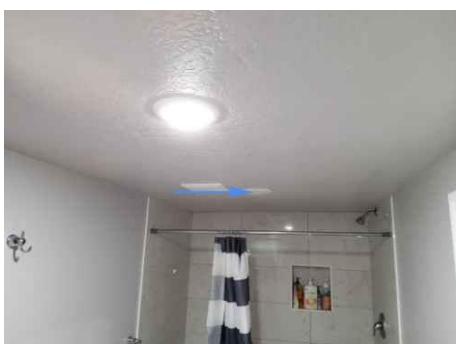
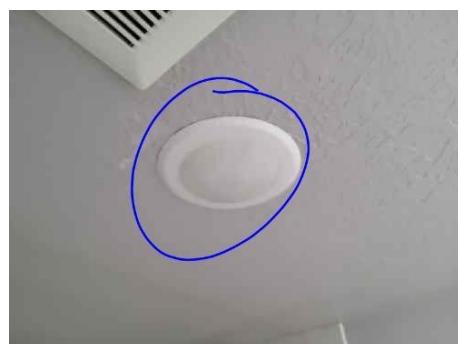
The light by the shower does not work. If it does not work after changing the bulb, recommend contacting a qualified electrician.

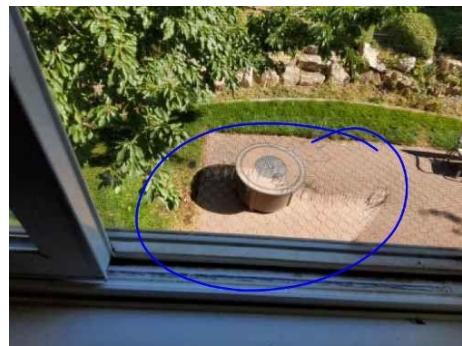
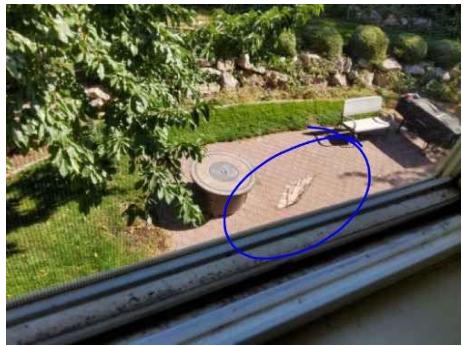
Both the window screens are falling apart. Recommend repair/replacement by a qualify window contractor.

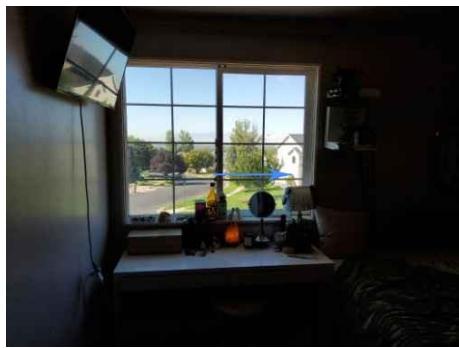
The window is missing the screen. Recommend repair / replacement by the homeowner or qualified window contractor.

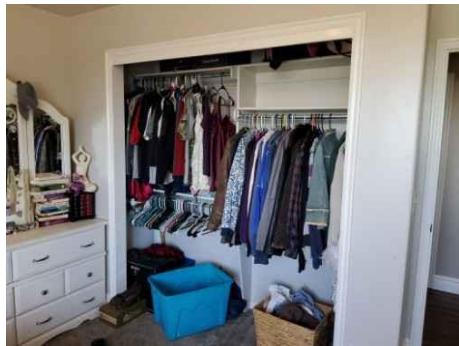
The doors are missing from the closet. Recommend repair / replacement by a homeowner or handyman.

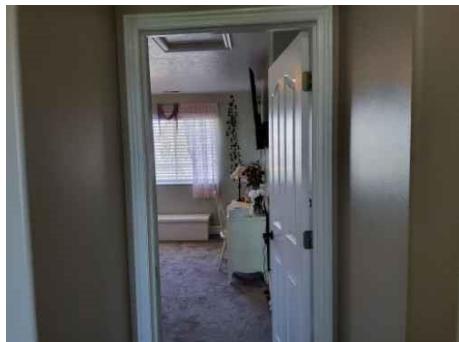
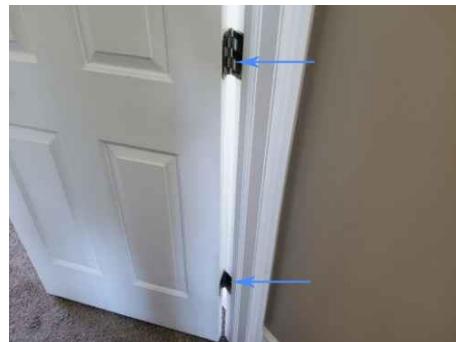
The hinges are loose. Recommend repair/replacement by a homeowner or handyman.

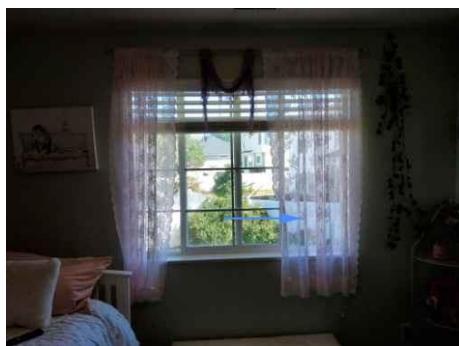
The window is missing the screen. Recommend repair / replacement by the homeowner or qualified window contractor.

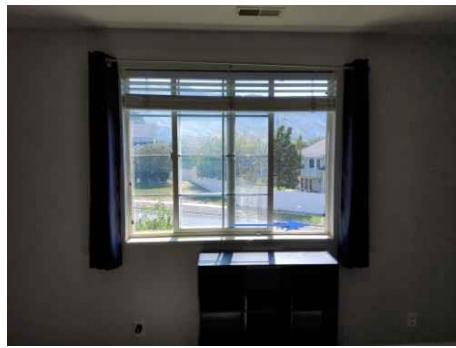
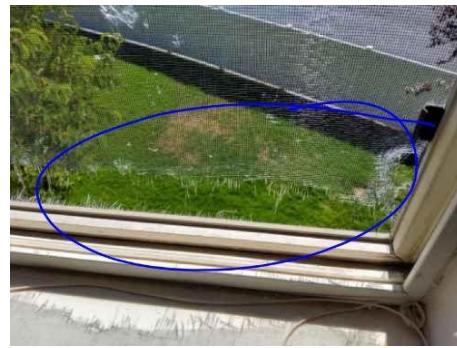
The window screen is falling apart. Recommend repair/replacement by a qualified window contractor.

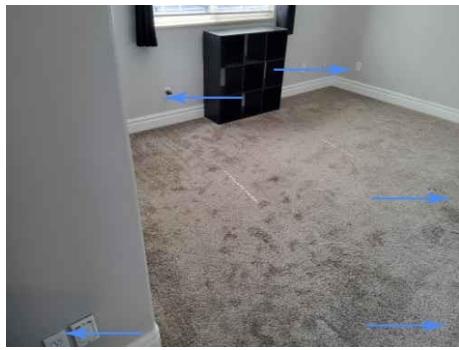
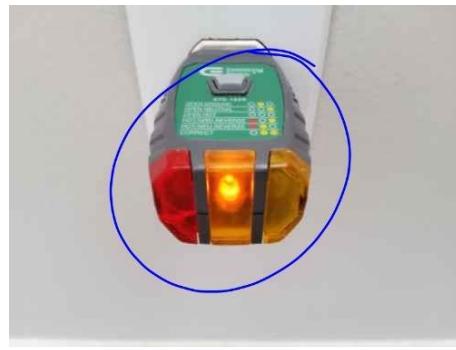
All the outlets indicate an open ground.

Recommend further evaluation from a qualified electrician.

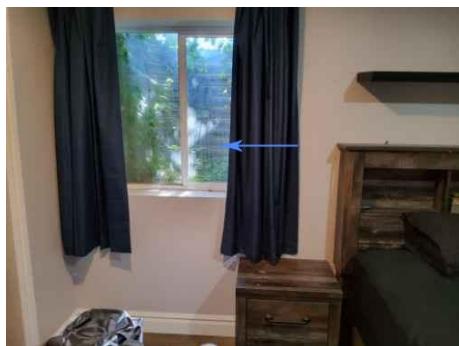
The window is missing the screen. Recommend repair / replacement by the homeowner or qualified window contractor.

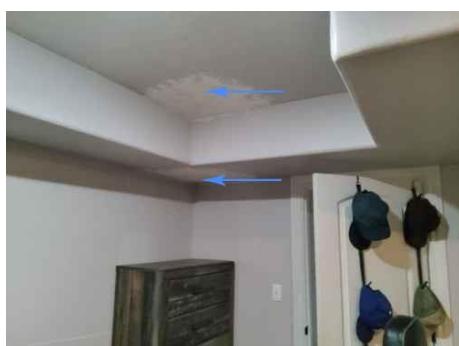
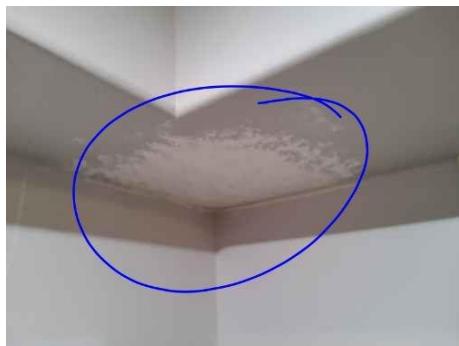
There are repairs in the ceiling by the door. It was not wet at the time of the inspection.

Recommend asking the current owner what caused the ceiling repair.

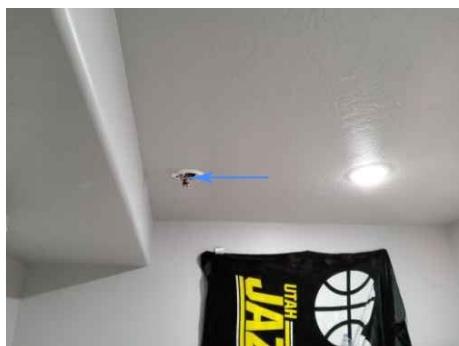
The smoke alarm is missing from this bedroom. Recommend replacing it.

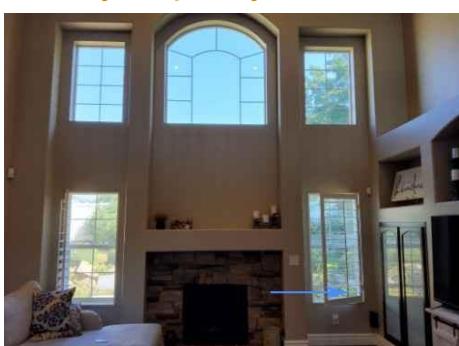
The east window screen is falling apart. Recommend repair/replacement by a qualify window contractor.

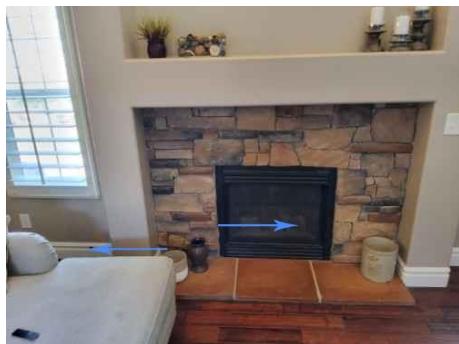
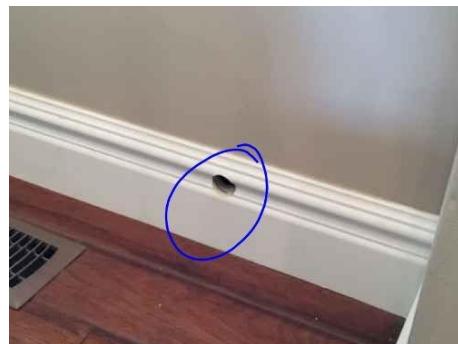
FIREPLACE Poor

I was unable to get the fireplace to ignite. There is a key slot in the wall to the left of the fireplace to turn the gas on. It was turned on but I was still unable to ignite the fireplace.

Recommend further evaluation/repairs by a qualified fireplace contractor or handyman.

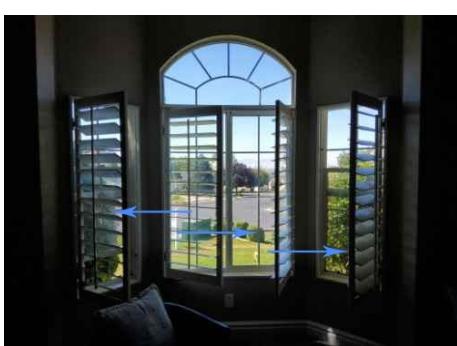
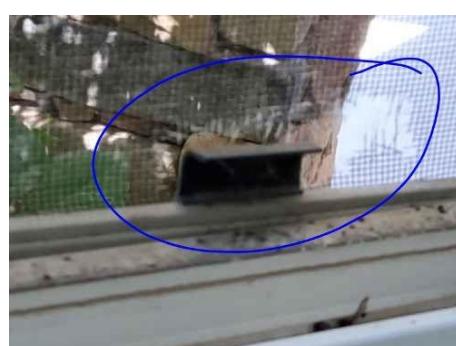
The center window is missing the screen and the frame is falling apart.

Recommend repair / replacement by the homeowner or qualified window contractor.

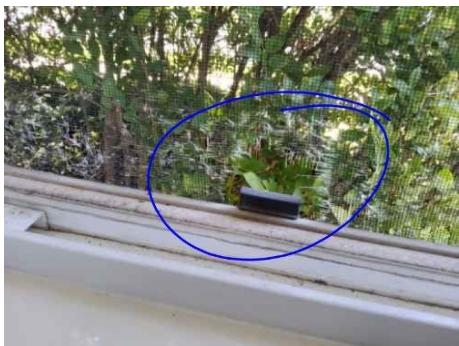
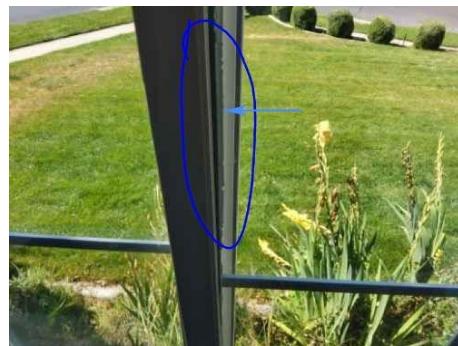
The side window screens are falling apart.

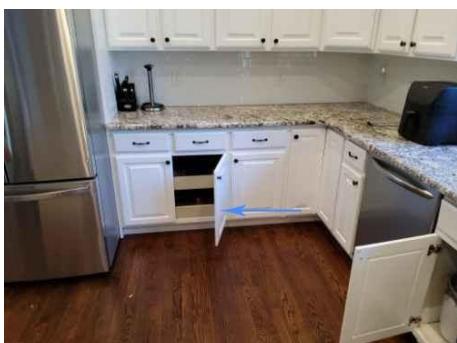
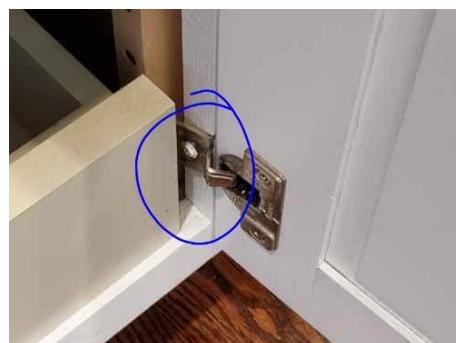
CABINETS Fair

The bottom hinge is loose on the cabinet door to the right of the refrigerator.

The bottom hinge is damaged in the bottom cabinet of the room between the kitchen and the den.

Recommend repair/replacement by a homeowner or handyman.

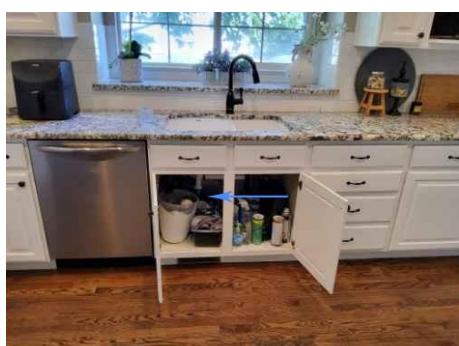
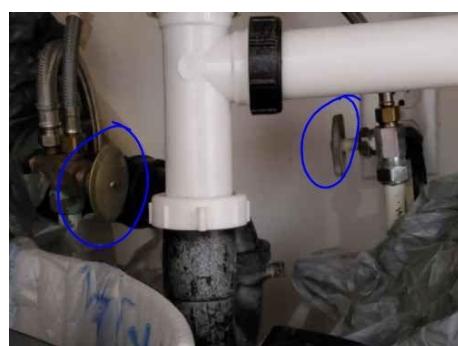
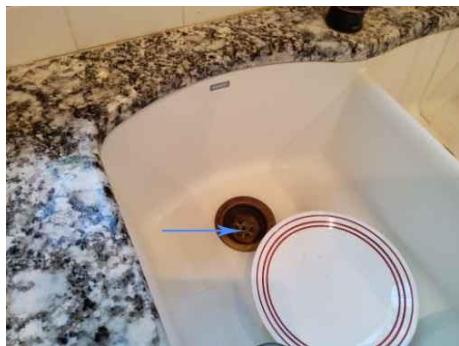
I am unable to turn the shut-off valve on the supply lines. They should turn very easily. I do not attempt to force them because they may break.

The left sink drains slowly.

Recommend further evaluation from a qualified plumber or handyman.

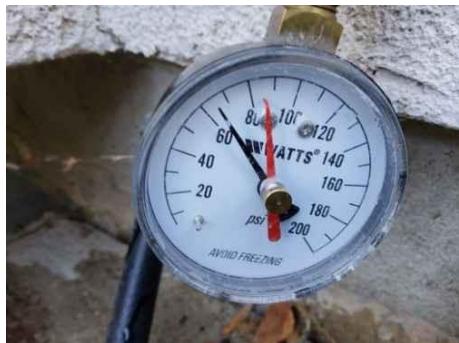
The water pressure should be between 30 and 80 psi. The water pressure is about 65 psi.

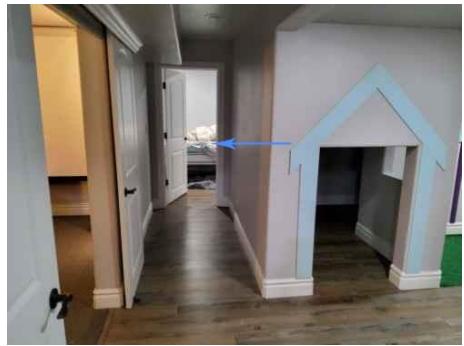
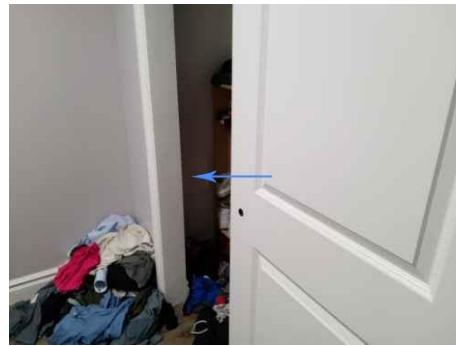
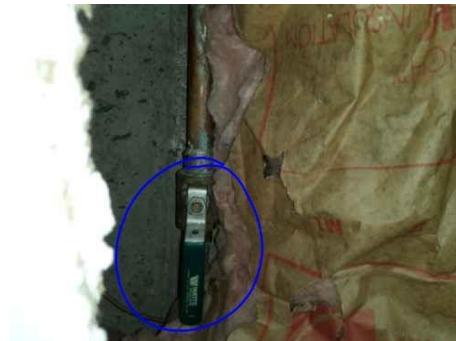
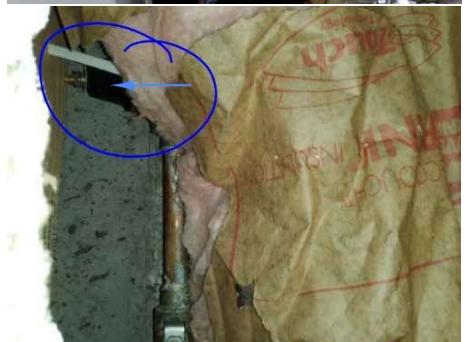
The main shutoff valve for the water is located in the east basement bedroom closet. The water pressure regulator/adjustment valve is directly above it.

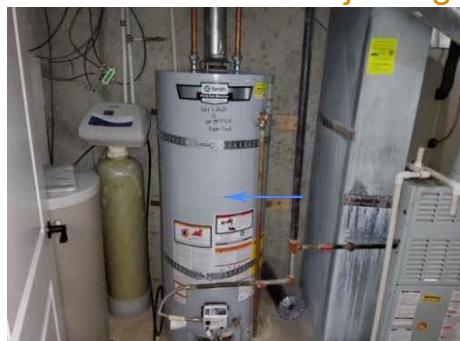
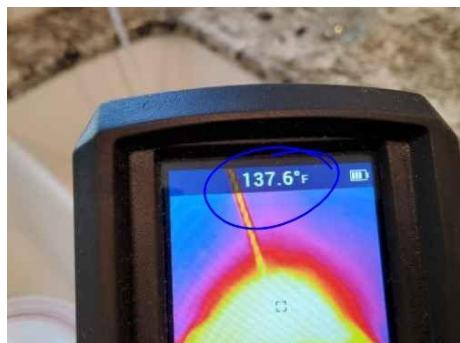
The typical maximum temperature of water from a water heater should be around 120 degrees. The water temperature is about 137.6 degrees.

Recommend adjusting the water temperature to 120 degrees or below.

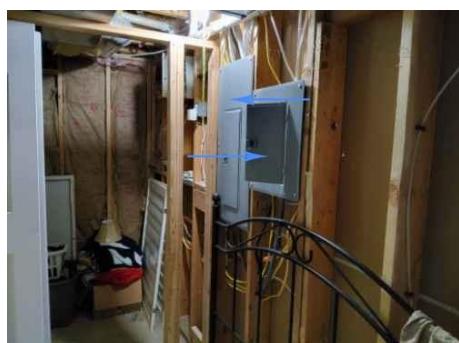
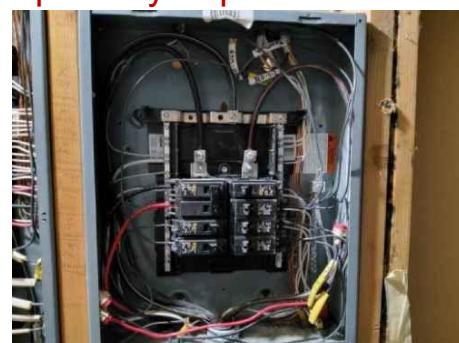
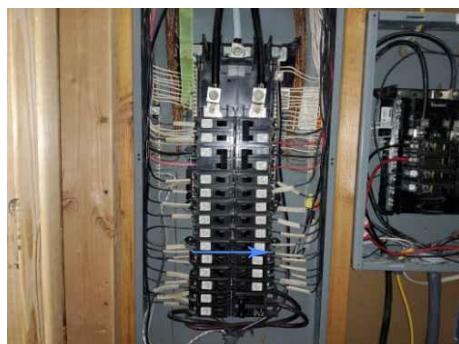
Some wires on the bottom right side (about 4 & 5 up) in the large circuit panel look burned as though they have been arcing.

Recommend further evaluation/repairs by a qualified electrical contractor.

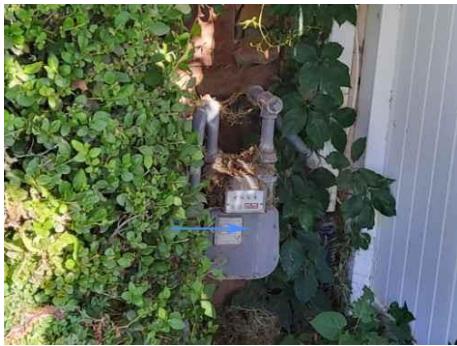
The gas meter is located outside on the east side of the house.

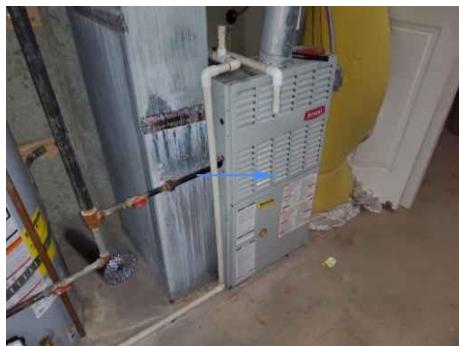
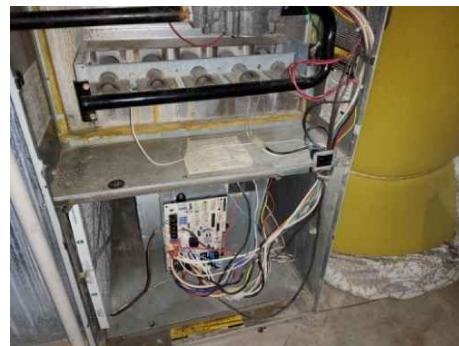
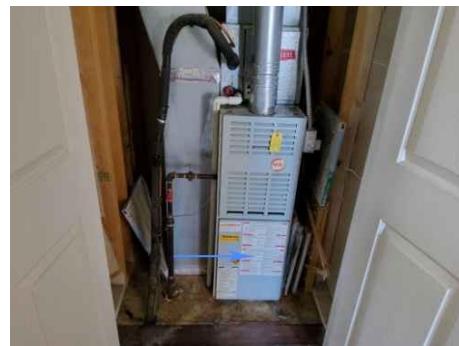
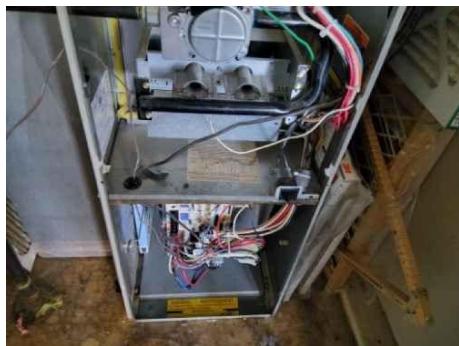
The furnace equipment is near the end of its service life.

Recommend annual maintenance and cleaning of the furnace.

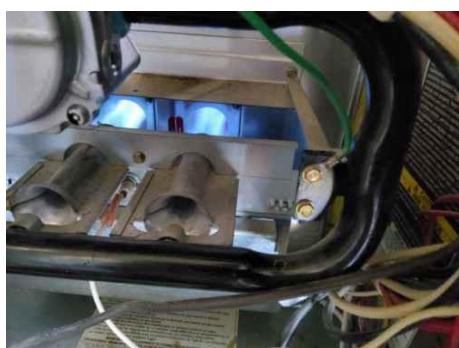
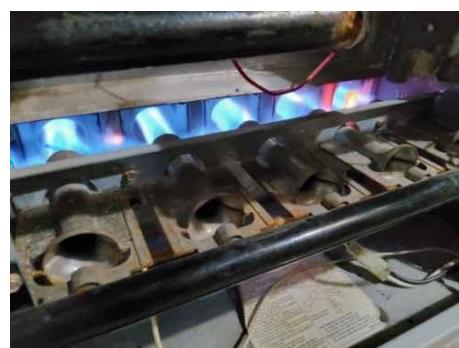
Both heating systems were functioning properly at the time of the inspection.

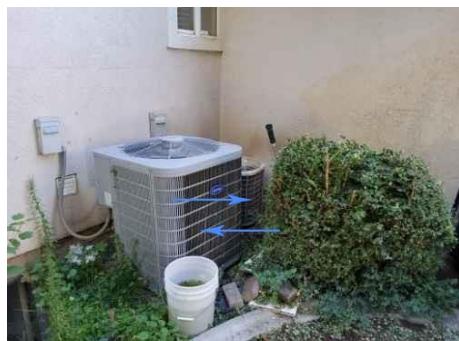
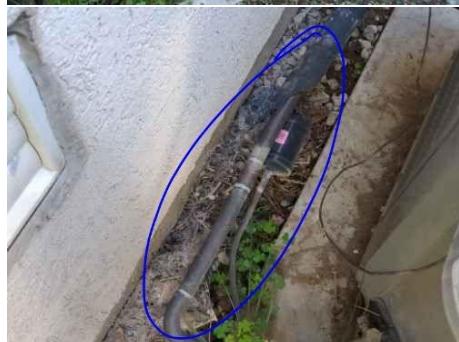
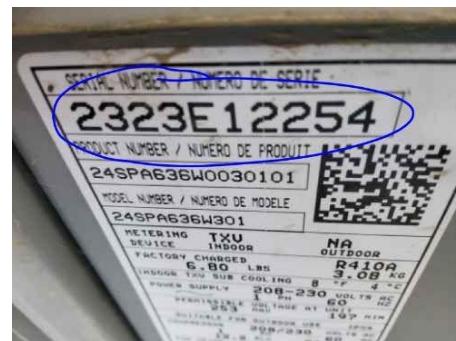
The north air conditioner is about 2 years of age.

The insulation on the north air conditioning unit tubing is falling apart.

The south air conditioner is about 27 years of age.

The south air conditioning equipment is near the end of its service life.

Recommend further evaluation/repairs by a qualified HVAC contractor or handyman.

Recommend keeping weeds and debris away from the condenser unit.

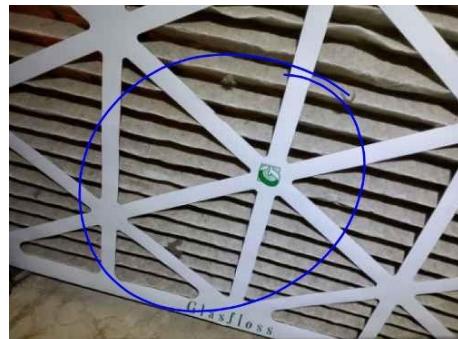
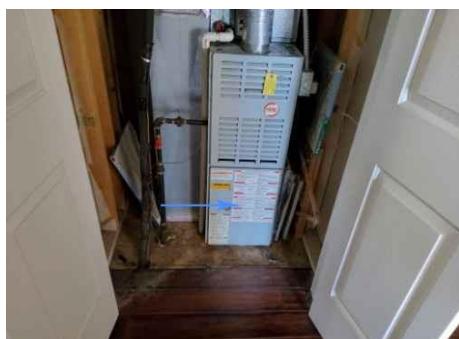
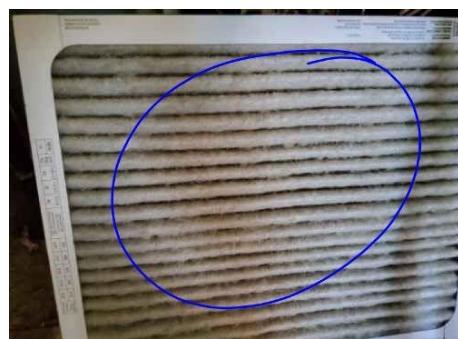
Both air filters need to be replaced.

Filthy air filters can lead to clogged evaporator coils, poor air flow and premature failure of the furnace and air conditioning equipment. When installing an air filter, ensure the arrow on the filter is facing the furnace.

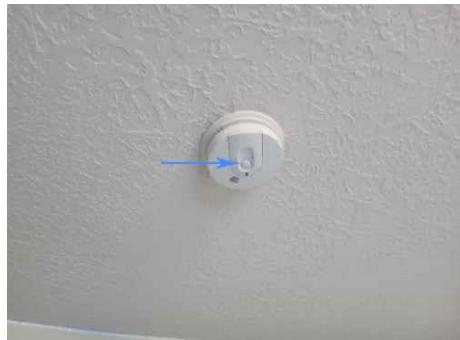
Only a couple smoke alarms were inspected. Recommend checking all the smoke alarms in the house and replacing if necessary.

Recommend replacing the smoke alarm(s)

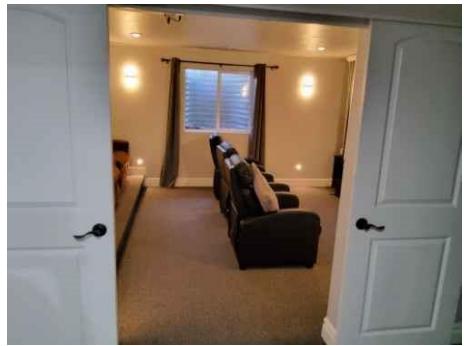
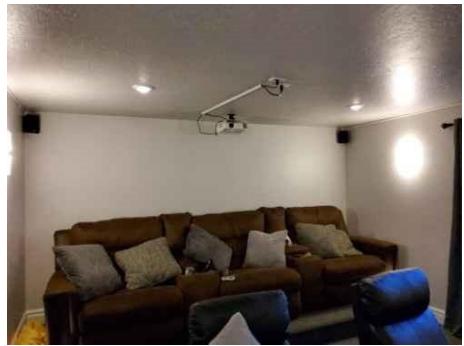
The window is missing the screen. Recommend repair / replacement by the homeowner or qualified window contractor.

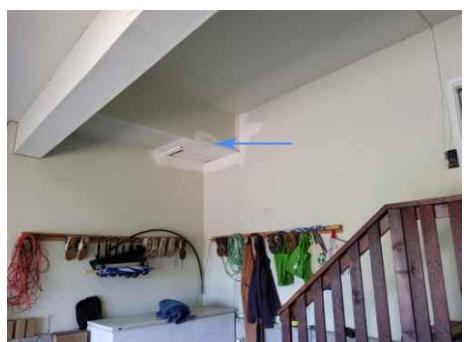
There are water stains and water damage on the ceiling of the garage. It was not wet at the time of the inspection. Recommend asking the current owner the cause of the water damage.

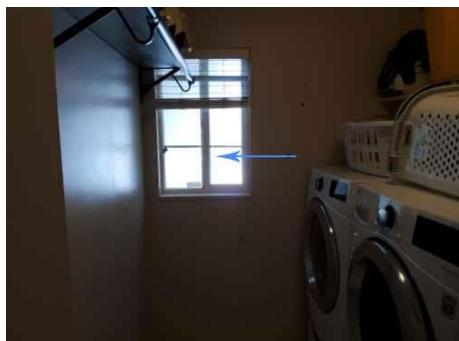
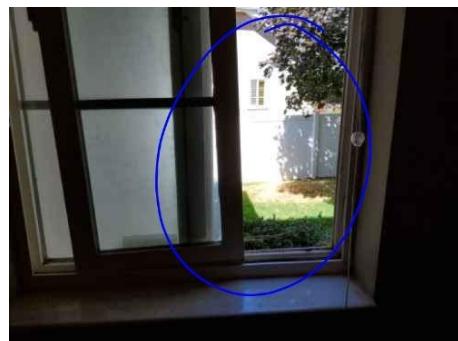
LAUNDRY ROOM Fair

The window is missing the screen. Recommend repair / replacement by the homeowner or qualified window contractor.

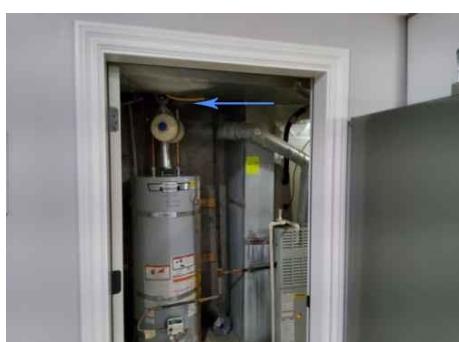
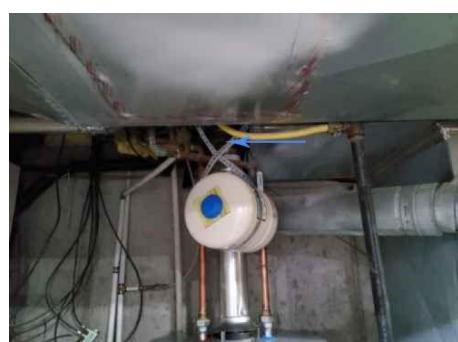
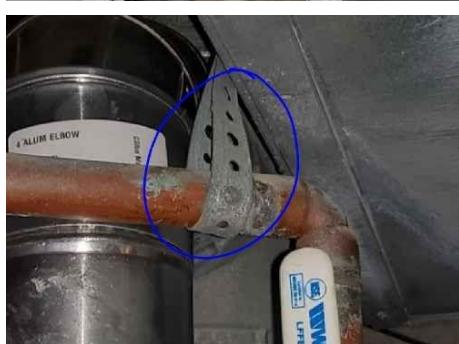
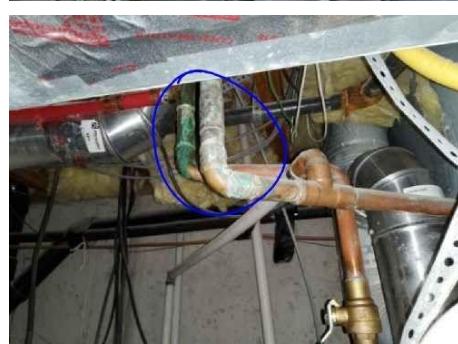
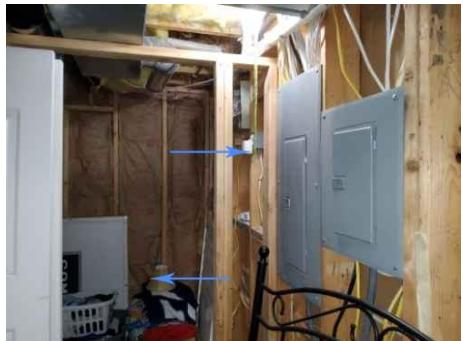
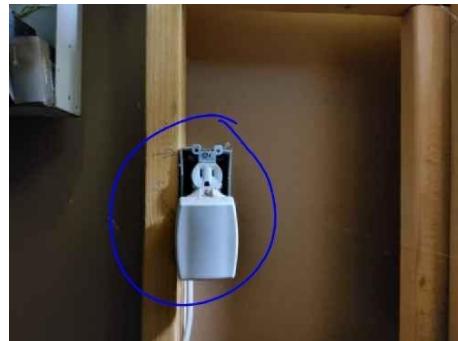
FURNACE ROOM Poor

Copper piping should not touch galvanized materials. This causes what is called galvanic corrosion and will damage the copper pipe.

Some of the copper pipe coming off the water heater has corrosion on it. Recommend repair from a qualified plumbing contractor.

Some electrical boxes are missing the cover plate.

Recommend repair / replacement by a homeowner or handyman.

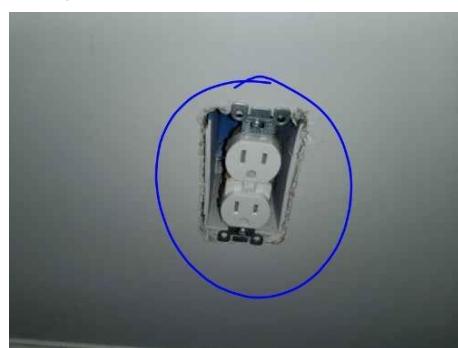
The electrical box is missing the cover plate.

Recommend repair / replacement by a homeowner or handyman.
