**Final Investigation Report of Abnormal Runway Contact Incident to
M/s.Trujet ATR72 aircraft, Registration VT-TMM on 16/11/2020 at Mysuru Airport**

Synopsis

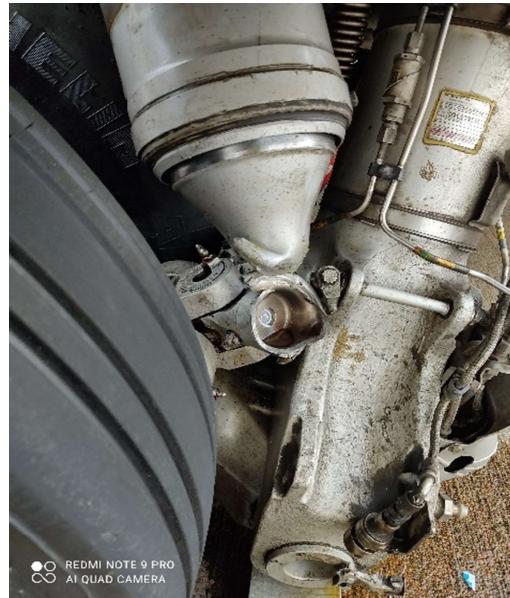
2. RH MLG shock absorber found sheared at bottom attachment (Trailing arm end) and its internal center rod component detached in Mysore.

Analysis report states that the presence of slant, fibrous and distortion features available on the fracture surface of the RH-MLG's piston rod, door's tie rod, door attachment lugs, centre rod and retaining bolt at shock absorber upper attachment end are indicative of overload failure of the components. The presence of dimple features seen on the fracture surfaces of the mentioned components under Scanning Electron Microscope (SEM) examination confirms that the components have failed in overload condition.

14. RH MLG's shock absorber bottom side nearby pivot joint got damaged. The center rod of the shock absorber and the RH MLG door found detached along with tie rod and found at the Mysuru airport touch down area. RHMLG components have failed in overload condition.

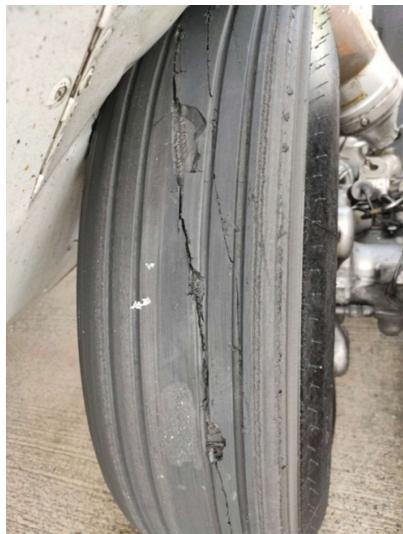
3. Scratch markings No # 3 MW tyre.

Landing Gear was not able to retract due to damage of hydraulic line. The crew flew the aircraft with landing gear down configuration to Chennai. With the broken RHMLG's shock absorber and the trunnion leg, trailing arm found distorted and leaning forward condition, during the landing roll could have resulted in #03 tyre rubbing and denting the AFT fairing structure.

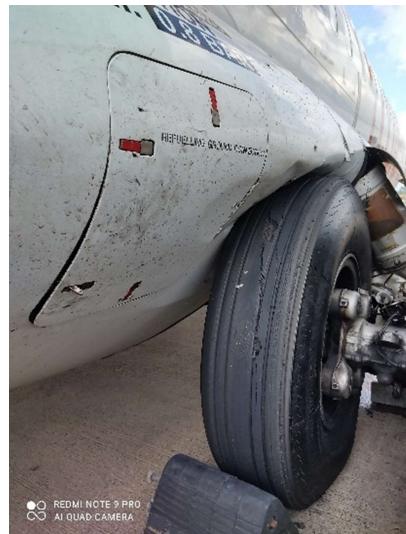
- 4.Damaged AFT fairing structure

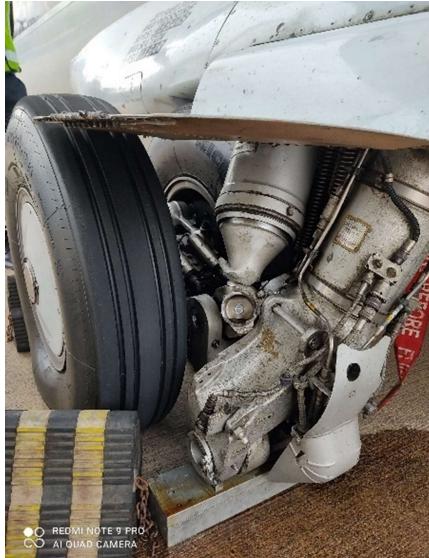
5. Trunnion leg and trailing arm found distorted & mechanically touching each other and whole LG assembly leaned forward.

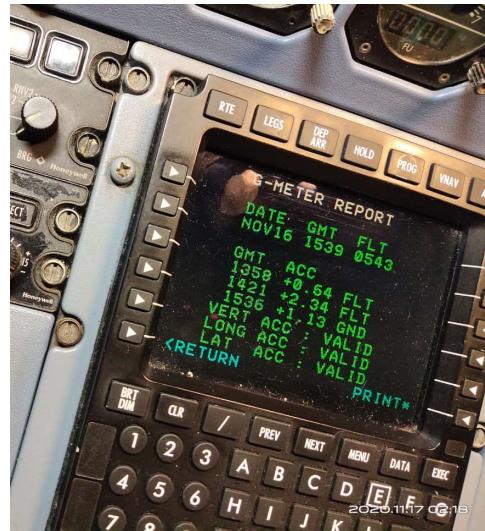
Aircraft G-Meter Report

Difference between G-meter Report of 2.34G and DFDR data of 5.2G was clarified by ATR that the limits of the G-meter reported is +/-5G via the MCDU and the system will not display a value above the +/-5G. In this case, it took the previous value recorded that was 2.34G.
