**FINAL INVESTIGATION REPORT  
ON  
TAIL STRIKE INCIDENT OF M/S INDIGO A321 NEO AIRCRAFT VT-IML  
OPERATING FLIGHT 6E-203 ON 14.04.2023 AT NAGPUR.**

**DIRECTORATE GENERAL OF CIVIL AVIATION**  
OPPOSITE SAFDARJUNG AIRPORT, AUROBINDO MARG, NEW DELHI-110003

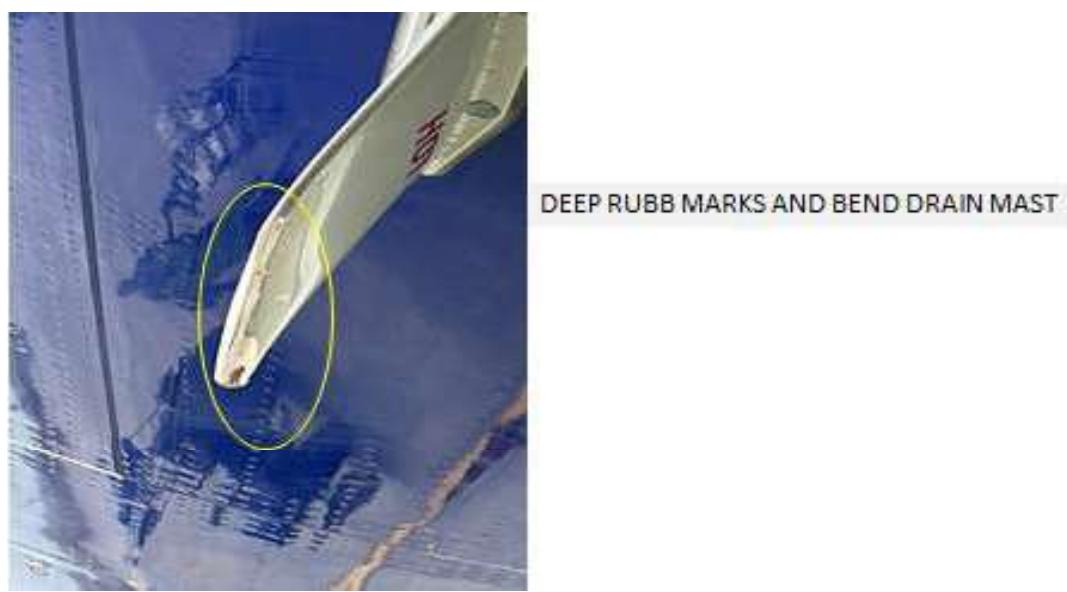
3. Drain mast installed on the skin found bent and rubbed.

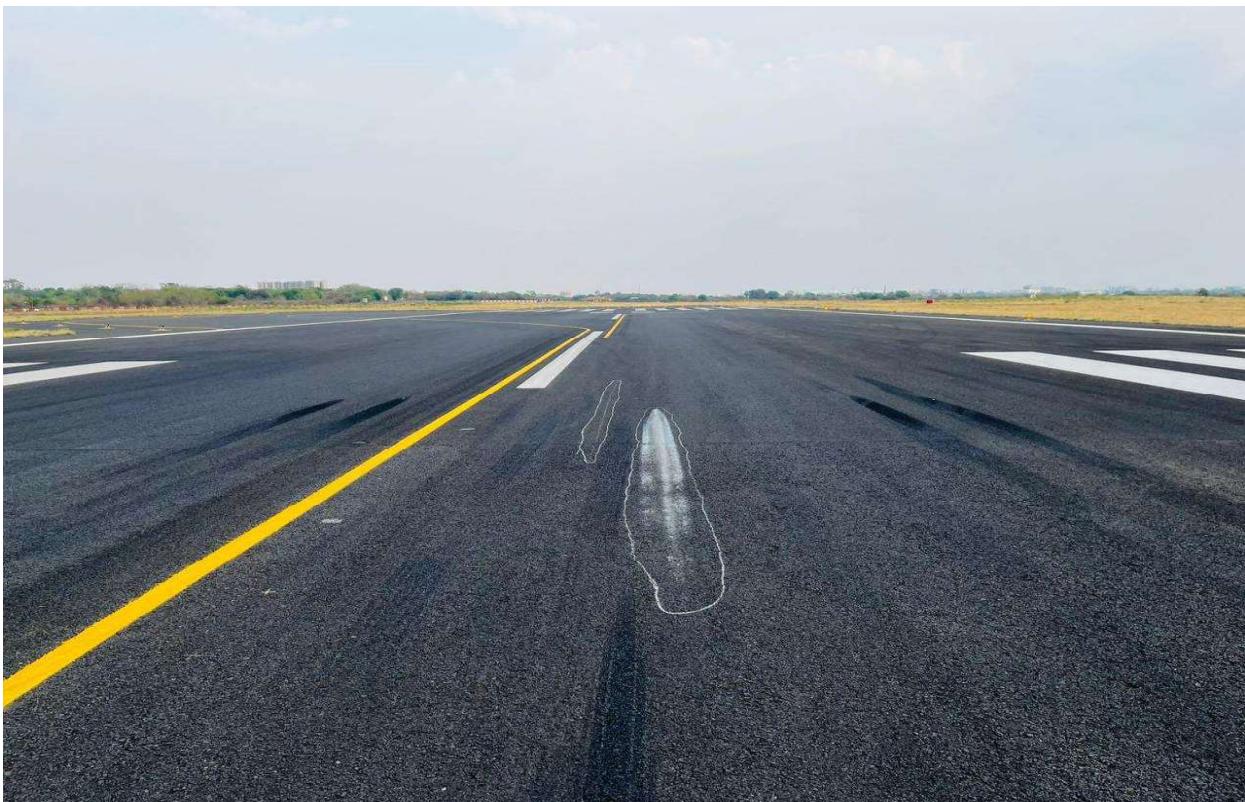
Runway inspection revealed that marks on runway abeam taxiway A where the tail of the aircraft touched the runway surface. There were 02 Nos. marks on the runway. First mark was white in colour at 157m from Runway 32 threshold and was about 8.90m long and 10cm wide. Second mark was light white-bluish colour (appears to be aircraft colour) which was at a distance of 161.80m from the Runway 32 threshold and was about 8.30m in length and 32 cm in width. Main landing gear impressions were also found in the said area. However, runway surface was in intact condition.
