**Final Investigation Report on Incident of EGPWS Warning to  
M/s Indigo Airbus  
A-320 aircraft VT-IGK on 27.02.2016  
while operating flight No. 6E-237 (Ahmedabad-Jaipur)  
on 27.02.2016**

**O/o Director Air Safety(NR),  
Safdarjung Airport, New Delhi-03**

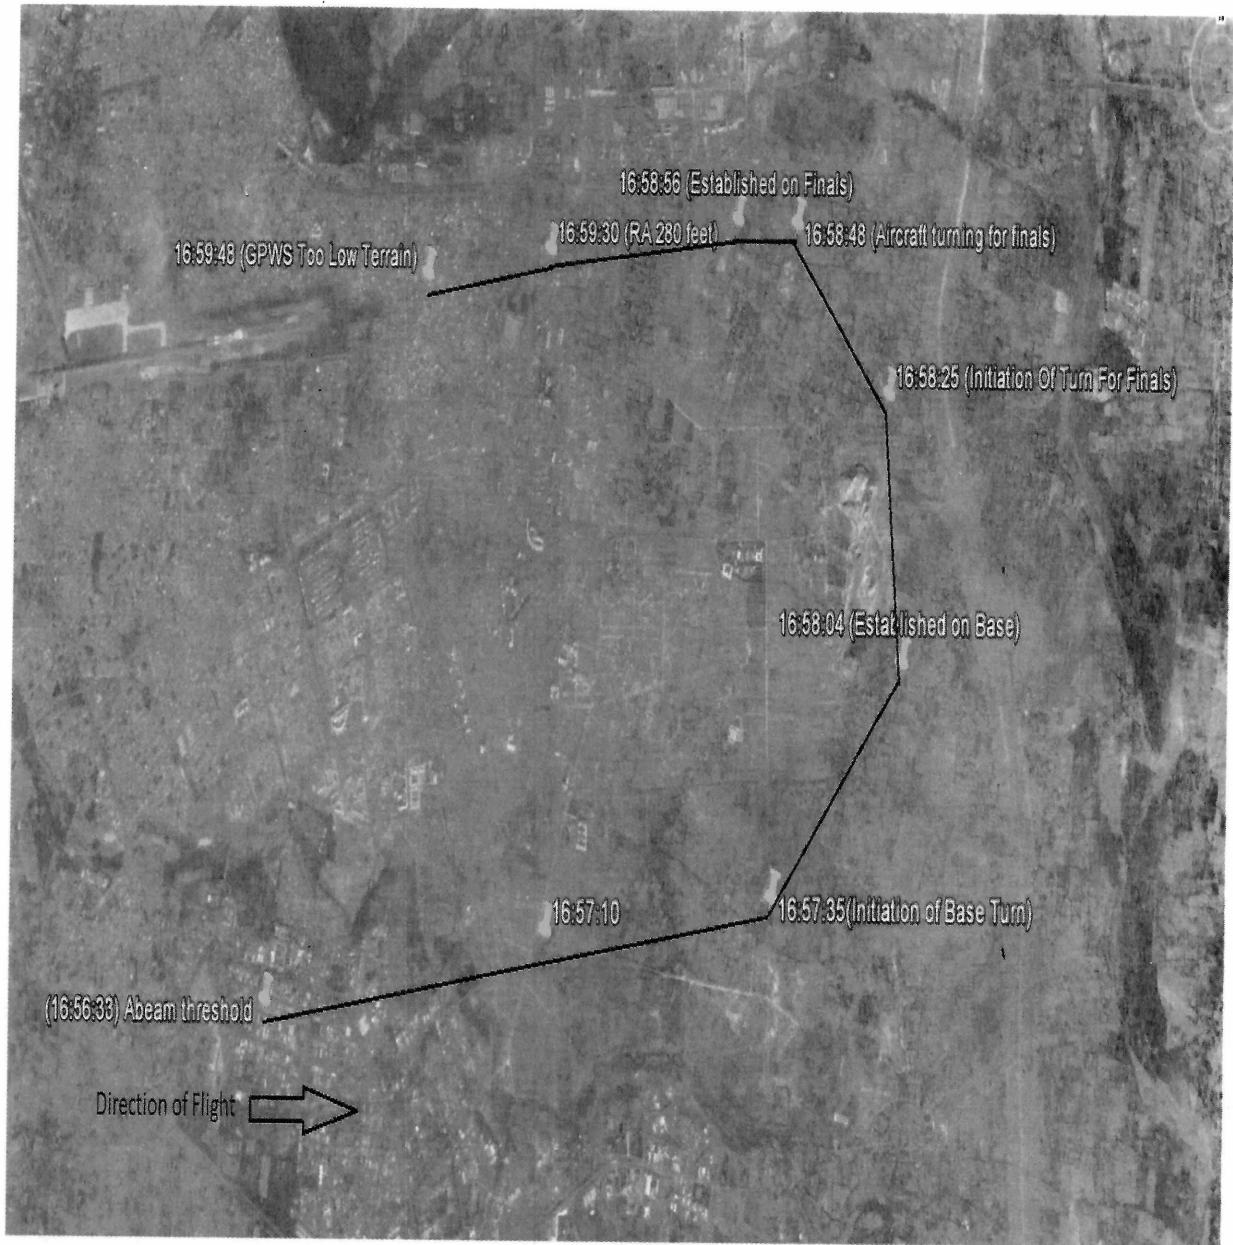
**Fig.1: Progress of Flight: from abeam Threshold R/W 27 to the point EGPWS warning was triggered.**

- At 3 NM from threshold, aircraft was at 480 feet RA with ROD continuously decreasing.
- Aircraft took approx. 39 seconds to descend from 400 feet RA to 200 feet RA.

- At approx. 1.7 NM from threshold, aircraft was at 250 feet RA and aircraft leveled off for approx. 10 seconds.
- At approx. 1.27 NM from threshold, aircraft was at 200 feet RA when EGPWS “Too Low Terrain” Warning was triggered.

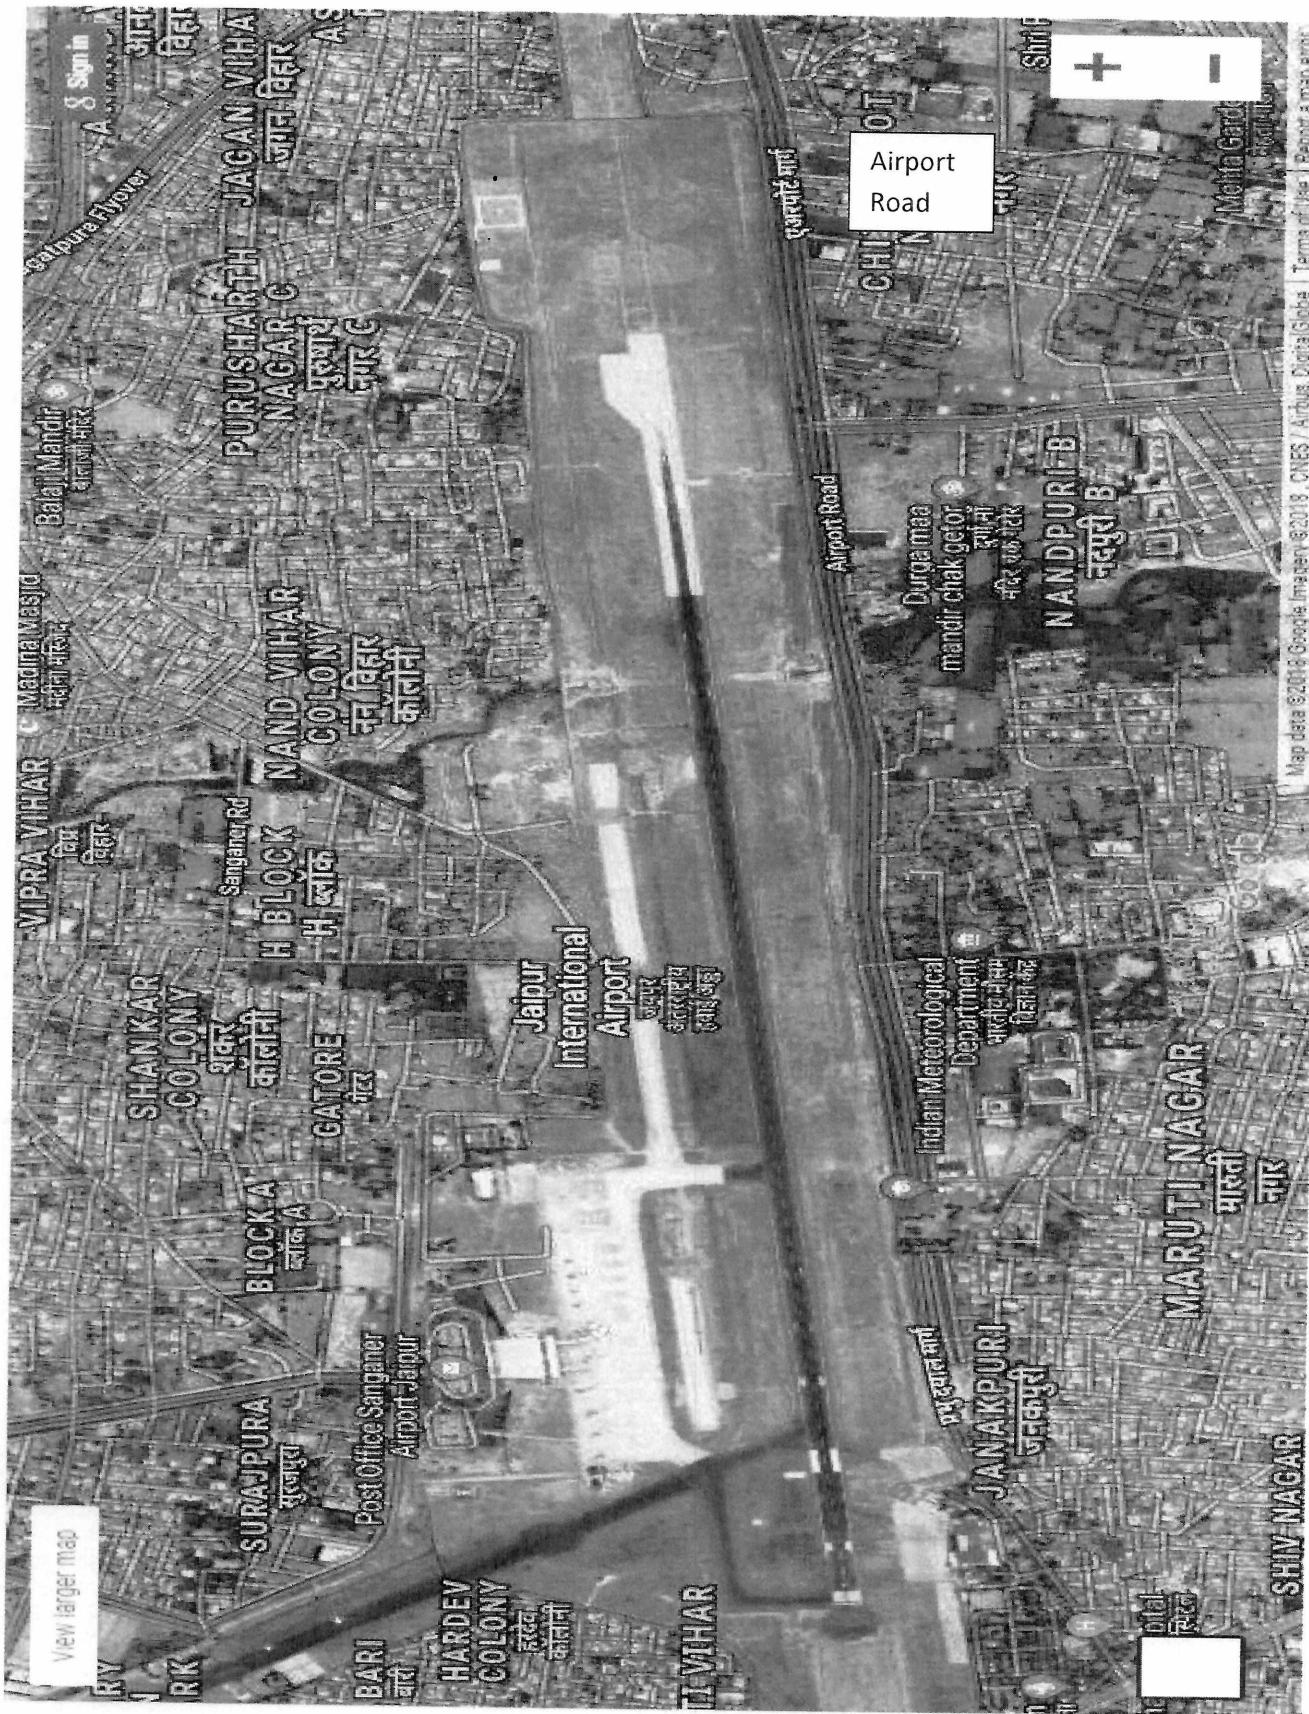
- 1.10.2 There is a city road 200ft wide running parallel to the runway 27 towards its left. The road is at approximately 380 meters away from center line of runway 27. The road is not straight and has traffic lights. There is a road divider running through the center of the road along its length.
- 1.10.3 There is no defined circuit pattern & Circuit altitude at Jaipur however MSA is 3600 feet.

Fig. 2 Position of Airport Road with respect to R/W

Jaipur airport is covered under the exception of sub para (a) and (b). The crew was roistered to operate to Jaipur after a gap of approximately two years. Due to lack of familiarity coupled with the Hazy conditions, The PIC mistook a wide road parallel to runway 27 on its left side as the runway.
