**FINAL INVESTIGATION REPORT ON RUNWAY EXCURSION INCIDENT TO
M/s. NAGPUR FLYING CLUB
CESSNA 152 AIRCRAFT, VT-EUK
ON 01.04.2023 AT Dr. BABASAHEB AMBEDKAR INTERNATIONAL
AIRPORT, NAGPUR.**

**GOVERNMENT OF INDIA
OFFICE OF DIRECTOR OF AIR SAFETY (WR)
INTEGRATED OPERATIONAL OFFICE COMPLEX,
SAHAR ROAD, VILEPARLE (E), MUMBAI – 400099**

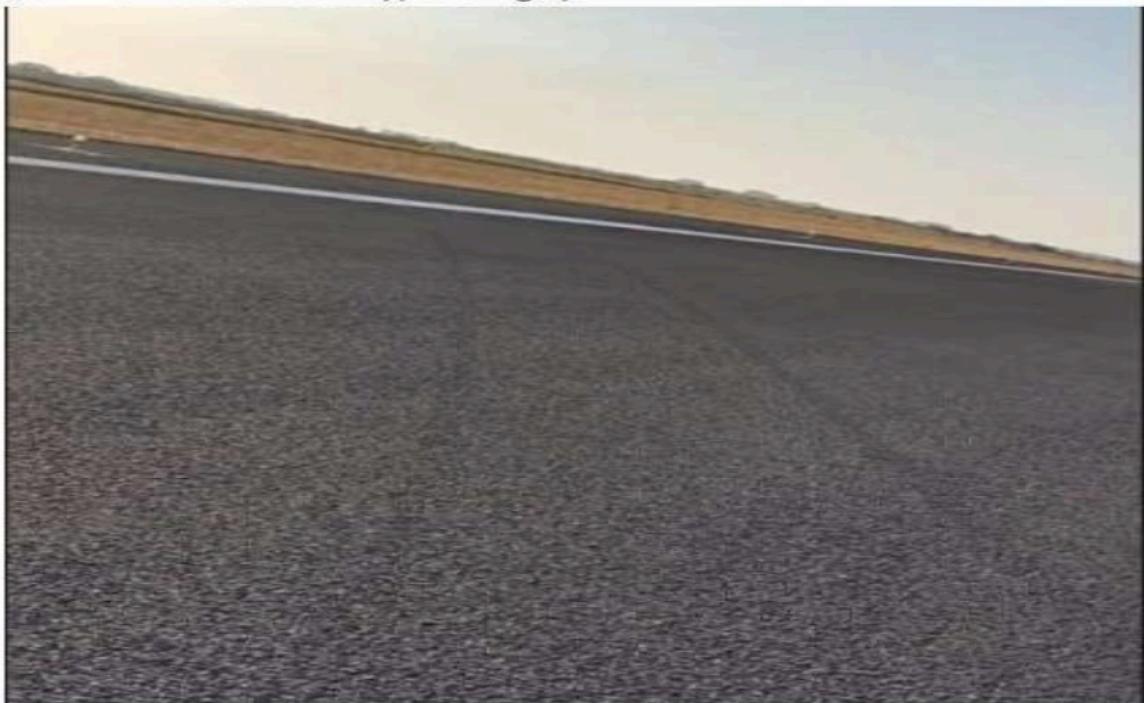
Over threshold, student pilot cut power to idle and flared the aircraft giving correction (right rudder and left aileron) as the winds were from left. Thereafter, the aircraft touched down at slightly left of centerline ($A=400$ m from threshold) on RWY 32. When the aircraft touched down, the student pilot released the nose wherein the rudder position was not neutral so the aircraft started drifting towards left on the runway as the student pilot felt the aircraft going further left, he applied right rudder followed by excessive left rudder. The tire markings($B=500$ m from thresh hold of RWY) show the aircraft moving towards the left of the center line and exiting the edge line just ahead of the A 41 edge light light($C=550$ m from the threshold).(Refer fig 2)

Fig 2: tire markings of aircraft moving towards the edge line of the RWY

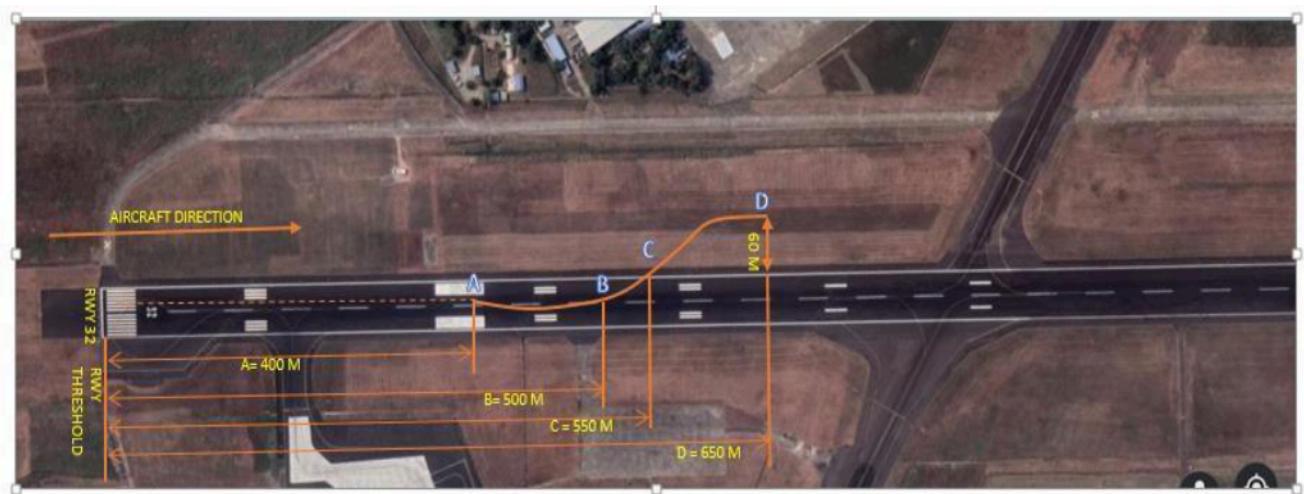
Fig 3: sequential events during landing at RWY 32.

As the aircraft reached left edge of the runway, student pilot applied brakes to stop the aircraft by then the aircraft left wheel was already out of the runway and eventually the whole aircraft had entered unpaved surface and halted at a distance (D=60 m lateral distance from edge line and 650 m horizontal distance from the RWY threshold. (Refer fig 3: sequential events during landing at RWY 32. Further the student pilot switched off ignition and master and informed ATC for assistance.

The student pilot was unable to maintain the aircraft on the RWY centerline while landing resulting in the aircraft touching down slightly left of the runway. This was followed by the student pilot applying left and right rudder inputs as an attempt to align the aircraft with the RWY centerline. The application of excessive left rudder inputs resulted in the aircraft veering towards the left side of the runway.

- Action as deemed fit by DGCA-HQrs in view of the findings.
