## READING IT WRONG

## HOW IT FAILED

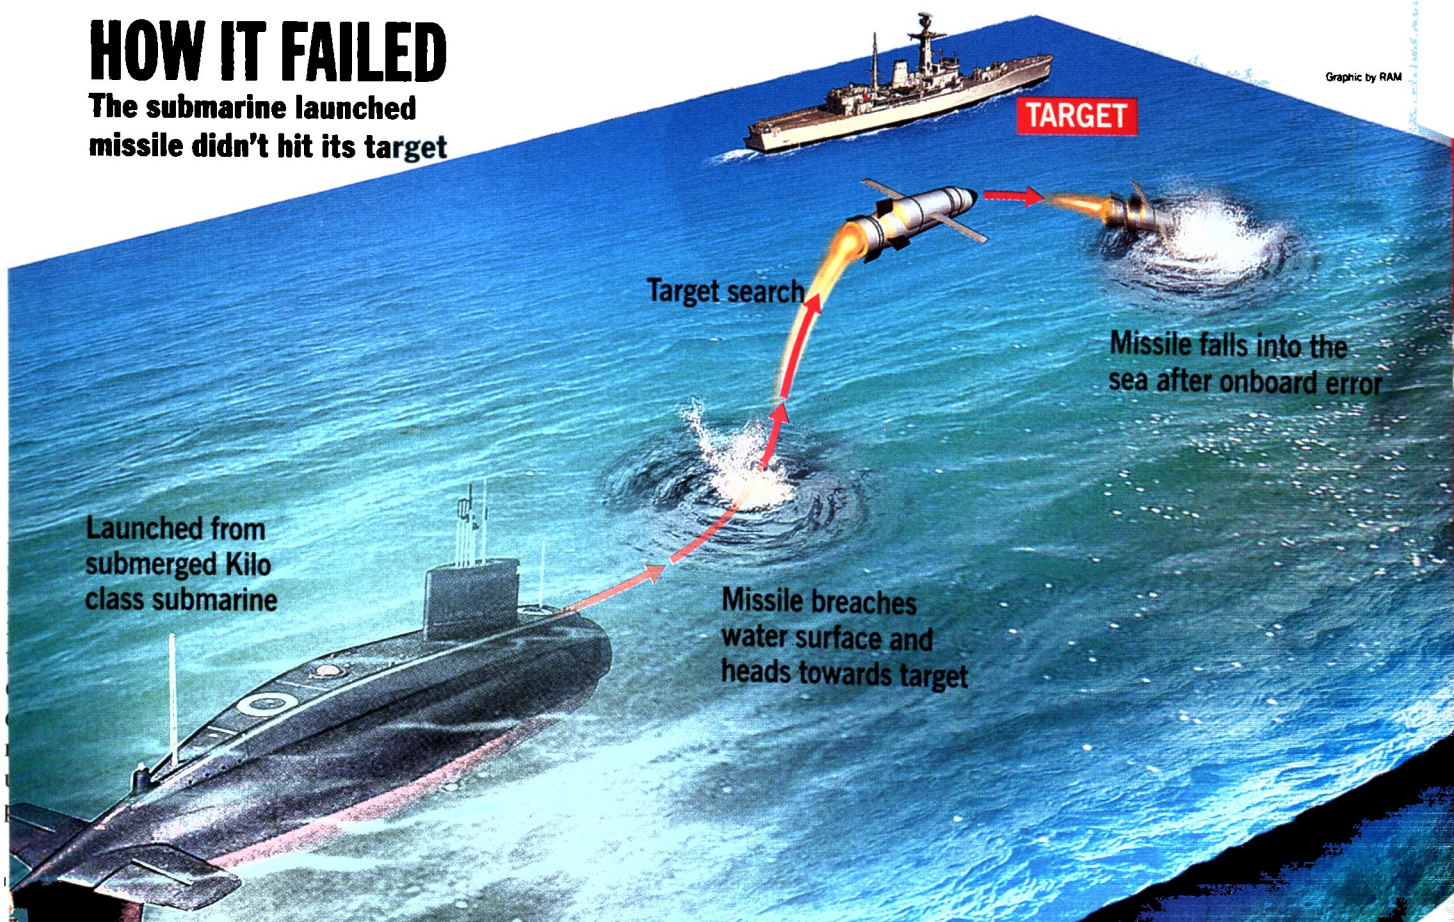
sea surface, the guidance coordinates fooled it into believing it was actually flying at an incline. So the missile's onboard gyroscope stabilised itself. This battle between the onboard coordinates and gyroscope continued several times and the manoeuvres exhausted the missile battery leading to a complete power loss.

■ **THE PROBLEM:** Missile fired from the submarine ditches into water before hitting target.

■ **THE REASON:** Delayed transmission of data between submarine and missile before launch

The submarine launched missile didn't hit its target

■ **THE SOLUTION:** New gyros for all submarines.
