# WHEN DISASTER STRIKES A FALCON

Should we be worrying about Falcon 9's – SpaceX's reusable rocket – latest disaster? Here's everything you needed to know about the fallen Falcon

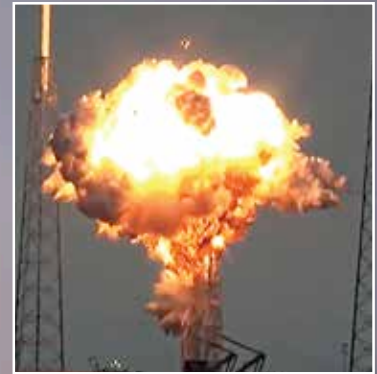
The supposed static fire explosion that brought the Falcon 9 down recently during testing
