# Teardown: Motorola Razr

The reboot of the iconic Razr of the yesteryears

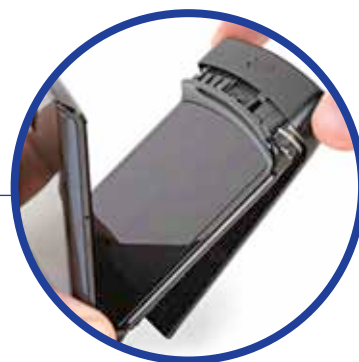
## Accessing the rear cover

Remember the simpler times when all you had to do was slide off the rear panels (plastic or metal) to access the battery of the phone? The modern-day rendition of the Moto Razr needs strategically-applied heat and quite a bit of prying to do the same. However, while separating the back-panel, the fingerprint sensor cable is found in a rather precarious position which can easily be torn if hasty.

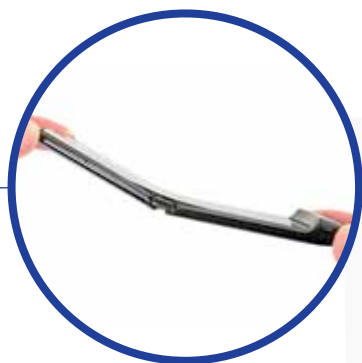
## Concerning gap between the display and hinge

Motorola designed the all-new Moto Razr foldable phone around the OG design of the 2004 Moto Razr flip-phone, and not the other way around. Therefore, you can see certain concerning build issues. One such issue is that midway through the folding action, you'll be able to see a rather alarming gap between the hinge of the phone and the display. Certain reports have already indicated that the screen is peeling off right at the fold...

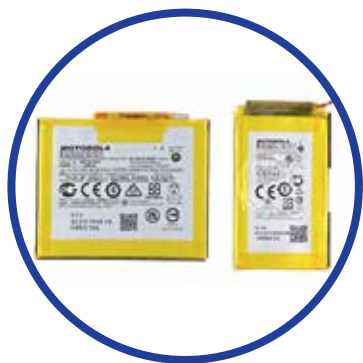
## Baby batteries and a single rear camera

The new Moto Razr comes equipped with two batteries which amount to a total of 2510 mAh. Rather lacklustre for a 2020 smartphone, we must say. In comparison, the Galaxy Fold has two batteries as well, with just one having about the same capacity as both of Razr's batteries. On the new Moto Razr, the first battery is easily extractable (with slight coercion) after prying off the rear panel, but the second one (behind the Quick View display) is hidden behind some cables. Surprisingly, this exorbitant phone sports only a single 16MP rear lens.
