## CASE STUDY:

# Harnessing Wind Energy At Tareybhiri: A Success Story

Bikash Rai is assistant engineer, Energy & Power Department, government of Sikkim

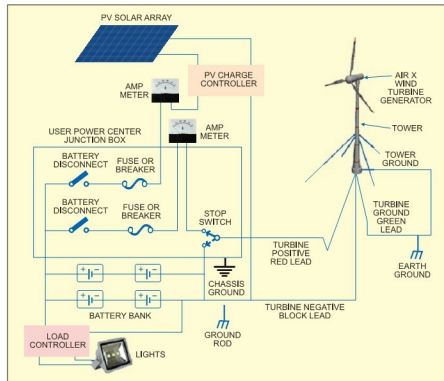
Fig. 1: Wind turbine with solar redundancy system

The next step was to get a turbine, its accessories, and get it installed. I needed funds for the project and no organisation was willing to take on the risk. Finally, I met with Siphora G. Targain, SREDA director, at Gangtok, Sikkim, on September 16, 2013. She gave me access to the ten-year-old, dead, unutilised wind-solar hybrid system at Assangthang (another village in south Sikkim), which was installed in 2004 for CFL street-light lighting purpose. It ran successfully for around three years and then went dead and was lying unutilised. The land owner, along with the local *panchayat*, wanted it removed from the site. This is when I decided to repair this damaged system.
