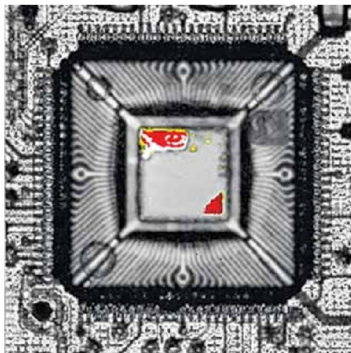
Fig. 4: Acoustic image of smaller component in Fig. 2

The die region of the larger IC package is shown in Fig. 4. This image was gated on the die surface—meaning that only echoes whose arrival time indicated that they had originated within a vertically narrow gate encompassing the die surface were used. Gates can be made very thin, if needed, and are used to avoid depth confusion among features, as well as to determine the precise depth of a single interface.

Fig. 4 displays numerous yellow, red, and white features, which are mostly associated with the perimeter of the die—meaning that the features are close to the vulnerable wire bonds. All of the anomalies can be classified as delaminations or voids. Red and white indicate the highest degree of reflection, while yellow indicates somewhat lower reflection, probably because the top surface of the anomaly is slanted rather than flat and thus

directs some of the echo away from the transducer.

Some of the peripheral features may be harmless, but there are three red-on-white features on the die itself that are not. These are the one at the lower right corner of the die, the one at the upper right corner, and the one about a third of the way up the left margin of the die. Each of these is in contact with the die surface and is capable of expanding its area and cleaving wire bonds—or may already have done so.

The large defect at the upper right corner appears to have a large, somewhat indistinct black area attached to it. This is almost certainly an extension of the void (which may actually be a crack) upward toward the surface of the mould compound. The transducer is collecting only those echoes whose arrival time matches the narrow gate enclosing the die surface. If this extension of the defect extends upward above the top of the gate, the x-y region corresponding to the extension will send no return echoes and system software will fill that region with black pixels, meaning no signal received from within this gate.

The defect along the left edge of the die has a similar black region associated with it, and probably of similar origin.
