The accident aircraft
was a McDonnell Douglas MD-83,

MCDONNELL DOUGLAS MD-83

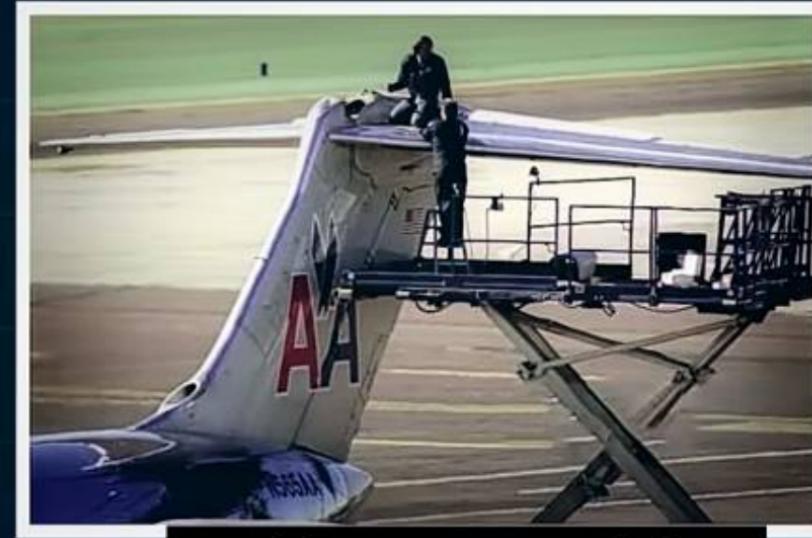
that there's only one ACME screw
and nut in this system.

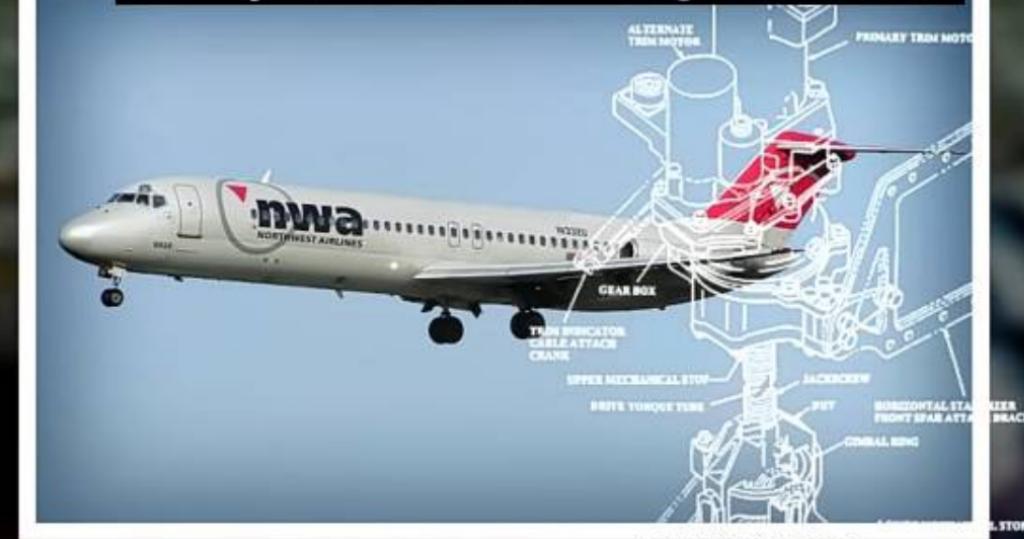
DC-9

LUBRICATION EVERY

300-350

FLIGHT HOURS

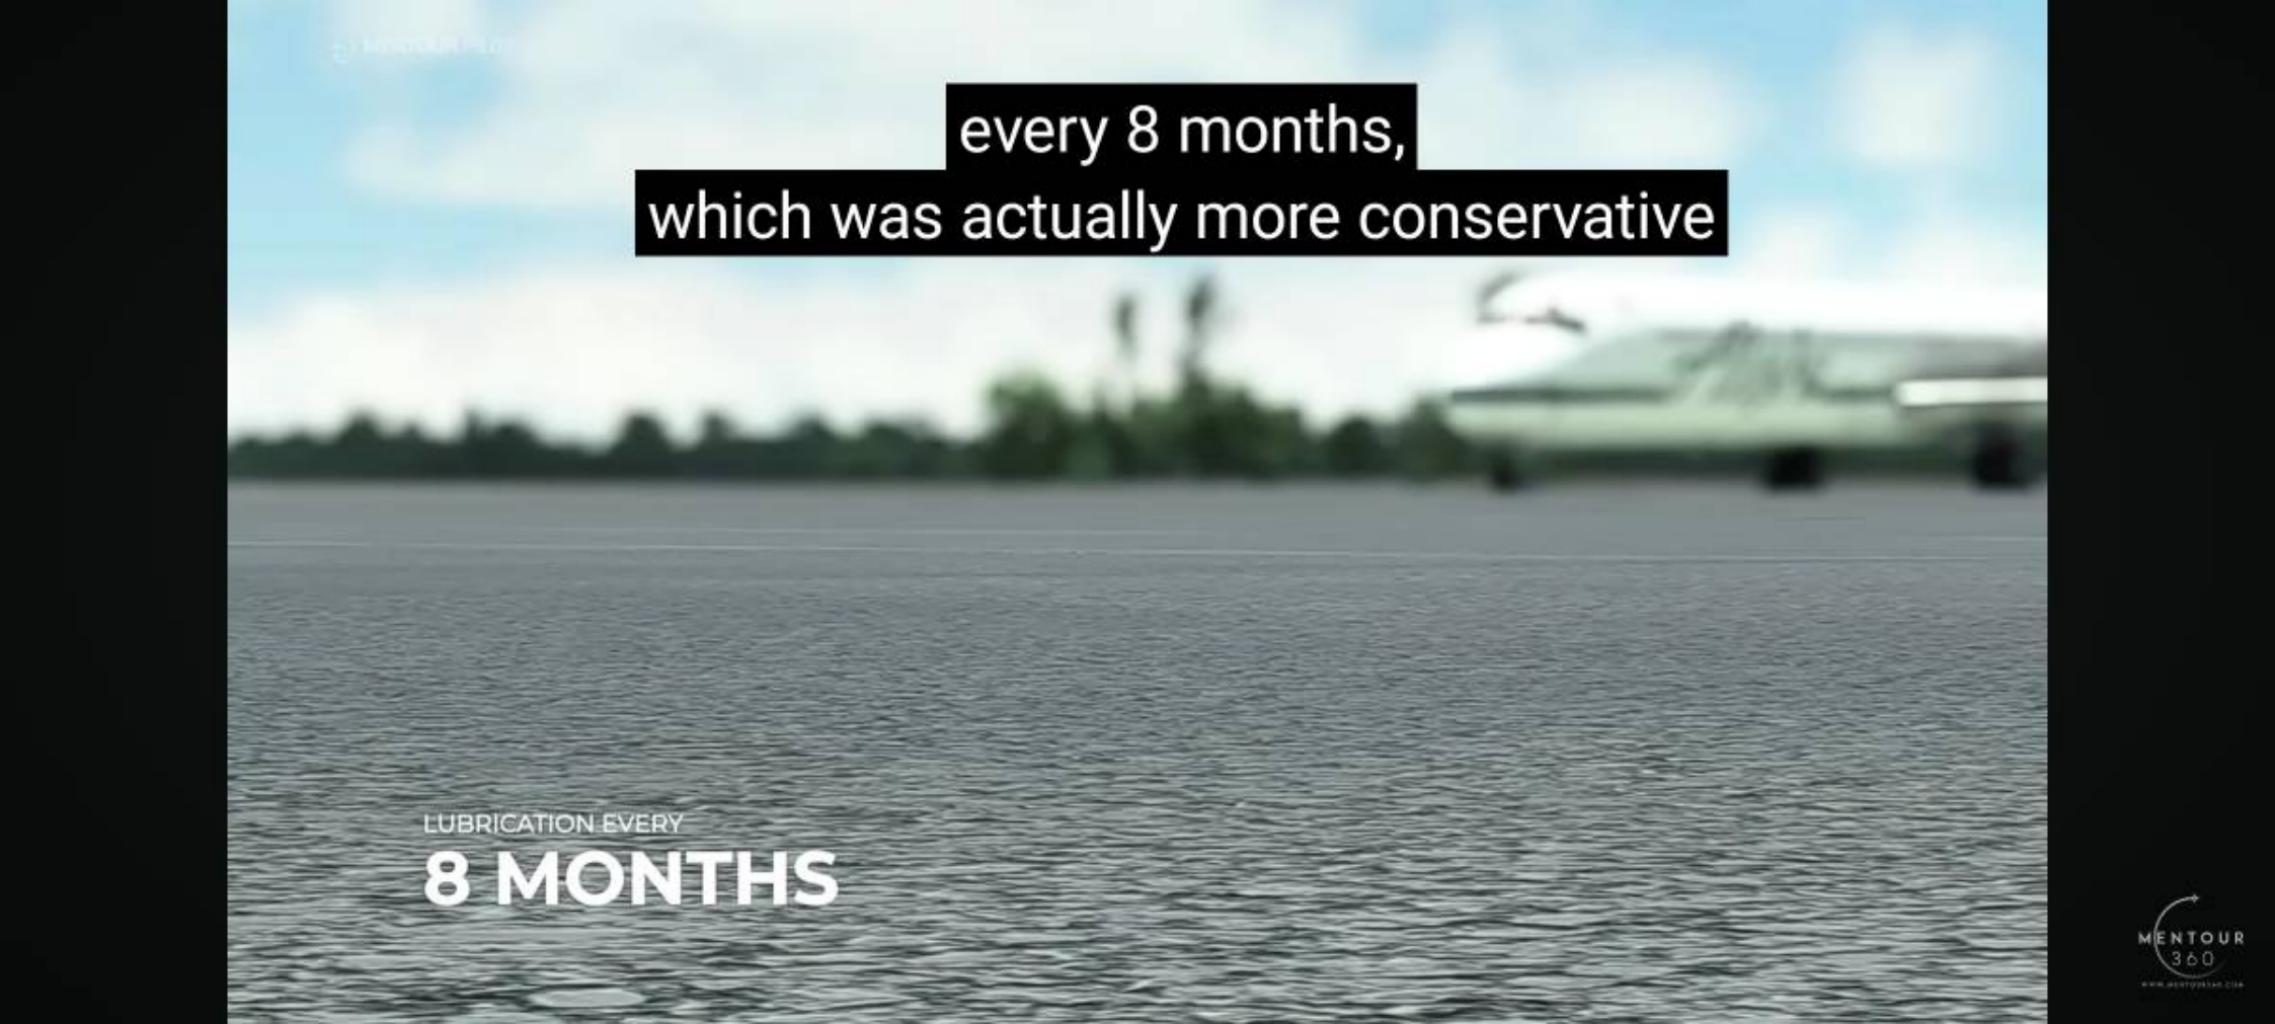
every 8 months,
which was actually more conservative

LUBRICATION EVERY
8 MONTHS

than the manufacturer's recommendation.

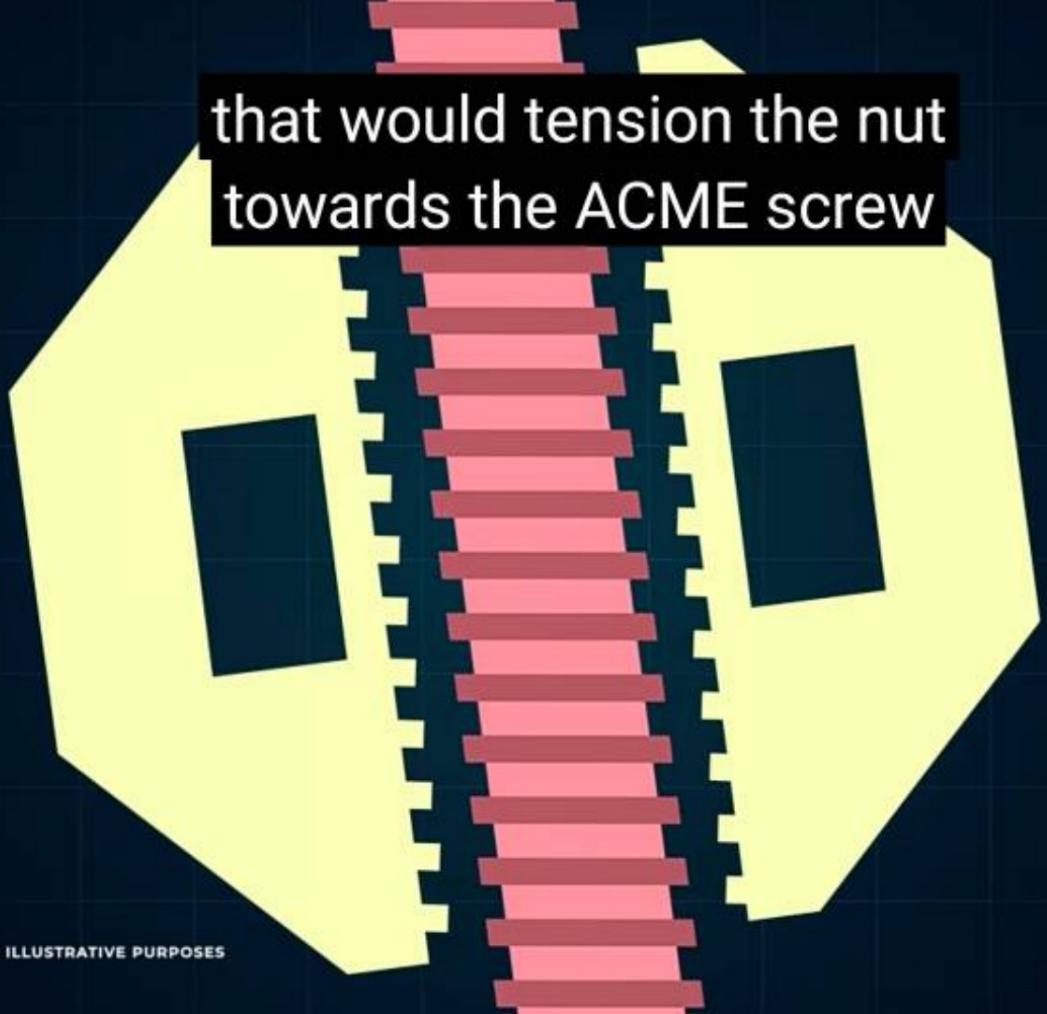
that would tension the nut
towards the ACME screw

and measure how much it would move.

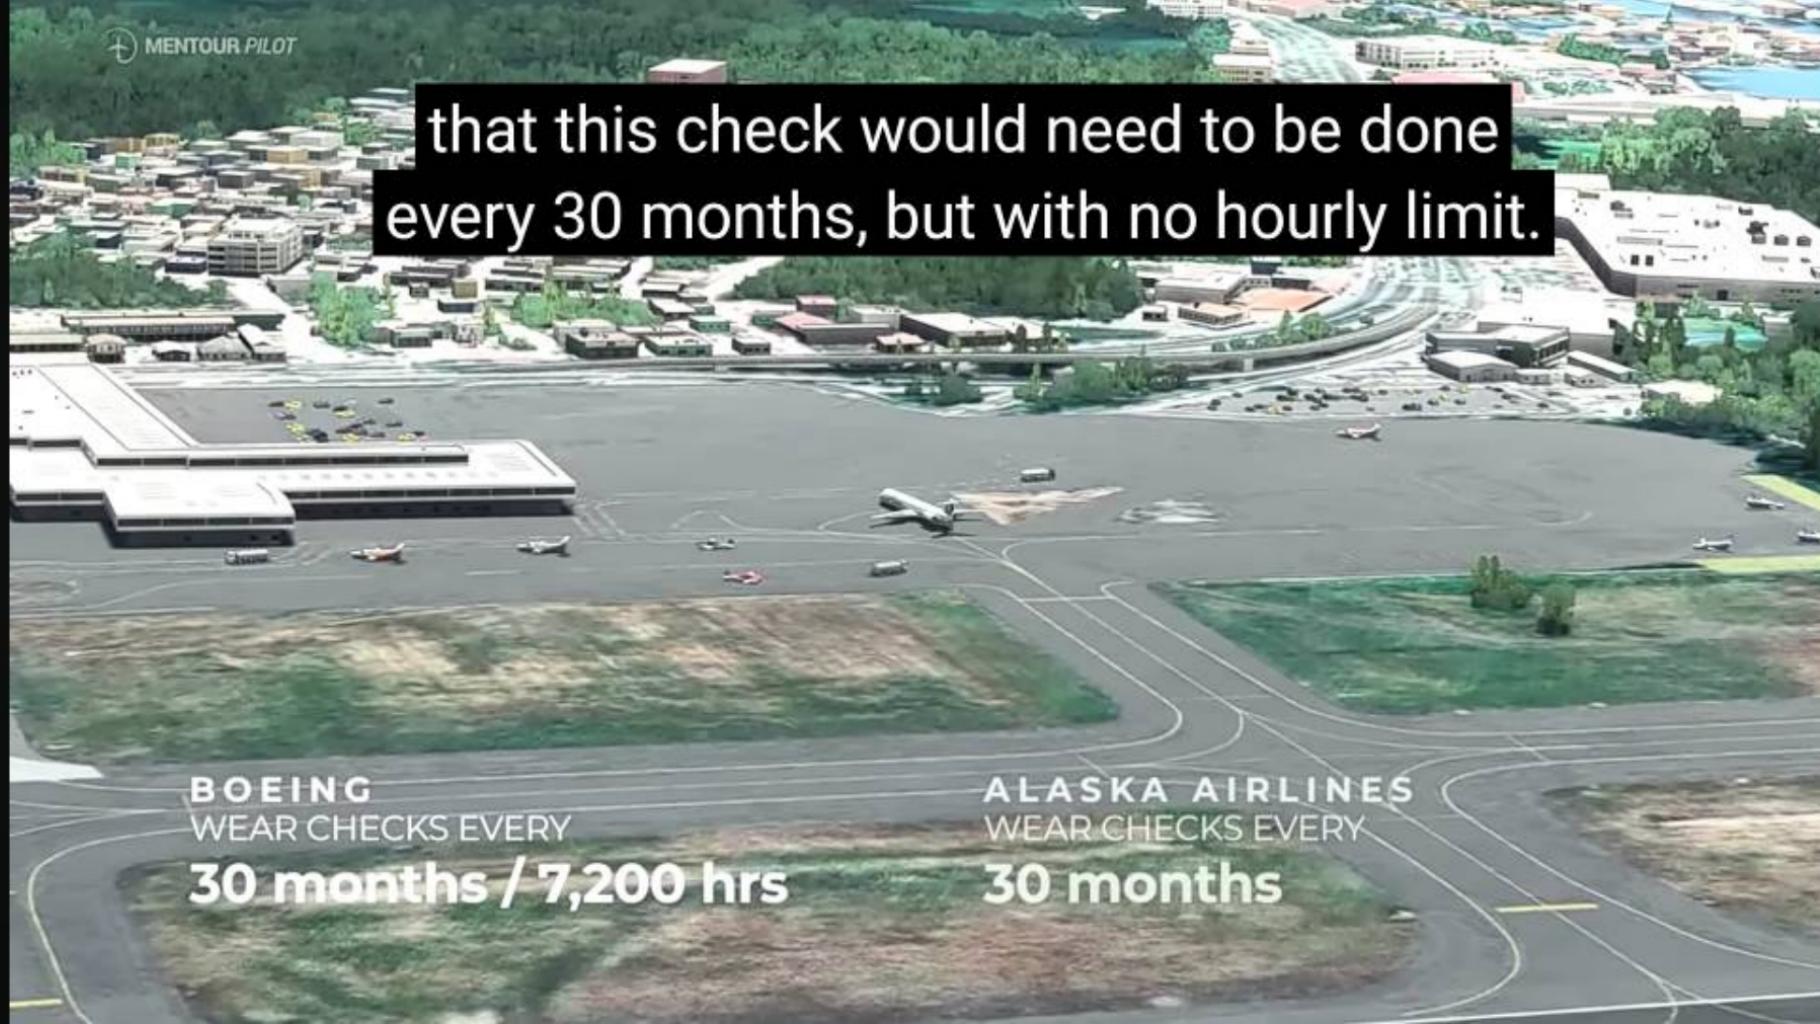
BOEING
WEAR CHECKS EVERY
30 months / 7,200 hrs

ALASKA AIRLINES
WEAR CHECKS EVERY
30 months

it would take close to 9,550 hours
between each of these checks.

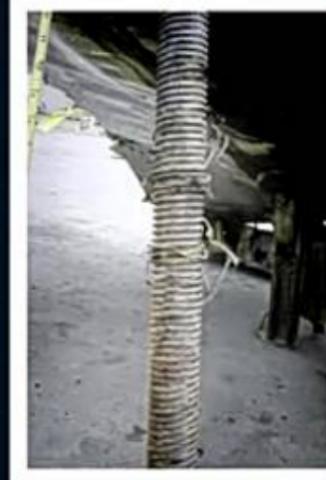
When they looked closer
on the ACME screw and nut,

they saw that the nut
was almost completely smooth,

with only remnants of threads
still left inside.

On the ACME screw, they found several spiral form pieces of thread

which had been ripped out of the nut,
likely during that first dive.

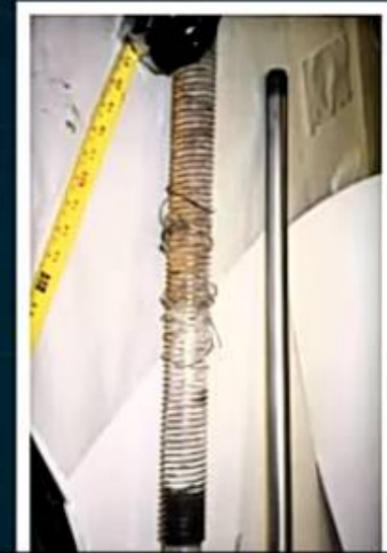
And the rest of the components
were completely dry.

There was no lubricant at all on them.
