## The concept of static liquefaction and its application in the stability analysis of tailings dams

**Ramon Verdugo**

*Geotechnical, CMGI-Chile, Chile, rverdugo@cmgi.cl*

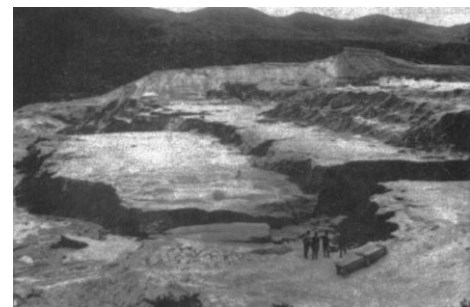
At the time of the earthquake and subsequent failure of a sector of the dam, the maximum height of the dam was 65 m, the upstream slope had an overall inclination of 2:1 (H:V), a freeboard of 17 m and a crest width of 12 m, as is shown in Fig. 11. The dam had a total length of 1,885 m, the failure occurred in the highest part of the dam, and consisted of a breach of 440 m in length, which compromised the total height of the dam. The geometry of the surface of the tailings that remained in the zone of the failure developed a stepped shape; rather flat terraces and almost vertical scarps were observed (Fig. 12 Troncoso et al, 1993).

Figure 12. Geometry of the failure surface (Troncoso et al, 1993)
