How to fix a mouldy keg valve

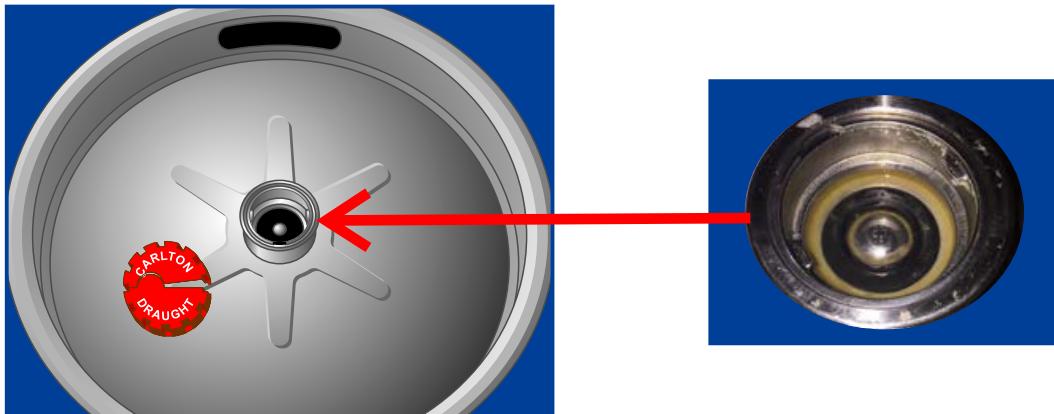
Occasionally, you may notice mould in the Keg Valve when the dust cap is removed.

This is generally caused by impact to the keg valve during transport and delivery. A small amount of beer may leak into the keg well and, conditions being right, can lead to mould growth.

- Always wear appropriate PPE when handling kegs (protective eyewear, gloves and footwear)
- Rinse the mould from the valve well with warm water, rinse out thoroughly and spray using sanitising spray (if available)
- When the valve is dry, tap the keg by itself (don't bank the keg) following Asahi Beverages recommended process below
- If you have any problems with the keg or product after following this process please call our Customer Contact Centre on 13 BEER
