Testing report of chip LAN9514 on Koruza V1.1

Author: Tadej Plej
Maribor, 19. April 2021

Problem description

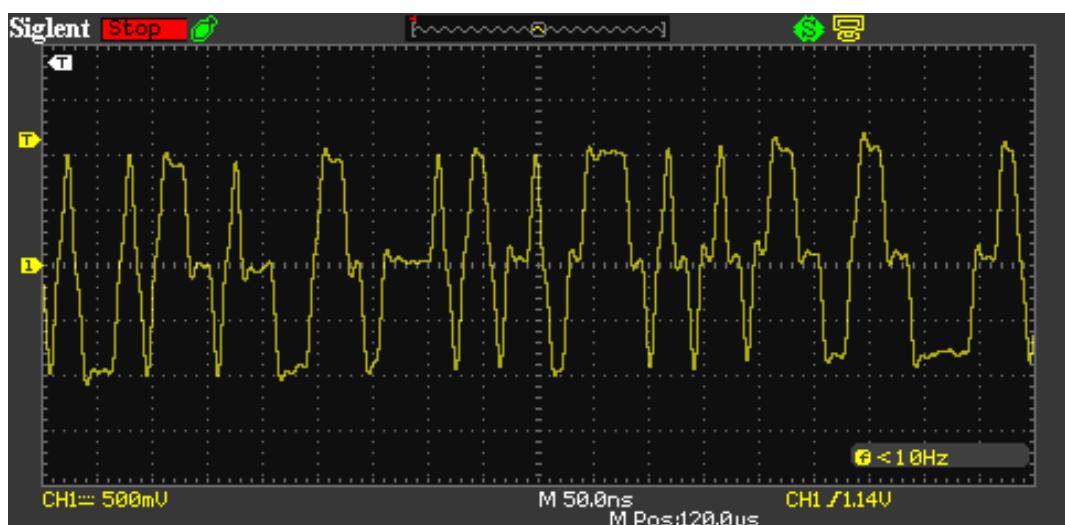
Measured a differential pair between R29 - TXP and R30 – TXN

Picture 67: Differential pair TXP-TXN

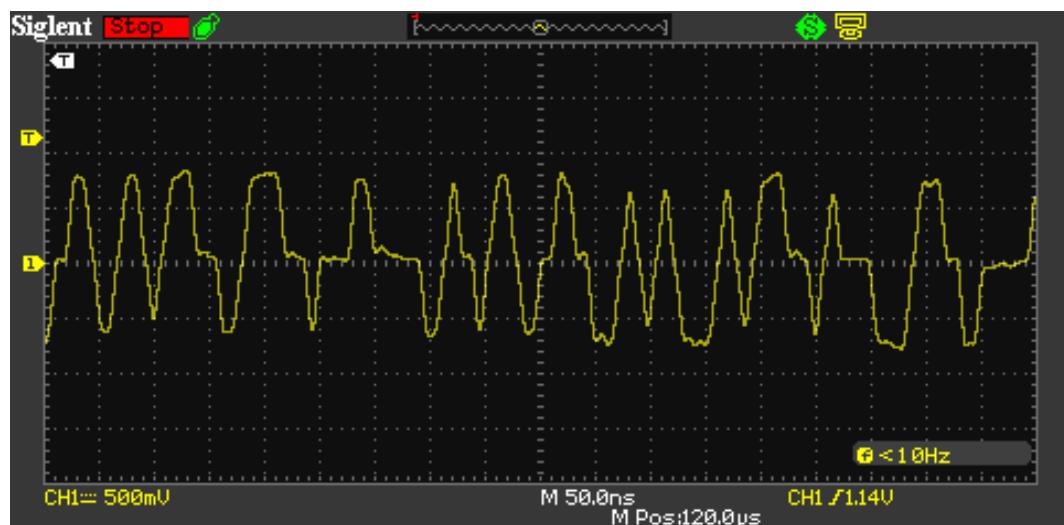
Measured a differential pair between R31 - RXP and R32 –RXN

Picture 68: Differential pair RXP-RXN

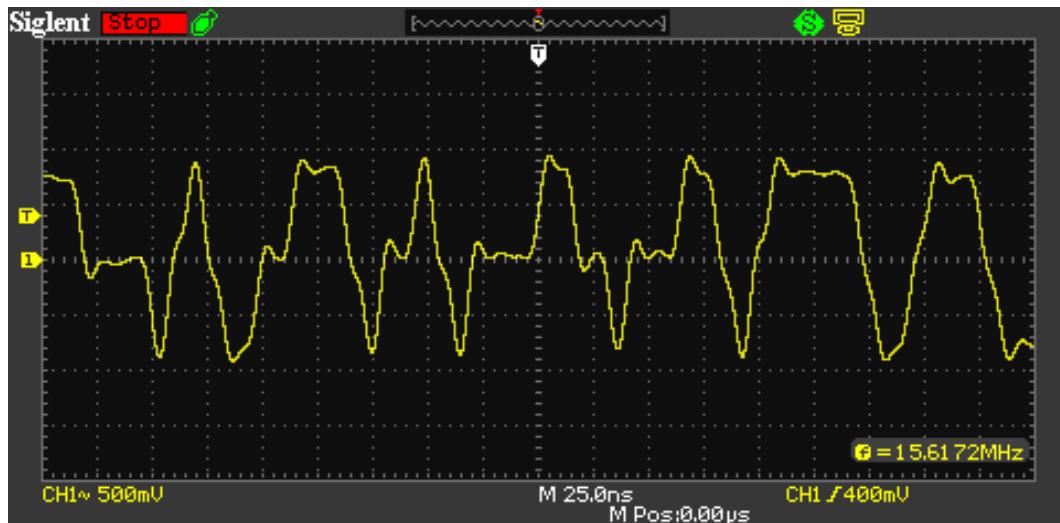
Measured a differential pair between R29 - TXP and R30 – TXN

Picture 69: Differential pair TXP-TXN

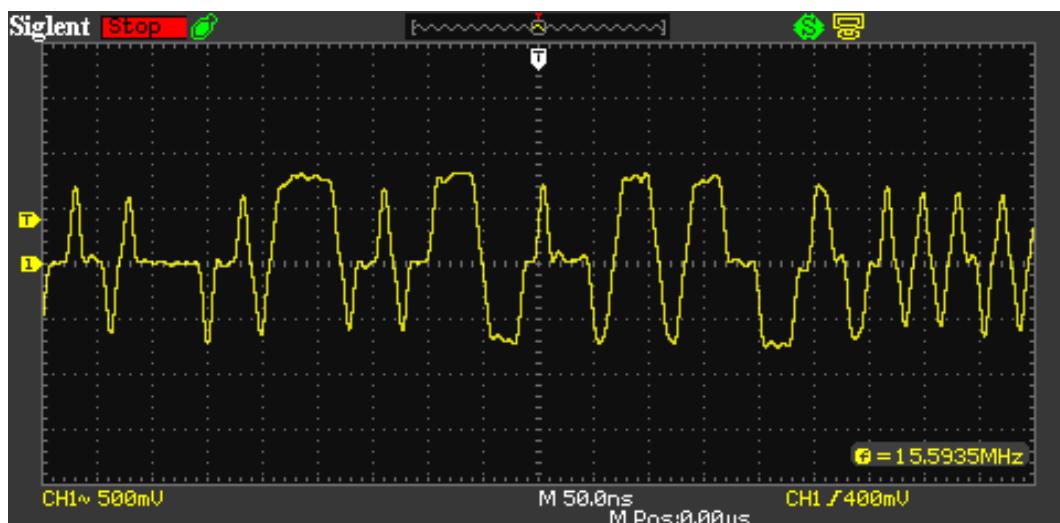
Measured a differential pair between R31 - RXP and R32 –RXN

Picture 70: Differential pair RXP-RXN
