# Property Risk Evaluation Report

**[PROPERTY]**

13 April, 2026

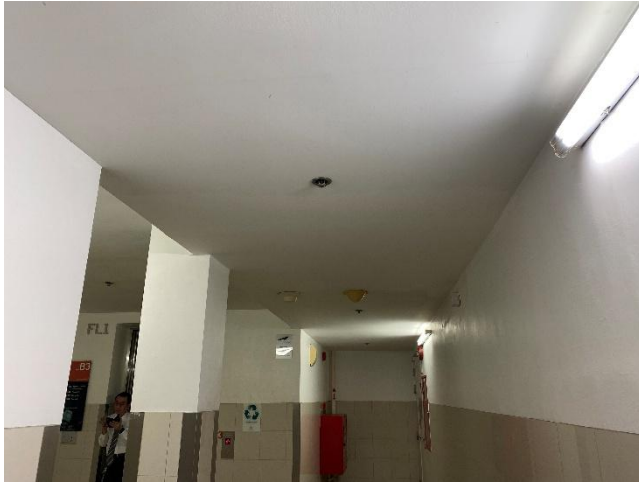
| 2026-02 | | Sprinkler Installation | |

| 2026-02 | | Sprinkler Installation | |
|---|---|---|---|
| Observation | As observed at B3 service corridor area, a few of the sprinkler heads are recessing more than 50% into the ceiling. This will impede the flow pattern of the sprinklers. | | |
| | Sprinkler head recess into ceiling | | |

| 2026-02 | | Sprinkler Installation | |
|---|---|---|---|
| Description | Ensure that sprinklers are properly installed and not recess into the ceiling. | | |
