ISIS Directive For Openreach and Partners

AEI/AEC/B357

Connector bend installation process

Safety issues caused by incorrect positioning of the connector bend on Poles

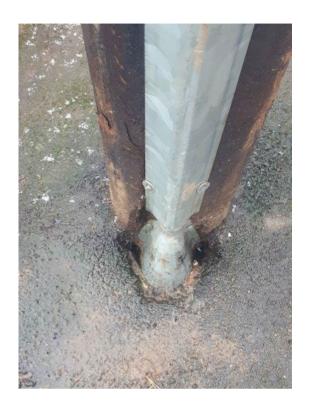
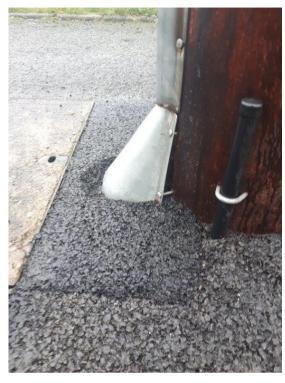
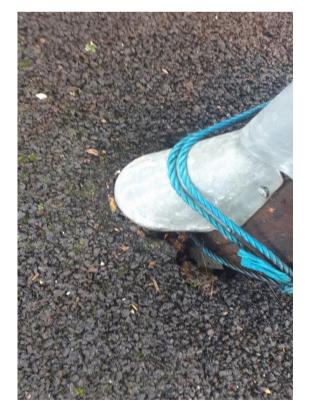
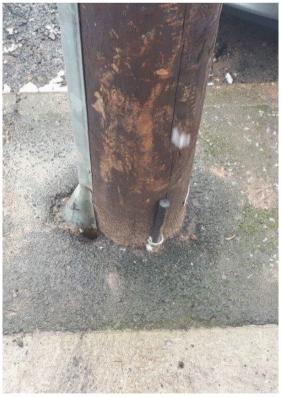
With the rollout of Fibre the Connector bend has to be removed more frequently to access the duct mouth. This has flagged up the issue that during pole renewal, many have been installed under the reinstatement level which is causing damage and failed inspections. Please see examples below.

Figures 1,2,3 & 4 are examples of poor installations and the effects of removing the connector bend.

From the images above the connector bend has been removed and the reinstated tarmac has been damaged. The subsequent repair is at the cost of Openreach.

The Connector Bend must be fitted on top of the reinstatement; this will greatly reduce the chances of the reinstatement being damaged if it is removed. See images below.

Where necessary, Duct 56 Split (I/C 095086) should be used to extend the duct to surface level.

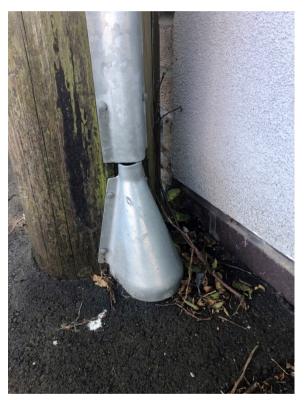
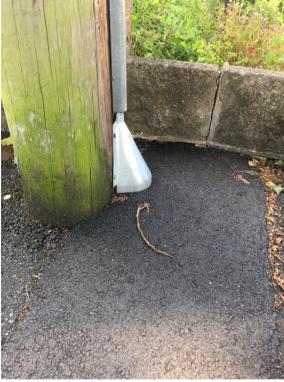
Figures 5 & 6 Show good examples of the connector bend being installed above the reinstatement.

With immediate effect, all Connector Bends must be installed above the surface level.
