KH6RS BEACON INSTALL REPORT

A new beacon was installed on January 10, 2016 at the QTH of NH6Y, Tom Worthington. The callsign is KH6RS, the club callsign of the Maui Amateur Radio Club (www.KH6RS.org).

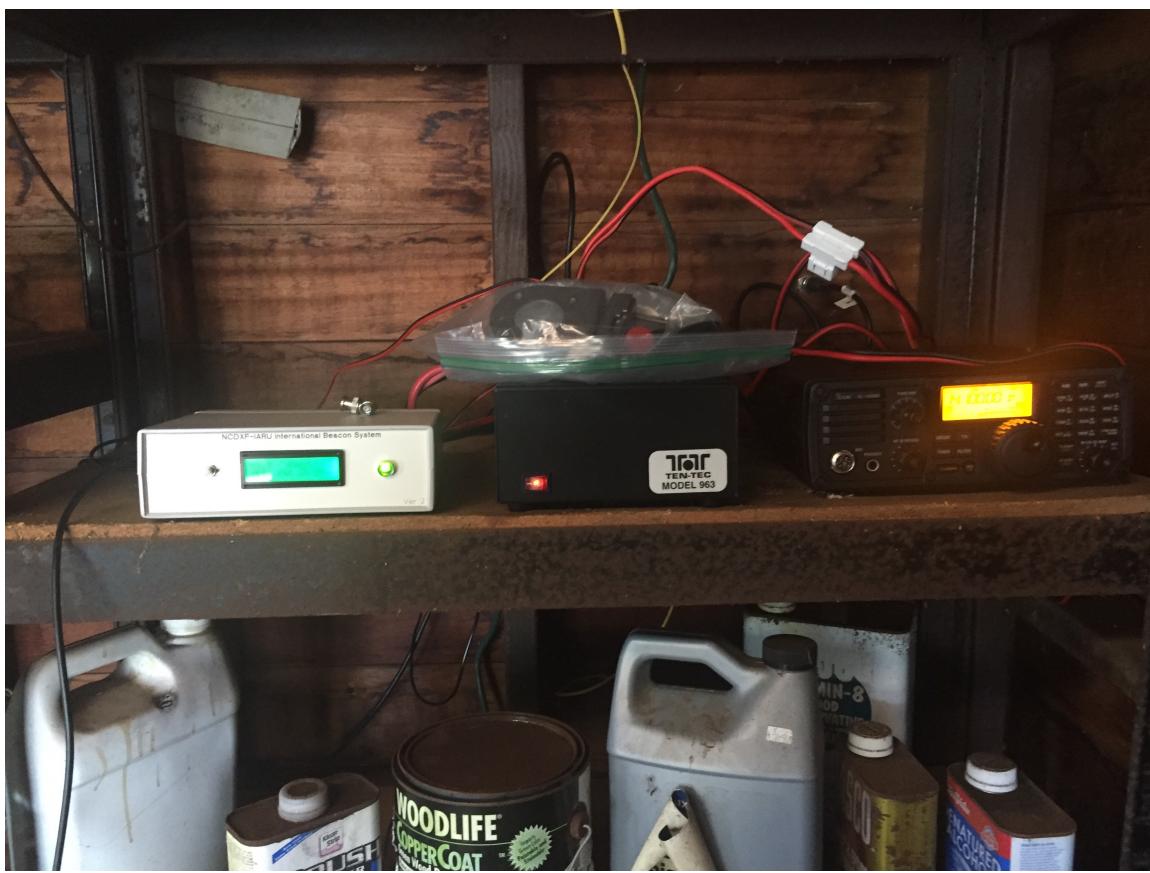
[KH6RS - garage NH6Y 1](#)

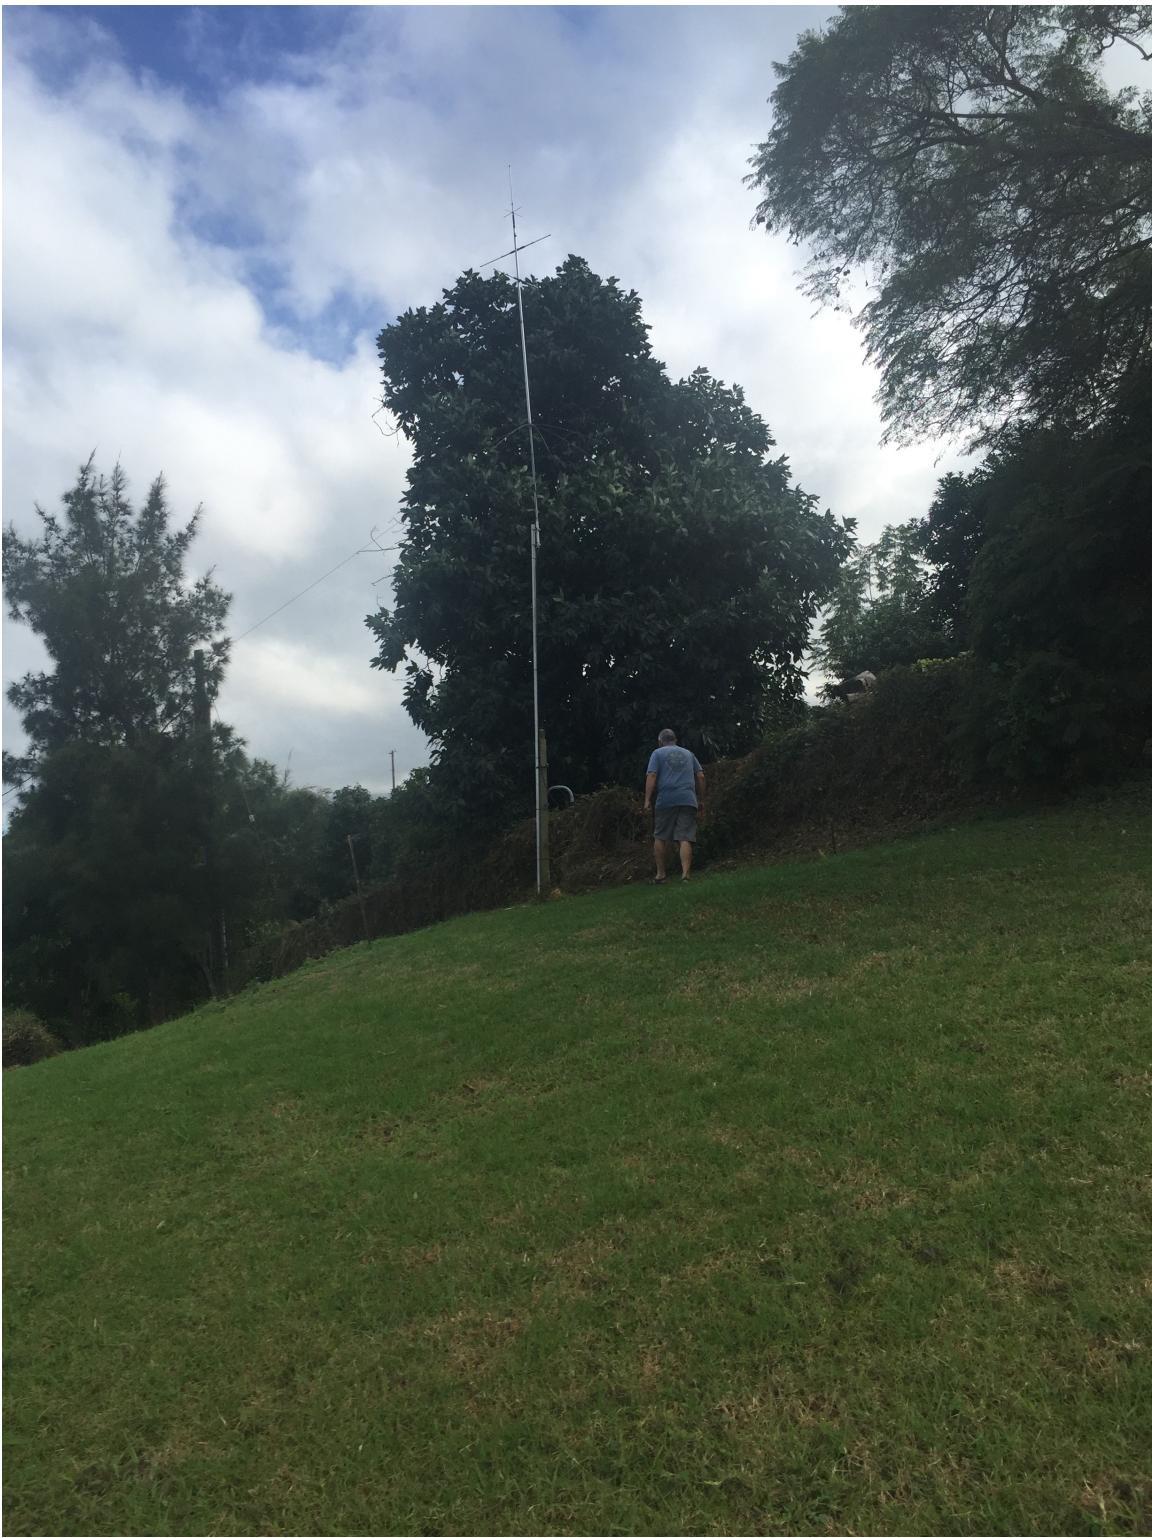
Antenna and Tom 1

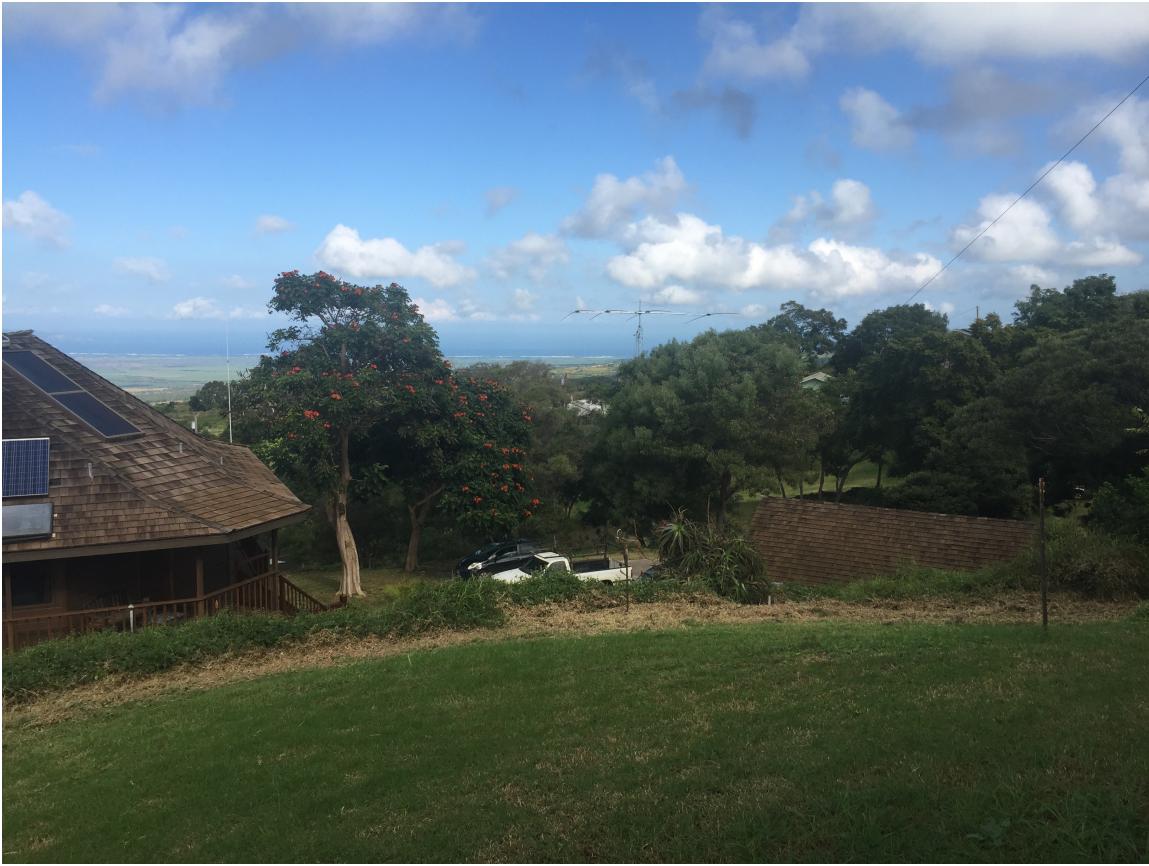
Looking NW from antenna 1
