EVANS WATER CORPORATION WATER MASTER PLAN STUDY

DECEMBER 2021

PROJECT NO. 220126

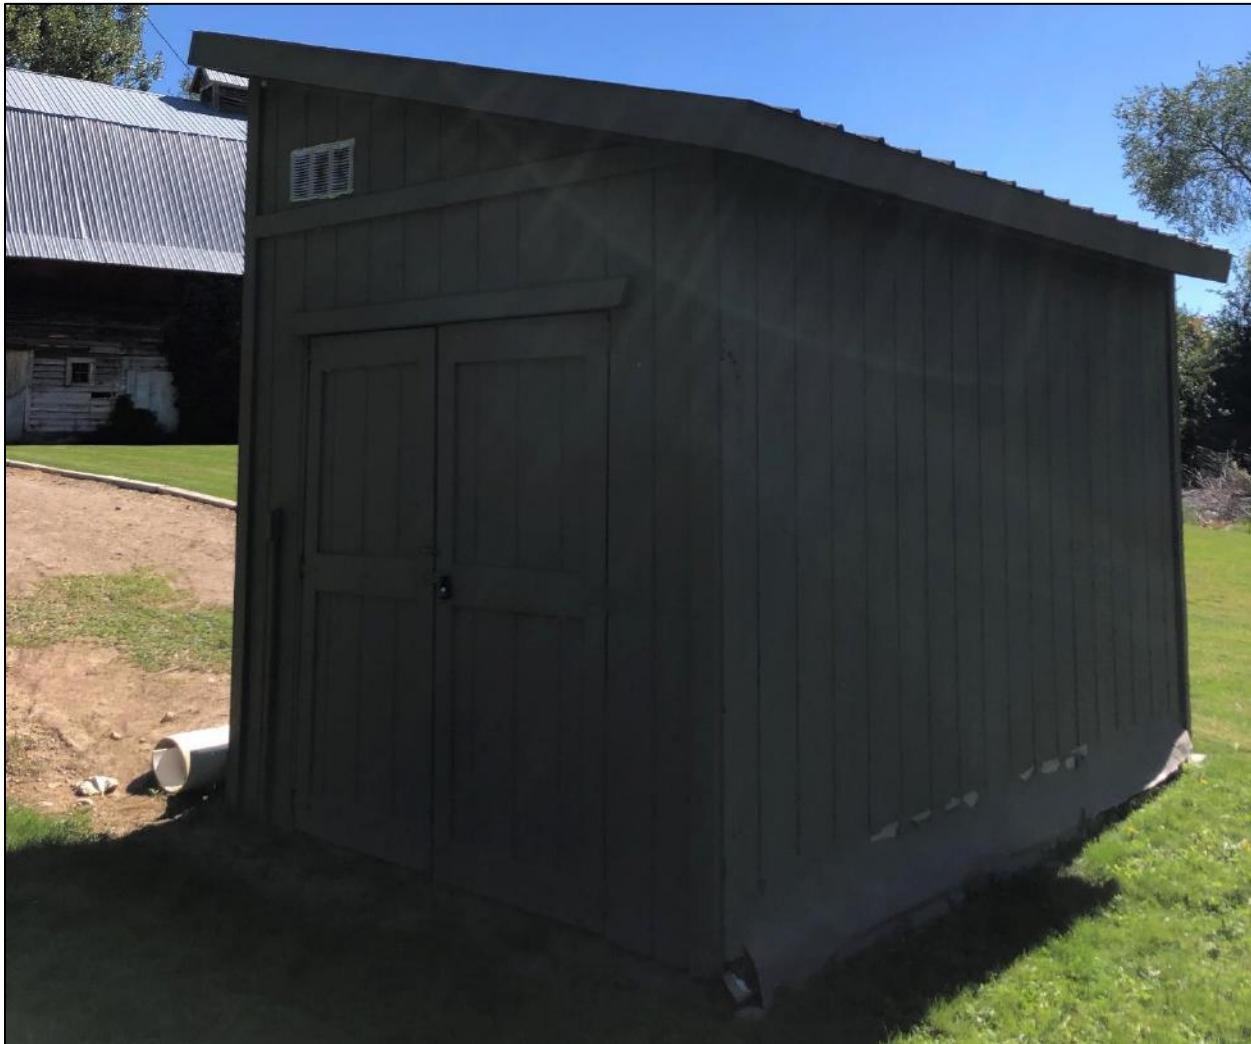
FIGURE 3-4: WELL #2 PUMP HOUSE

The well was investigated again in October 2021 with video footage showing that the well casing is in fair condition, however, the pump screens were bent away from the pump and toward the casing walls. It is recommended that this pump be pulled up and repaired or replaced. The pump was reported to be installed approximately 40 feet below the static water level, and below the pump, there is no casing. Pump testing was completed for Well #2 and the static water level was recorded at 47.7 feet below the ground surface. The well was run for approximately 10 minutes and a drawdown of 5.9 feet was observed.

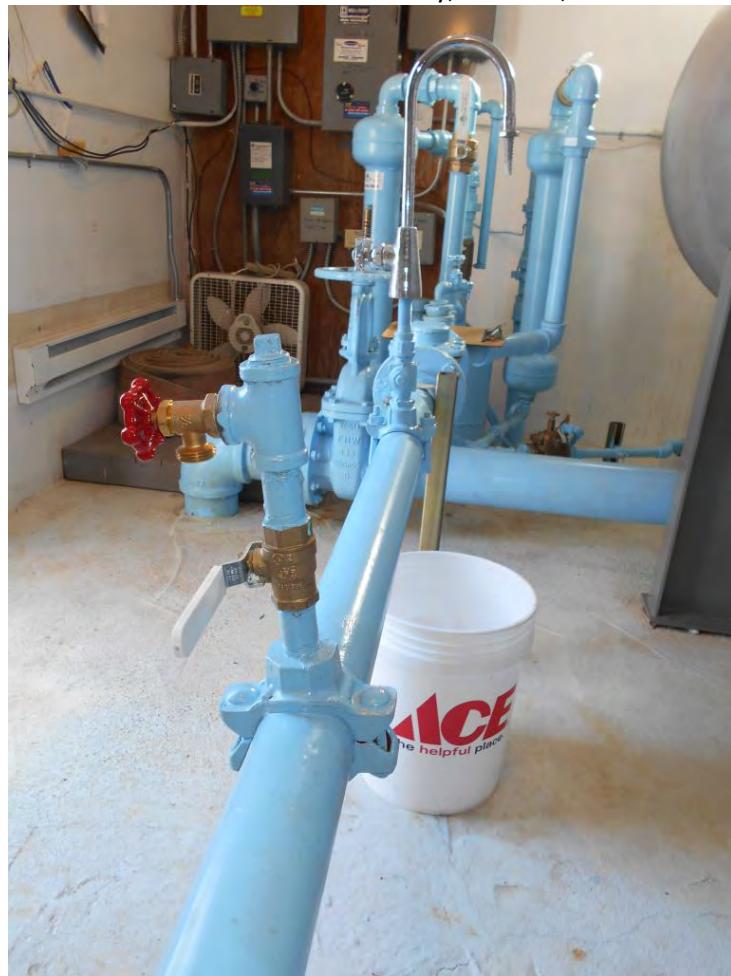
Photograph 7 :View of piping downstream of manifold with Well #1, and view of unprotected spigot

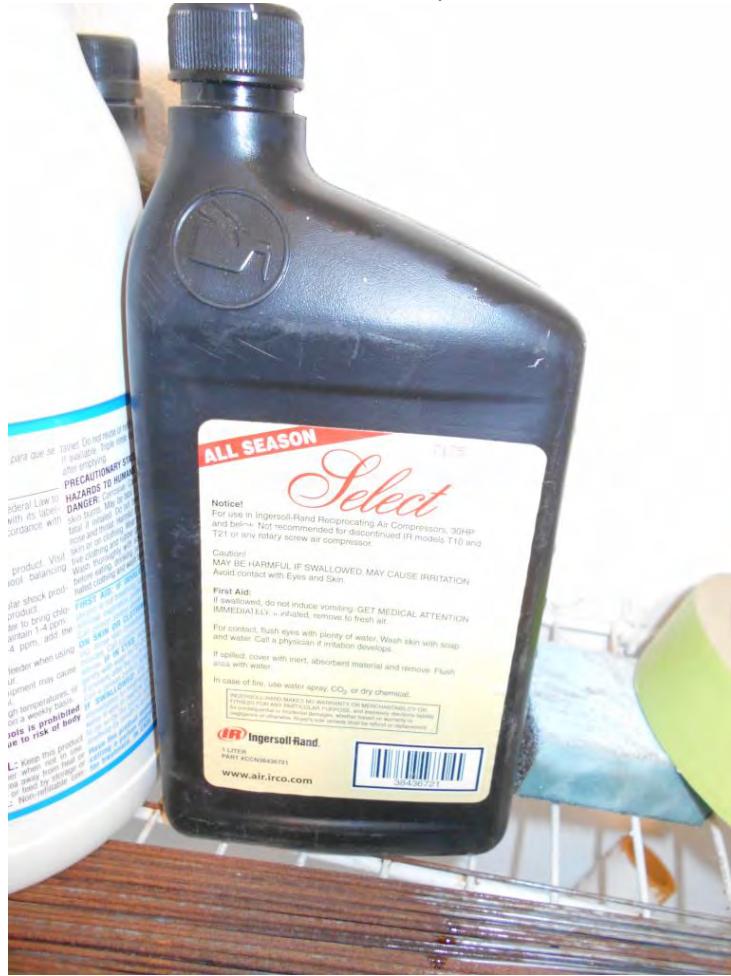
Photograph 9 :Non-NSF Approved oil being used in the air compressor

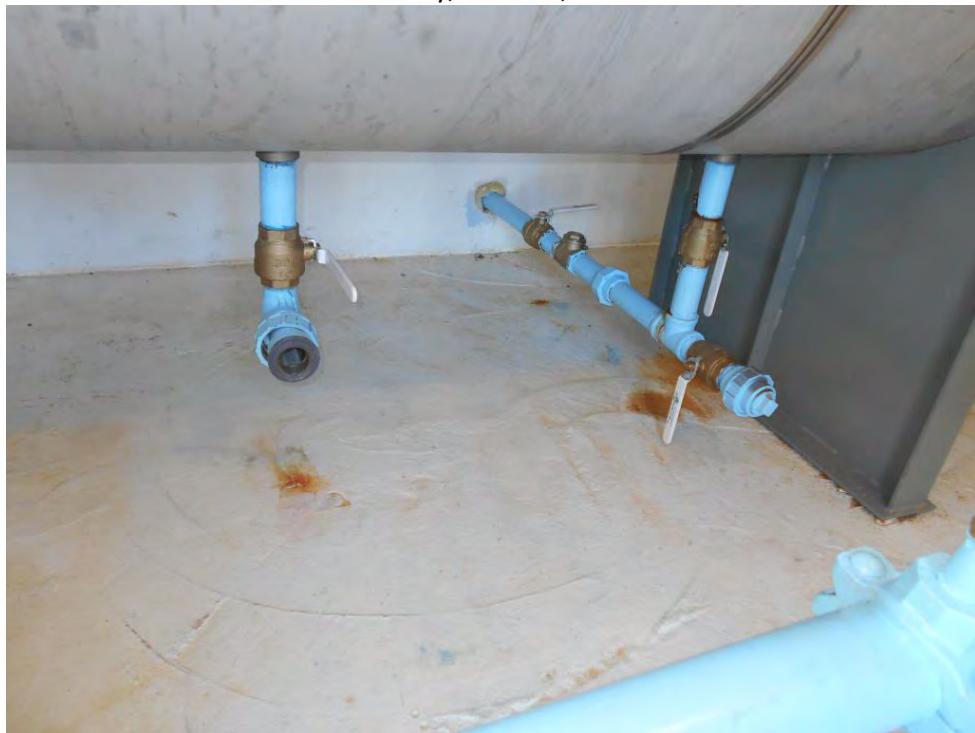
Photograph 10 :View of bottom of pressure tank. Piping on right goes into adjacent doghouse for sprinkler system. Piping on left can be used for flush to waste

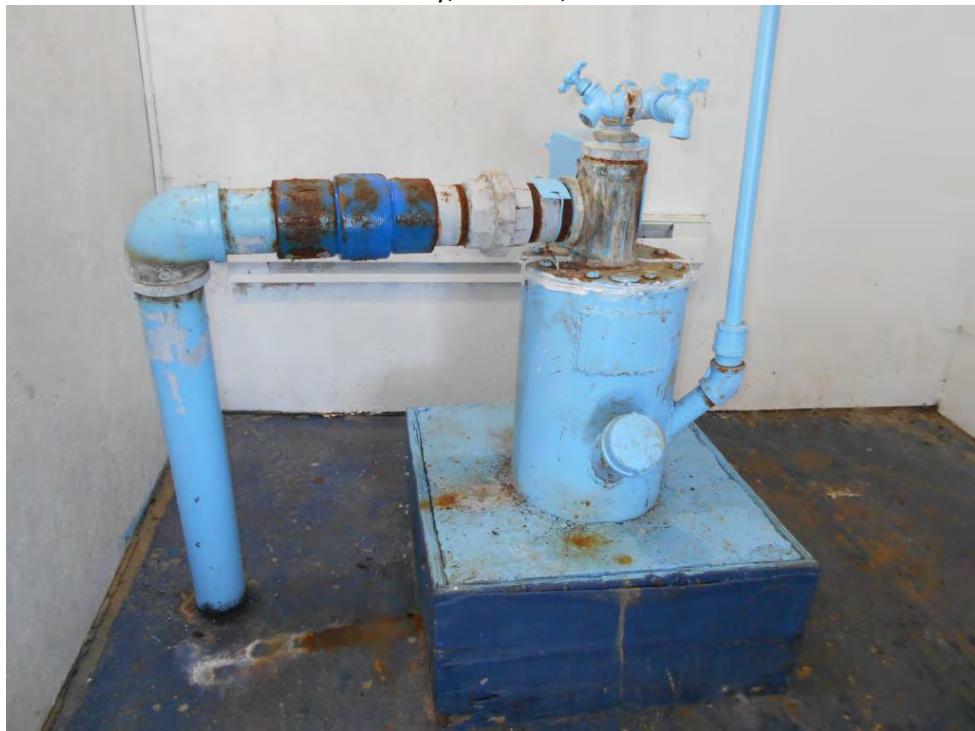
Photograph 18 :Well #2 wellhead
