# EVANS WATER CORPORATION WATER MASTER PLAN STUDY

Date: Feb 14, 2022 DECEMBER 2021

PROJECT NO. 220126

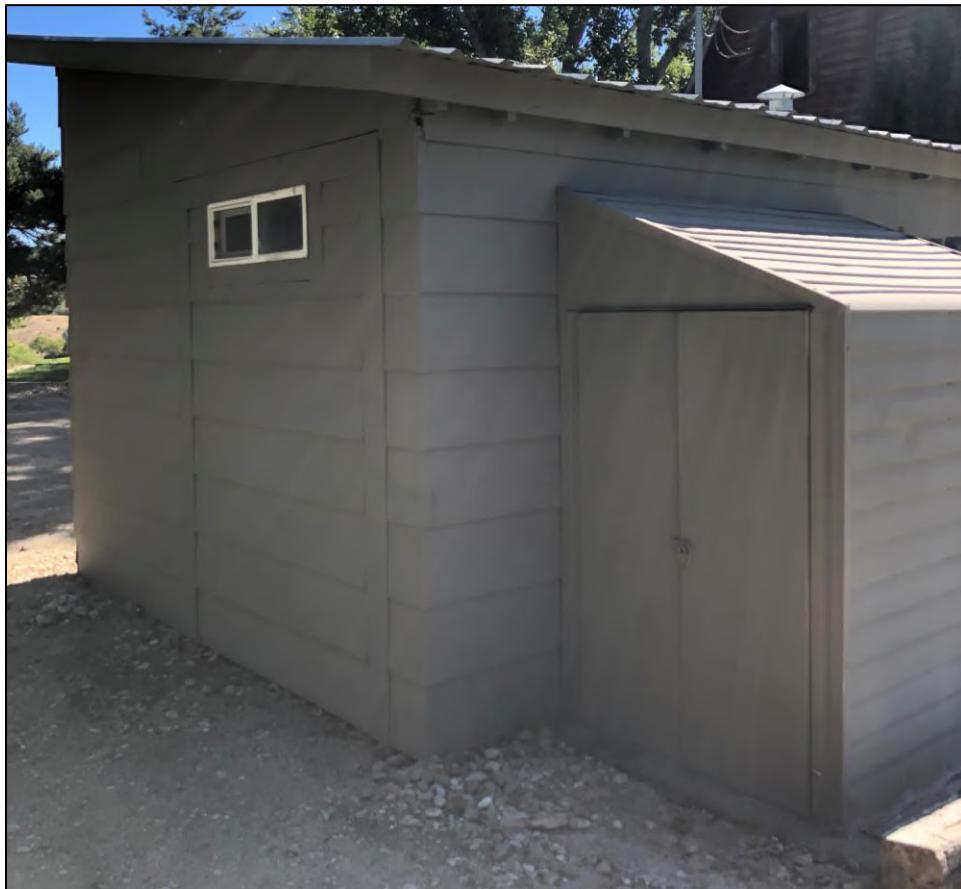
FIGURE 3-2: WELL #1 PUMP HOUSE

Well #1 is located in a wood pump house near 321 North Dicky Drive. The property is owned and maintained by the Corporation. The interior of the housing was replaced with cement board walls in 2011. The interior and exterior paint is maintained as needed by the Corporation and the exterior was painted in 2019. The pump house has a single rooftop vent and two windows which can be opened for ventilation. The pump house is also heated with a floorboard heater. The pump house is shown in Figure 3-2 below.

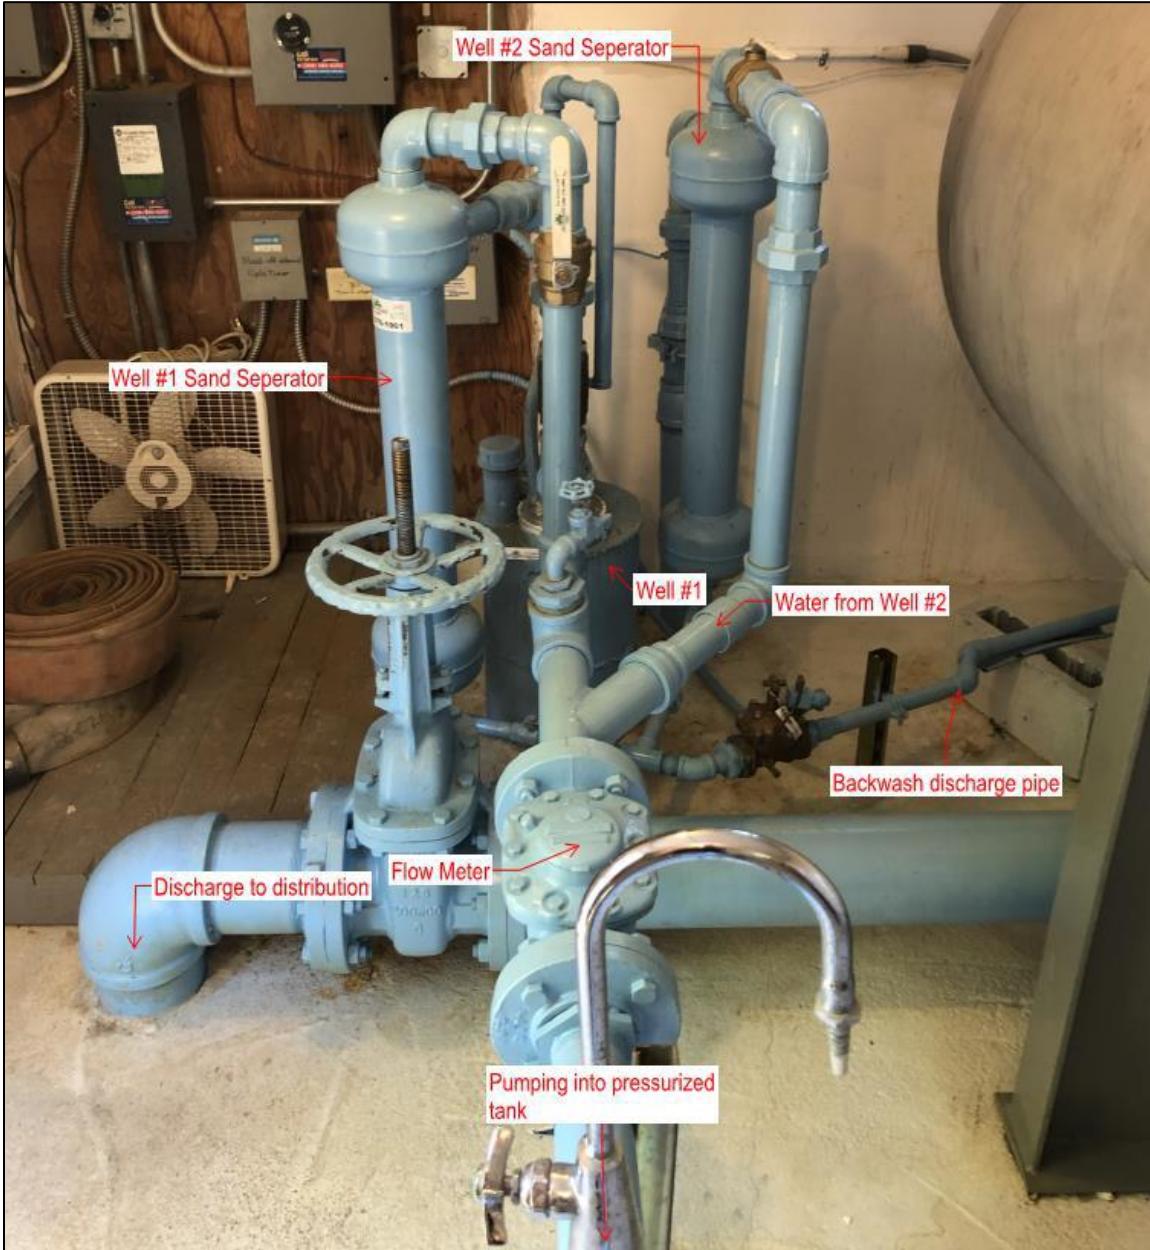
FIGURE 3-3: WELL #1 PUMP HOUSE CONFIGURATION

The Well #1 pump and motor were replaced in July 2019 with a 6", 7.5 horsepower (hp) submersible pump. The pump has a reported capacity of 100 gpm at 200 feet of total dynamic head (TDH). The Corporation completed a pump test of Well #1 and reported a flow rate of approximately 50 -70 gpm, is lower than expected flow given the pump's design point. Further investigation was completed and a well pump test was conducted in October 2021. The static water level was recorded at 55.2 feet below the ground surface and the well was operated for approximately 10 minutes with 7.6 feet of drawdown. The static and pumping water level are similar to the levels in Well #2. One potential reason for the decreased pump production could be because the TDH of

the pump is higher than the reported design point. With a 65-psi discharge pressure at the pressure tank and with the observed drawdown, the pump is pumping against 213 ft of TDH, which could be resulting in lower flow rates to deliver the necessary TDH. Based on the pump curve, at 213 ft of TDH, the pump should be pumping about 80 gpm. The exact reason for the lower pumping yield from Well #1 should be further investigated and the pump should be pulled and inspected for deficiencies.

This well alternates running with Well #2 and turns on based on water level setpoints in the pressurized tank. Neither Well #1 nor Well #2 have a back-up power source, and it is recommended that the Corporation update the electrical configuration for use with a portable generator or obtain an onsite generator for emergency situations. Additionally, neither well has an option for pumping to waste, therefore it is recommended that the piping be configured to be able to pump to waste. Well #1 piping configuration is shown in Figure 3-3.

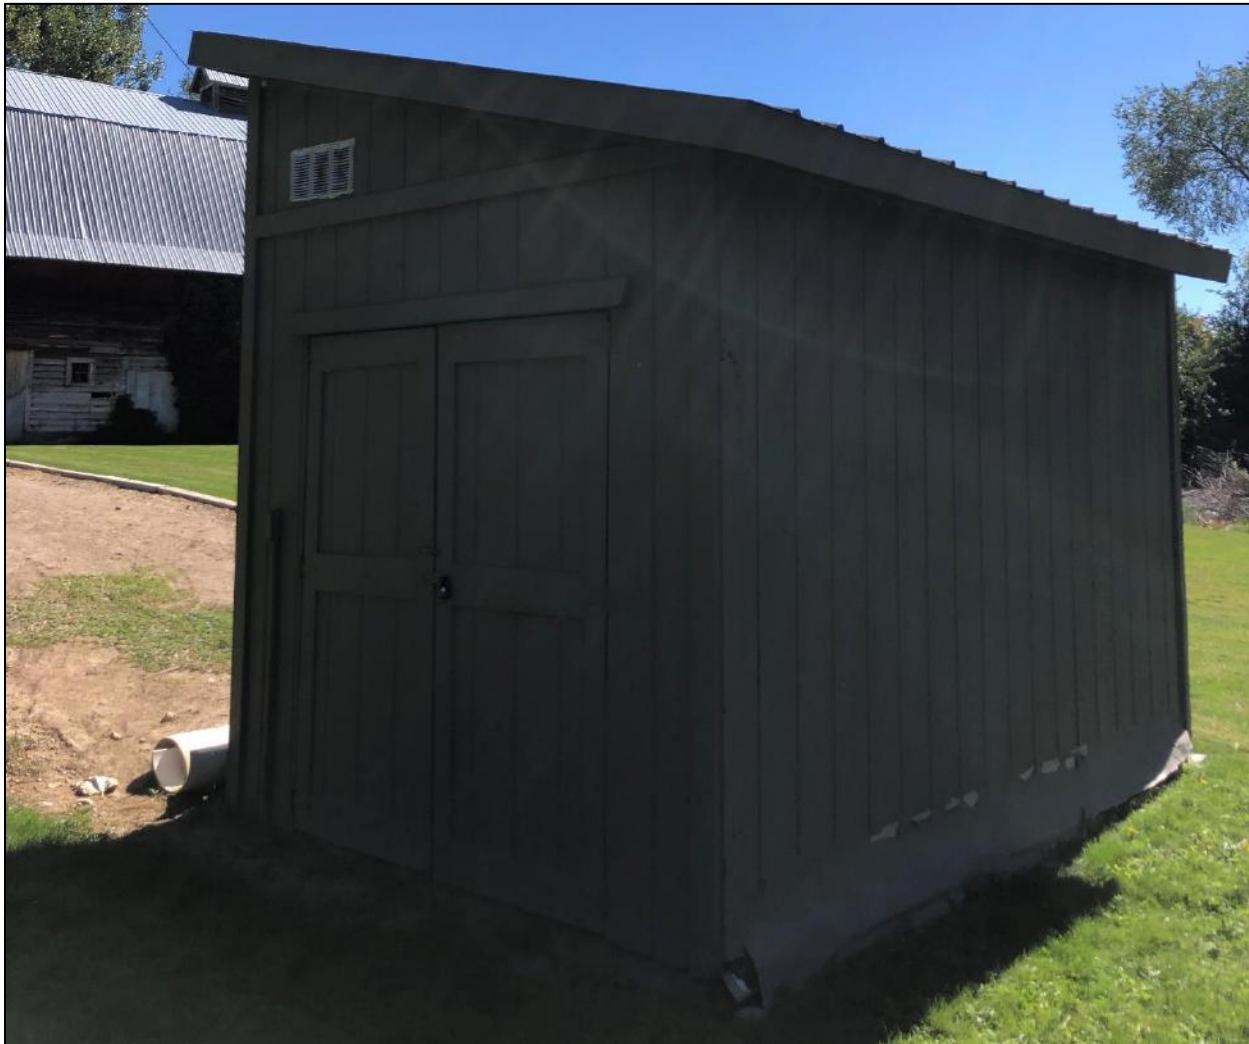
FIGURE 3-4: WELL #2 PUMP HOUSE

Well #2 is located in a wood pump house approximately 150 feet west of the Well #1 pump house. The pump house has a single vent and is heated by a floorboard heater.

The well was investigated again in October 2021 with video footage showing that the well casing is in fair condition, however, the pump screens were bent away from the pump and toward the casing walls. It is recommended that this pump be pulled up and repaired or replaced. The pump was reported to be installed approximately 40 feet below the static water level, and below the pump, there is no casing. Pump testing was completed for Well #2 and the static water level was recorded at 47.7 feet below the ground surface. The well was run for approximately 10 minutes and a drawdown of 5.9 feet was observed.

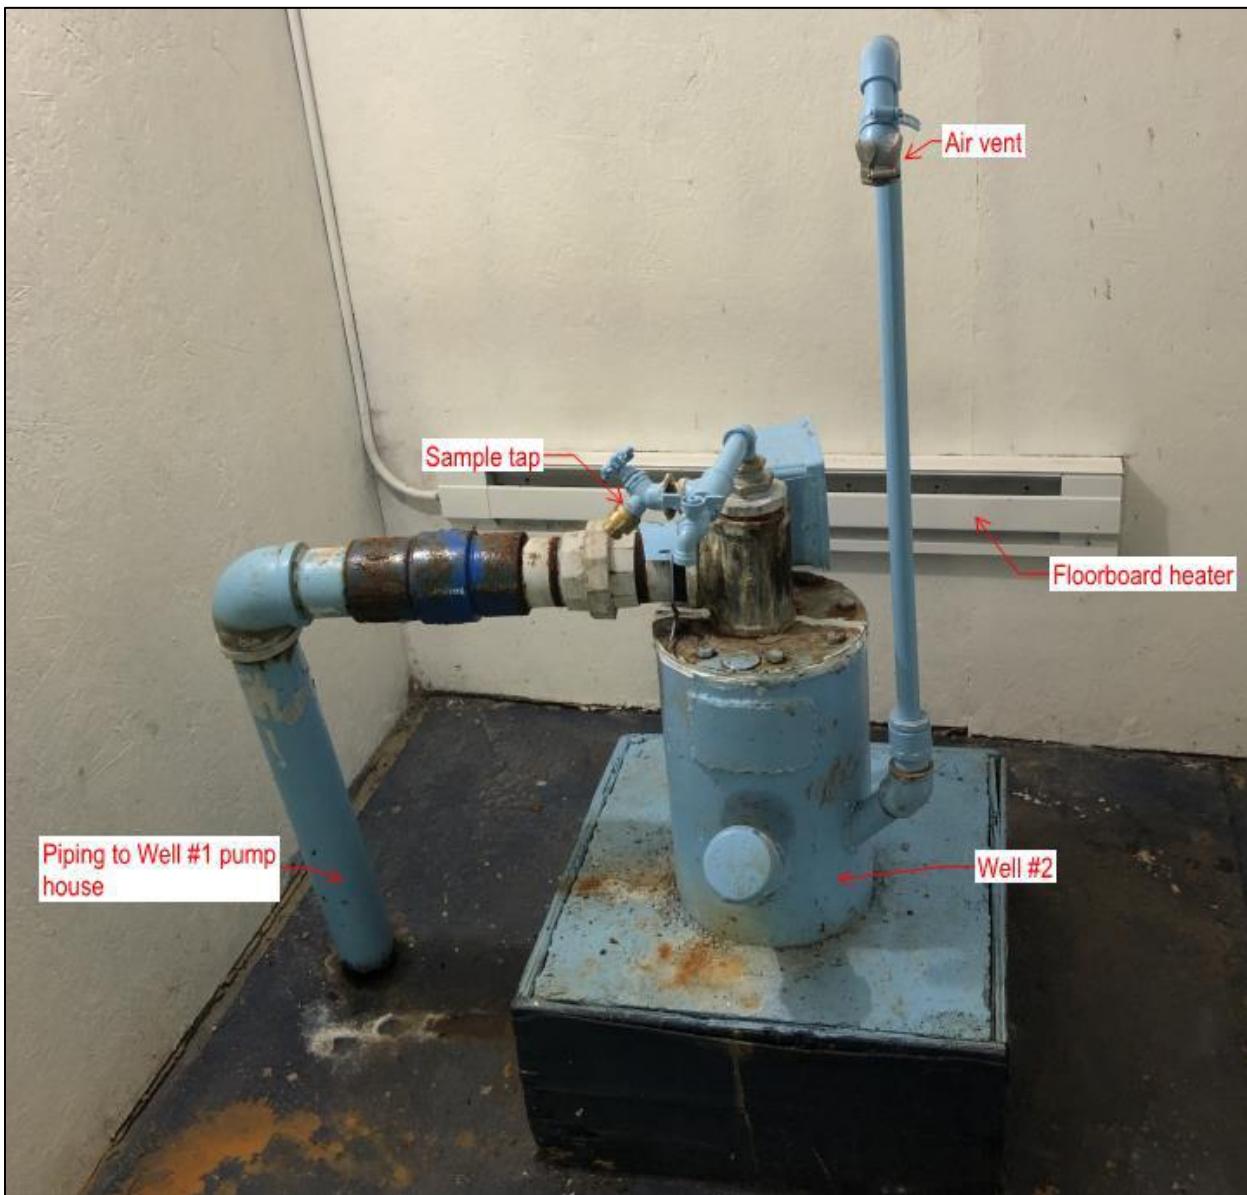
FIGURE 3-5: WELL #2 PIPING CONFIGURATION

The Well #2 pump and motor were last replaced in 2009. The pump has a reported capacity of 100 gpm, which the Corporation confirmed by completing a pump test which showed flows similar to the reported capacity. The well alternates running with Well #1 and turns on based on water level setpoints in the pressurized tank. Power is provided by a connection to Idaho Power and the motor is run by three phase power. The pump will shut off if any power phase is lost to limit heavy wear on the pumps with less than three phases. Well #2 also does not have a back-up power source. Well #2 piping configuration is shown in Figure 3-5.

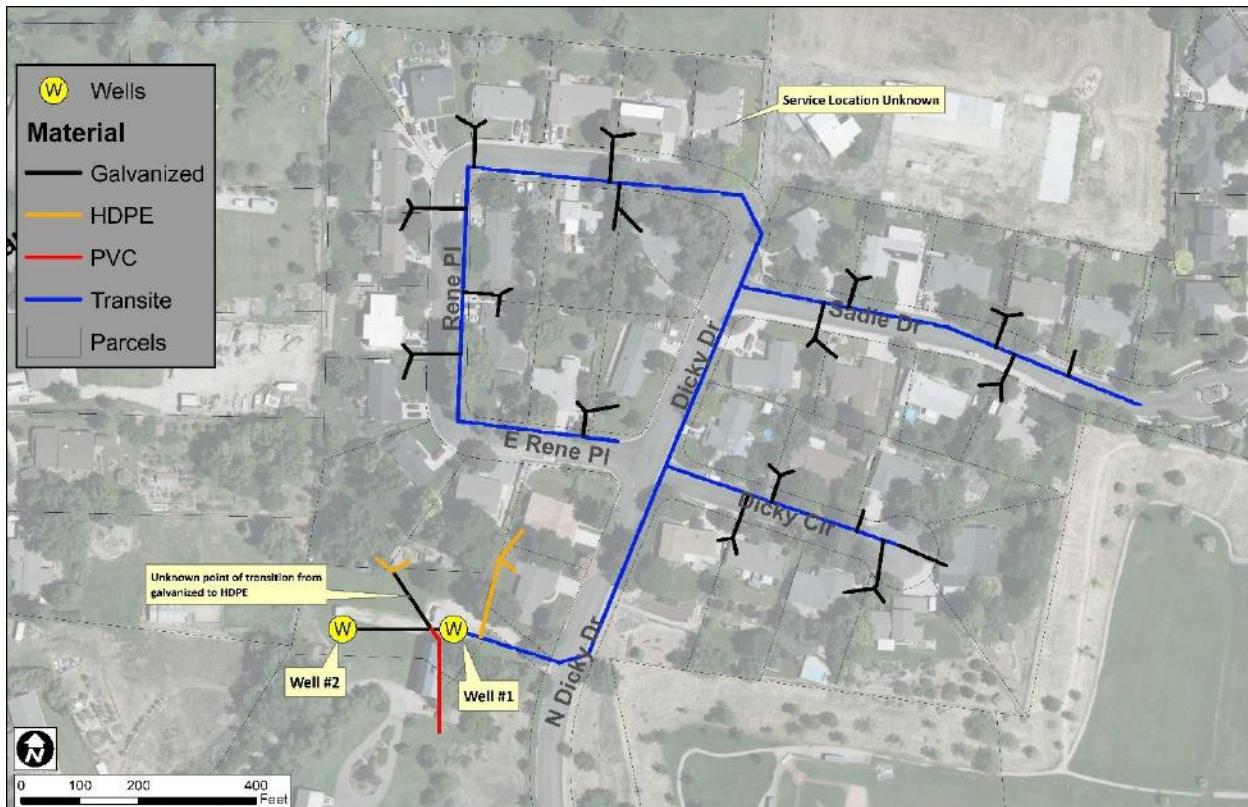
FIGURE 3-6: EXISTING DISTRIBUTION PIPING MATERIAL

The water service lines consist mostly of galvanized steel pipe. The Corporation recently replaced the service line near Well #1 with high density polyethylene pipe (HDPE) after a leak was discovered. Additionally, the service connected off of the back of the pump house serving the property to the south is made of PVC and the pipes serving the properties to the north are made of galvanized steel pipe to an unknown transition point where it becomes HDPE to the services. The pipe materials are shown in Figure 3-6.

The main deficiency in the Corporations pipe network is the 2-inch galvanized service pipes which are reaching the end of their useful life. Numerous 2-inch galvanized steel service pipes in the system have formed leaks and the Corporation has had to make emergency patch repairs to address the leaks. The Corporation believes that most of the galvanized steel pipe in the system is reaching its useful life and more leaks will occur if not replaced. It is recommended that the Corporation replace the aged service pipes with HDPE in the near future. As noted above, the mainline pipe material is aged transite and cracks easily if disturbed. Extreme care should be taken during the replacement of the service laterals to not damage the existing transite mainlines.

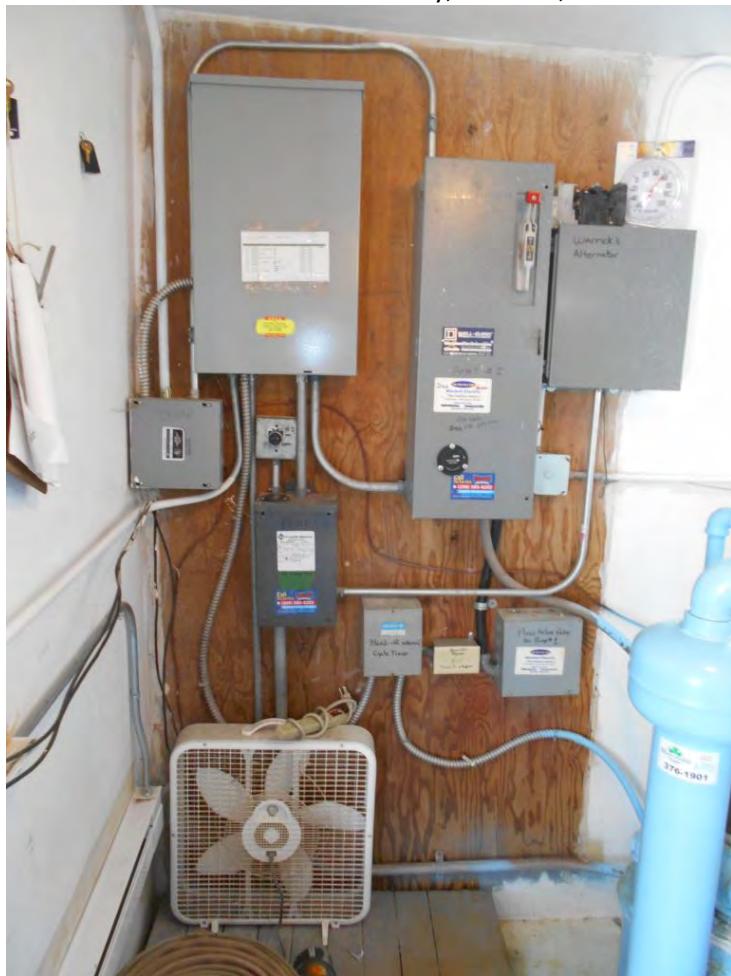
Photograph 1 :Control panel

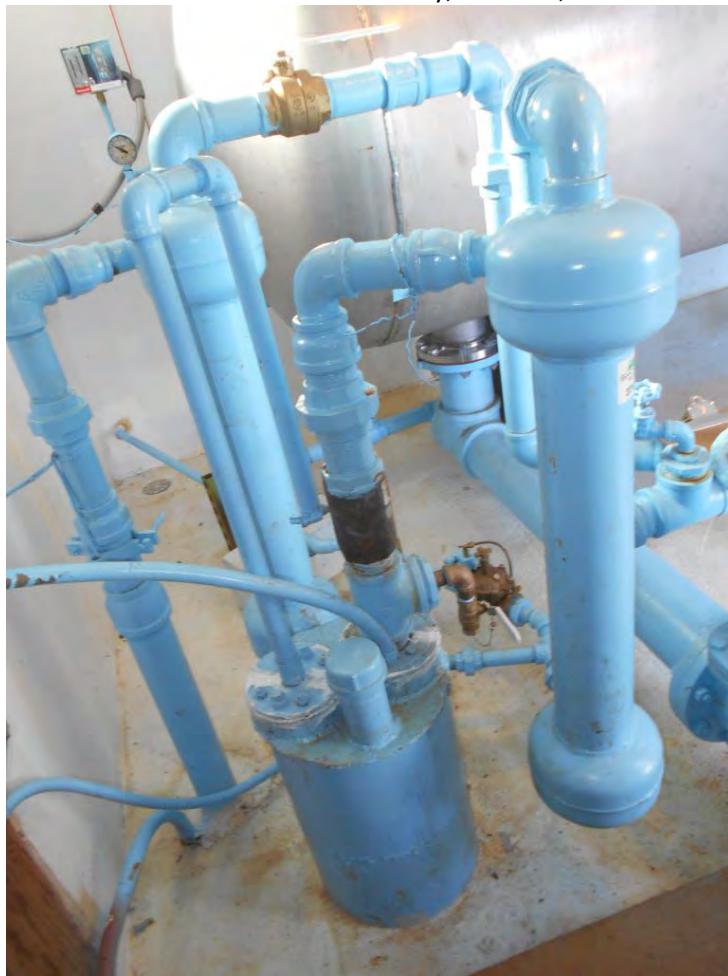
**Photograph 2 :Well #1 wellhead, valves, and piping. Left of the wellhead is the line from Well #2, which goes through its sand filter and manifolds with Well #1 piping.**

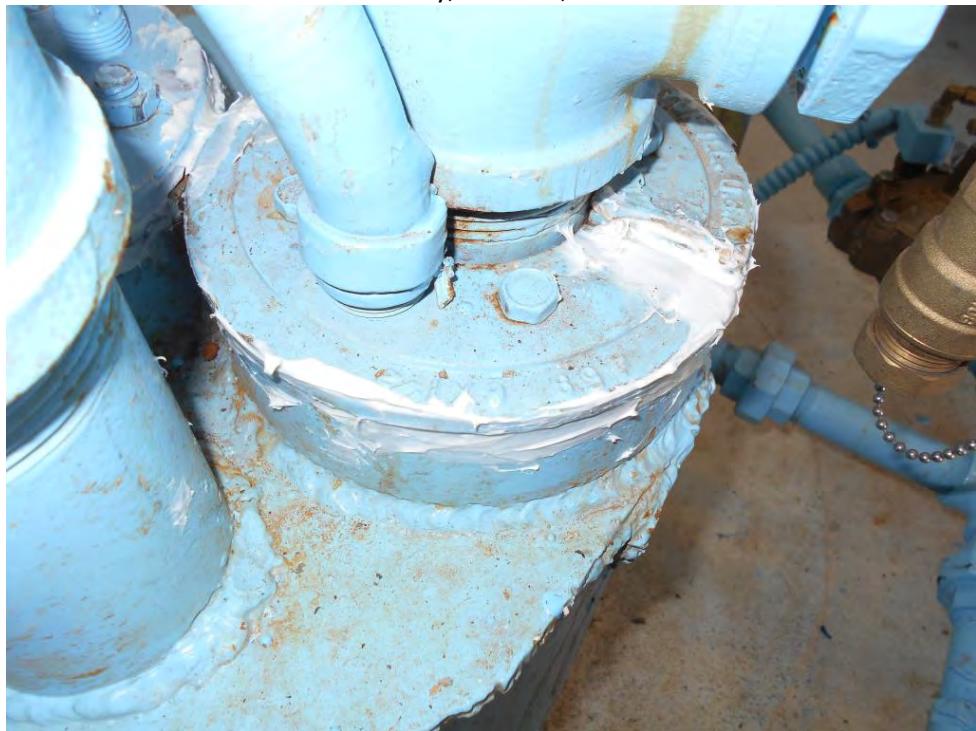
Photograph 3 :Well #1 gaps in wellhead

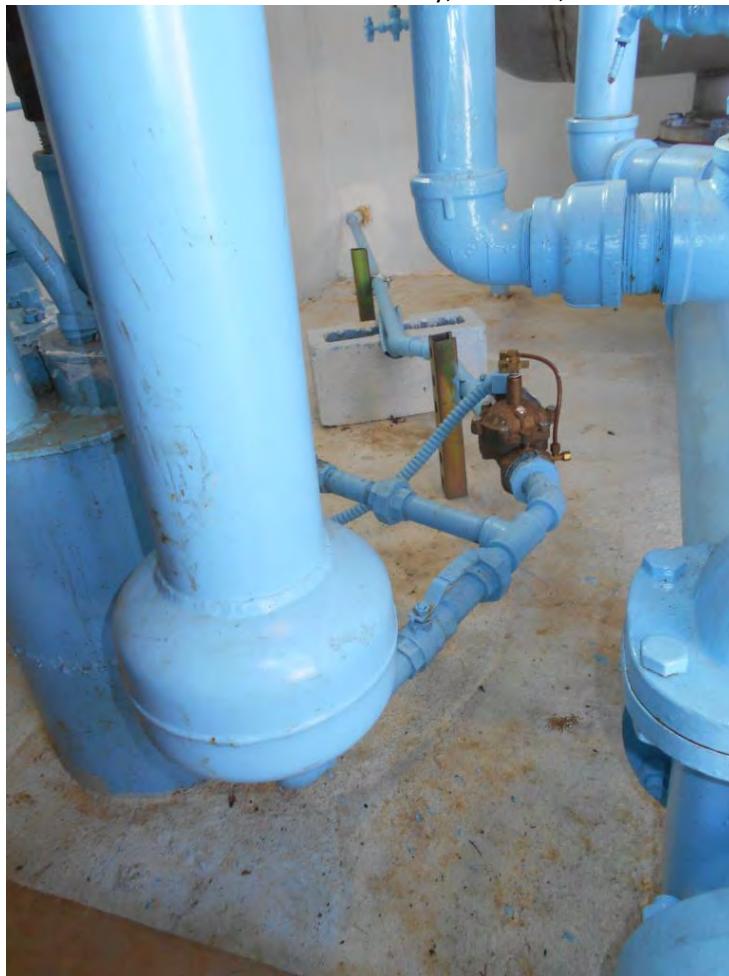
Photograph 4 :Well #1 sand trap and view of where flush lines exit the building

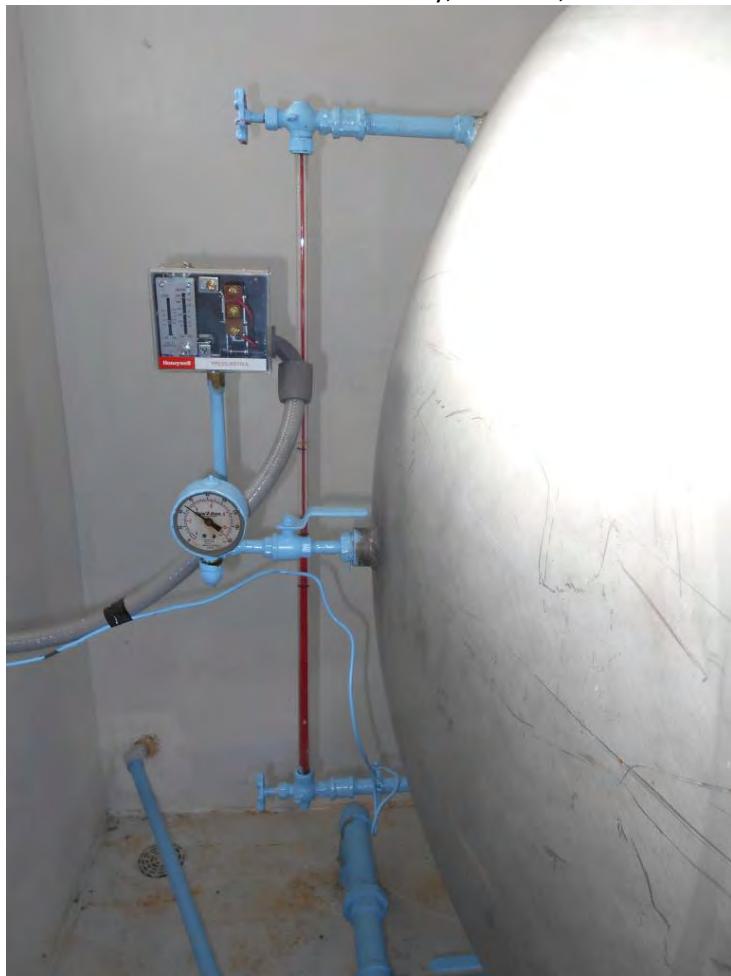
**Photograph 5 :Sight glass and pressure gauge on end of pressure tank.**

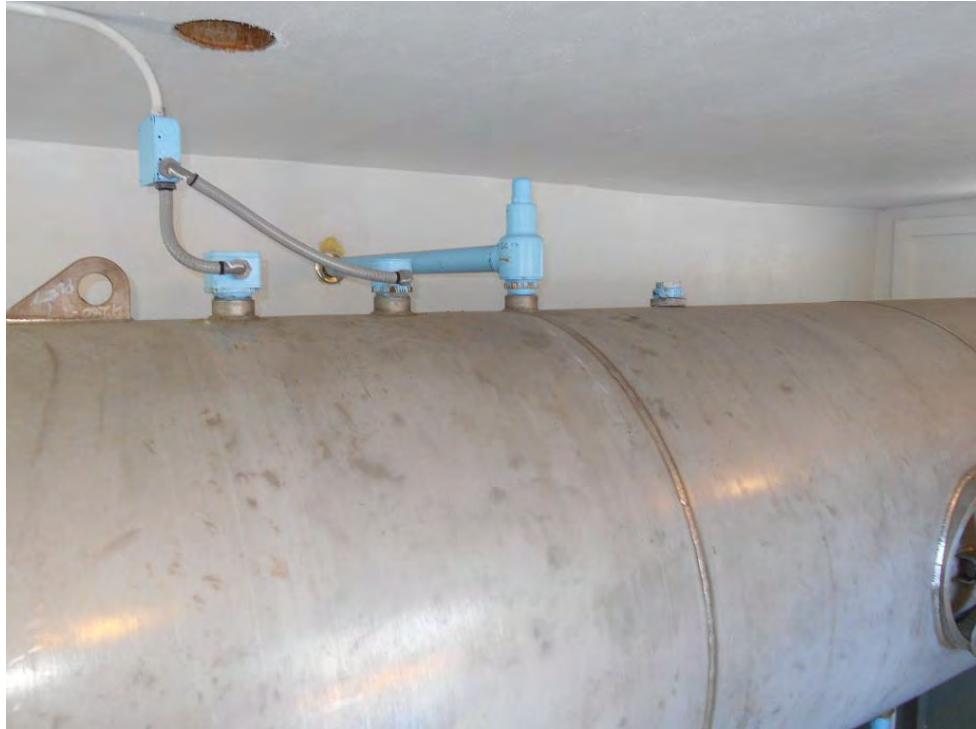
Photograph 6 :Top of pressure tank illustrating pressure relief

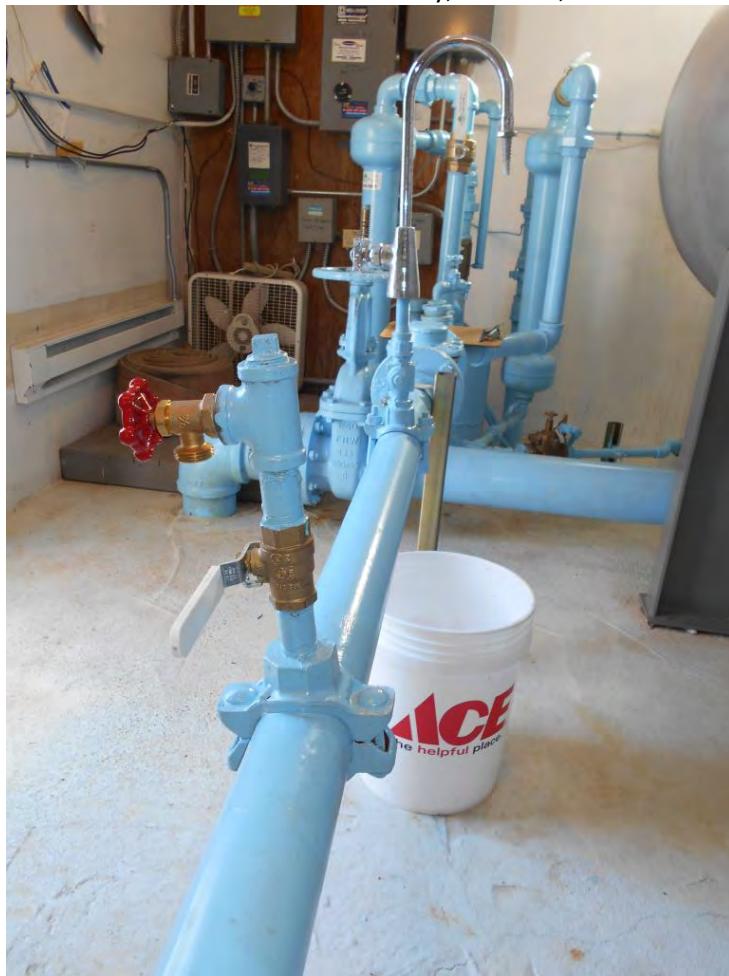
Photograph 7 :View of piping downstream of manifold with Well #1, and view of unprotected spigot

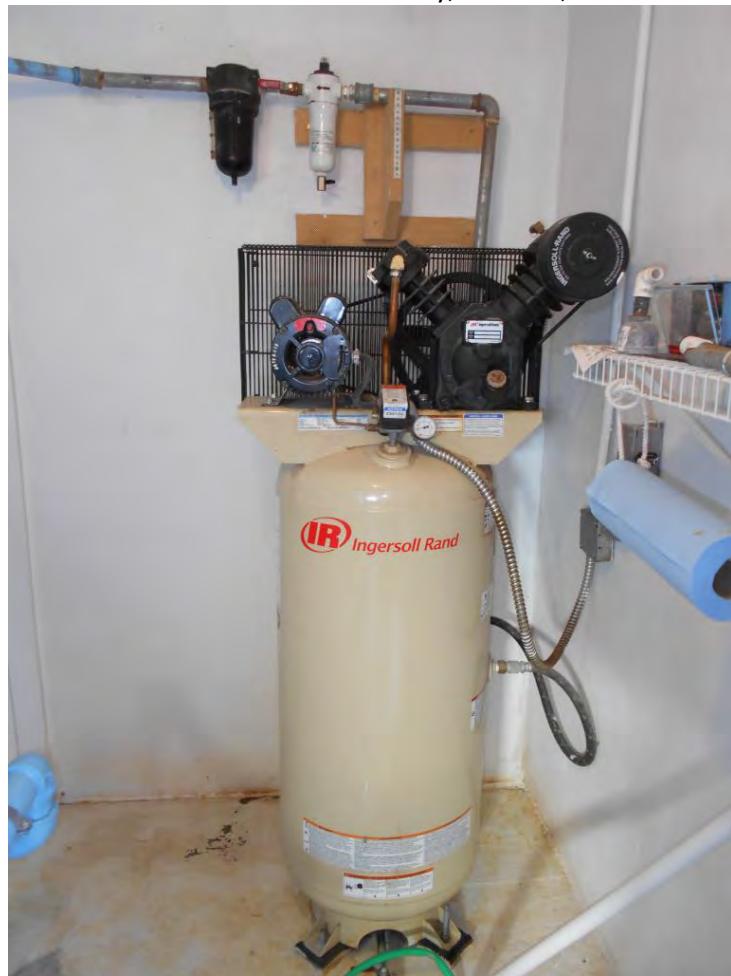
Photograph 8 :Air compressor used to maintain system pressure

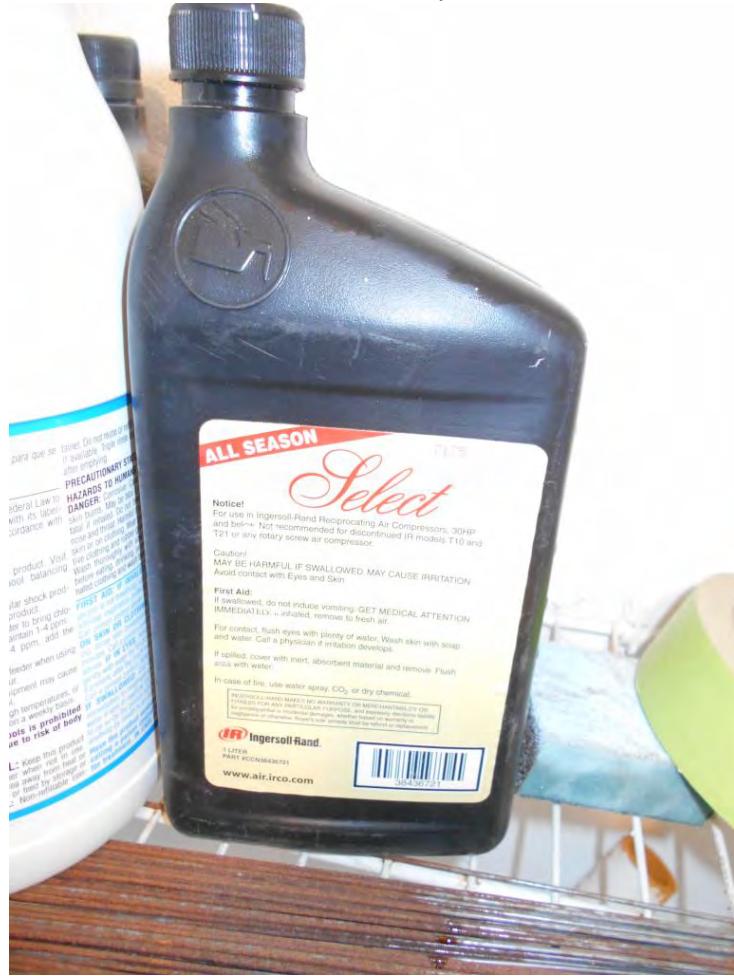
Photograph 9 :Non-NSF Approved oil being used in the air compressor

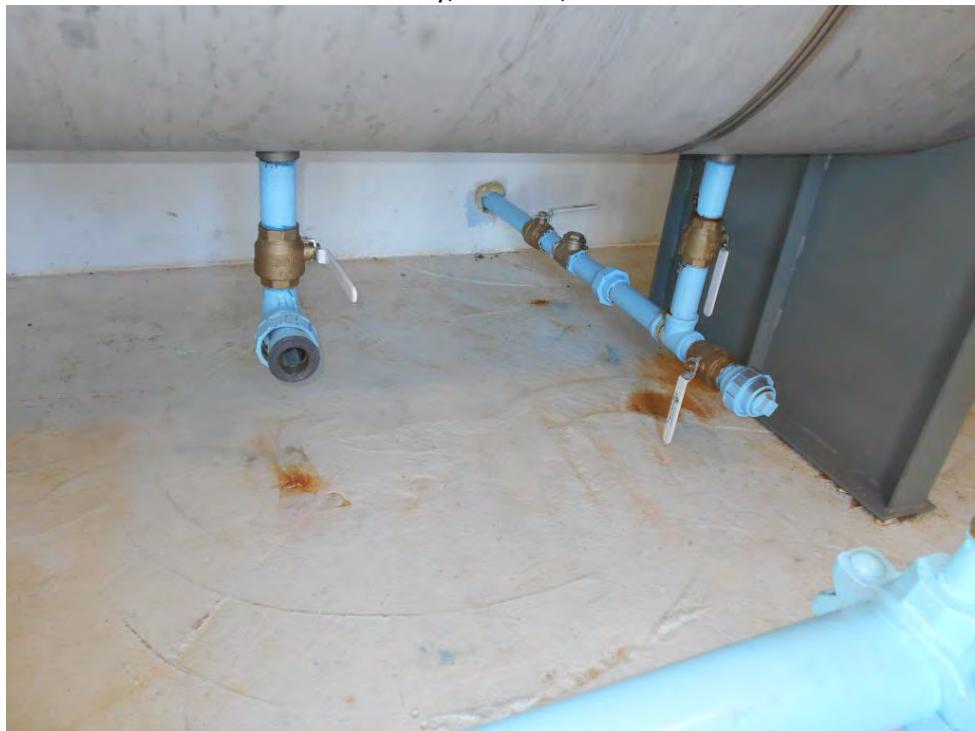
**Photograph 10 :View of bottom of pressure tank. Piping on right goes into adjacent doghouse for sprinkler system. Piping on left can be used for flush to waste**

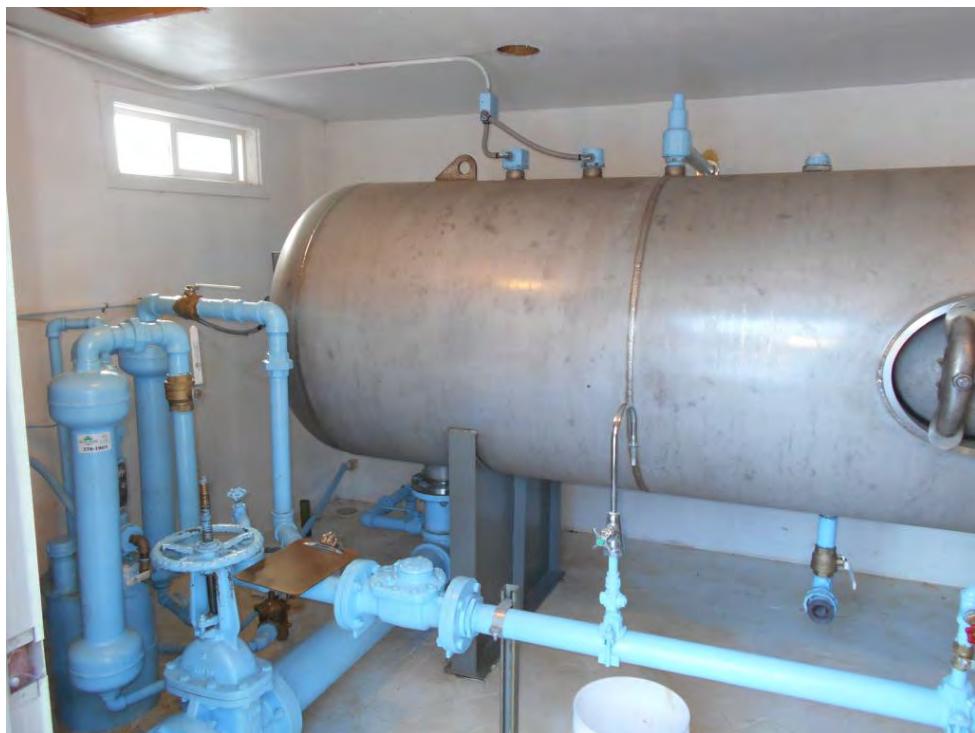
**Photograph 11 :View of left half of pressure tank and associated piping**

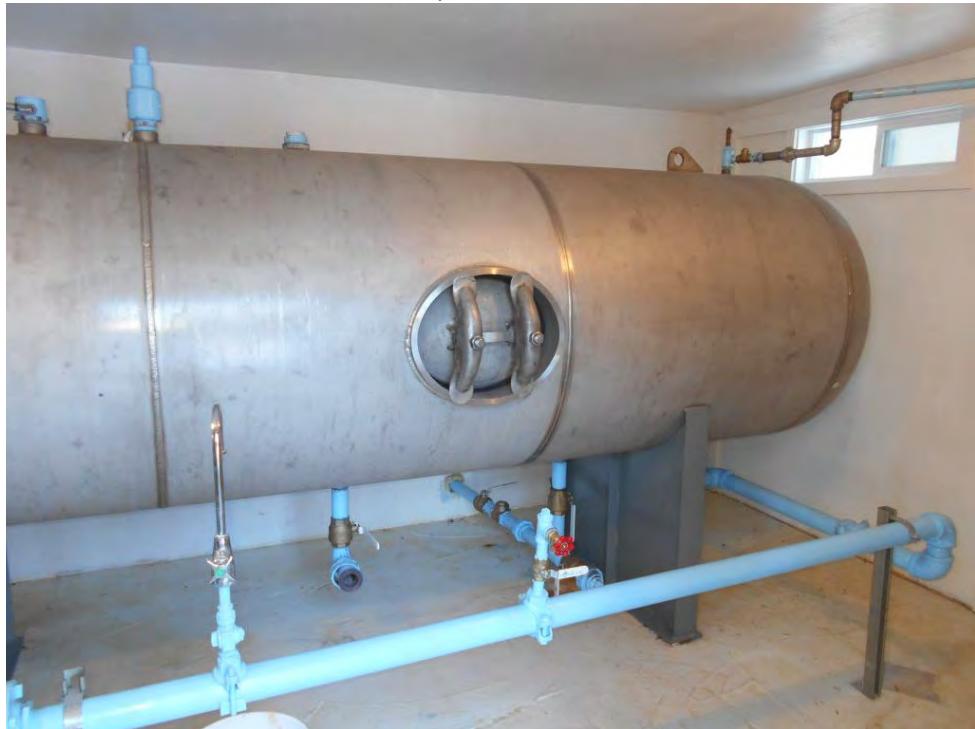
Photograph 12 :View of right half of pressure tank and associated piping

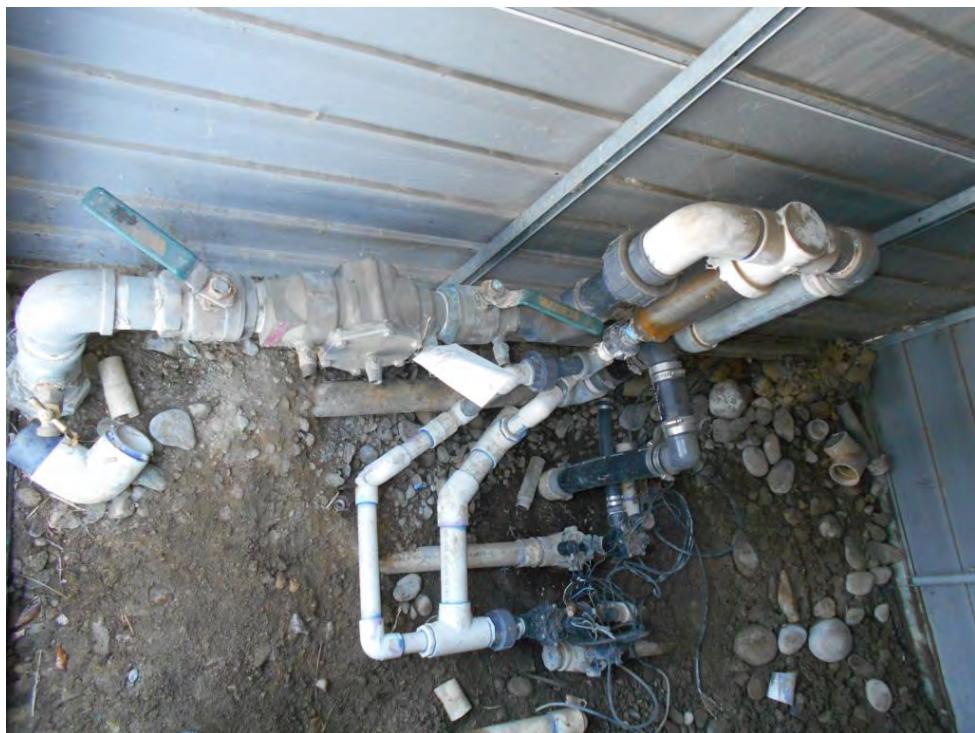
Photograph 13 :Sprinkler system piping that is just outside of wellhouse. Note filter and its discharge valve is on upstream side of backflow assembly.

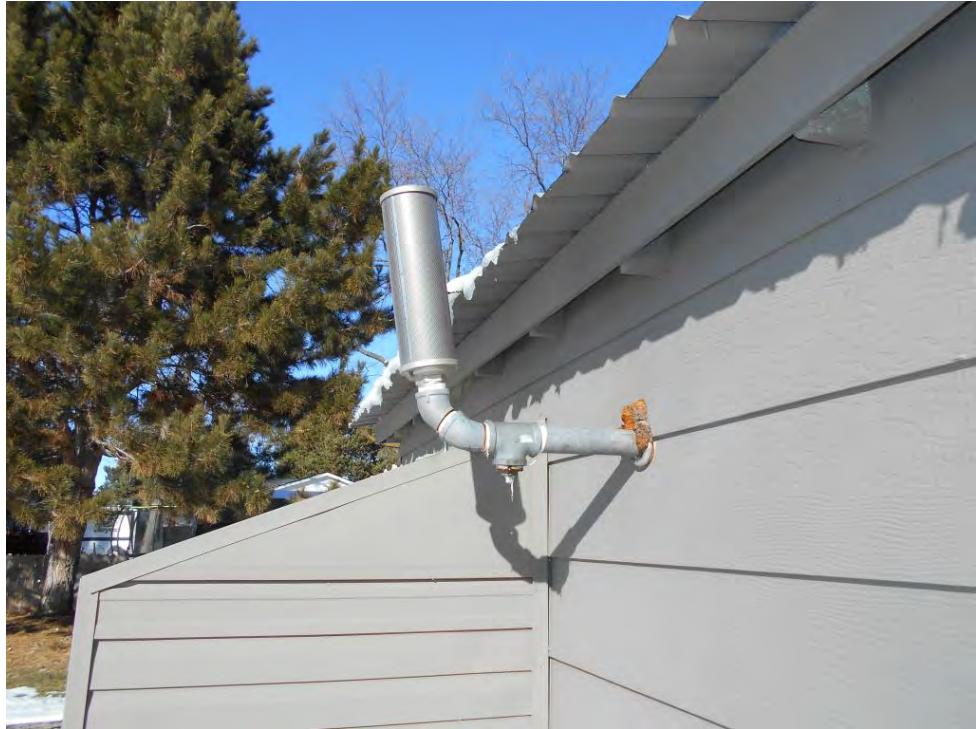
**Photograph 14 :Pressure relief discharge point. Muffler looking apparatus installed in response to neighbors complaining about noise of original design**

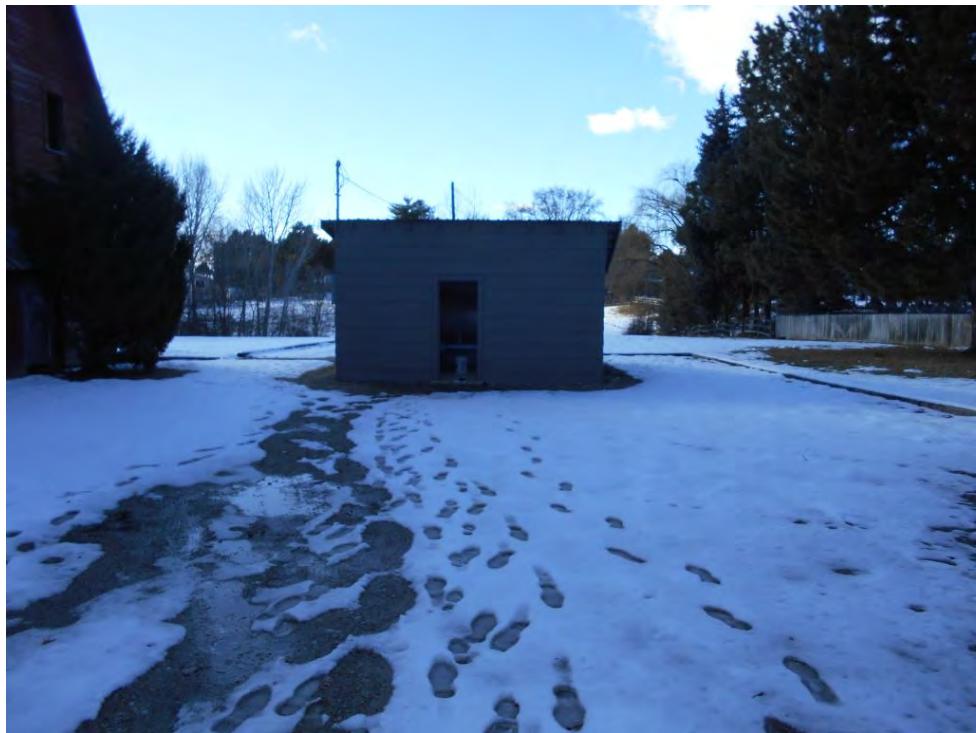
**Photograph 15 :View of front of Well #1 wellhouse**

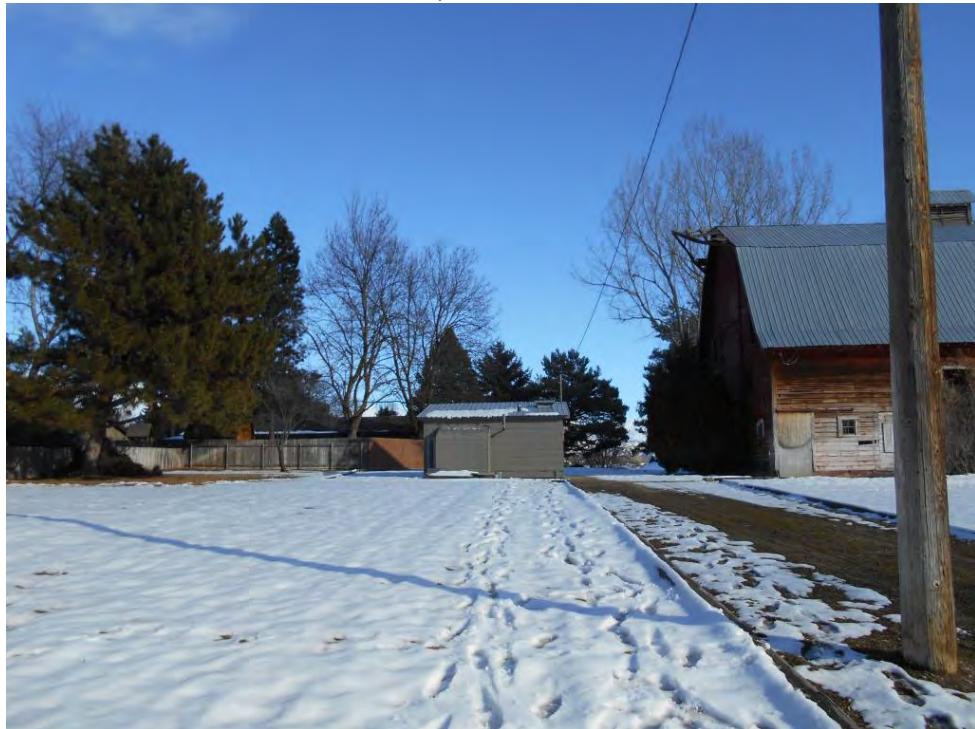
Photograph 16 :View of back of Well #1 wellhouse

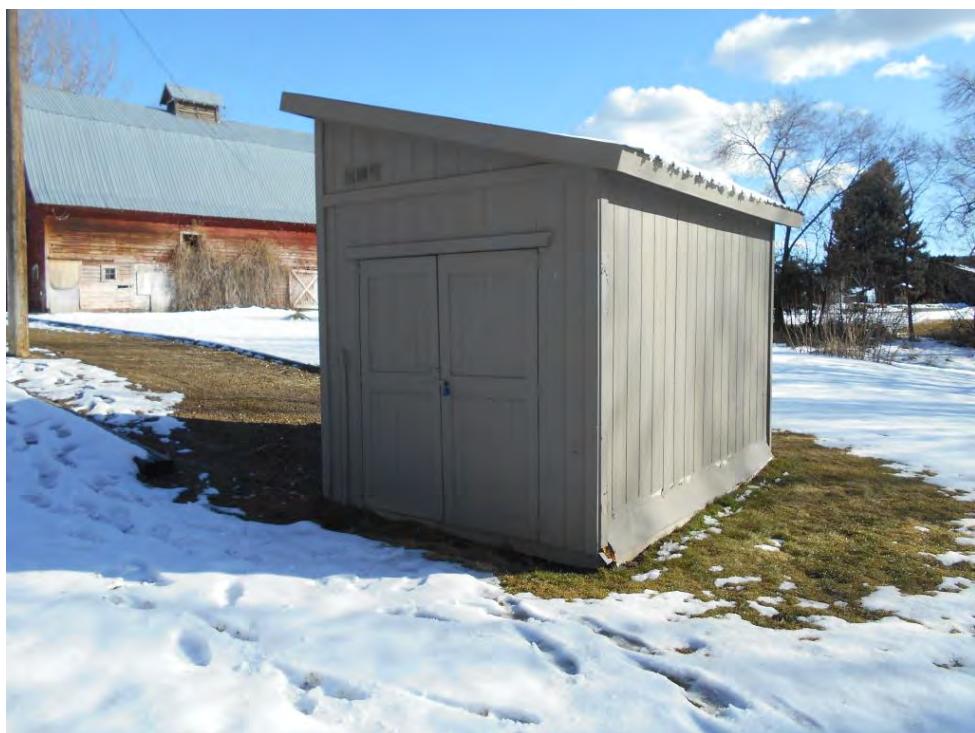
Photograph 17 :Well #2 wellhouse

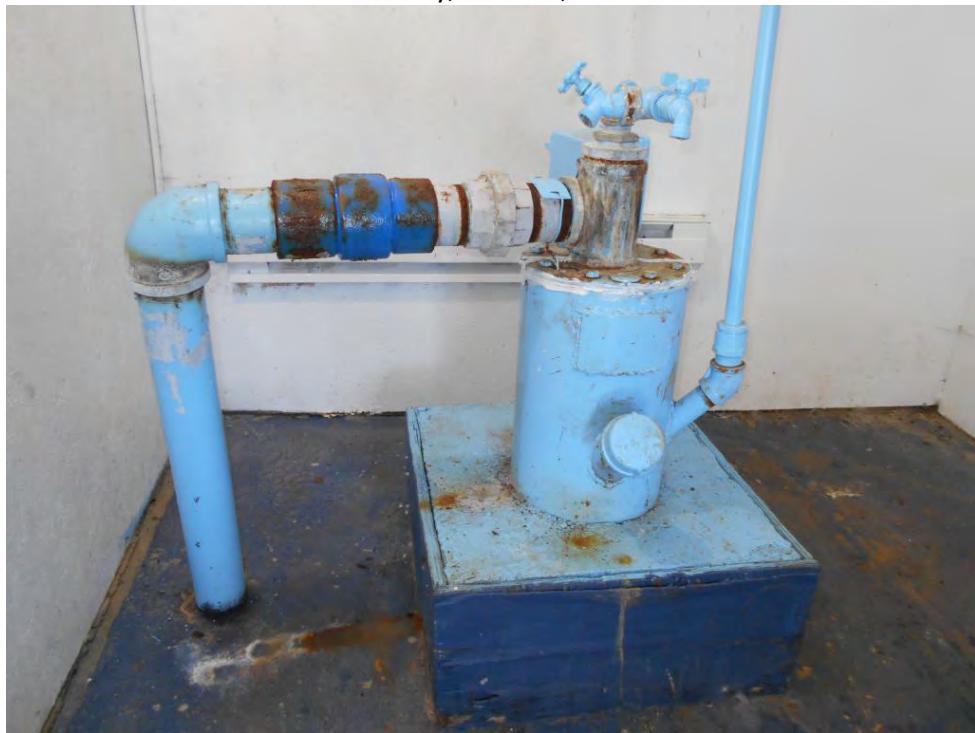
Photograph 18 :Well #2 wellhead

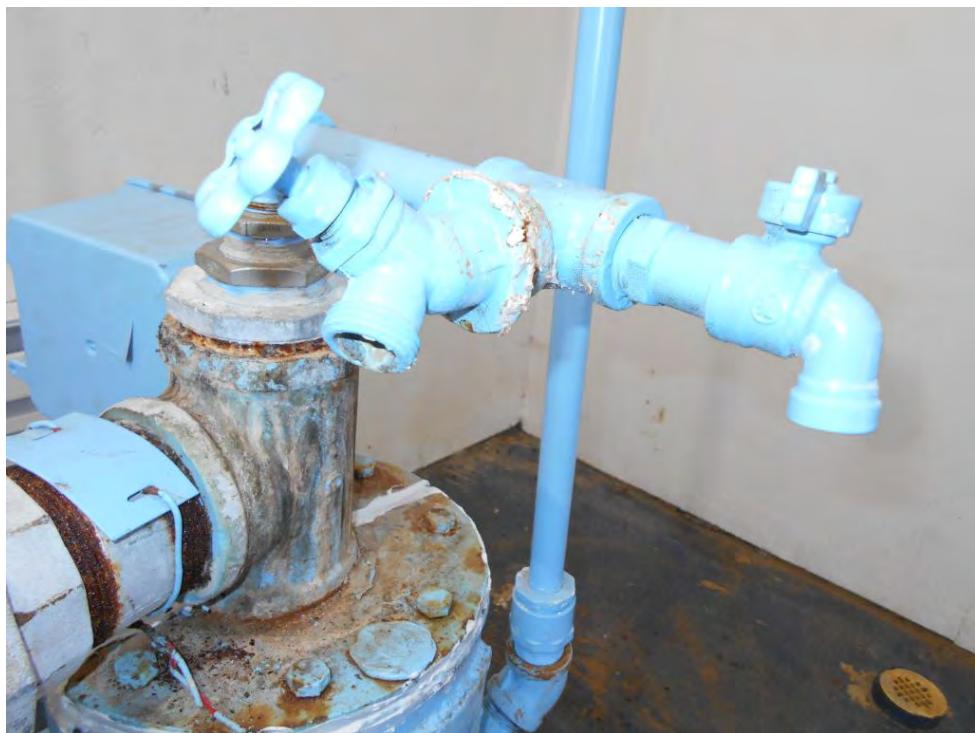
Photograph 19 :Well #2 sample tap. Threaded tap needs backflow protection.

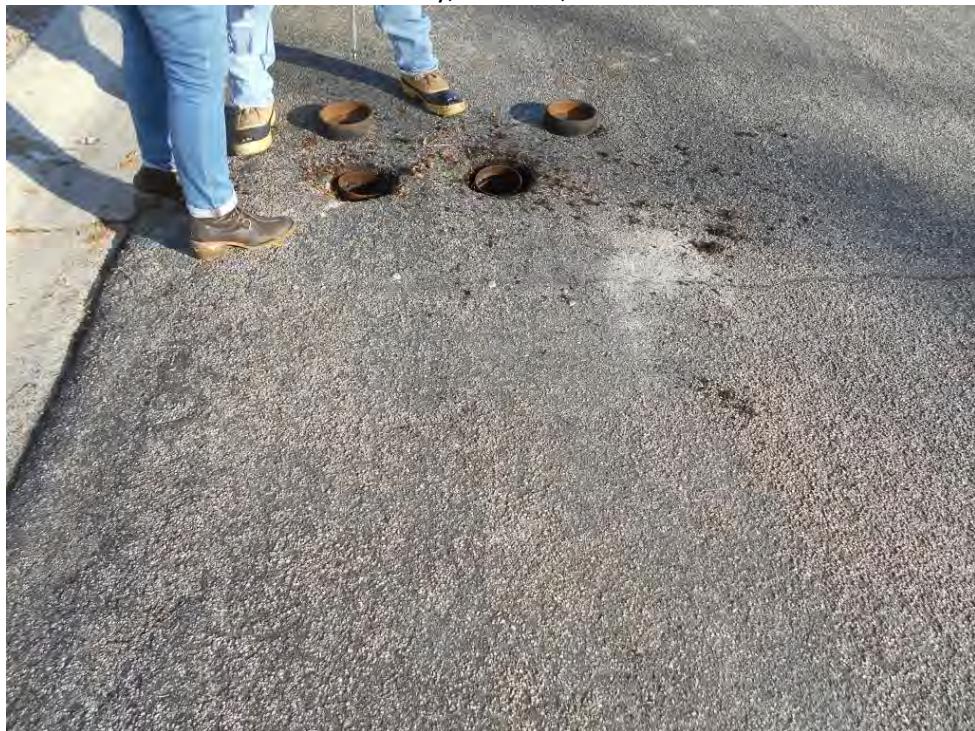
Photograph 20 : View of typical blow offs for system. One cap houses valve, other cap houses pipe to which directional flushing pipe can be attached

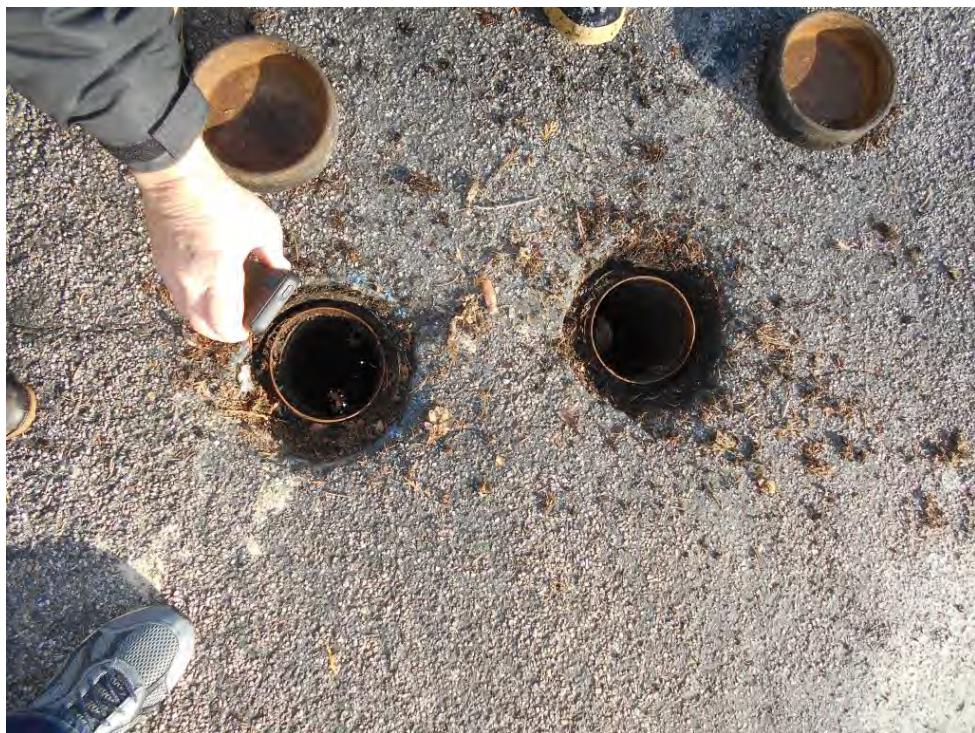
Photograph 21 :Closeup view of cap contents
