# EVANS WATER CORPORATION WATER MASTER PLAN STUDY

Date: Feb 14, 2022 DECEMBER 2021

PROJECT NO. 220126

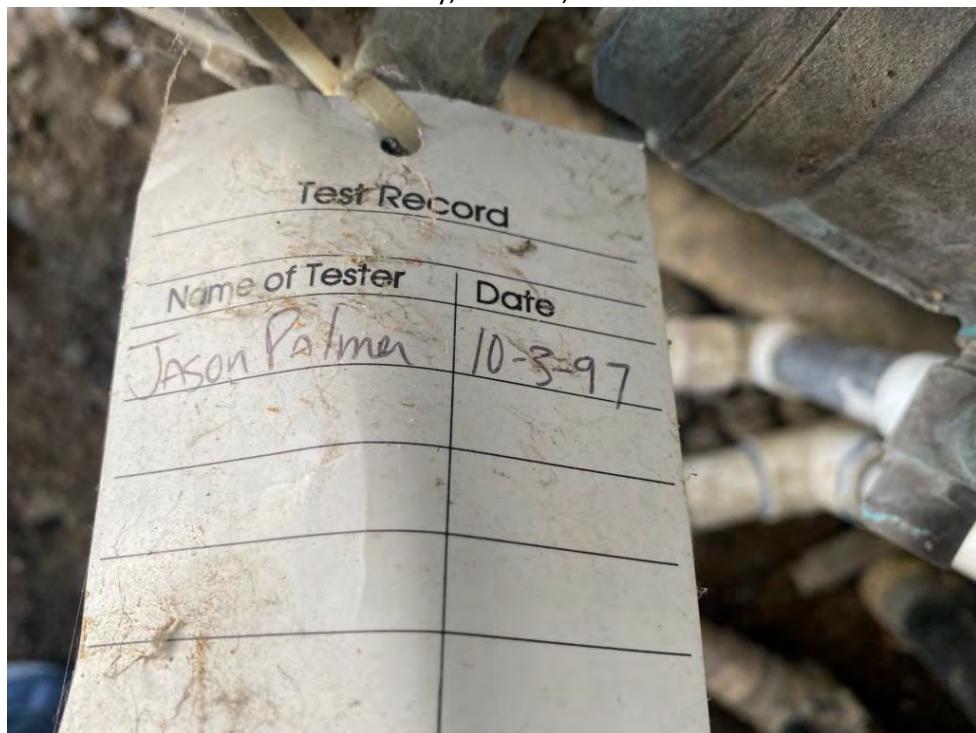
Photograph 22 :Tag for backflow assembly. Has not been tested since 1997, per paperwork.

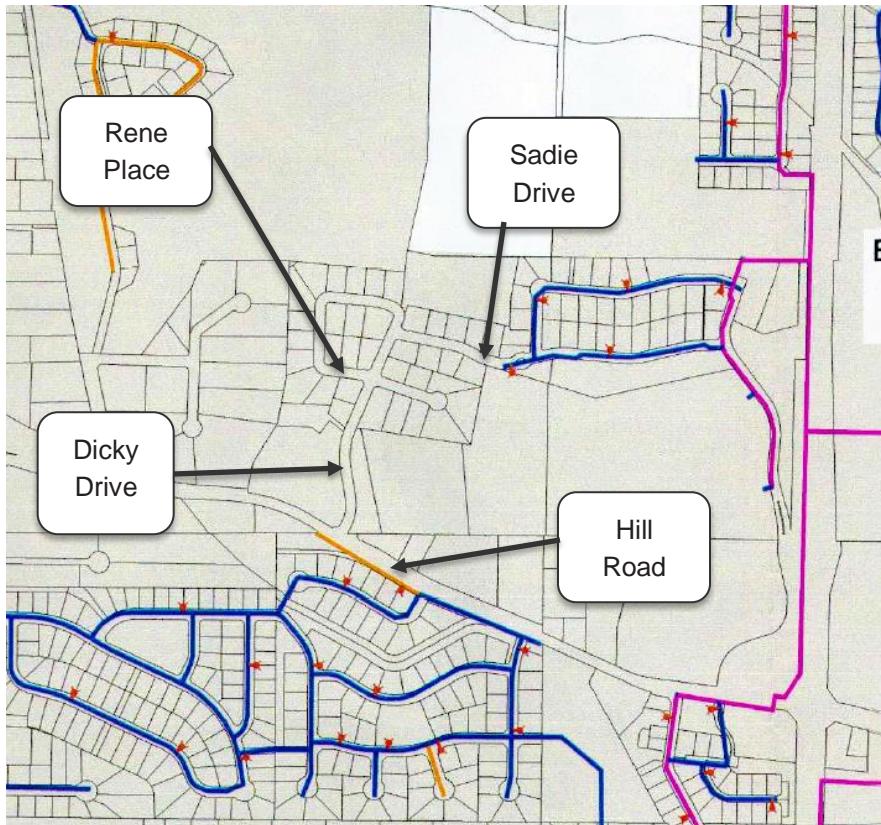
Figure 1 – Existing Eagle Water Company Infrastructure near Evans Water Corporation

Evans Water Corporation would be completely within the SUEZ certificated area, therefore no formal IPUC process would be anticipated. Figure 1 shows existing Eagle Water Company pipelines near Evans Water Corporation. **Yellow** are 6-inch diameter mains, **blue** are 8-inch diameter mains, **pink** are 12-inch diameter mains. Fire hydrant locations are also shown.
