## Technical Site Visit Report

| Report Number | ESV-2026-0125 |
| Project Name | Bomman Sreekumar |
| Site Address | #5, Krishna kuteer villas, phase 2, 5th cross, Hoodi.Bangalore 560048 |

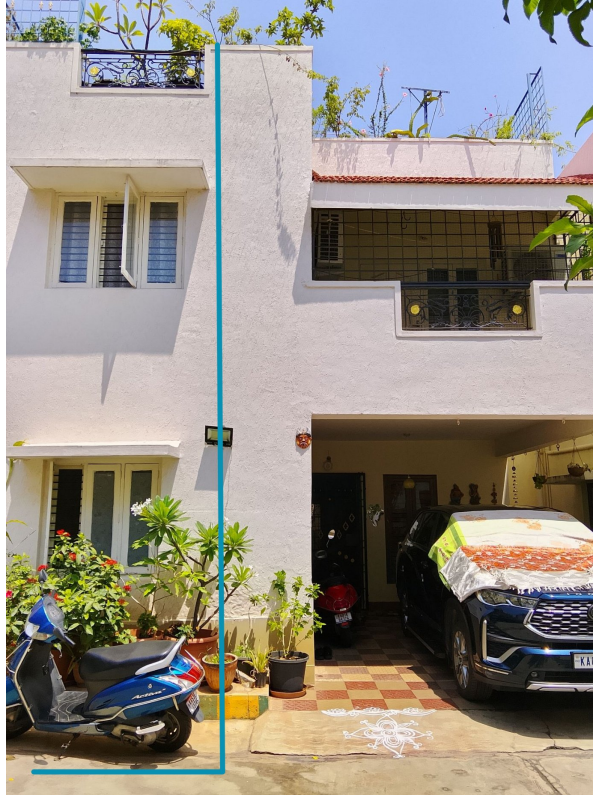
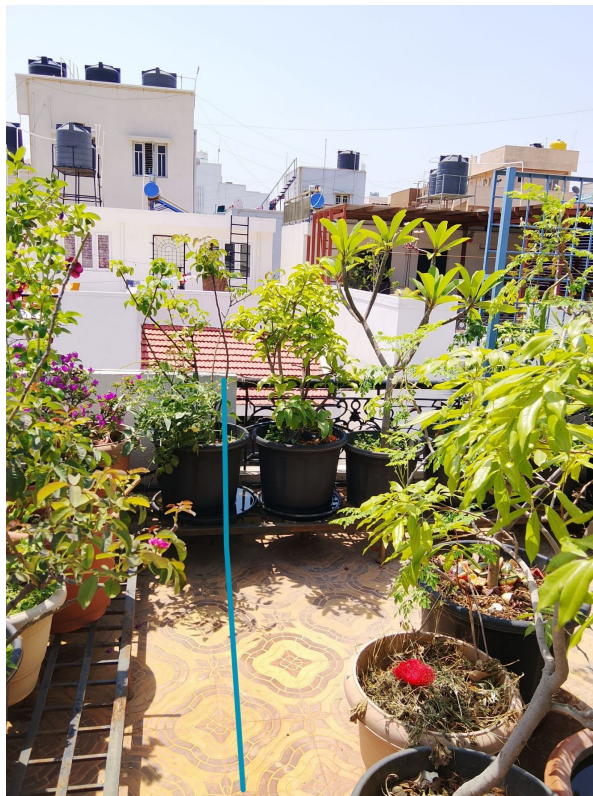
## Material Delivery Route

*This route (using lifting) will be followed to carry large items (like Panels).*

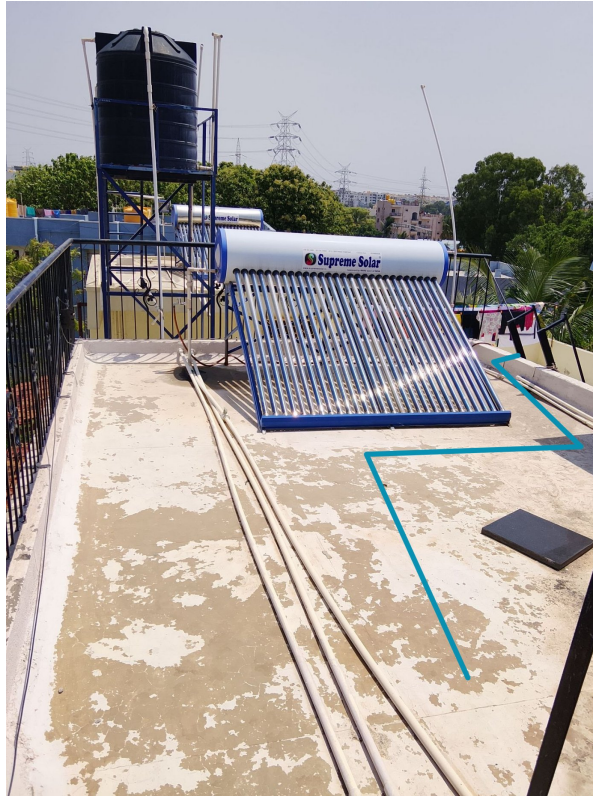
*At the time of installation removing solar water is under customer scope*

| # | Observation |
|---|---|
| 4 | Re locate the solar water heater is under customer scope |

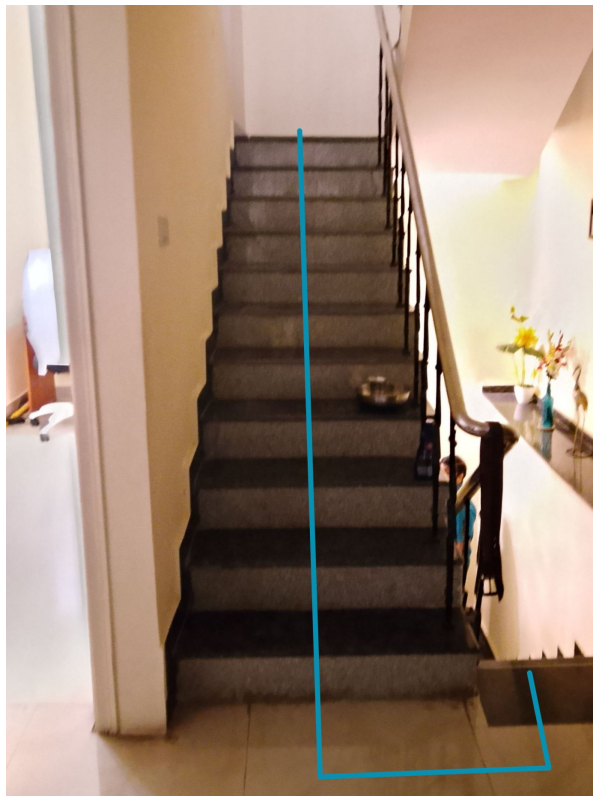
*This route (using Staircase) will be followed to carry Small items.*

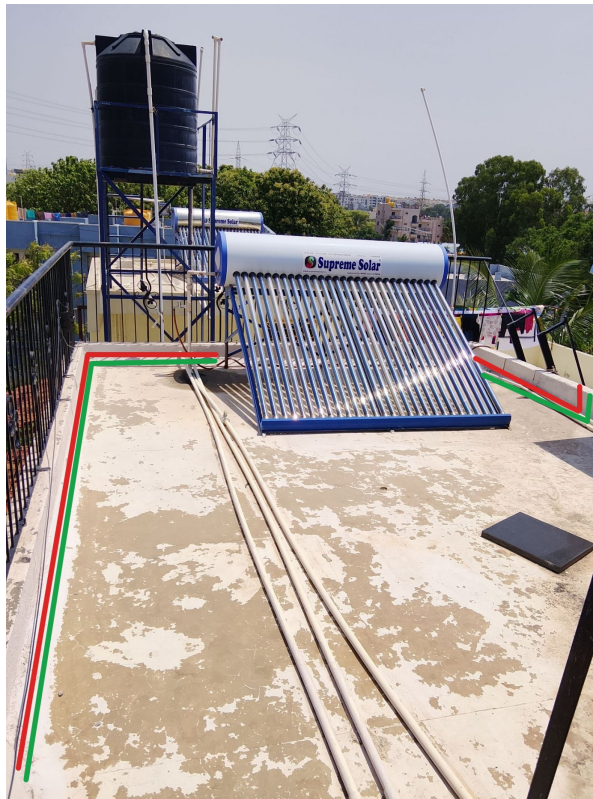
### Cable Routing

*Make a hole to run the DC Cable inside the solar meter location*

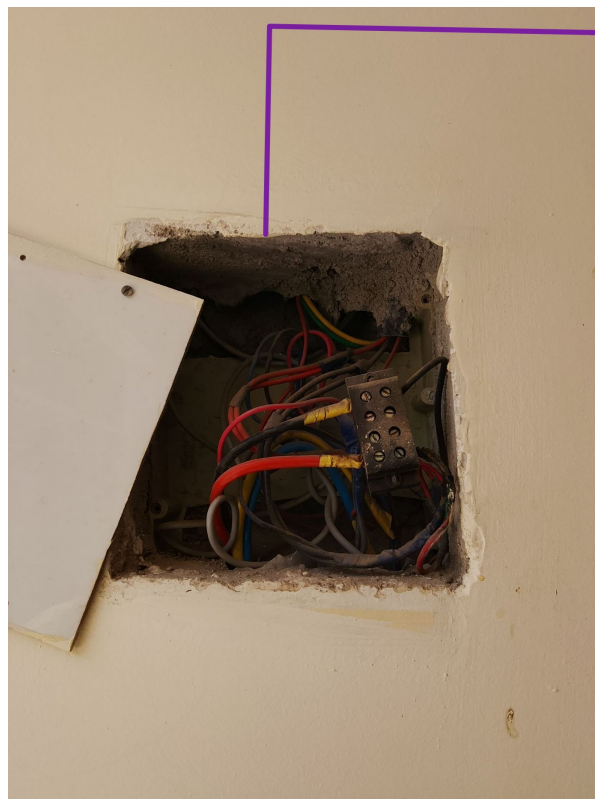
| # | Observation |
|---|---|
| 1 | The client main meter is located faraway ,but we have to terminate in main distribution board |

*The AC cable has to be terminate in the main distrinution board*

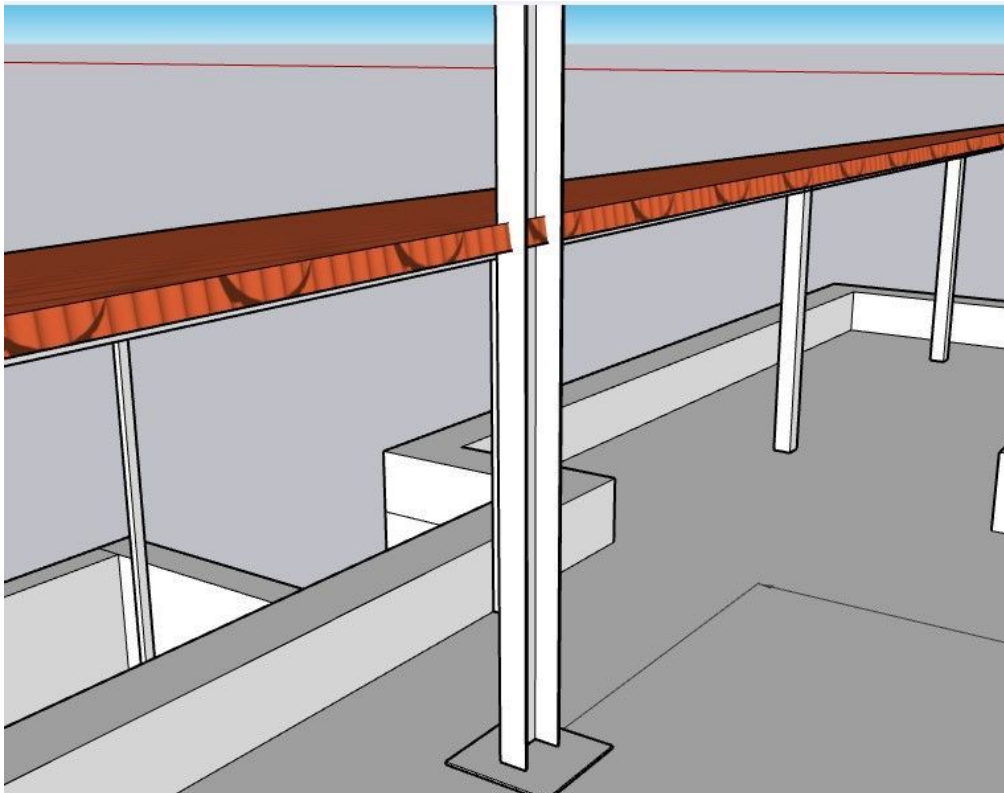
| # | Question | Answer | Notes |
|---|---|---|---|
| 2 | Are there any obstructions on the roof that could affect the solar installation? | details: The manglore tiles are | - |

| # | Question | Answer | Notes |
|---|---|---|---|
| | | the obstructions on the roof that could affect the solar installation. | |

*At the time of installation client has to be removed some tiles to avoid installation distrubnces*

| # | Observation |
|---|---|
| 3 | At the time of installation client has to be removed some tiles to avoid installation disturbances |

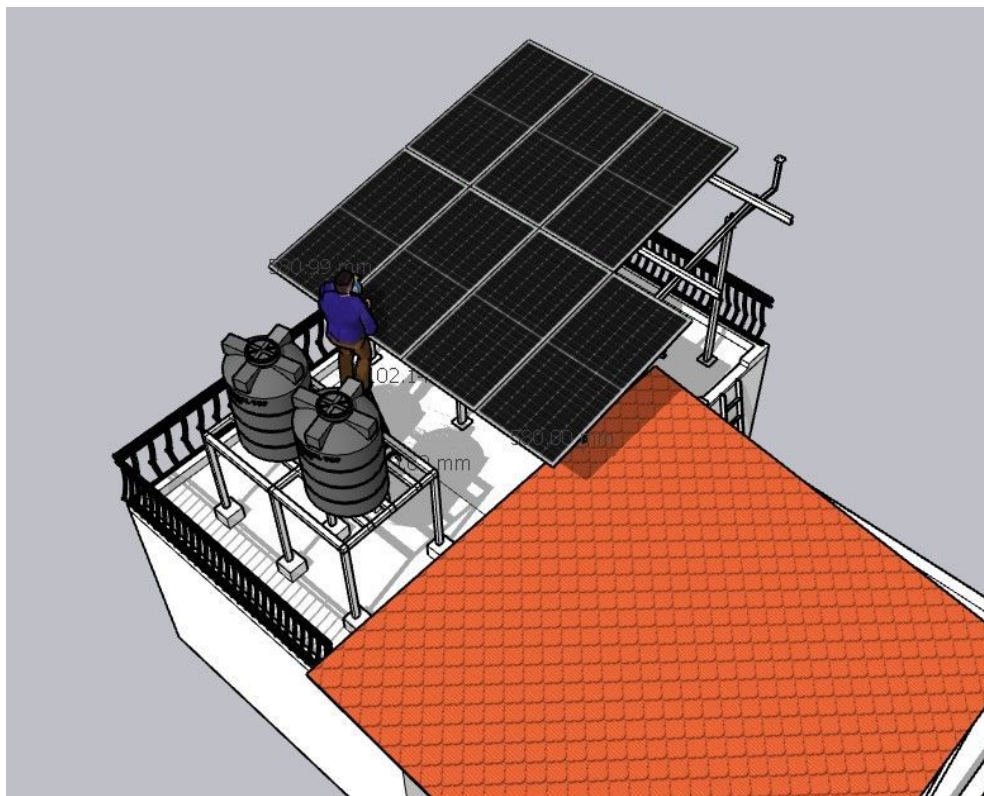
## Shadow Analysis

| # | Question | Answer | Notes |
|---|---|---|---|
| 23 | Is there any shadow that affects the solar installation? | Yes | The existing water tank shadow will fall on the panels during the month of May to september between 3.30 PM to 4.00 PM. |

The existing water tank shadow will fall on the panels during the month of May to september between 3.30 PM to 4.00 PM.
