## Technical Site Visit Report

Prepared for: Sridhar Babu Y - Villa #185

| Report Number | ESV-2026-0146 |
| Billing Name | Sridhar Babu Y_La Villa Township Subsidy_4.8kWp_String |

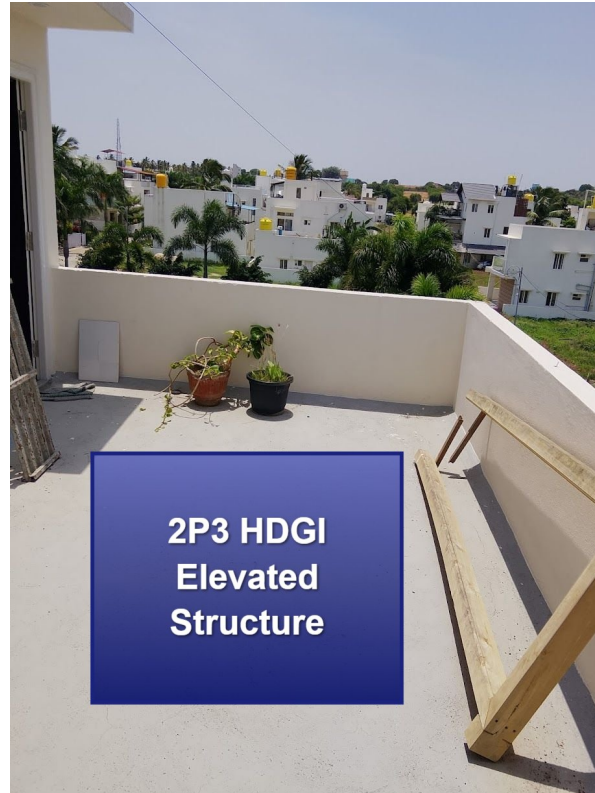
## Proposed PV Area

*2P3 HDGI Elevated structure with 2.5 m height*

| # | Observation |
|---|---|
| 4 | Based on the site conditions the HDGI front height should be maintained 2.50m. |
