## Technical Site Visit Report

Prepared for: Sridhar Babu Y - Villa #185

| Report Number | ESV-2026-0146 |
| Project Name | Sridhar Babu Y |

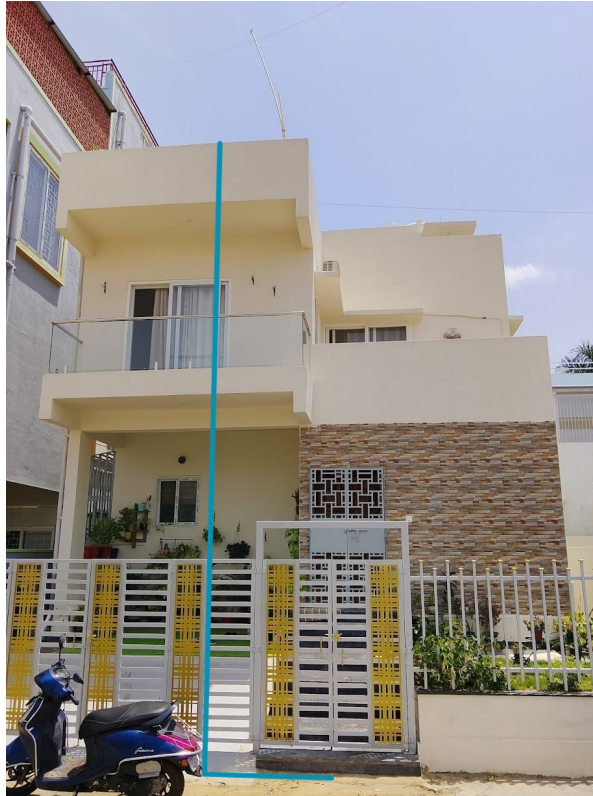
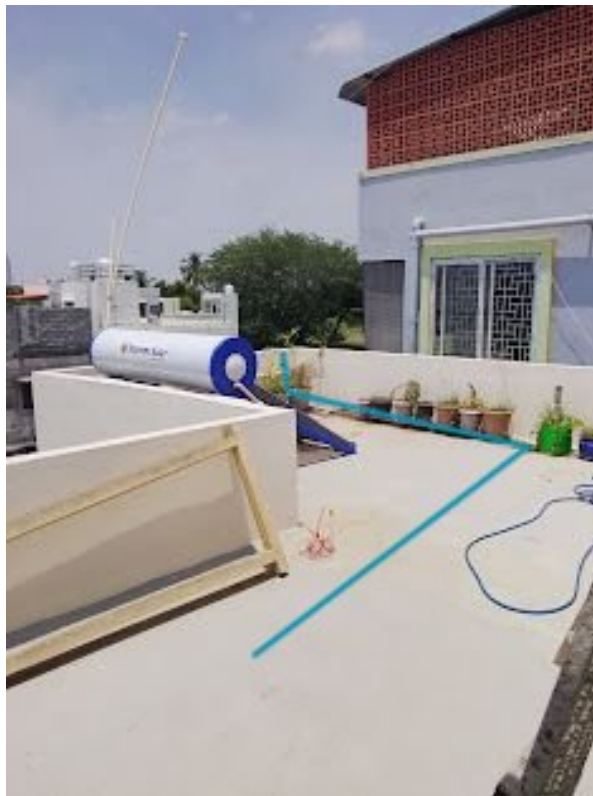
*This route (using lifting) will be followed to carry large items (like Panels).*

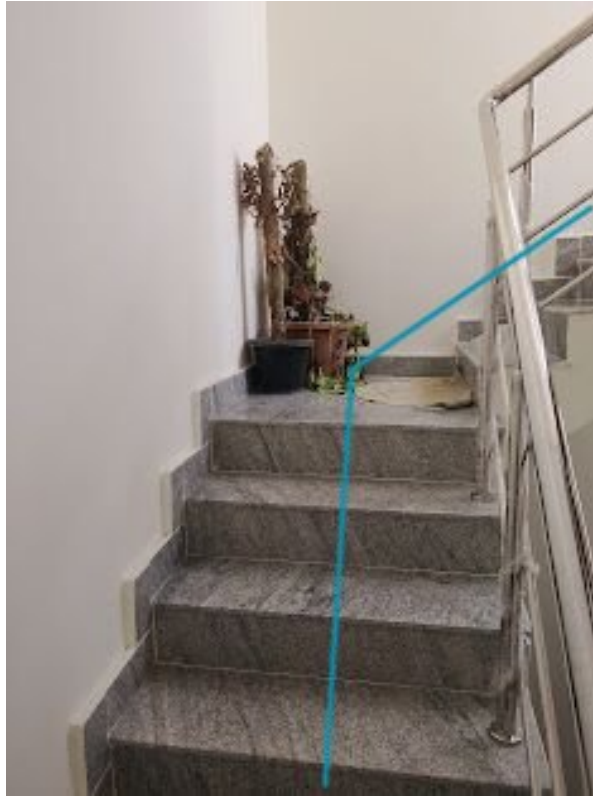
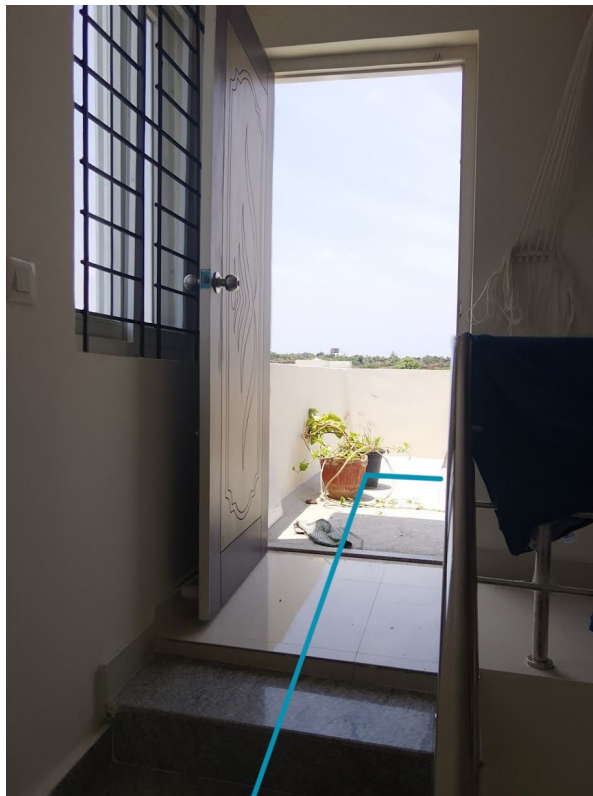
*This route (using Staircase) will be followed to carry Small items.*

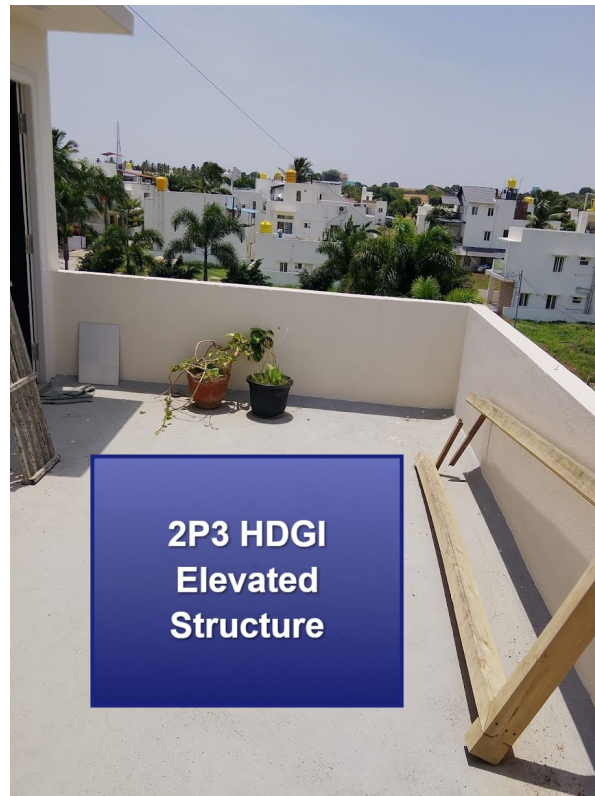
*2P3 HDGI Elevated structure with 2.5 m height*

| # | Observation |
|---|---|
| 4 | Based on the site conditions the HDGI front height should be maintained 2.50m. |

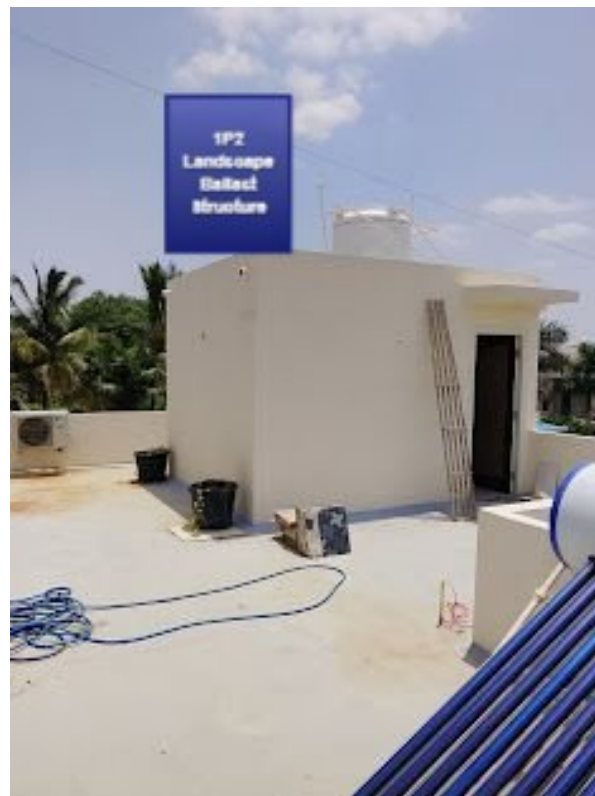
*1P2 landscape Ballast structure with 0.45m front clearance*

| # | Observation |
|---|---|
| 1 | At the time of installation based on the site conditions to keep the landscape Ballast structure |

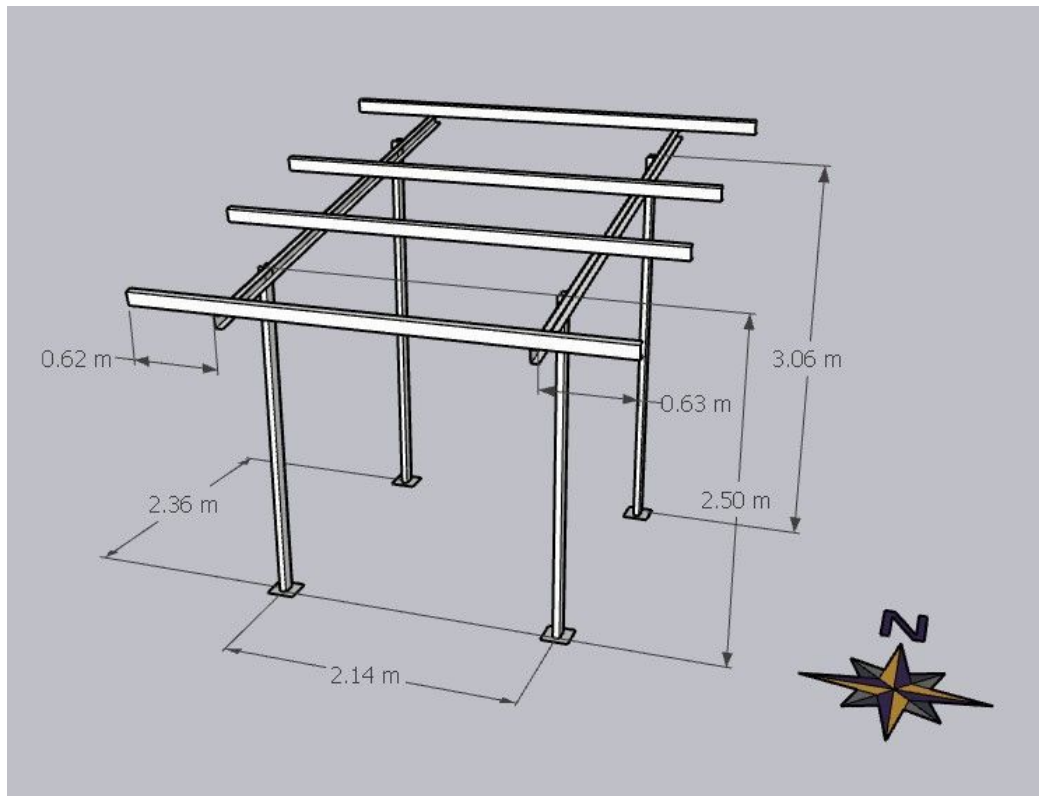
*Dimensions of 2.5m HDGI structure*

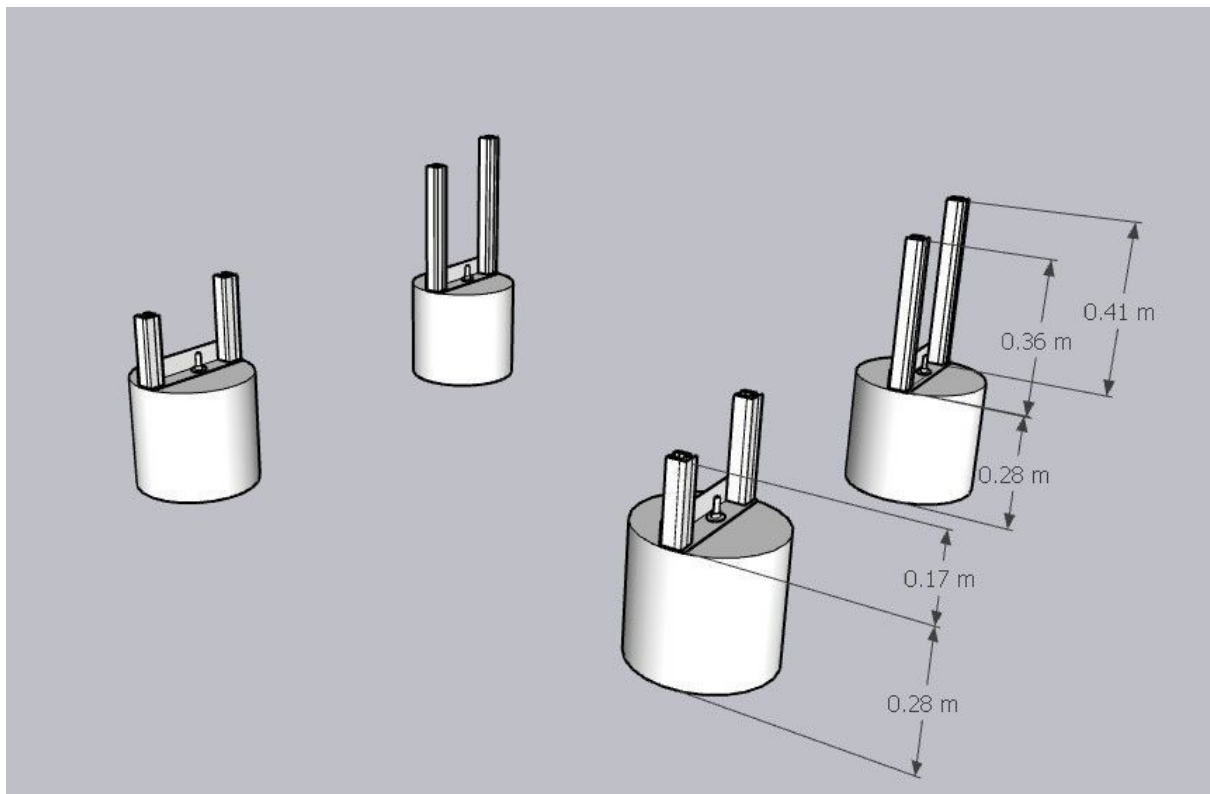
*Landscape Ballast Structure with 0.45 m front clearance*

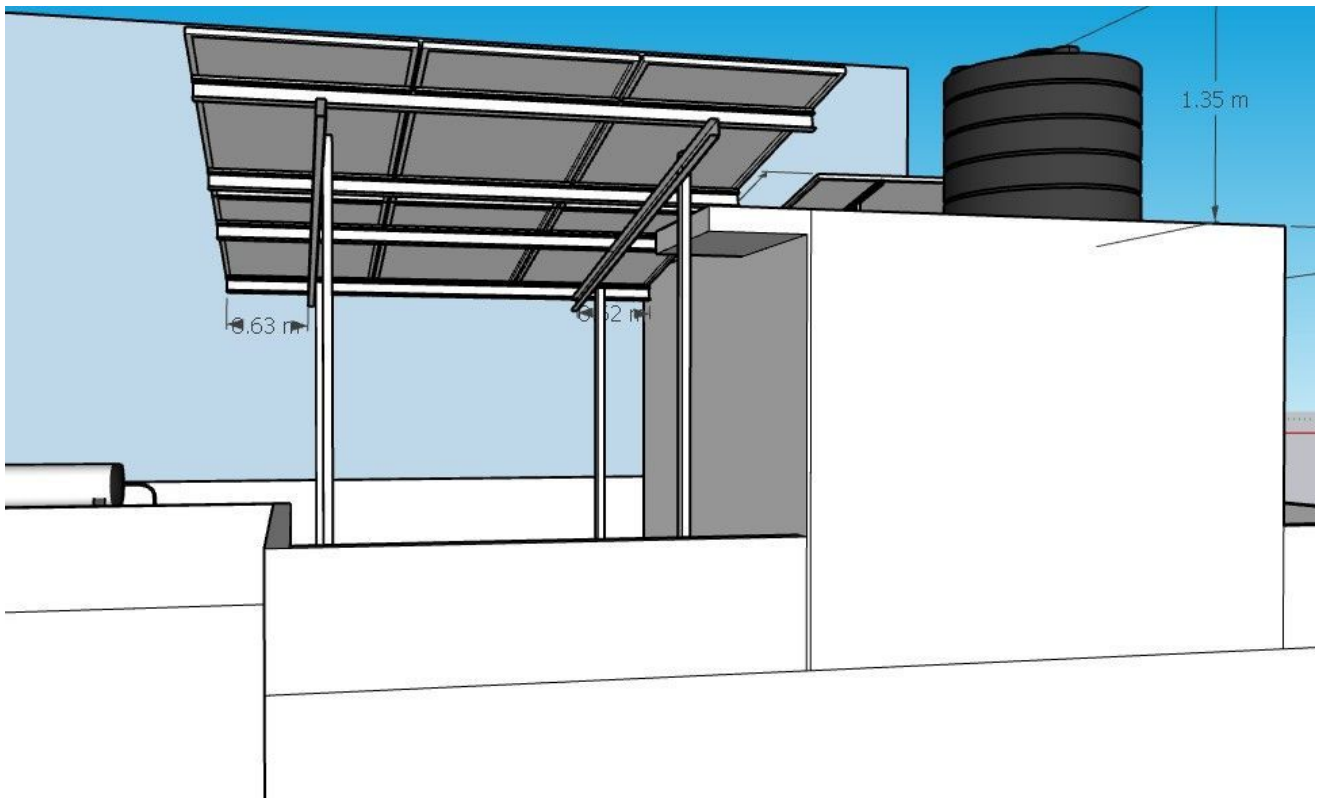
*Due to the space constistance the structure post should keep near to the headroom chajja*
