## Technical Site Visit Report

| Report Number | ESV-2026-0125 |
| Project Name | Bomman Sreekumar |
| Visit Date | 2026-05-30 |

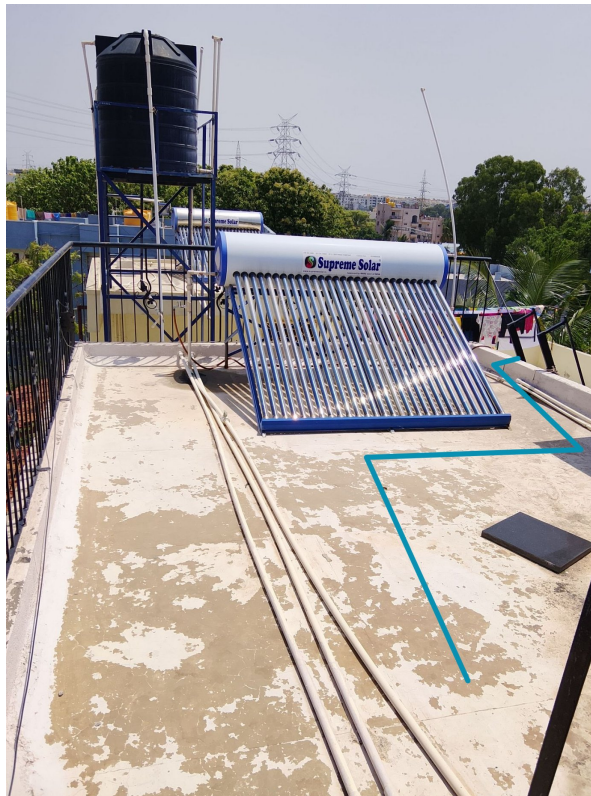
*At the time of installation removing solar water is under customer scope*

| # | Observation |
|---|---|
| 4 | Re locate the solar water heater is under customer scope |

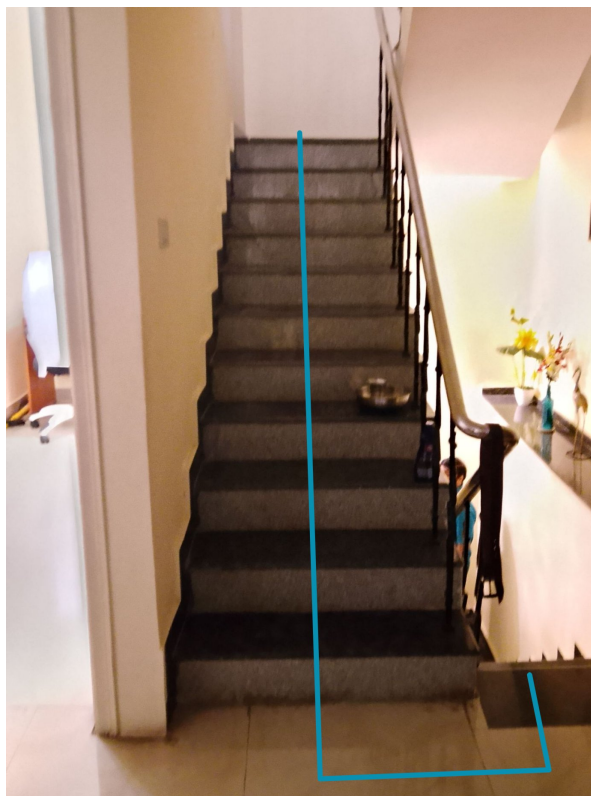
*This route (using Staircase) will be followed to carry Small items.*

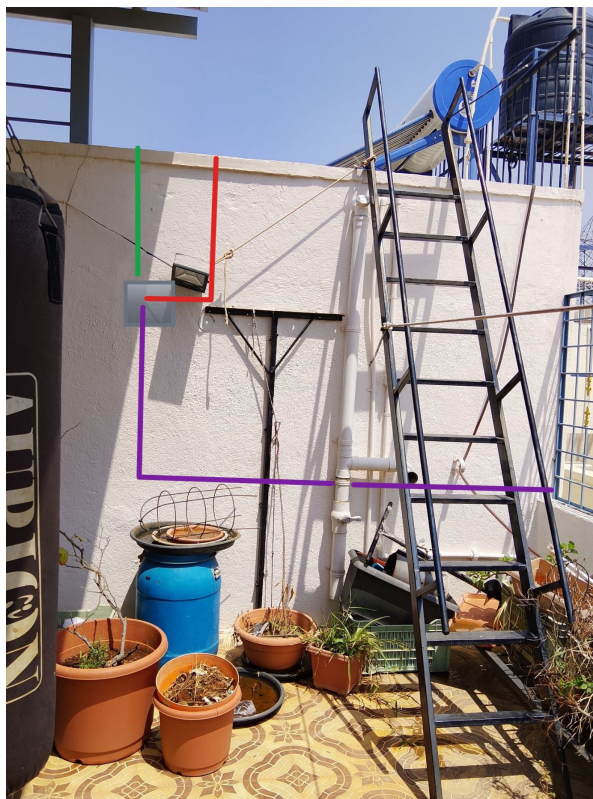
*Make a hole to run the DC Cable inside the solar meter location*

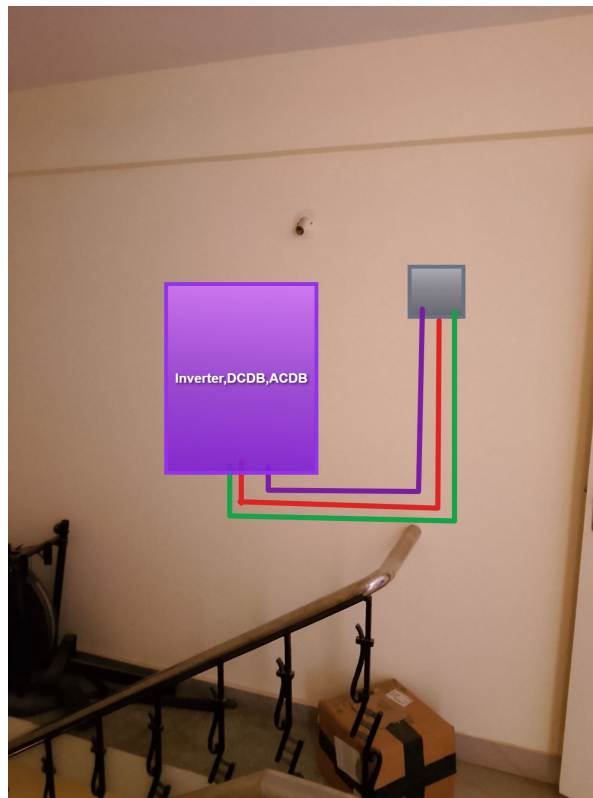
*In same hole to run the AC cable and Ac earthing Cable*

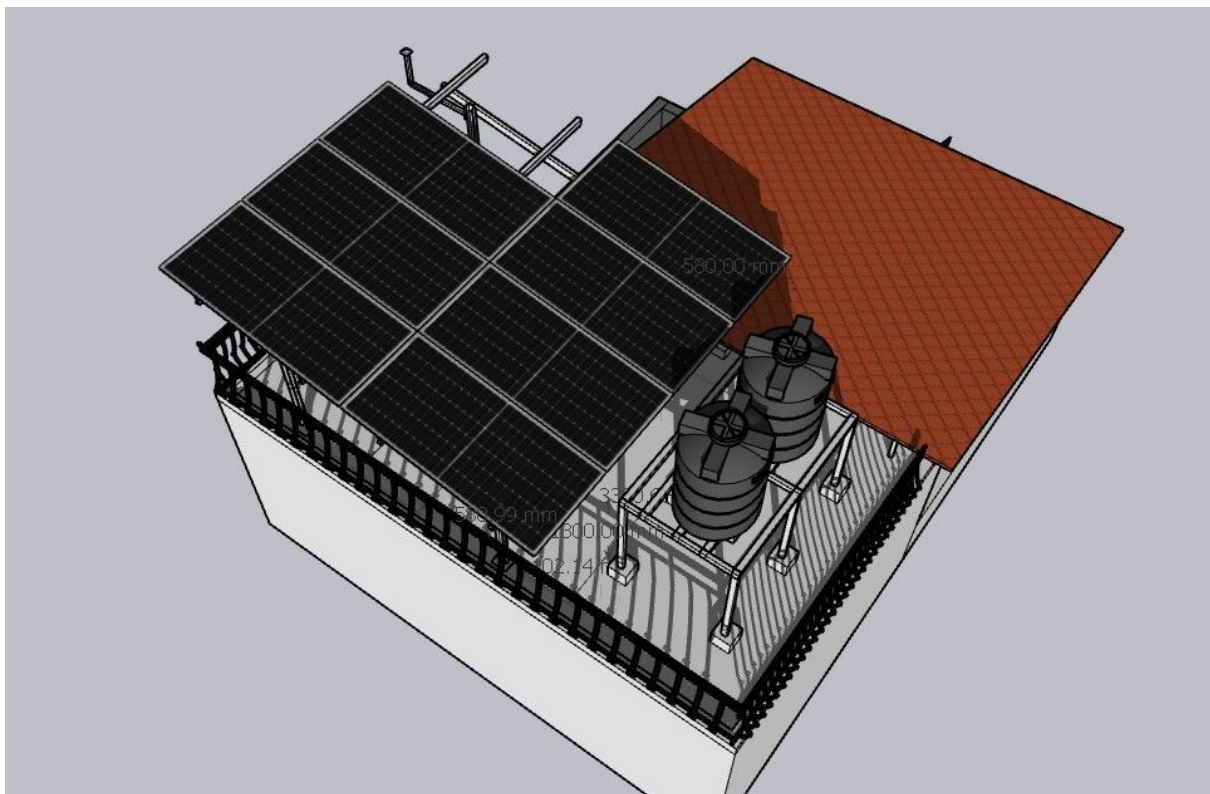
## Shadow Analysis

| # | Question | Answer | Notes |
|---|---|---|---|
| 23 | Is there any shadow that affects the solar installation? | Yes | The existing water tank shadow will fall on the panels during the month of May to September between 3.30 PM to 4.00 PM. |

The existing water tank shadow will fall on the panels during the month of May to September between 3.30 PM to 4.00 PM.
