## Technical Site Visit Report

| Report Number | ESV-2026-0125 |
| Project Name | Bomman Sreekumar |
| Site Address | #5, Krishna kuteer villas, phase 2, 5th cross, Hoodi.Bangalore 560048 |

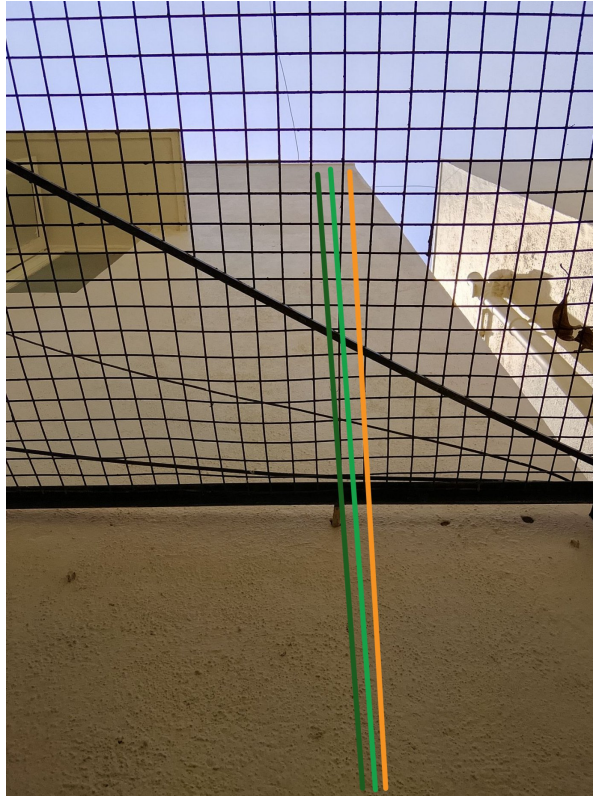
*The AC cable has to be terminate in the main distrinution board*

| # | Observation |
|---|---|
| 1 | The client main meter is located faraway ,but we have to terminate in main distribution board |
