# AI ROAD INSPECTION REPORT

## Surface Crack Detection System

**Inspection ID:** INS-20260720-082436

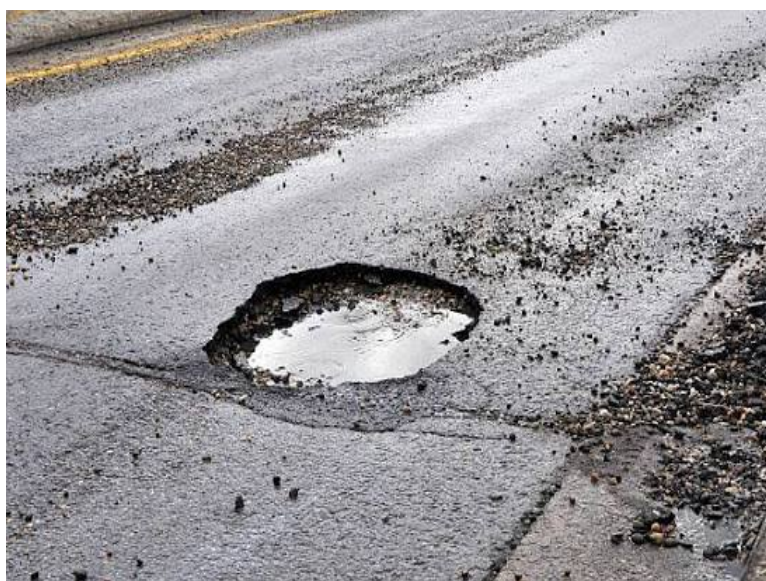
| Parameter | Value |
|---|---|
| Prediction | Potholes |
| Confidence | 74.40% |
| Severity | High |

Immediate pothole patch repair using cold asphalt.
