PROJECT : PROPOSED COMMERCIAL BUILDING FOR NIGHTINGALE

NURSING HOME SITUATED AT NO 129, THELANGAPATHA ROAD, WATTALA.

REFERANCE: CERTIFICATION OF CIVIL STRUCTURAL WORKS

Structural Safety Report - Nightingale Nursing Home

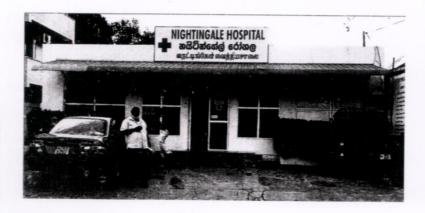
Figure - 3, Front view of Building

The construction of the building is good quality. The materials and workmanship, where visible, are good. The exterior walls of the building appear to be rough finish with temporary canopy attachments. Common minor settlement cracks (Hair crack) were observed in the foundation walls along the north side of the building. But, repair should not be necessary. The roof coverings are generally in good condition.

Visible portions of the floor, walls, and roof framing and structural components were in good condition. No major defects or deficiencies noted at the time of inspection.
