**TCNA TEST REPORT NUMBER:** TCNA-0219-19 **PAGE: 1 OF 8**

**TEST REQUESTED BY:** United Plastics Corporation

**TEST PROCEDURE:** [ASTM C627-18: "A Standard Test Method for Evaluating Ceramic Floor Tile Installation Systems Using the Robinson-Type Floor Tester"](#)

**TEST SUBJECT MATERIAL:** Identified by client as: "dB Ceramic"

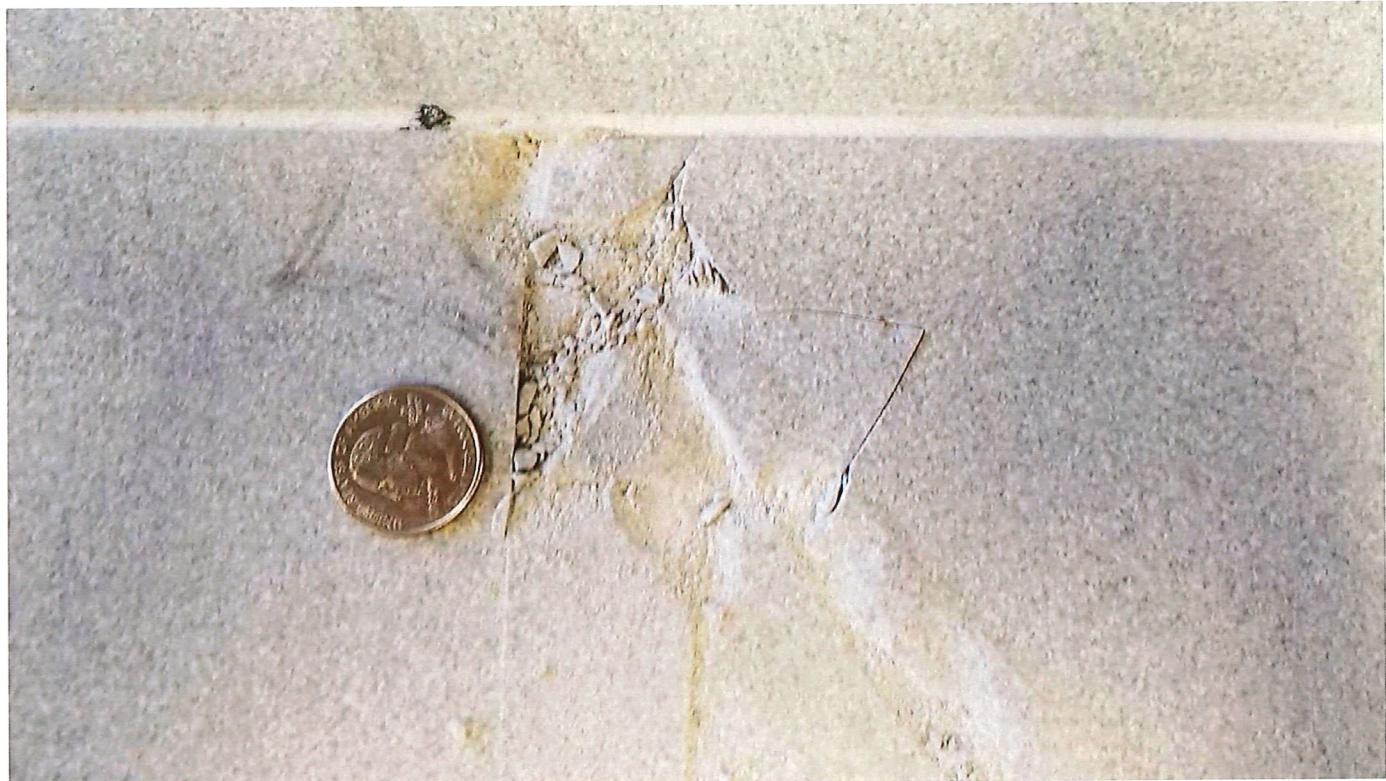
Cycle	Wheels	Weight (lb)	Observations
1	Soft Rubber	100	No damage observed.
2		200	No damage observed.
3		300	No damage observed.
4		300	No damage observed.
5	Hard Rubber	100	No damage observed.
6		200	3 broken tiles observed.
7		300	
8		300	
9	Steel	50	
10		100	
11		150	
12		200	
13		250	
14		300

**Image 2:** Broken Tile

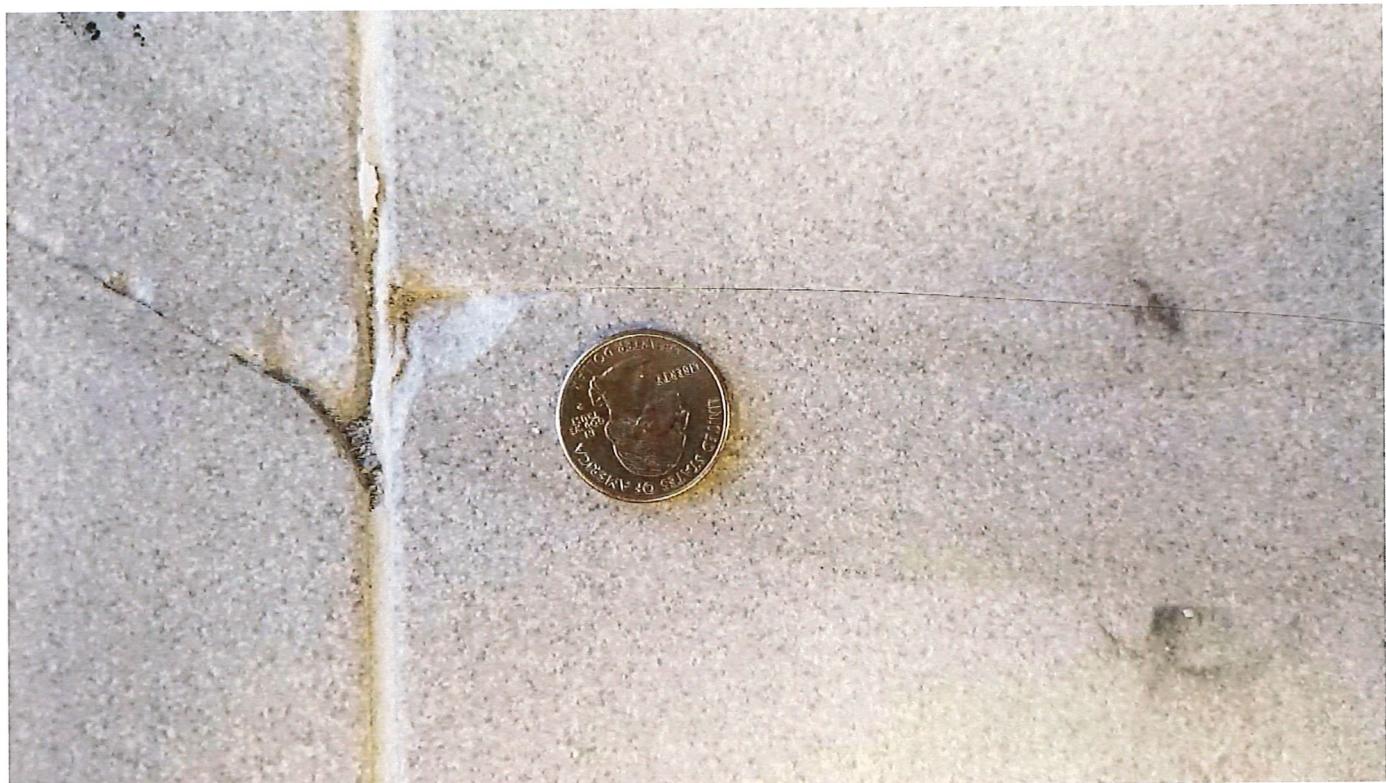
**Image 3:** Broken Tile

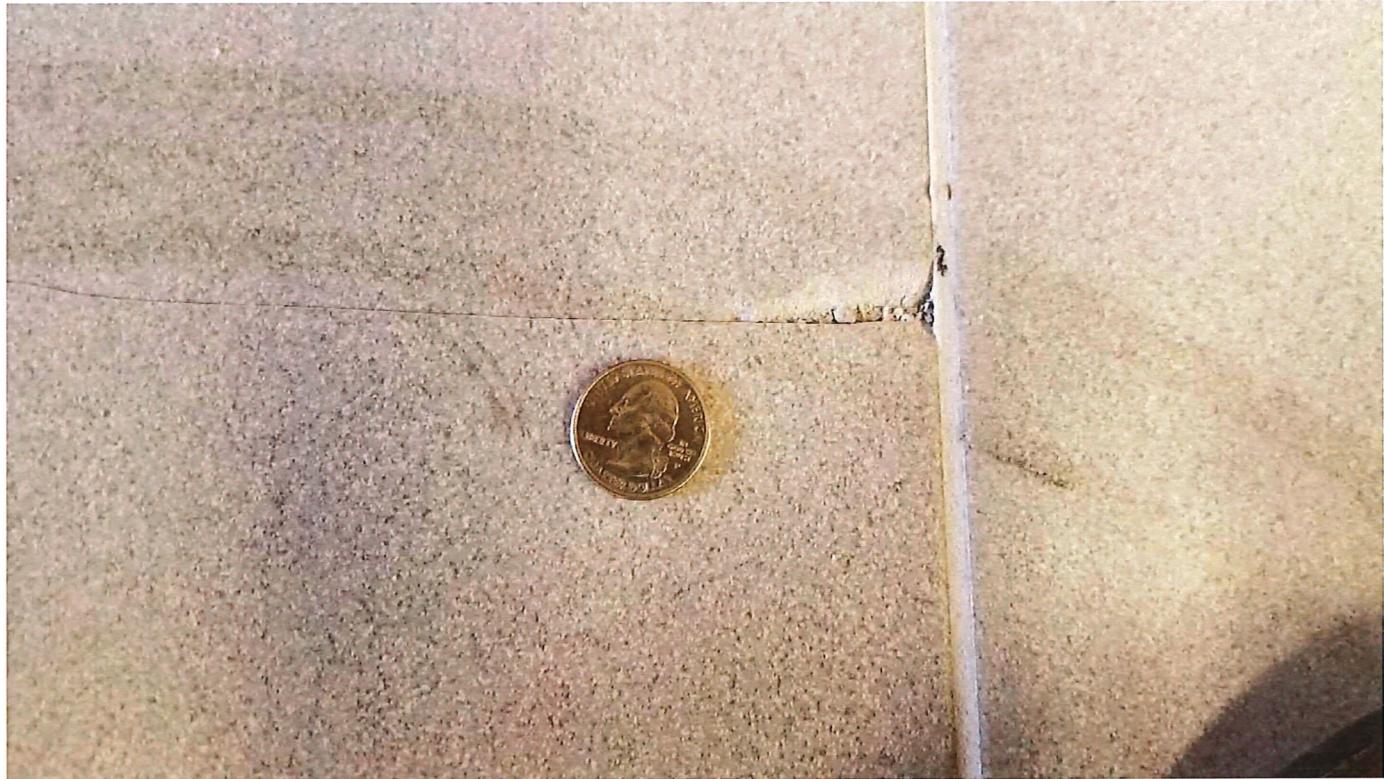
**Image 4:** Broken Tile
