- CBCT/CT 503 QA Test -  
 - CTP 404 Results -  
 HU Linearity tolerance: 40  
 HU Linearity ROIs:  
 Air: 84.0, PMP: 691.0, LDPE: 754.0, Poly: 794.0,  
 Acrylic: 922.0, Delrin: 1081.0, Teflon: 1560.0  
 HU Passed?: False  
 Low contrast visibility: 2.06  
 Geometric Line Average (mm): 50.18  
 Geometry Passed?: True  
 Measured Slice Thickness (mm): 1.028  
 Slice Thickness Passed? True

- CTP528 Results -

- CTP486 Results -

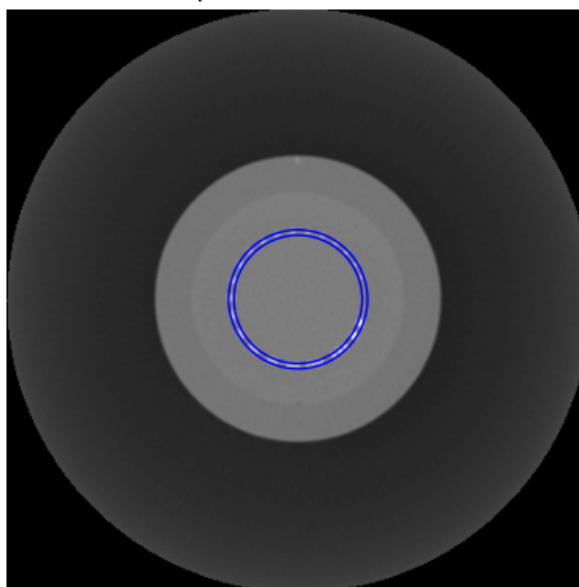
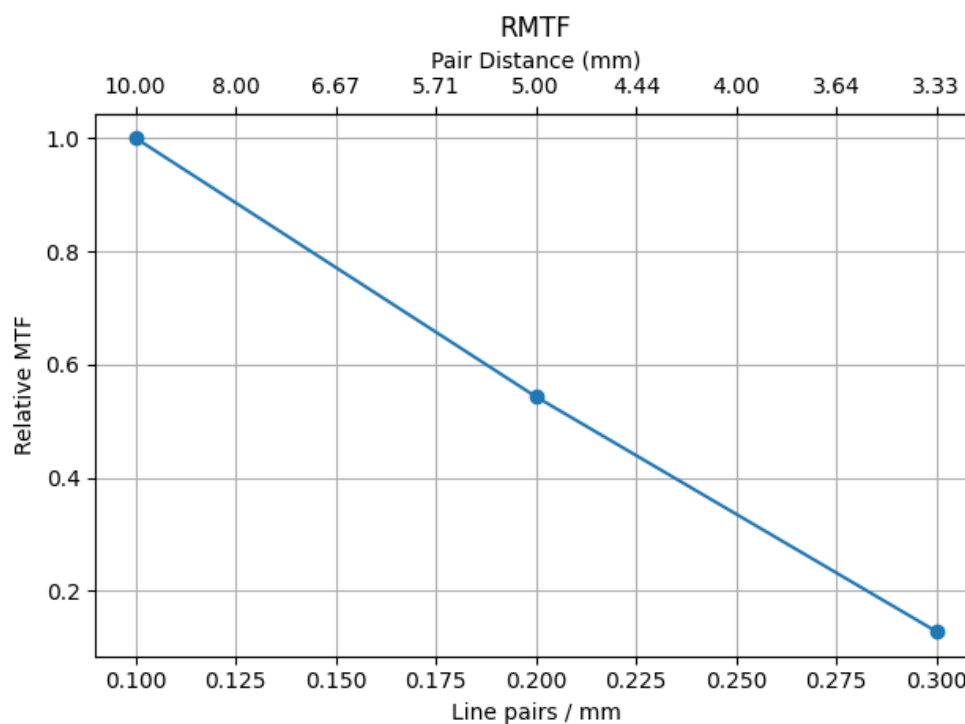
Spatial Resolution

MTF 80% (lp/mm): 0.14

MTF 50% (lp/mm): 0.21

MTF 30% (lp/mm): 0.26

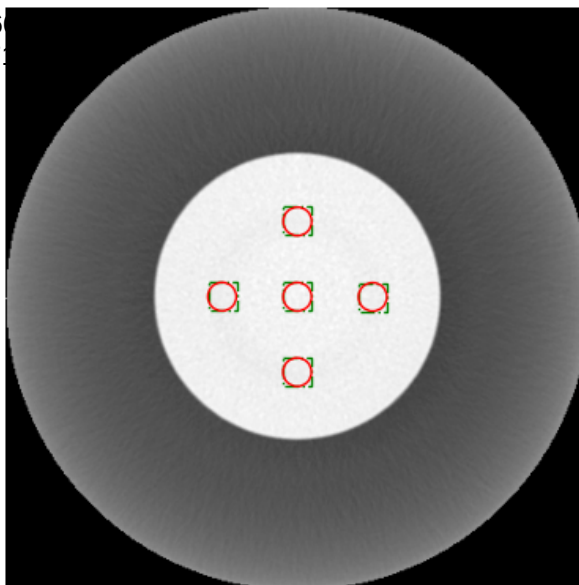
HU Uniformity

Uniformity ROIs: Top: 831.0, Right: 829.0, Bottom: 821.0, Left: 822.5, Center: 849.0

Uniformity index: -1.514

Integral non-uniformity: 0.0076

Uniformity Passed?: False
