Metadata:  
 Físico: Victor  
 Unidade: True Beam  
 Data: 25\_10\_2024

- CBCT/CT 504 QA Test -  
 - CTP 404 Results -  
 HU Linearity tolerance: 40  
 HU Linearity ROIs:  
 Air: -1000.0, PMP: -207.0, LDPE: -111.0, Poly:  
 -54.0, Acrylic: 118.0, Delrin: 363.0, Teflon:  
 1005.5  
 HU Passed?: True  
 Low contrast visibility: 14.88  
 Geometric Line Average (mm): 49.77  
 Geometry Passed?: True  
 Measured Slice Thickness (mm): 1.427  
 Slice Thickness Passed? False

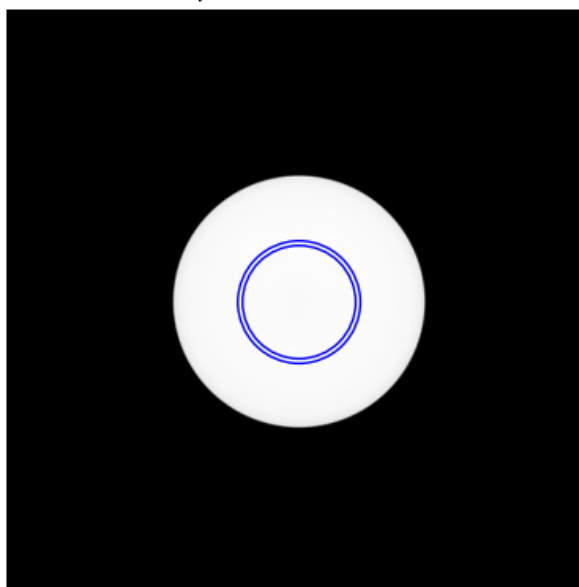
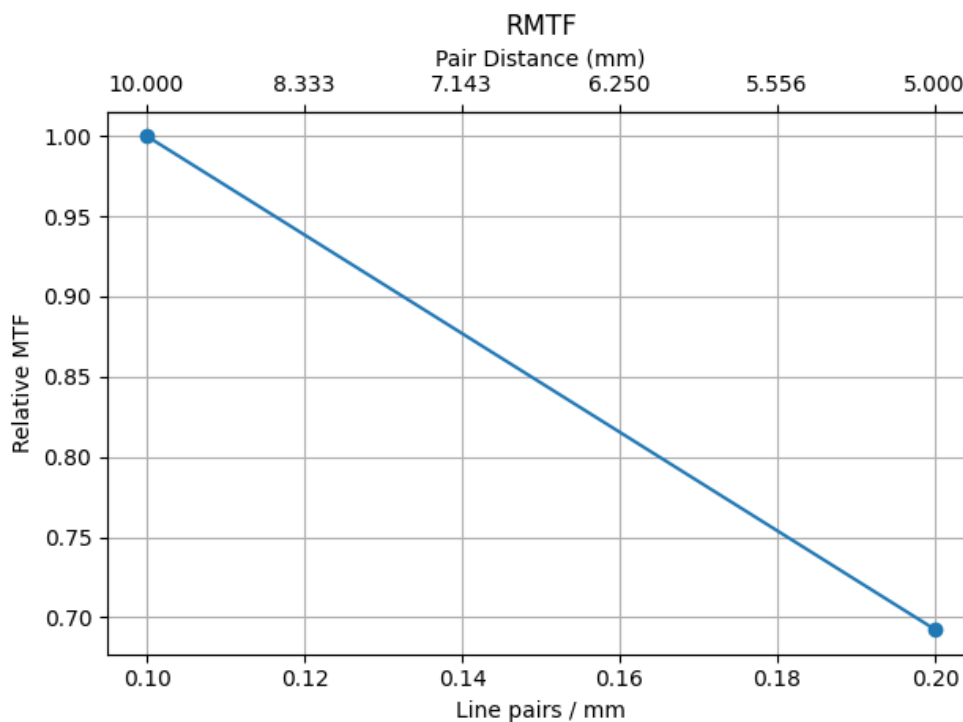
Spatial Resolution

- CTP528 Results -

MTF 80% (lp/mm): 0.17

MTF 50% (lp/mm): 0.26

MTF 30% (lp/mm): 0.33

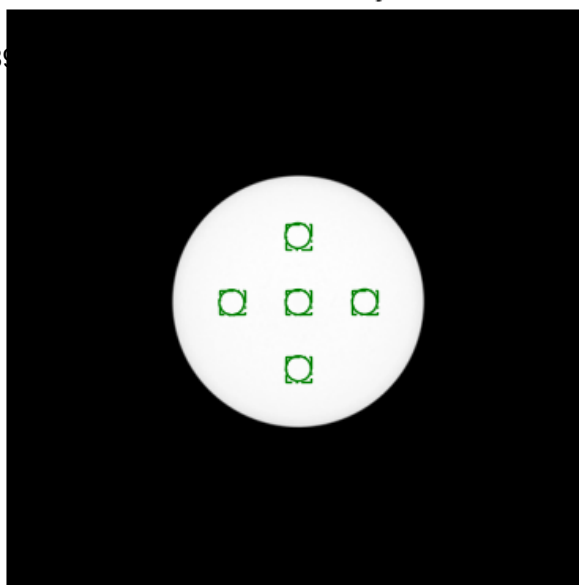
HU Uniformity

- CTP486 Results -

Uniformity tolerance: 40

Uniformity ROIs: Top: 0.0, Right: -2.0, Bottom: -4.0, Left: -3.0, Center: -2.0

Uniformity index: 0.200

Integral non-uniformity: 0.0020

Uniformity Passed?: True

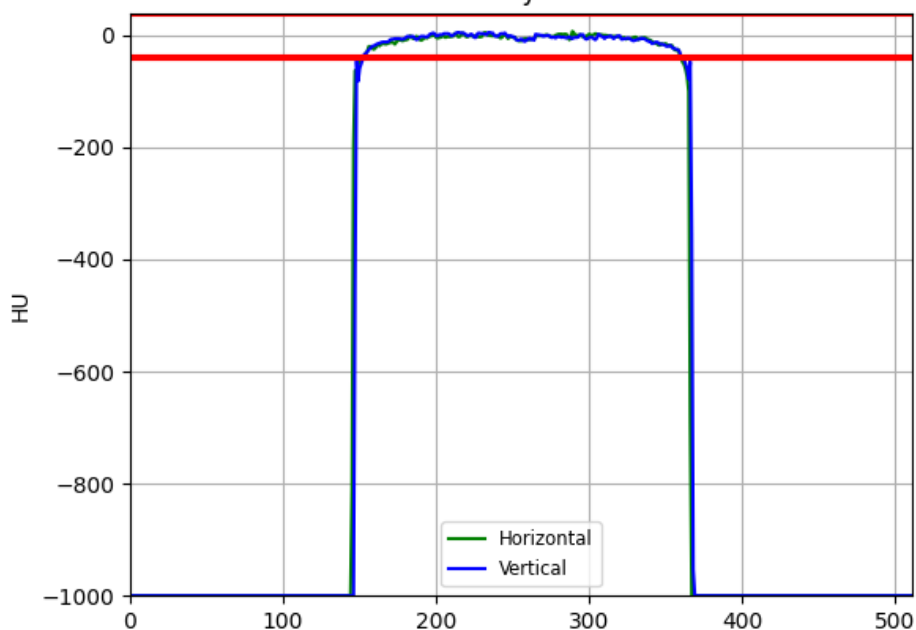
Uniformity Profiles

Max Noise Power frequency: 0.0625

Average Noise Power: 0.1326405887739

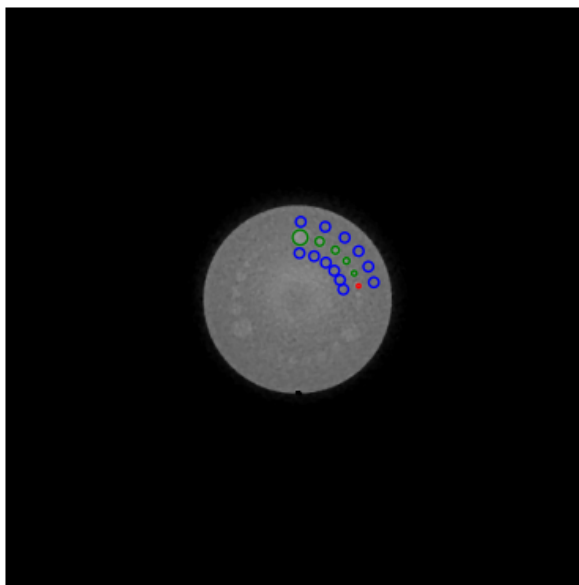
Low Contrast

- CTP515 Results -

CNR threshold: 15

Low contrast ROIs "seen": 5
