Unidade: Versa

Data: 11\_11\_2025

- CBCT/CT 503 QA Test -

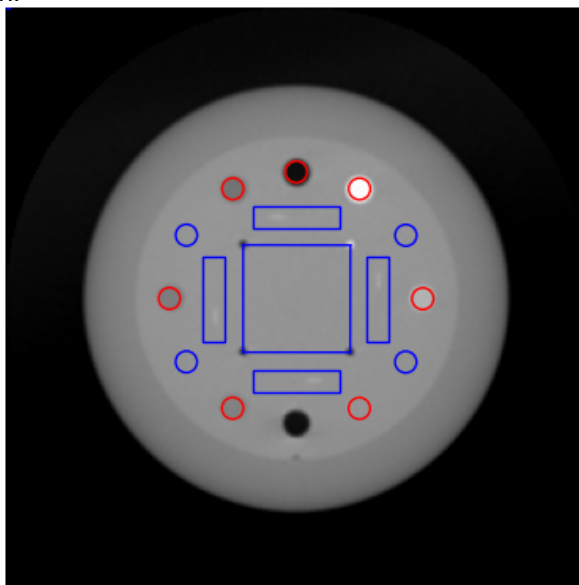
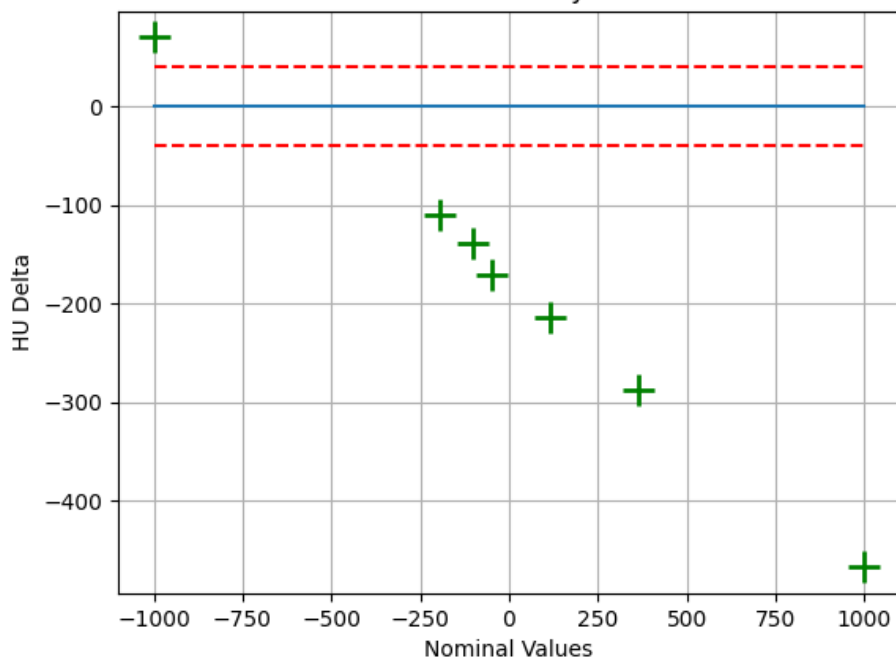
HU Linearity tolerance: 40

HU Linearity ROIs:

Air: -930.0, PMP: -305.5, LDPE: -242.0, Poly:

-218.0, Acrylic: -99.0, Delrin: 78.0, Teflon:

533.0

HU Passed?: False

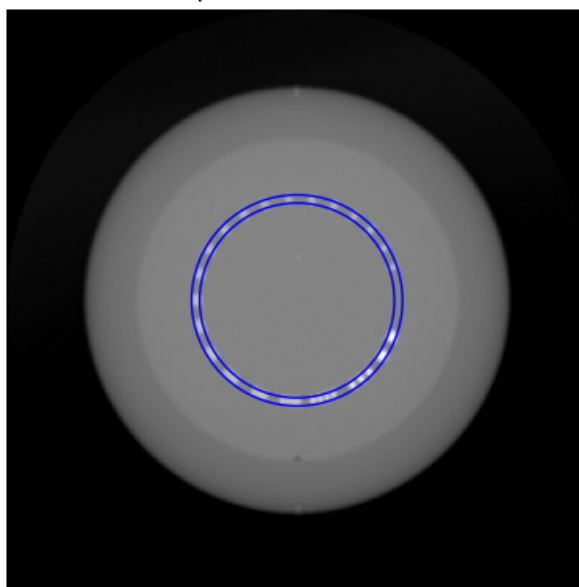
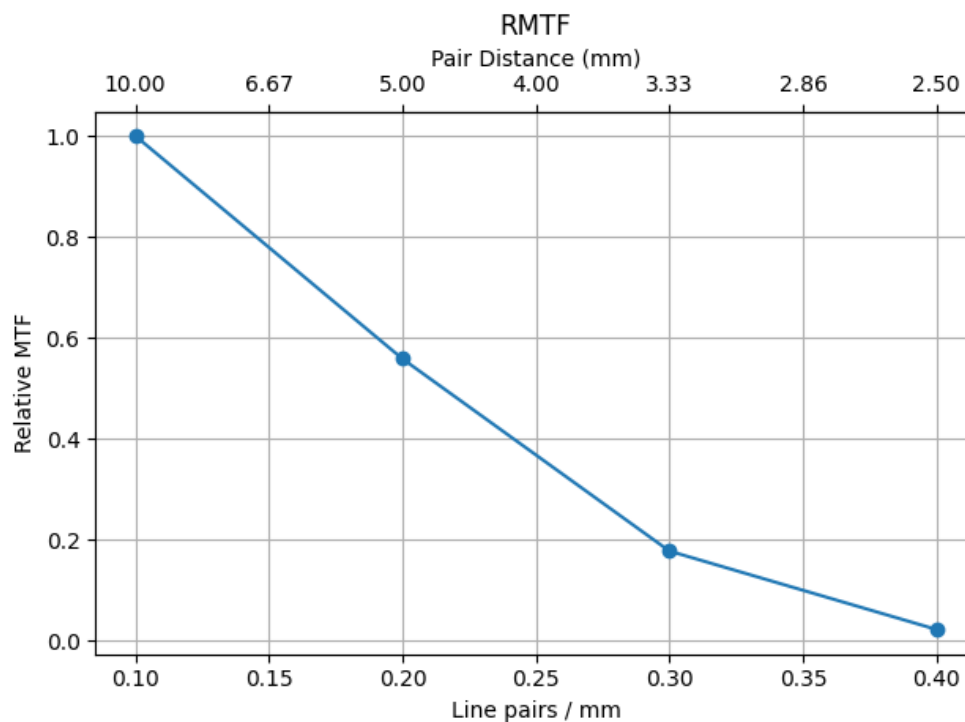
Spatial Resolution

MTF 80% (lp/mm): 0.15

MTF 50% (lp/mm): 0.22

MTF 30% (lp/mm): 0.27

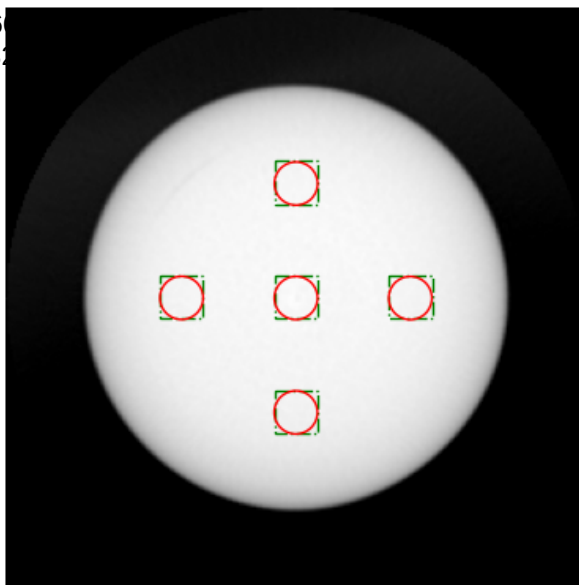
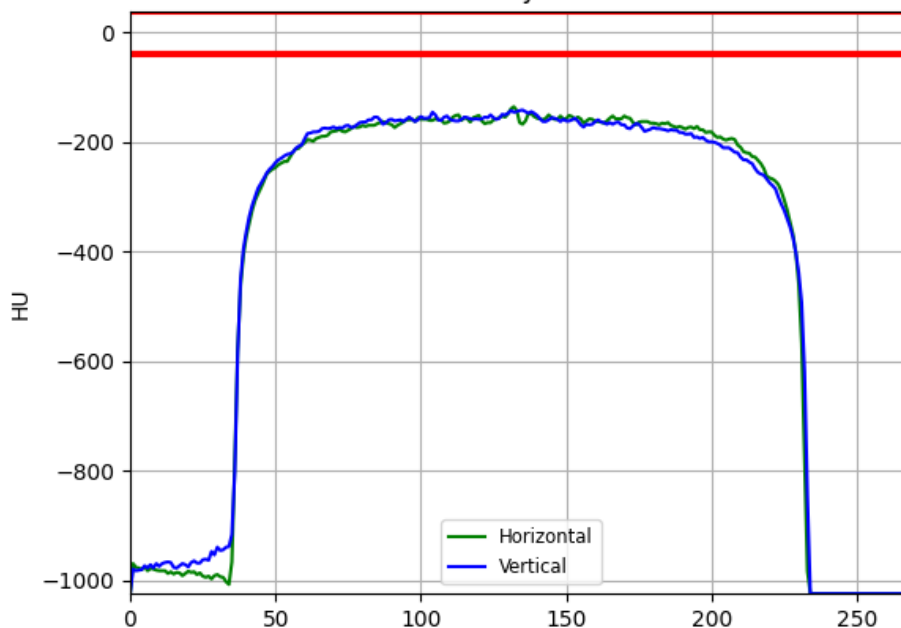
HU Uniformity

Uniformity tolerance: 40

Uniformity ROIs: Top: -163.0, Right: -169.0, Bottom: -180.0, Left: -169.0, Center: -155.0

Uniformity index: -2.959

Integral non-uniformity: 0.0150

Uniformity Passed?: False
