Unidade: Versa

Data: 05-07-2026

- CBCT/CT 503 QA Test -

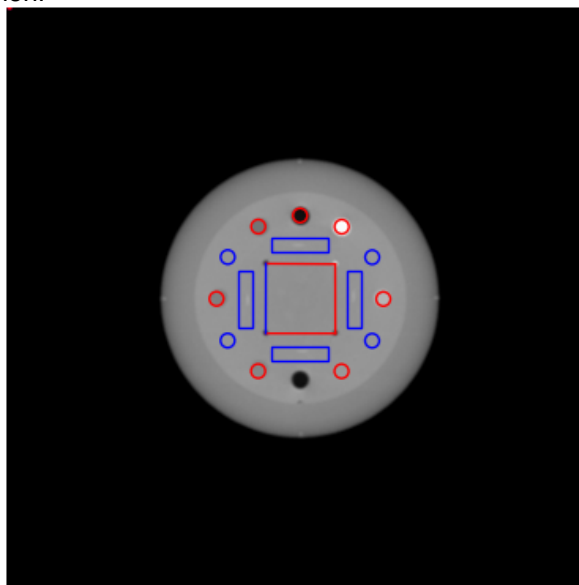
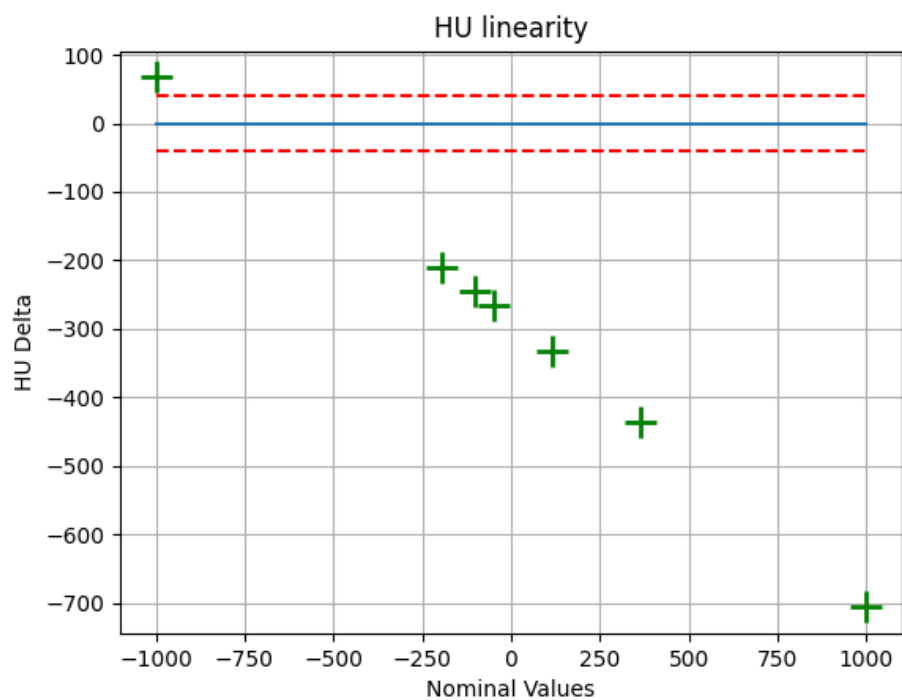
HU Linearity (44)

- CTP 404 Results -

HU Linearity tolerance: 40

HU Linearity ROIs:

Air: -933.0, PMP: -407.5, LDPE: -349.0, Poly:

-313.5, Acrylic: -217.0, Delrin: -70.5, Teflon:

294.0

HU Passed?: False

Low contrast visibility: 2.03

Geometric Line Average (mm): 48.87

Geometry Passed?: False

Measured Slice Thickness (mm): 2.612

Slice Thickness Passed? False

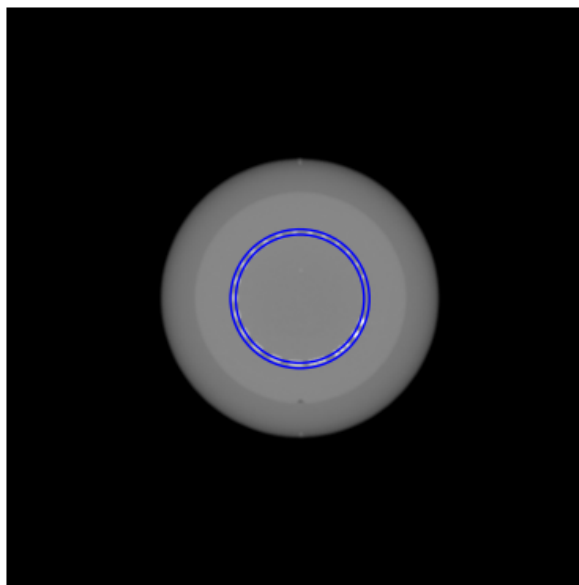
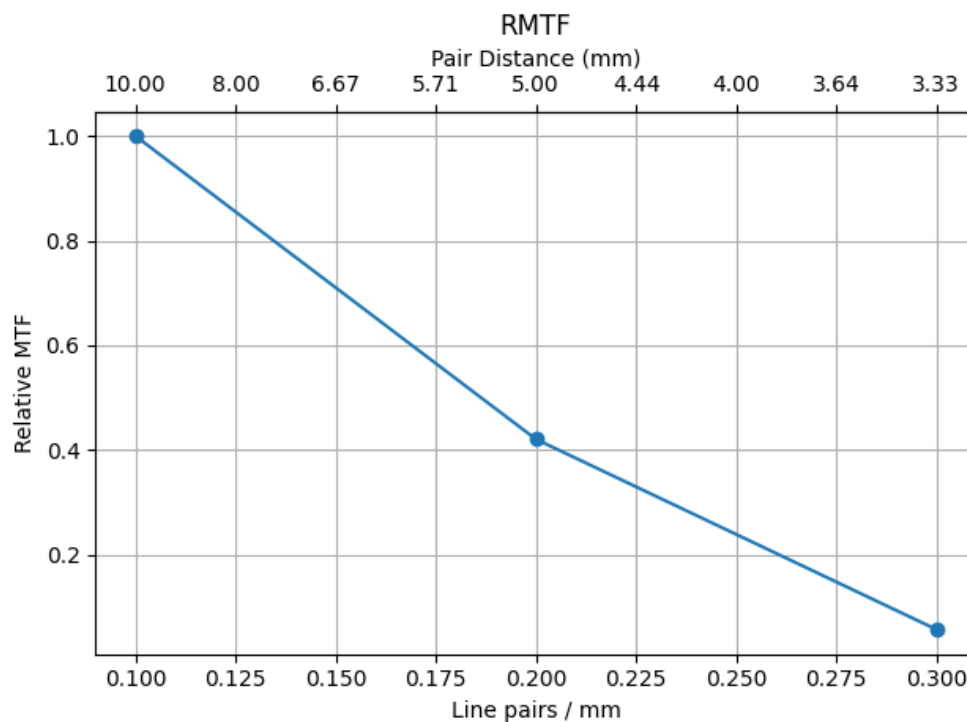
Spatial Resolution (34)

## - CTP528 Results -

MTF 80% (lp/mm): 0.13

MTF 50% (lp/mm): 0.19

MTF 30% (lp/mm): 0.23

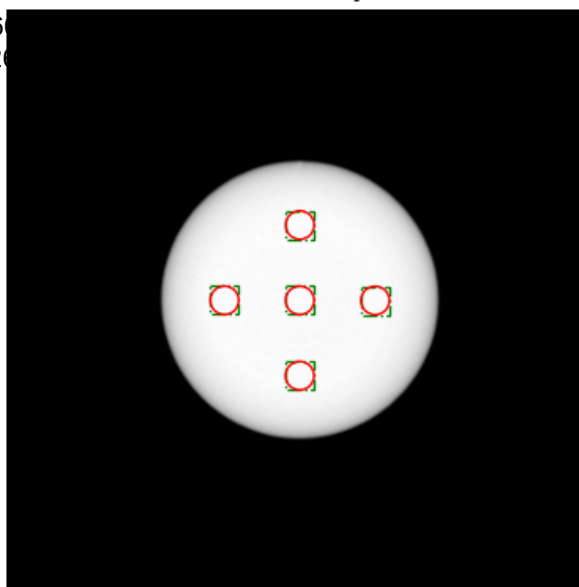
HU Uniformity (7)

## - CTP486 Results -

Uniformity tolerance: 40

Uniformity ROIs: Top: -253.0, Right: -255.0, Bottom: -255.0, Left: -253.0, Center: -256.0

Uniformity index: 0.403

Integral non-uniformity: 0.0020

Uniformity Passed?: False

Max Noise Power frequency: 0.0666666

Average Noise Power: 0.204243902762
