## Complaints about NYC subway safety

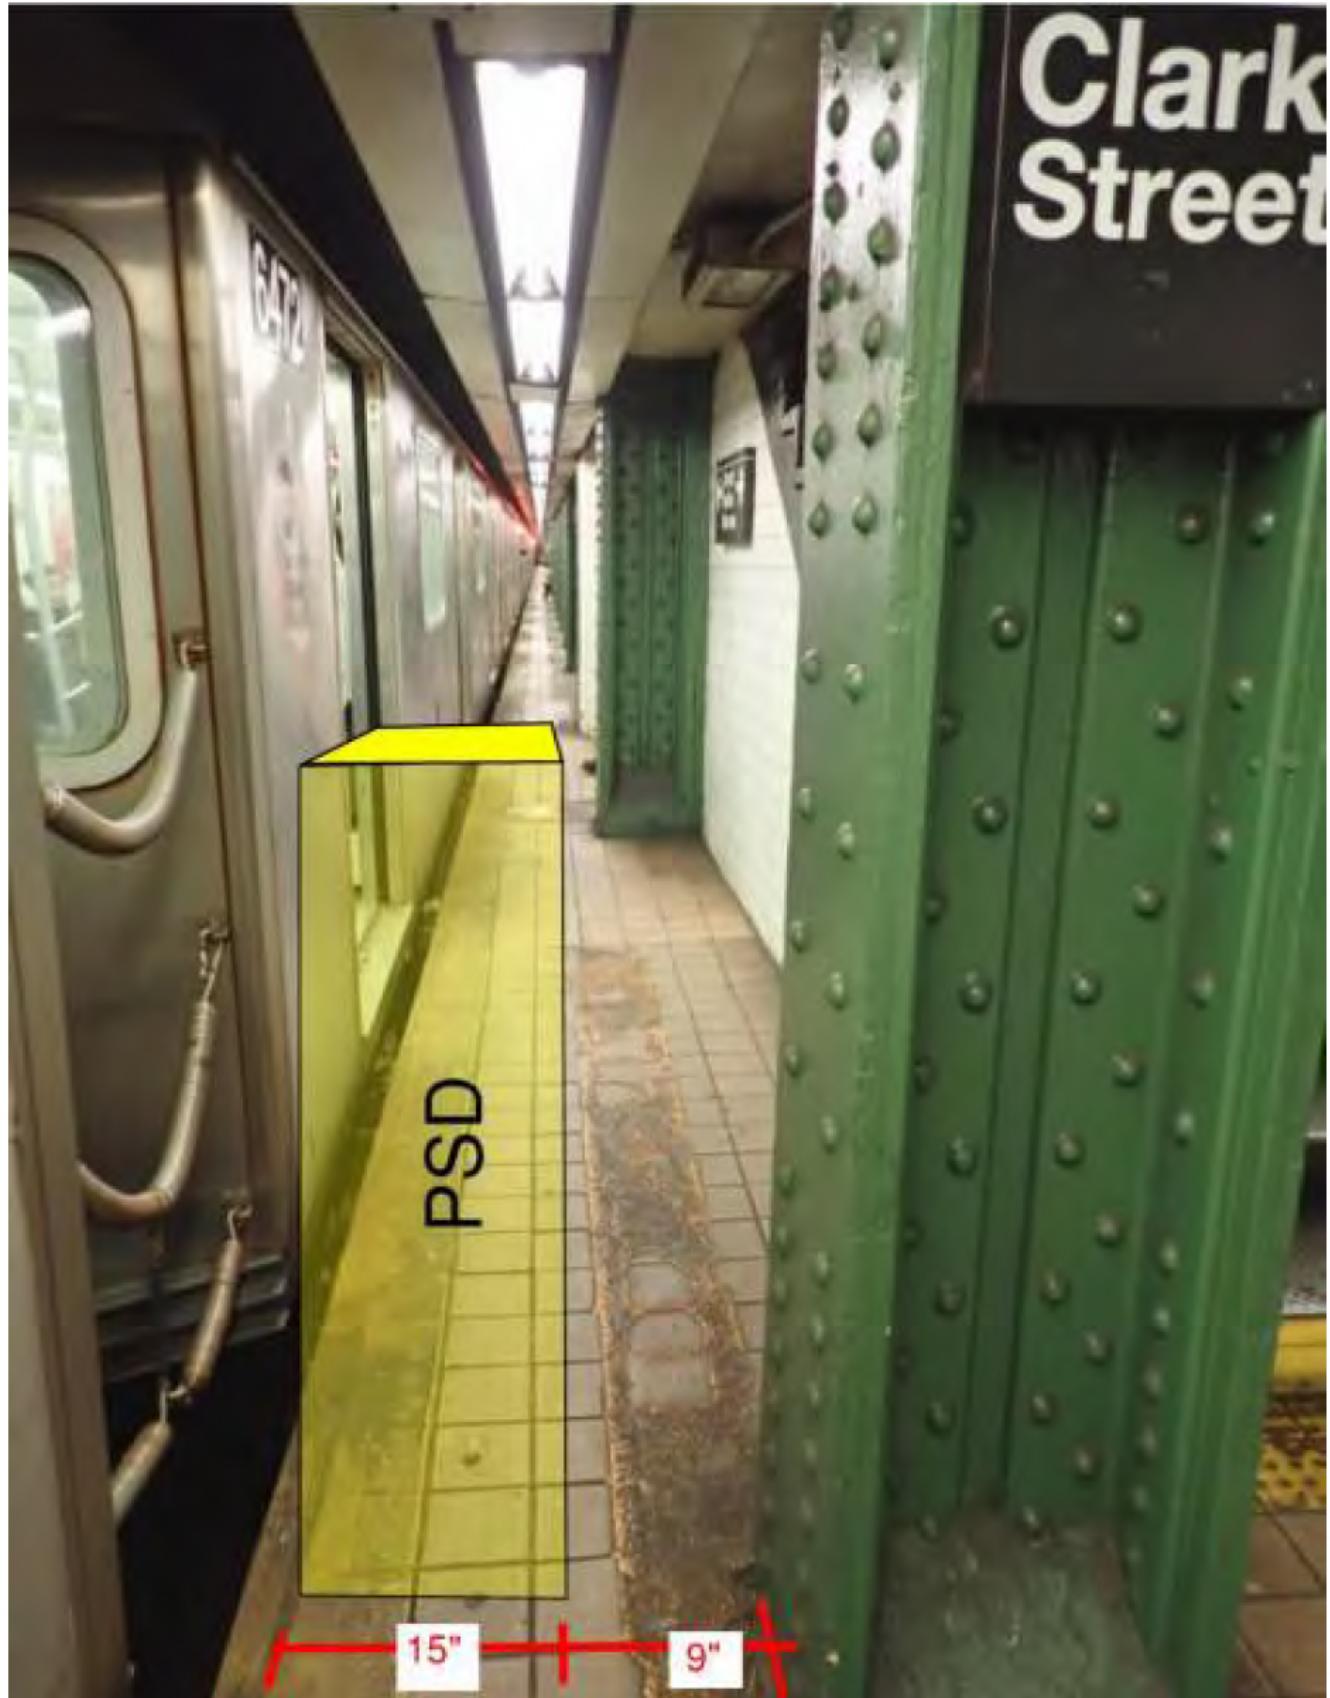
The subway system also has a lot of sketchy and narrow spots that are hazardous. For instance see the image below from Clark street. This image was captured from their 4000 page platform screen door feasibility study page 385 (see <https://www.mta.info/document/73241>). That study is very much a case of cherry picking data so that MTA can make excuses to not make safety improvements. They cited 32 inches is needed for ADA compliance that section is 24 inches even without a platform screen door. The fact that they are to board and off-board trains in that strip of the platform is downright despicable. No one regardless of disability should be standing on or walking through those tight platform sections.

**Figure 1 – Non-compliant ADA condition  
Clark Street Station**

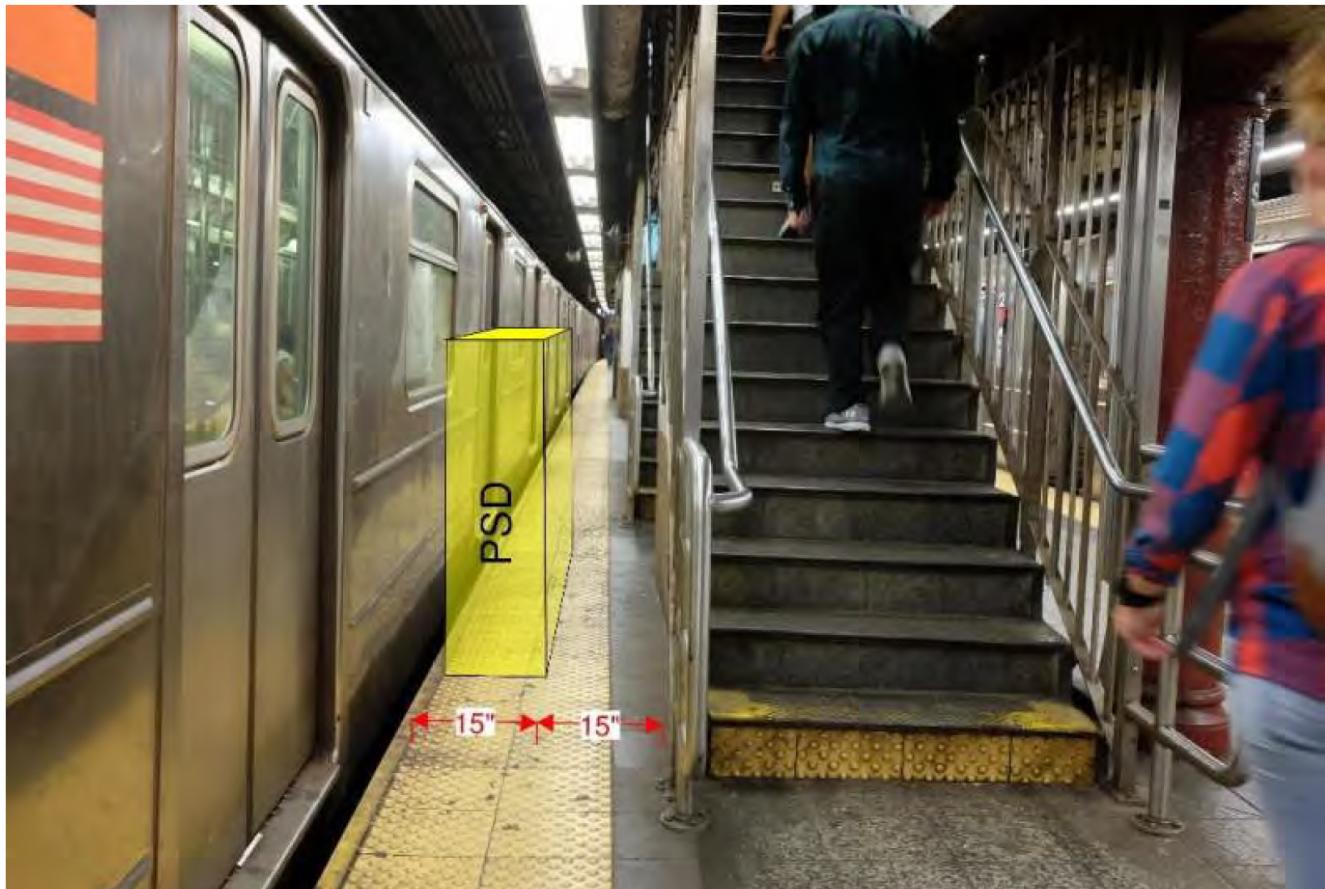
Another example is 72nd street. It is 30 inches without the platform screen door (PSD) and ADA requires 36 inches. If someone tried to roll a wheel chair through that section they would be on the yellow recommended no-step line.

*Figure 1 – Non-compliant ADA condition  
72<sup>nd</sup> Street Station*
